Aviation Safety Department
2701 N. Forum Drive, D10
Grand Prairie, Texas 75052

Vehicle Engine Multifunction Display (VEMD) Summary for U.S. CBP AS350B3 S/N 3592

NTSB Accident #: CEN15TA017
Aircraft Model & S/N: AS350B3 S/N 3592
Aircraft Registration: N852BP
Operator: U.S. Customs Border Protection
Location: Lordsburg, New Mexico
Date: 18 October 2014

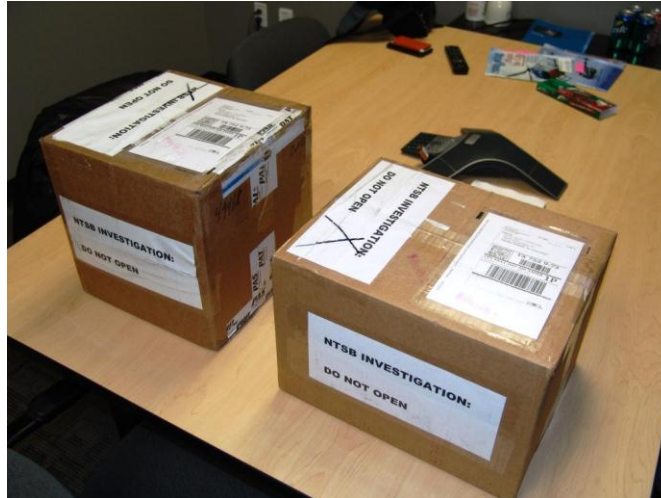
VEMD and DECU Boxes as received

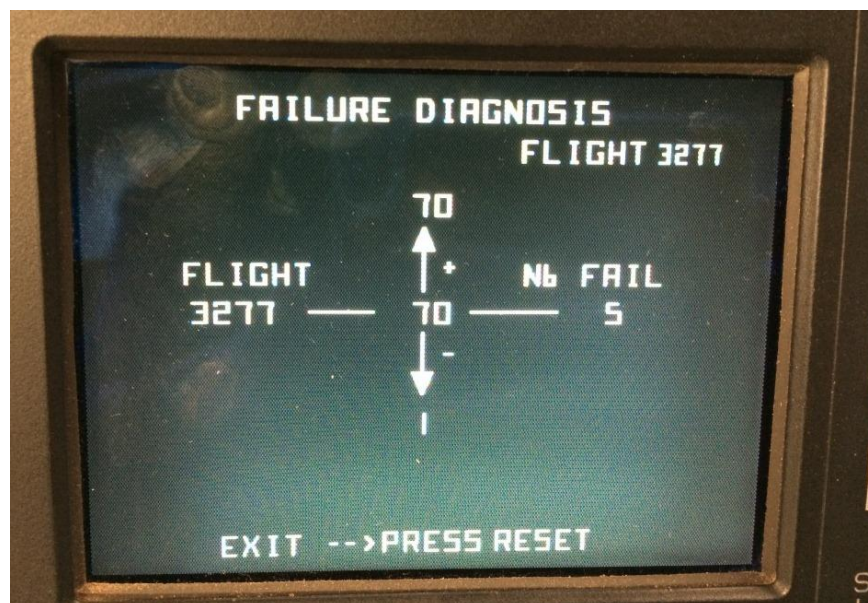
Test Reference 48 “INVAL NGMD – A” recorded on left module at 09 mn 01 s.

This failure code is raised when one of the NG values is declared invalid or is not available (the DECU of the B3 is a single channel).

FAIL	
NG	92.0	%
TRQ	77.0	%
T4	679	°C
T4A	3563.1	°C
T4B	5490.0	°C
PO	847.6	mB
OAT	27.7	°C
IGEN	71	A
VBUS	28.1	V
NF	322	RPM
NR	285	RPM
START	0	A
H/B/P2 P/M	1/1/0/1	Boolean

Parameters associated with detected failure Test Reference 48 “INVAL NGMD – A”

The parameters above indicate that the free turbine speed (NF) was higher than the main rotor speed (NR) and lower than the nominal speed which is consistent with the failure of the engine / main gear box coupling consistent with the main rotor blade impact with the ground.
