Steep Climb and Uncontrolled Descent During Takeoff  
National Air Cargo, Inc., dba National Airlines  
Boeing 747 400 BCF, N949CA  
Bagram, Afghanistan  
April 29, 2013

**Accident Report**

NTSB/AAR-15/01  
PB2015-104951

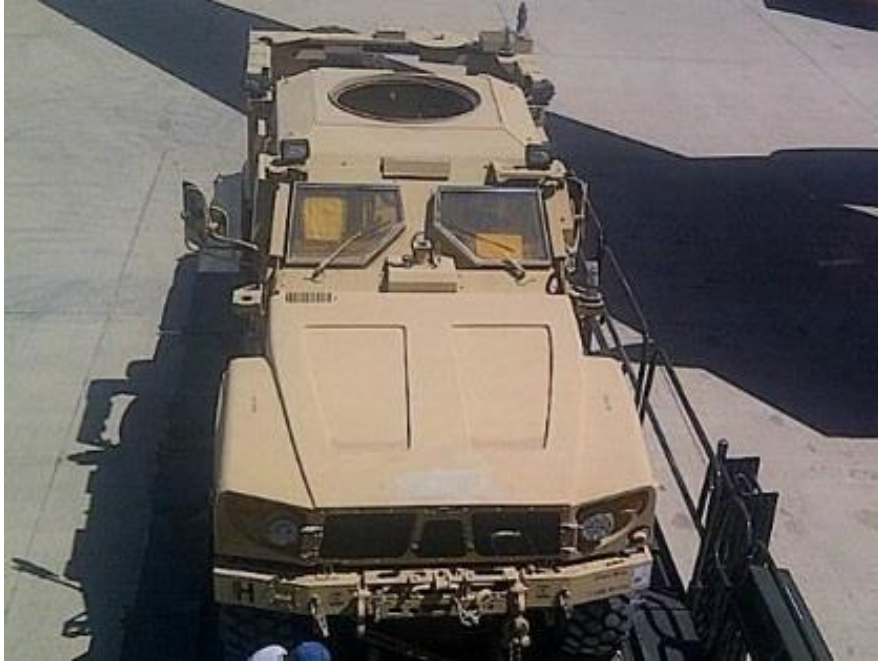
**Figure 1.** Photograph of one of two M-ATVs (secured by chains to its respective pallet) during loading onto the accident airplane via a side door aft of the left wing.

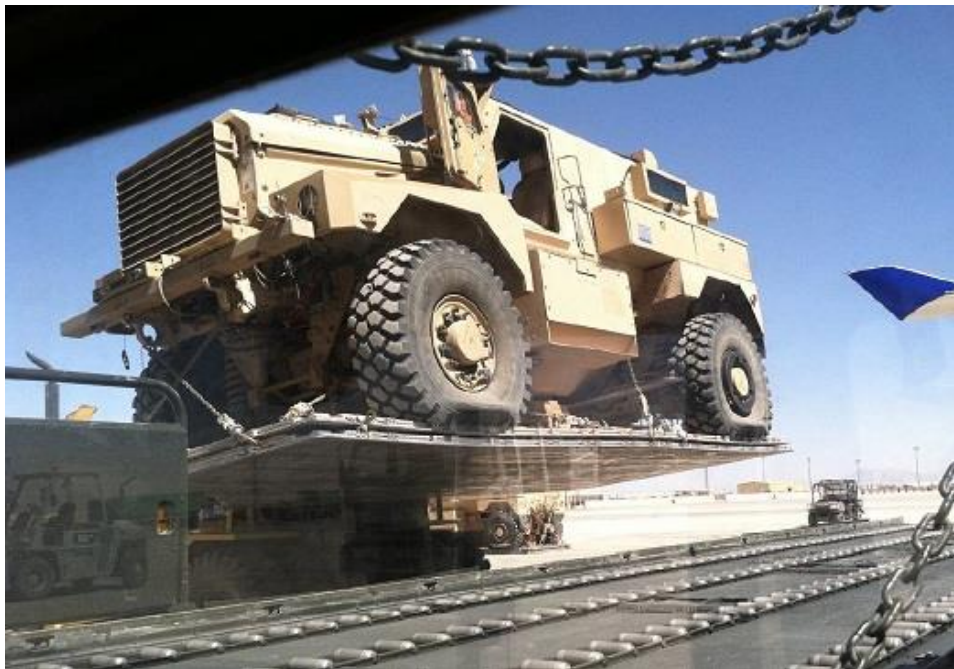
**Figure 2.** Photograph of one of three Cougars (secured by chains to its respective double-pallet platform) during loading onto the accident airplane via a side door aft of the left wing.

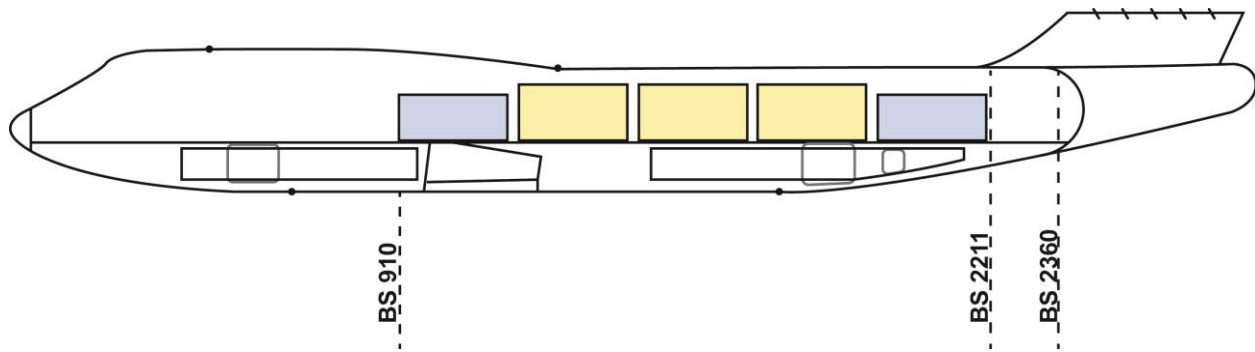
**Figure 3.** Diagram showing the loaded positions of the two M-ATVs (blue) and three Cougars (yellow) with respect to select airplane body station (BS) locations.

**Note:** All of the vehicles were loaded facing forward. All depicted locations are approximate. The back of the rear M-ATV was located about BS 2211, and the front of the forward M-ATV was about BS 910. BS 2360 corresponds with the location of the airplane's aft pressure bulkhead.<sup>6</sup>

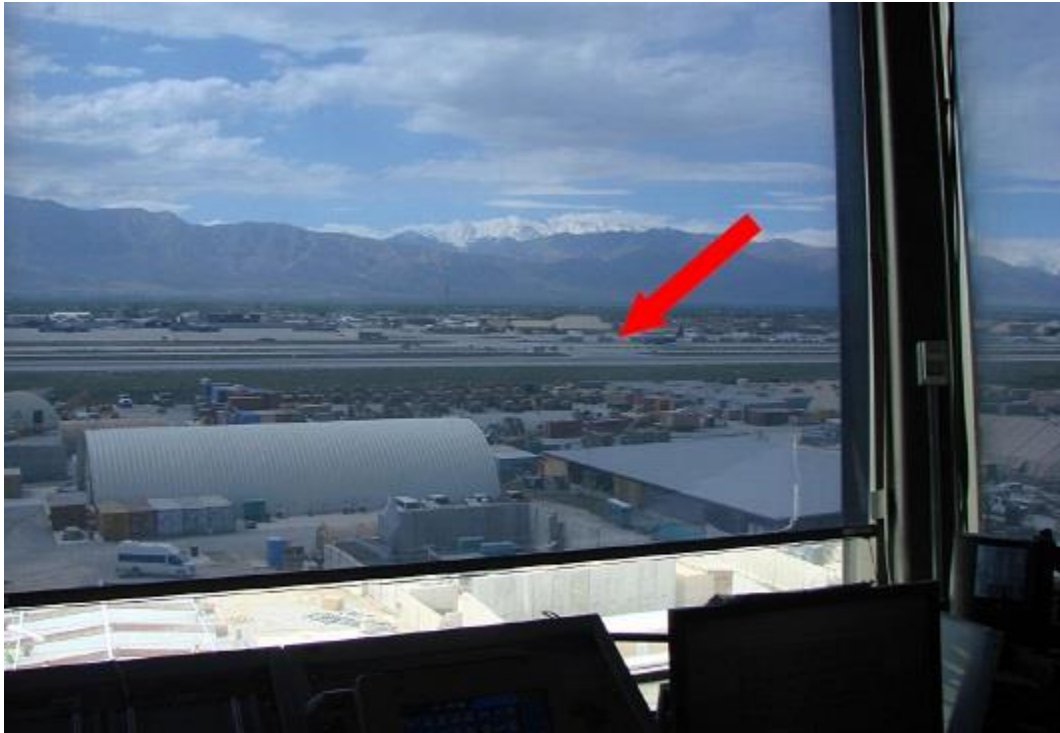
**Figure 4.** Photograph showing the view from the Bagram control tower looking west toward runway 3.

**Note:** The accident airplane departed to the north (from left to right). The red arrow indicates the location of the taxiway C intersection, near where the airplane reportedly rotated.

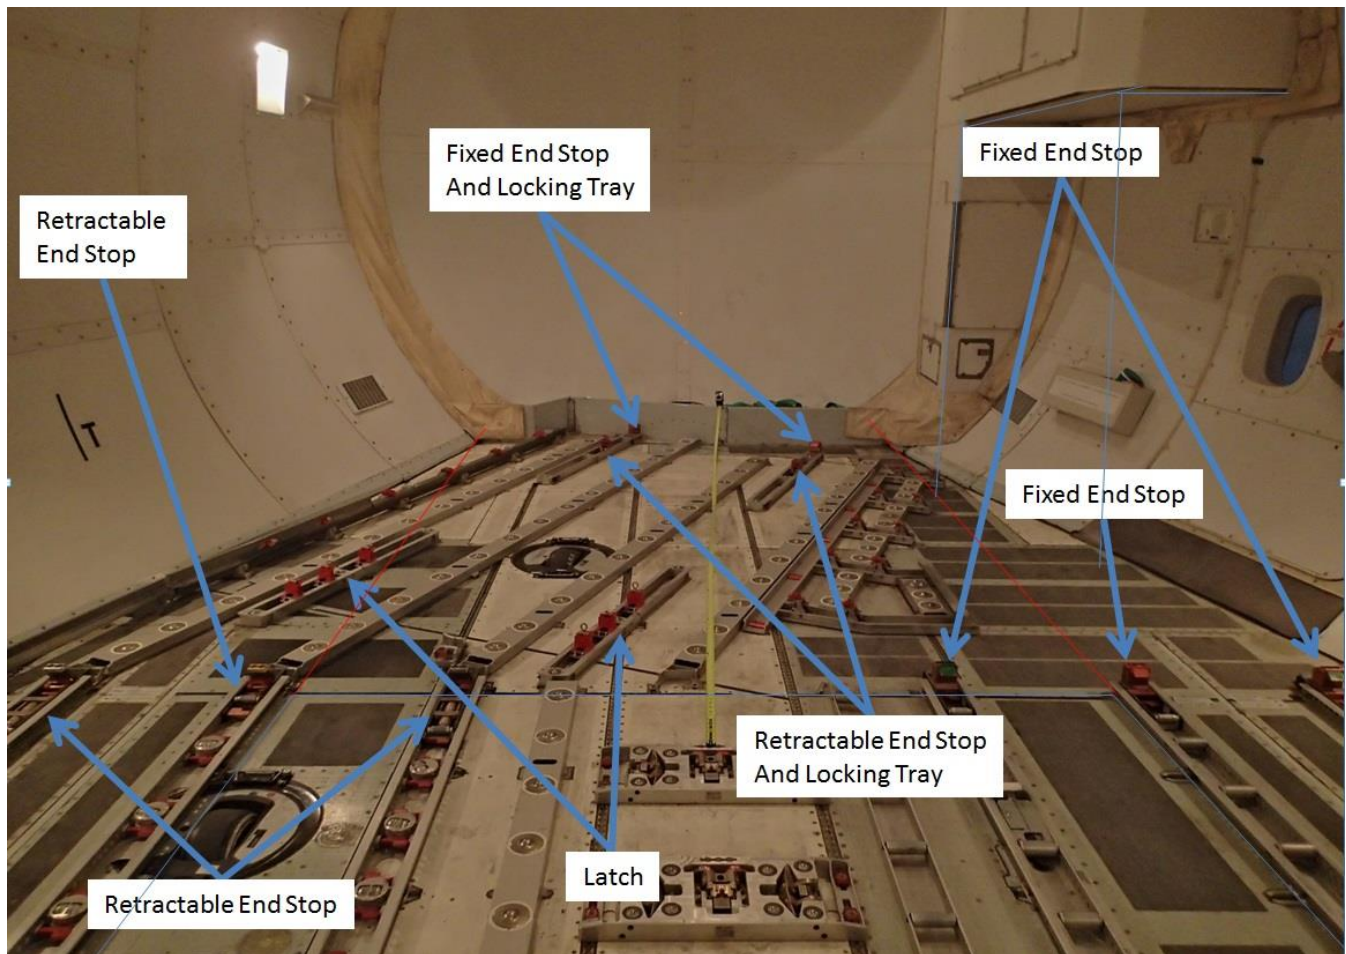
**Figure 6.** Photograph of a section of main deck flooring in the back of an exemplar airplane, looking aft.

**Note:** The locations of various fixed and retractable end stops and latches of the cargo handling system are noted with blue arrows. Note: The CVR and FDR shelf is in the upper right corner of the picture.

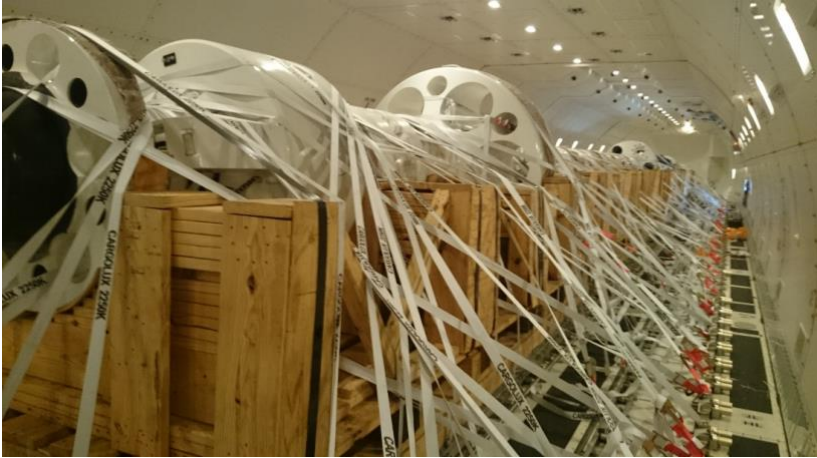
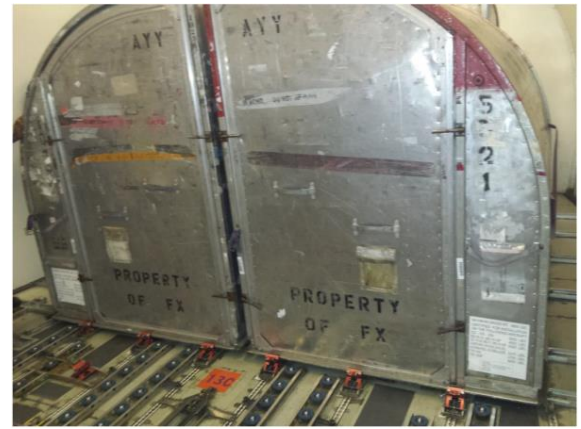
The accident flight's MRAP vehicle cargo (which was secured to G-code pallets and centerline-loaded) was considered a heavy vehicle special cargo load because its size precluded use of ULD containers capable of locking into the airplane's cargo handling system.<sup>13</sup> Such cargo instead required special handling or restraint devices such as approved tie-down straps secured to approved locations in the main cargo deck floor (see figure 7).

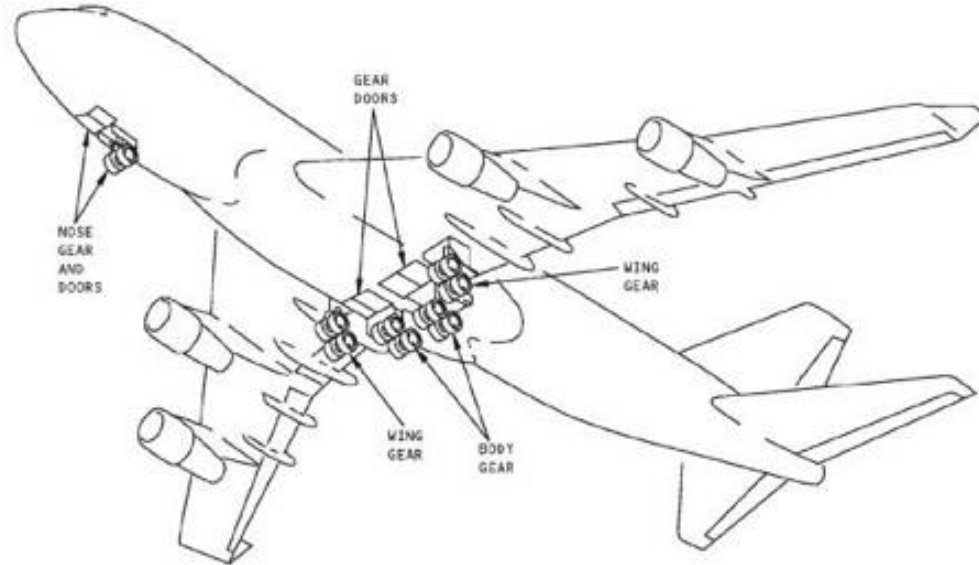
**Figure 14.** Diagram showing the respective locations of the nose, wing, and body landing gear on a Boeing 747-400 BCF.

The image study used Autodesk Softimage 2013 to compare the image data to a three-dimensional model of the airplane. The study found that, during the portions of the flight captured by one or more cameras, the airplane's left wing landing gear was not visible, consistent with it being in the retracted position. The right body landing gear, left body landing gear, and nose landing gear were visible (captured by one or more cameras), consistent with them being in the extended position. The study also found that the nose landing gear door was visibly protruding, consistent with the fully open position (see figure 15).

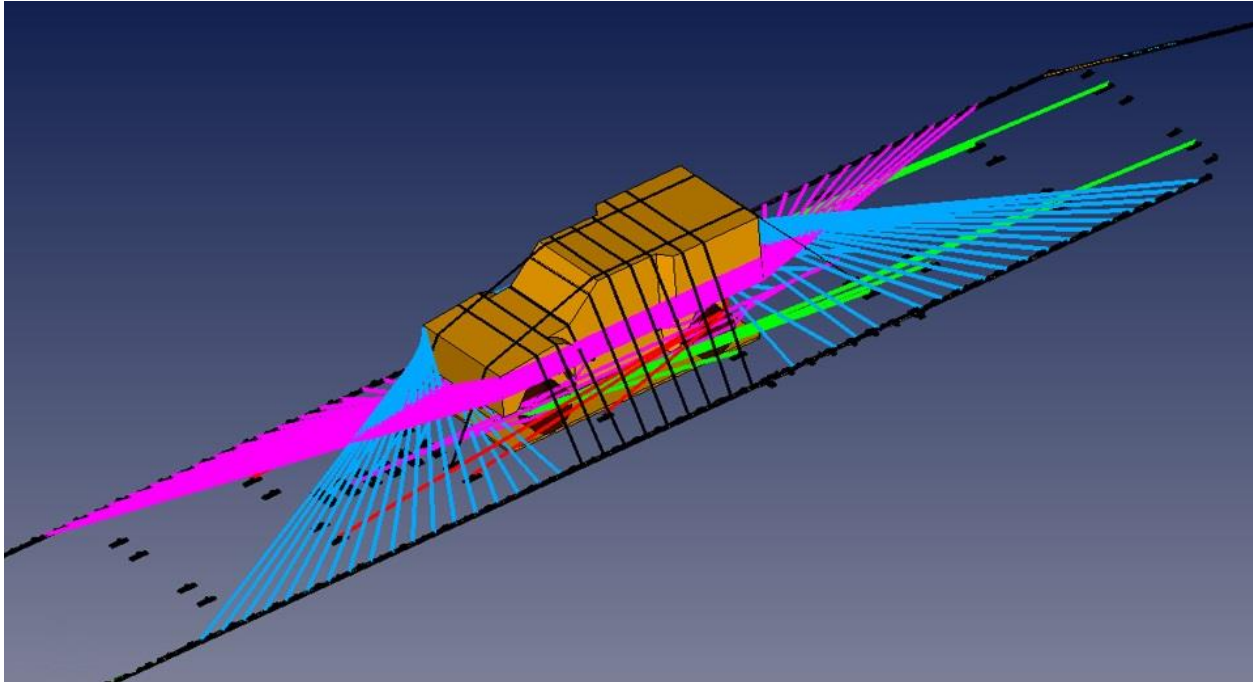
After the accident, both Boeing and Telair performed studies to determine if it was possible to transport centerline-loaded MRAP vehicles on pallets in compliance with the TRC requirements. In its study, Boeing determined that one centerline-loaded M-ATV on a G-code floating pallet could be transported in accordance with the guidelines in the Boeing and Telair weight and balance manuals. The study determined that, to meet the TRC requirement, the M-ATV must be positioned no farther forward than BS 1281, secured by 60 5,000-lb-rated tie-down straps, and be positioned aft of a specified quantity of frangible cargo in ULDs (see figure 16).

**Figure 16.** This line drawing provides an exemplar configuration showing how about 60 straps could secure a M-ATV to approved floor structures.

The study found that no centerline-loaded Cougars on G-code floating pallets could be secured and transported in the airplane in accordance with the weight and balance manual because the vehicle would have to be positioned aft of BS 1480 and would exceed the structural strength limitations of the main deck cargo floor in that area.
