Collision with Terrain
Hageland Aviation Services, Inc.
dba Ravn Connect Flight 3153
Cessna 208B, N208SD
Togiak, Alaska
October 2, 2016

NTSB/AAR-18/02
PB2018-100871

Aircraft Accident Report

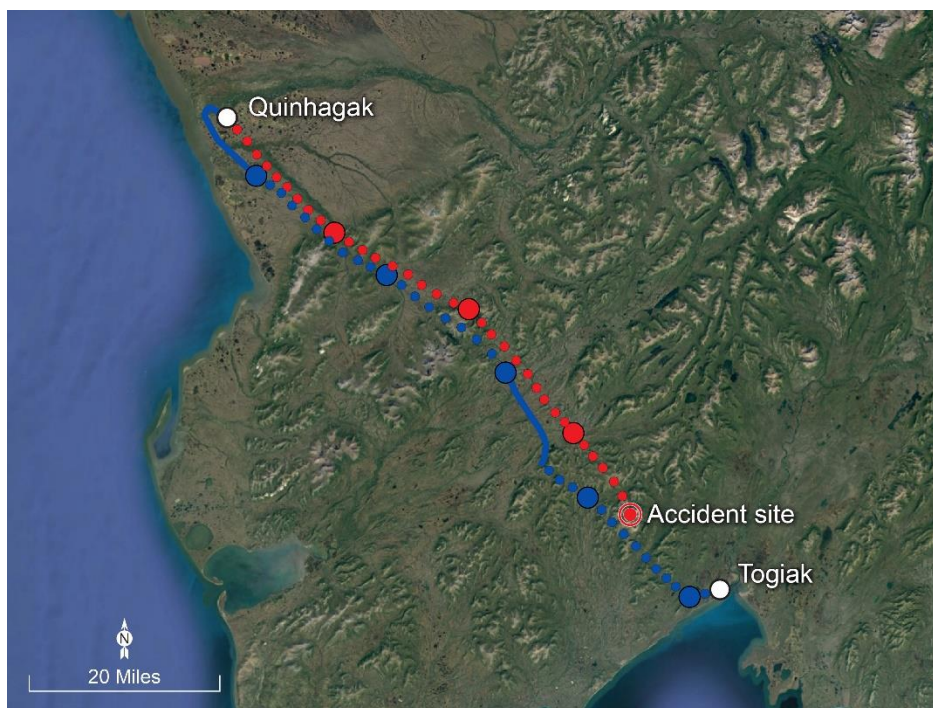
A second Hageland flight crew, consisting of a PIC and a safety pilot, in a Cessna 208B departed PAQH about 2 minutes after the accident flight.⁵ According to Spidertracks and automatic dependent surveillance-broadcast (ADS-B) data for that airplane, the second flight crew's route was initially similar to the route and altitude of the accident flight. (No ADS-B data were available for the accident airplane because the equipment was inoperative, which is discussed in section 1.3.1.) The data showed that, as the second flight approached the mountainous terrain, at 1156, it diverted more toward the south, which allowed it to remain over lower terrain than the route the accident flight followed (see figure 1).

Figure 1. Topographic map depicting accident flightpath in red and the path flown by the second company crew in blue.

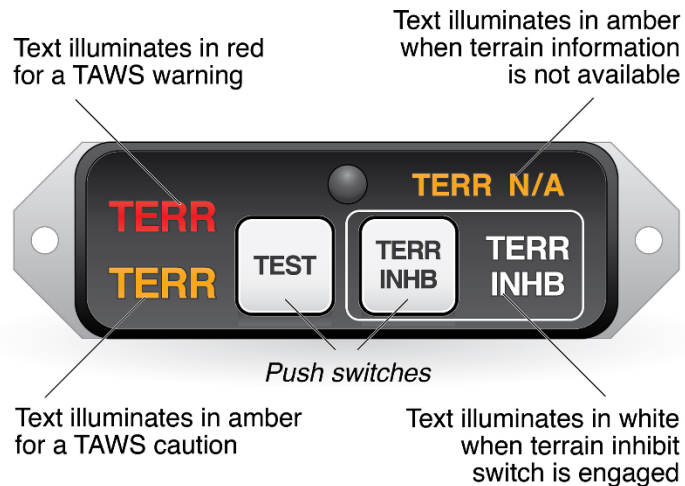
The terrain awareness annunciation control unit also provided a test feature that enabled pilots to push a test switch to activate the TAWS computer's self-test. (See section 1.8.2.5 for information about Hageland's guidance to pilots on TAWS use.) The unit's amber TERR N/A lamp would illuminate if terrain information was not available (see figure 4).

Figure 4. Drawing of the terrain awareness annunciation control unit with all annunciation lamps and the test and terrain inhibit switches labeled.

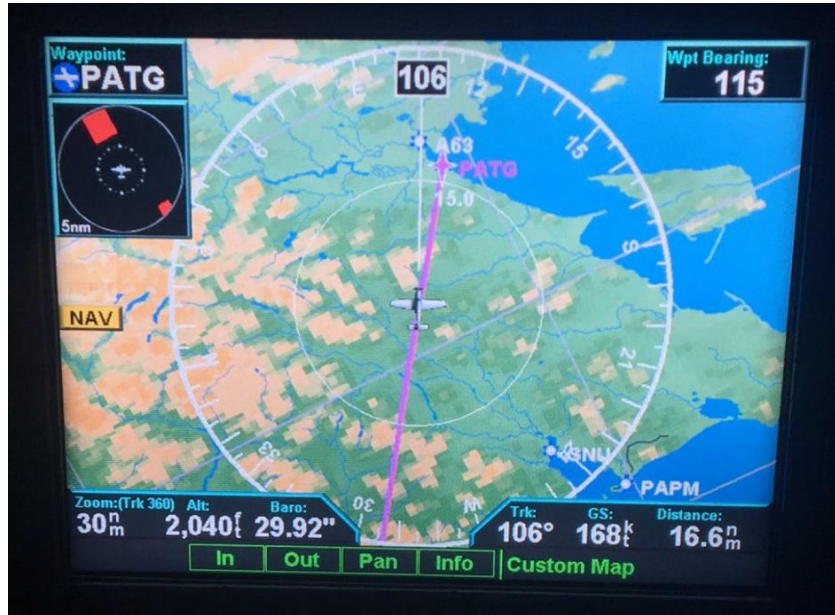
When using the custom map function, a terrain thumbnail appeared in the upper left corner of the display to depict in red the relative location of terrain within 5 nm of the airplane's position that may present a collision risk (see figure 8). A flashing white terrain advisory flag (showing the text "TERR") also appeared on the left side of the display below the thumbnail during the simulation but was not captured in the photograph due to the timing of the flag's flash and the screen freeze. (An example of a terrain advisory flag is shown in figure 9.)

Figure 8. Photograph of the simulator’s Garmin MX 20, using the custom map function.

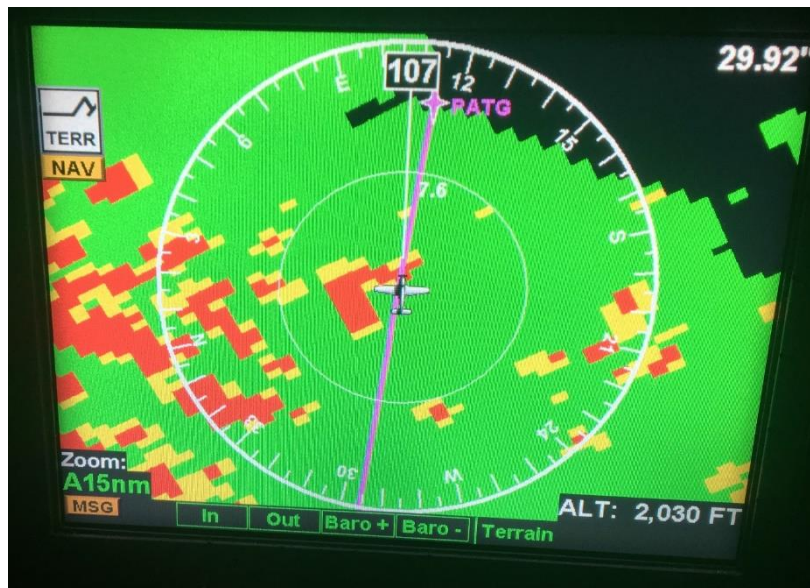
When using the MFD’s terrain function, the display depicted in red and yellow the location of terrain that may present a collision risk. A flashing white terrain advisory flag (showing the text “TERR”) also appeared on the left side of the display (see figure 9).

Figure 9. Photograph of the simulator’s Garmin MX 20, using the terrain function.
