Docket No. SA-521

Emery 17 Airplane Performance Study

Emery Flight 017 Airplane Performance Study

Location: Rancho Cordova, California
Date: February 16, 2000
Time: 1951 Local Time
Aircraft: Douglas DC-8-71, N8079 U
Operator: Emery Worldwide Airlines, A CNF Company (FAR Part 121
Supplemental)
NTSB#: DCA-00-MA-026

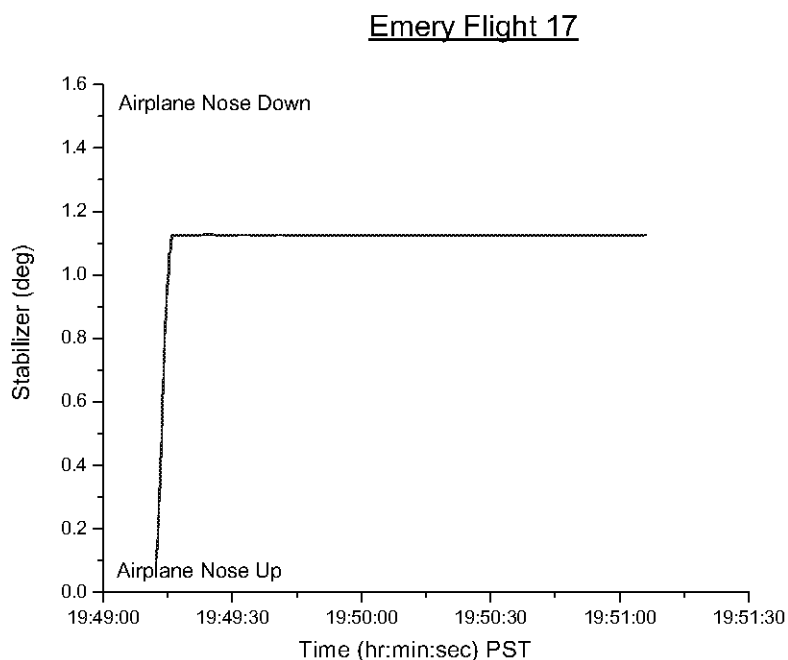
Figure 7: Input Stabilizer

A time history of stabilizer is required as a Kinsurf input to extract elevator. This time history was obtained using the takeoff trim setting from the CVR, the time and duration of the stabilizer motion alert from the CVR and the full nose down stabilizer position obtained from wreckage examination. The resulting stabilizer time history is plotted in figure 7.

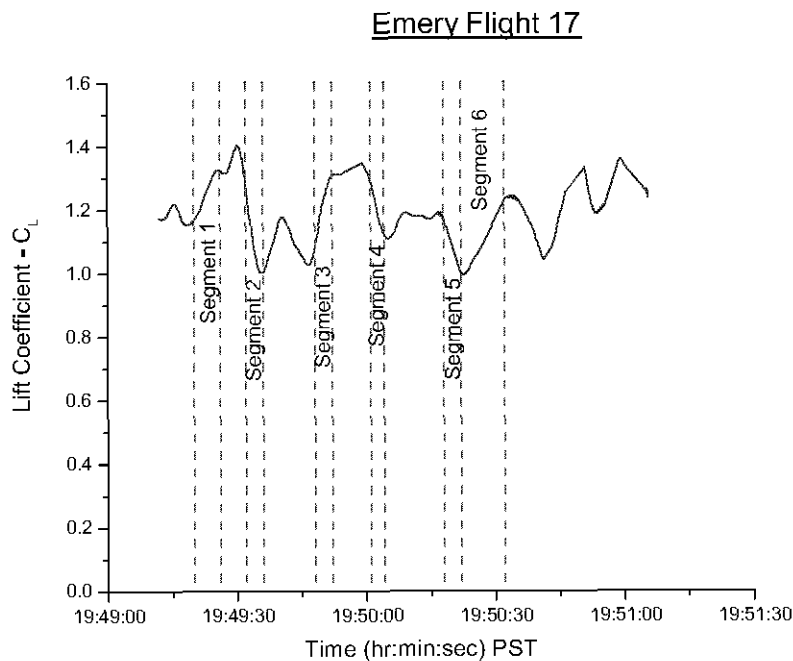
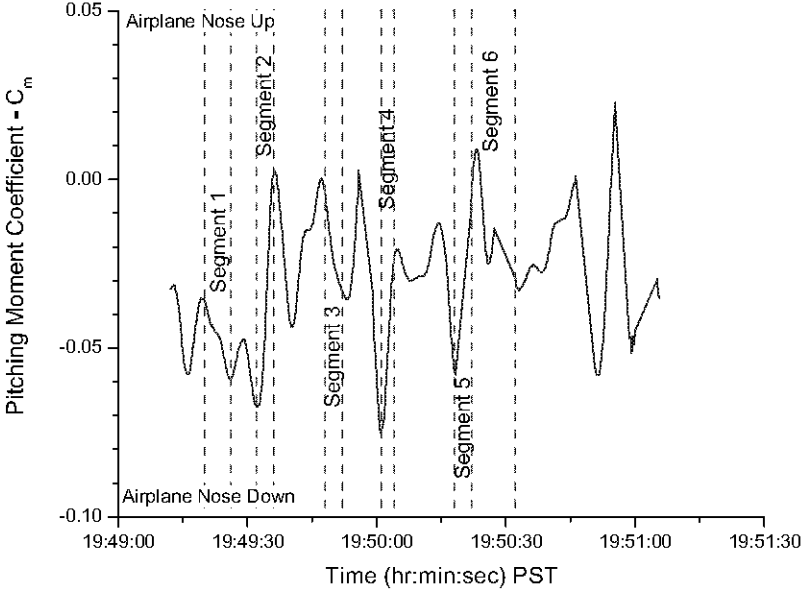
Figure 9: Lift Coefficient Time History

The lift and pitching moment time history for the accident flight are presented in figures 9 and 10. Six segments with large lift changes have been identified for $\delta C_m / \delta C_L$ determination and are indicated on the plots.

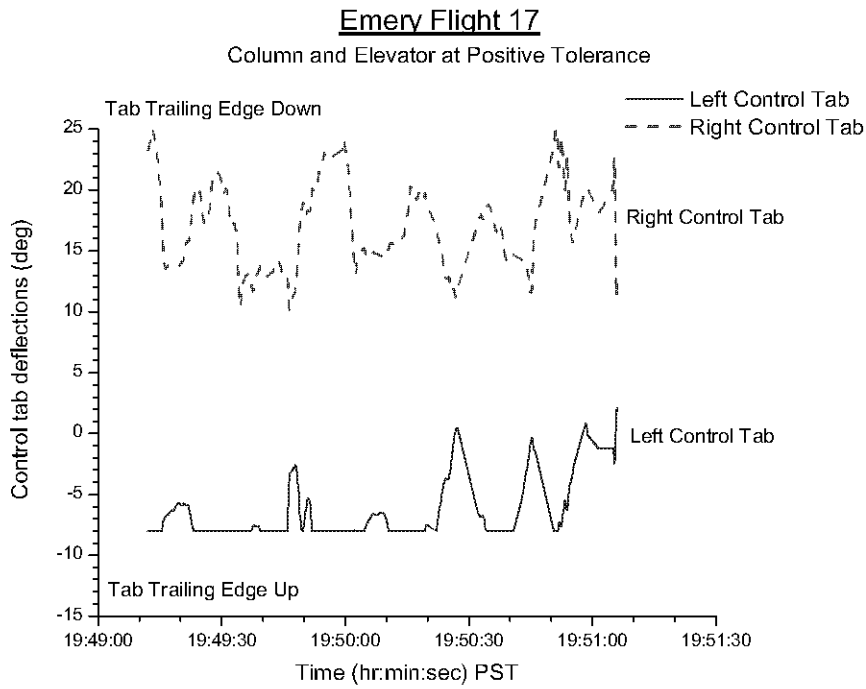
Figure 15: Extracted Control tab deflections (positive FDR tolerance)

For a normally operating tab, a positive (trailing edge down) change in elevator produces a positive (trailing edge down) change in control tab. Similarly, a positive (aft) change in column produces a positive change in control tab. Thus, the elevator and column tolerance/compliance combine for the maximum positive (trailing edge down) tolerance effect on the normally operating left control tab when both elevator and column are at their positive tolerance limit. Control tab positions were extracted adding 2 deg to the nominal FDR column and elevator to obtain the tab positions with the elevator and column at the end of their tolerance/compliance. The tab deflections extracted with the input elevator and column at their tolerance/compliance boundaries to give the most positive left control tab are shown in figure 15. The accompanying stick force (excluding force from the tab stop) is shown in figure 16.

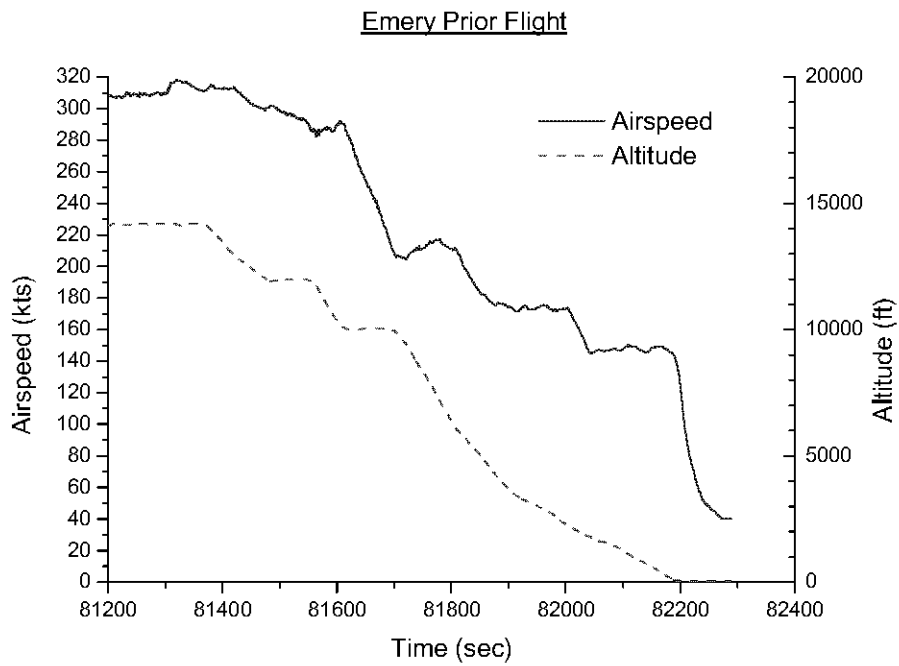
Figure 18: Sacramento Landing Airspeed and Altitude

Examination of the FDR data for the landing at Sacramento prior to the accident flight showed a change in the character of the column and elevator data at about 81700 sec elapsed FDR time. This is shown in figure 17 with the corresponding airspeed and altitude shown in figure 18. A cross-plot of elevator vs. column in figure 19 shows the change in effective column to elevator gain at the time of the anomaly. Note that the 11 deg elevator and 13.5 deg column correction have been applied to these plots.

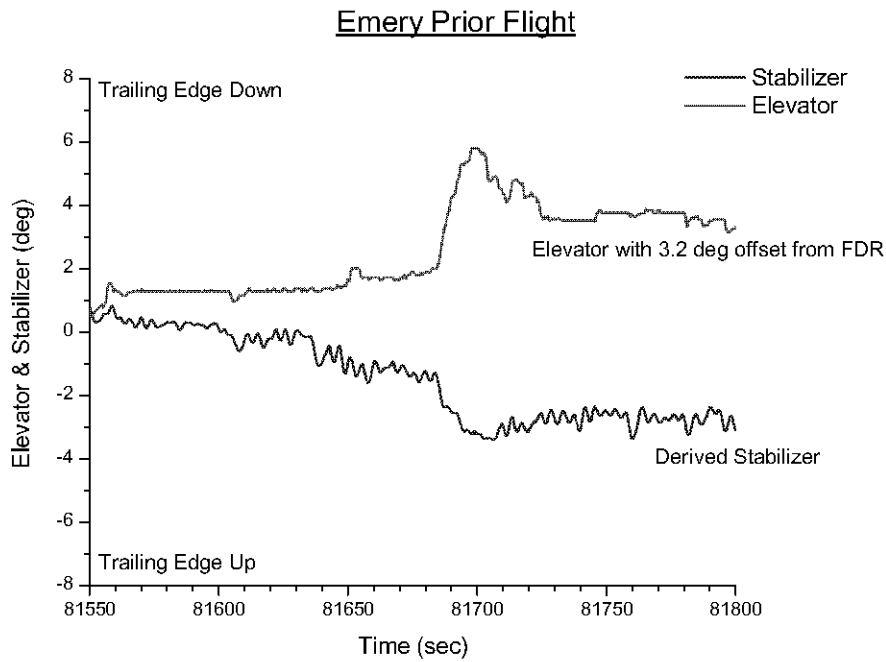
Figure 26: Trimmed elevator and stabilizer for control anomaly

As can be seen in figure 17, the recorded elevator was between 4 ½ and 5 deg trailing edge down before the control anomaly. The DC-8 Flying qualities report shows elevators generally between 1 ½ and 2 ½ degree trailing edge down for trimmed flight. The Kinsurf program was run iterating on column offset and elevator offset to find the trim condition during the period before the control anomaly. That is, the offset to the elevator trace was found that produced zero column force while the offset to the column trace was used to make sure that the control tab obtained from mechanical gearing and linkage (modeled with the left tab) matched the control tab required to get the elevator deflection (modeled with the right tab). Kinsurf calculated a stabilizer for each offset elevator trace. The Zero column Force, aircraft equilibrium trim condition was satisfied with a 3.2 deg trailing edge up offset to elevator and with no offset to column. Figure 26 shows the elevator with the offset required for column force trim and the stabilizer required for equilibrium. The trim elevator approaching the anomaly is within the 1 ½ to 2 ½ degree range. The control tab deflections extracted through the anomaly are shown in figure 27. The accompanying stick force is plotted with column deflection in figure 28. A trace of floating position for the control tab is also included in figure 27 for comparison. As discussed before, this floating position is the position that the tab would assume with no mechanical force input from the tab linkage. It is the tab position where the aerodynamic hinge moment is zero with the recorded elevator position and the tail angle of attack derived with Kinsurf as input.

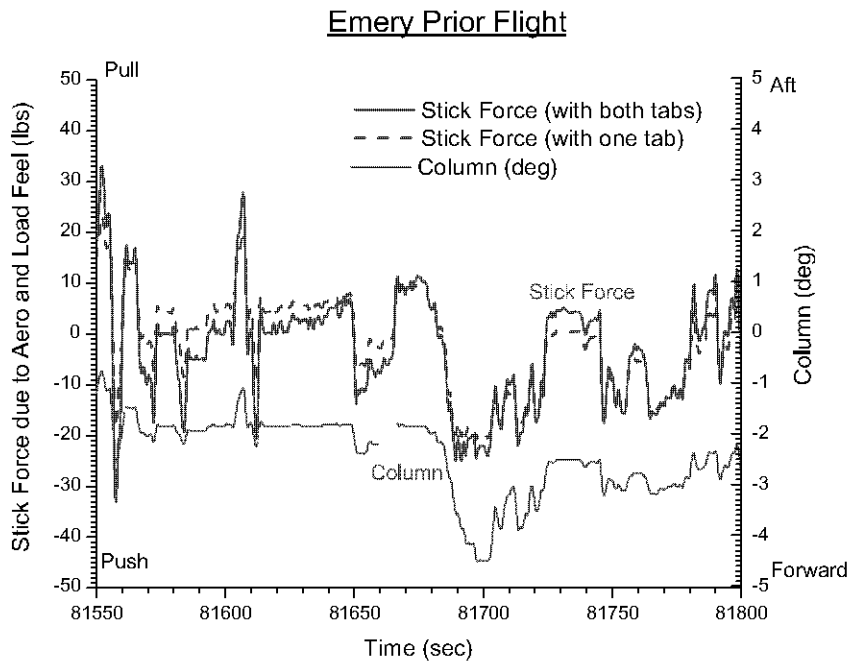
Figure 28: Column force and position for control anomaly

The Kinsurf program was used to determine the control tab deflections during the control anomaly on approach to Sacramento for the flight previous to the accident. As before, the left tab operates normally as a function of column and elevator position. The right tab is calculated to provide the hinge moment required to balance the elevator at the elevator deflection.
