National Transportation Safety Board
Office of Research and Engineering
Washington, D.C. 20594

Performance Study

Specialist Report
Marie Moler
August 30, 2013

Location: Soldotna, AK
Date: September 5, 2012
Time: 18:42 UTC (10:42 Alaska Daylight Time)
Aircraft: DHC-8-100, N886EA, ERA Flight 874
NTSB Number: DCA12IA141

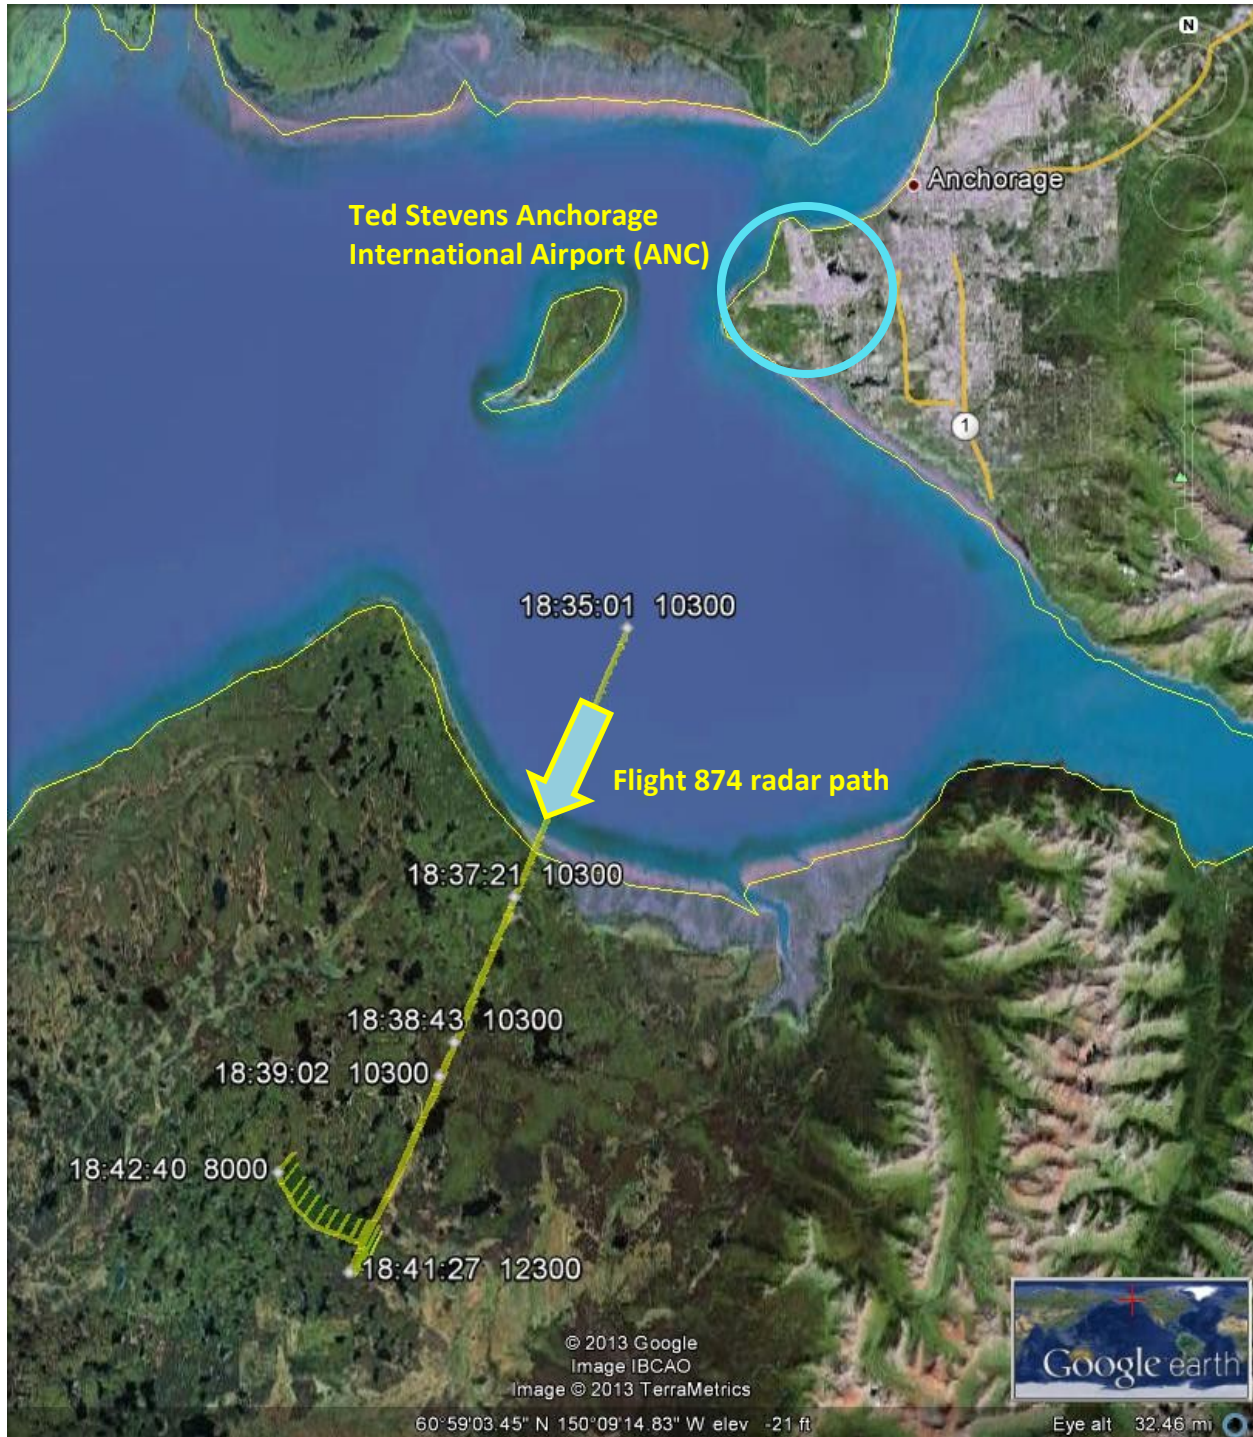
Figure 3. ANX radar path of Flight 874, UTC time.

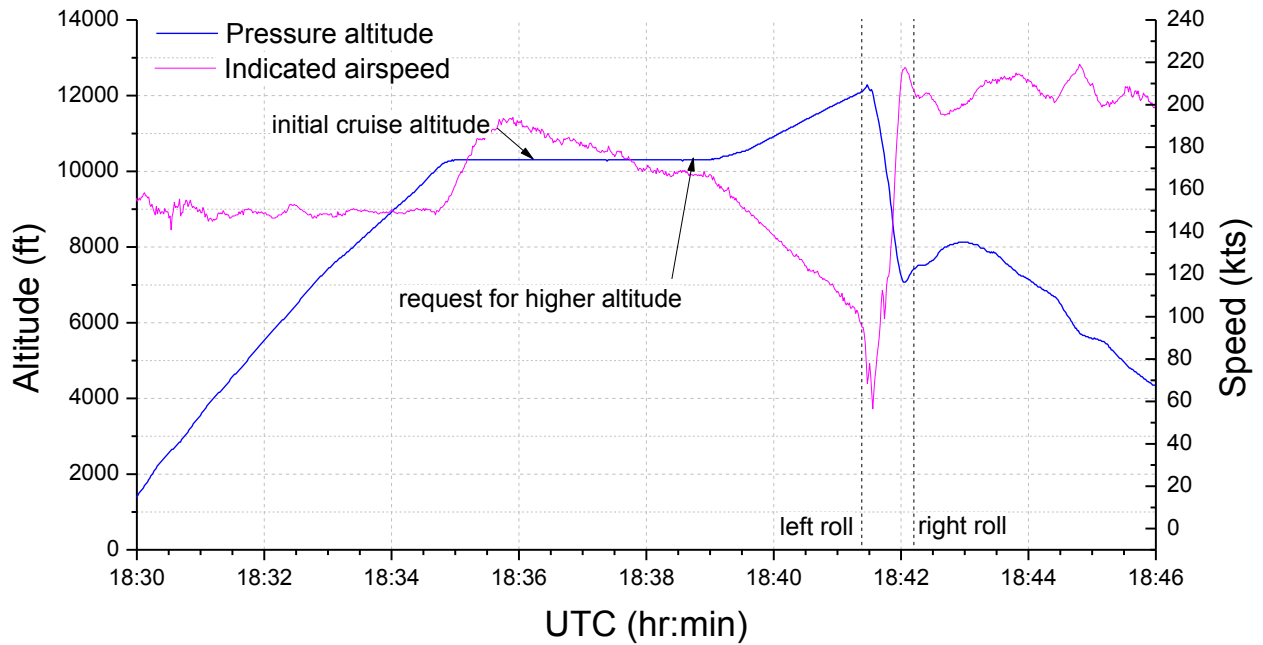
The aircraft took off from Anchorage at 18:29 UTC and climbed to a cruising altitude of about 10,000 ft as shown in Figure 4 and Figure 5. Once the aircraft reached its cruising altitude its airspeed was reduced from approximately 190 kts to a constant 170 kts. At 18:38:42 the aircraft reported moderate mixed ice and requested a new altitude of 14,000 ft. Anchorage Center cleared the request and the aircraft began to climb at 18:39:03.

Figure 4. Altitude and airspeed for take-off, climb, and the loss of control event indicated by the left roll.

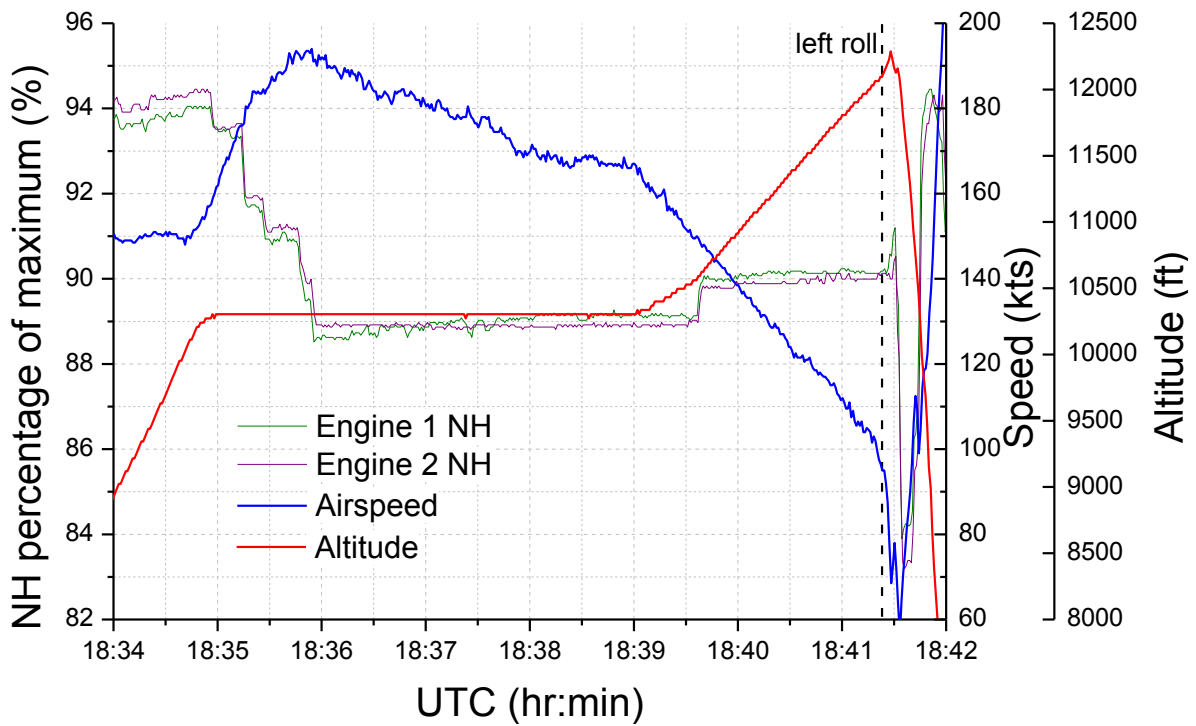
During the climb to 14,000 ft, the aircraft gained altitude at a steady rate of 850 ft/min. For the duration of the climb, the aircraft was steadily slowing, from an initial airspeed of 170 kts down to 97 kts when it started to roll off left. Figure 5 shows the recorded high pressure compressor speed (NH) throughout the climb.

Figure 5. NH as a percentage of maximum, airspeed, and altitude for level flight and climb to loss of control.

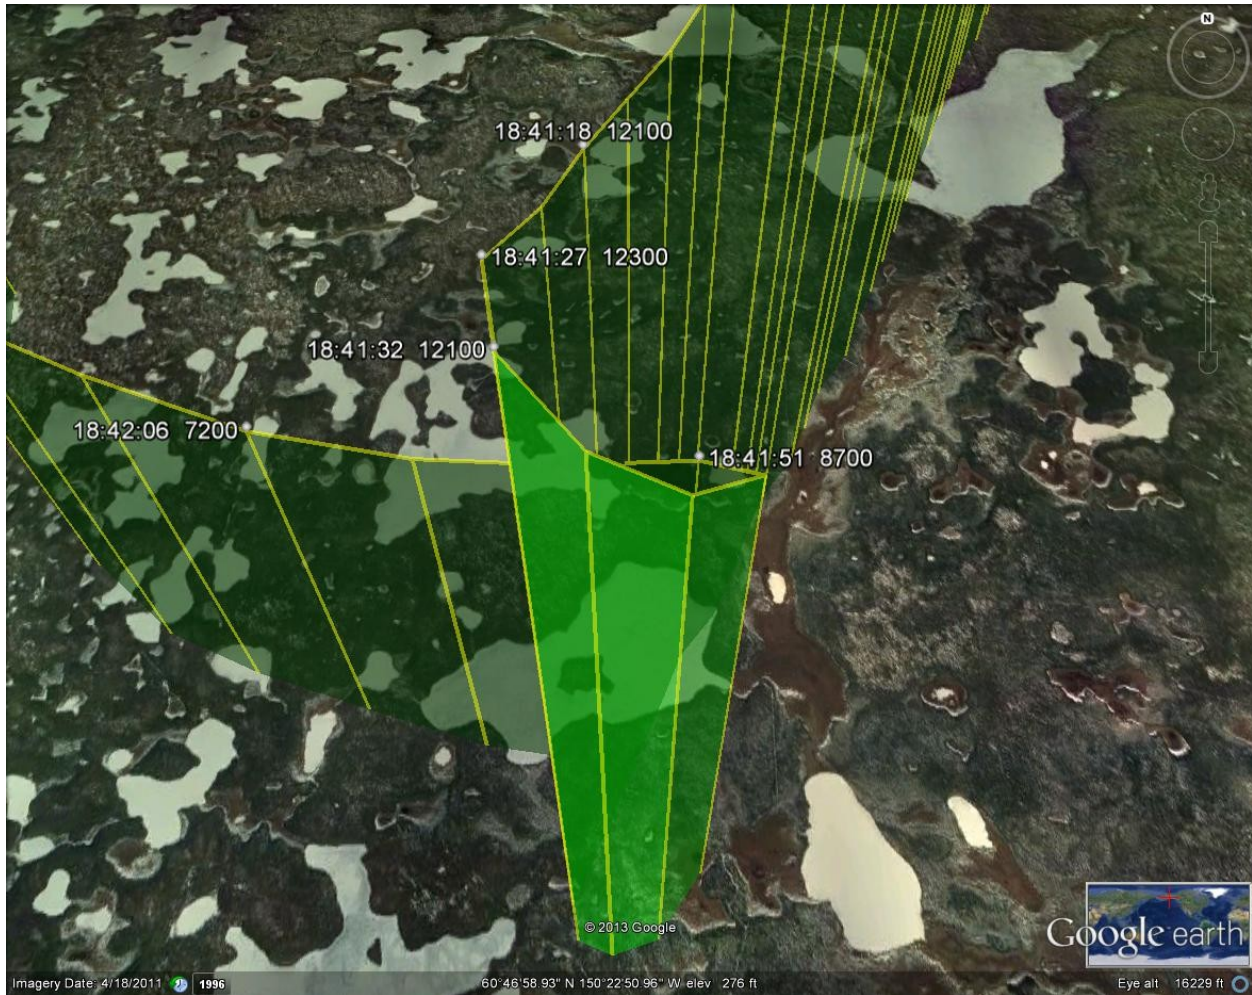
Approximate radar positions corresponding to some of the events discussed above are shown below in Figure 10. A tabular time history of the described loss of control event for ERA Flight 874 is shown in Table 1. The drop in vertical load factor has been selected to be the onset of the loss of control event.

Figure 10. ANX radar path of Flight 874 during loss of control event, UTC time.

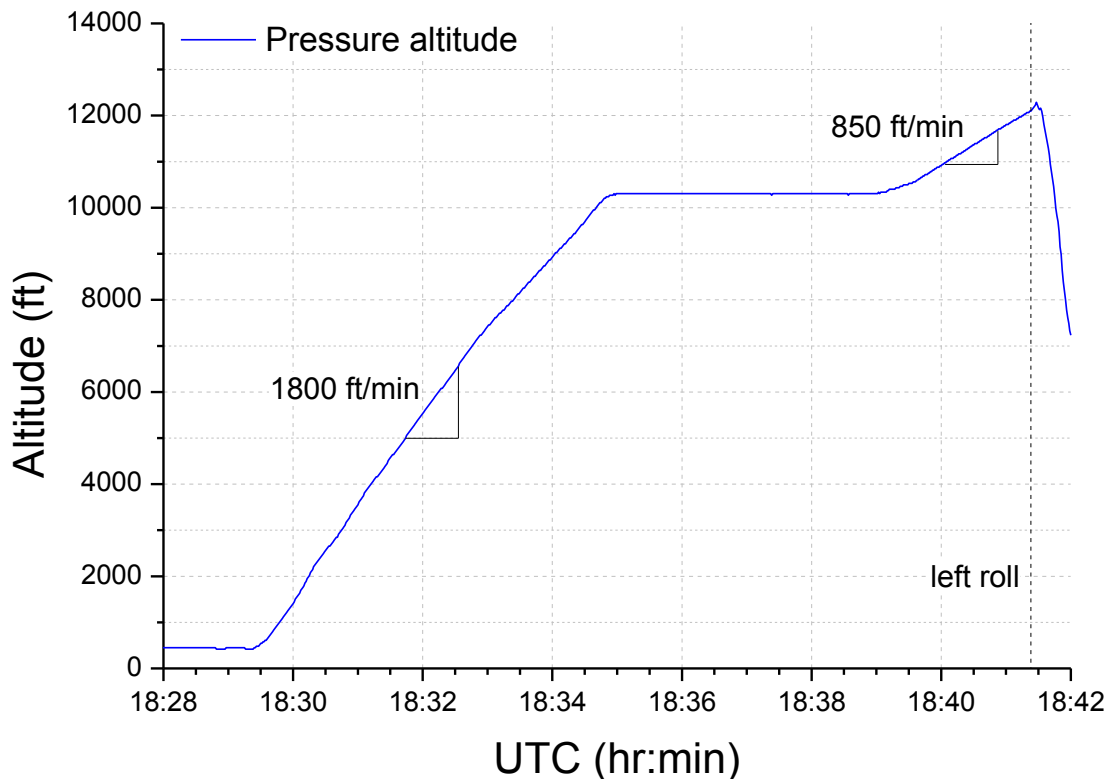
The initial climb rate of the aircraft as it ascended from 2,000 to 10,000 ft was about 1,800 ft/min. The rate of climb from 11,000 to 12,000 ft was about 850 ft/min. Climb rates for these portions of flight are shown in Figure 11.

Figure 11. Climb rates.

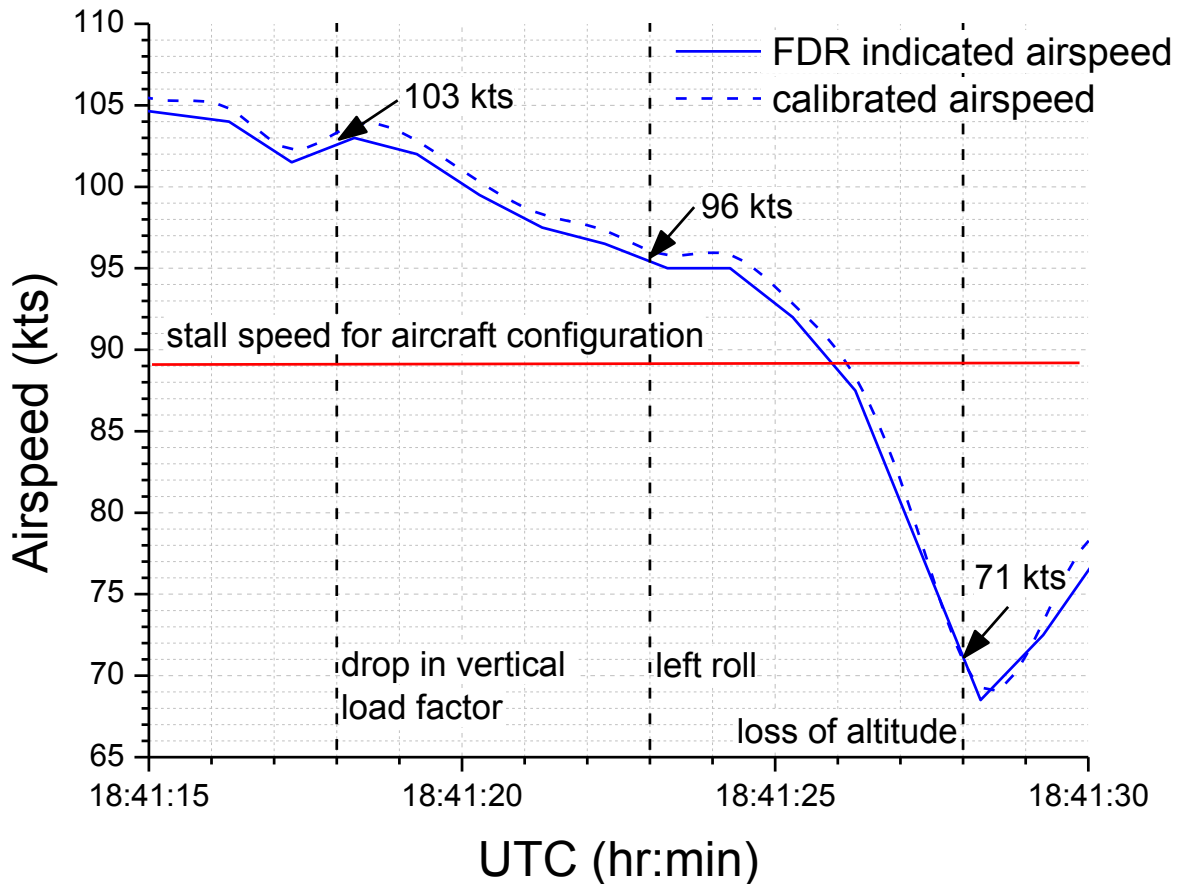
Figure 15, below, shows the aircraft's indicated airspeed and calibrated airspeed during the stall event. Calibrated airspeed was calculated using Honeywell Technical Newsletter data on the Dash-8 [Reference 6]. The difference between calibrated and indicated airspeed at the time of the upset was ≤ 1 kts. At the time of the drop in vertical load factor when stall began, the aircraft's airspeed was approximately 103 kts, 14 kts above the predicted stall speed shown in Figure 14. After roll-off, the aircraft's pitot-static system may not be as accurate, so speeds after the drop in vertical load factor have higher uncertainty.

Figure 15. Aircraft airspeed for upset events.
