# National Transportation Safety Board

## Airplane Performance Study

Location: Gaithersburg, MD  
Date: December 8, 2014  
Time: 1041 EST  
Airplane: Embraer EMB-500 Phenom 100, Registration N100EQ  
NTSB Number: DCA15MA029

DCA15MA029, Embraer EMB-500 Phenom 100, N100EQ , 12/8/2014

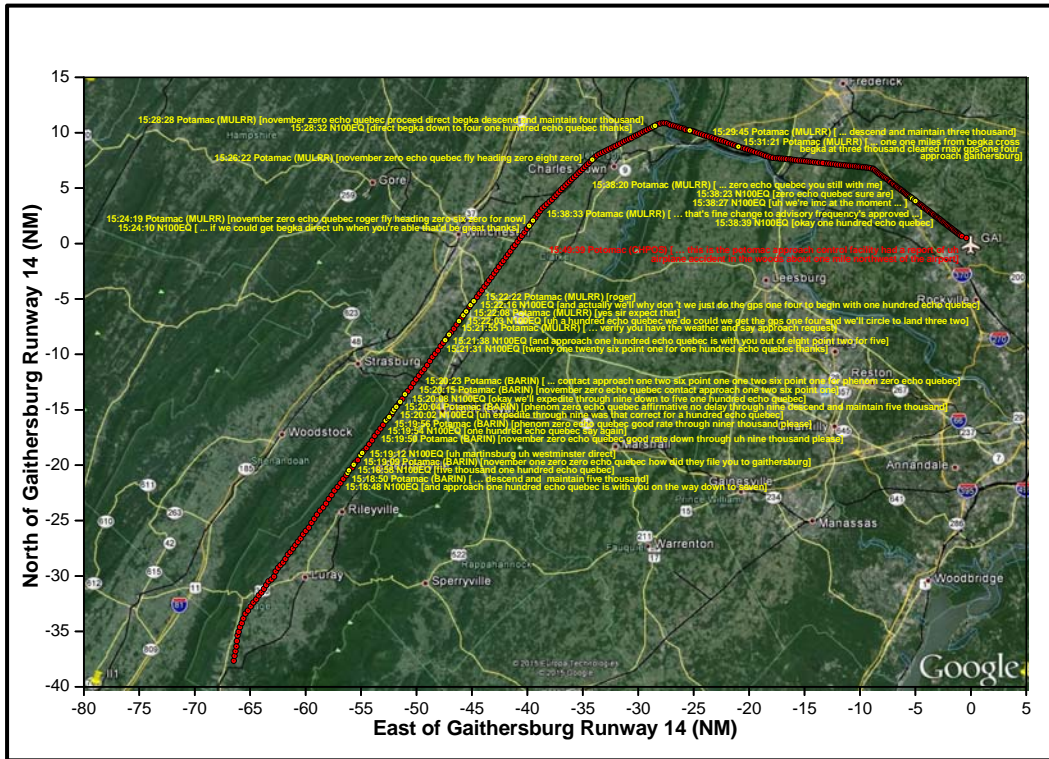
**Figure 5: Radar Ground Track and Select Radio Communications<sup>14</sup>**

Figures 5 and 6 highlight the radar ground track for the final 27 minutes of flight. The radar “points” are actually boxes as shown in red in the figure. This is because of the uncertainty associated with the radar data mentioned earlier. The figures also show select radio communications between N100EQ and Potomac Consolidated Terminal Radar Approach CONtrol (TRACON) as the airplane flew vectors to the Global Positioning System (GPS) approach 14 at GAI. See Figure 7 for the instrument approach plate and Figure 8 for the approach plate superimposed on the radar ground track.

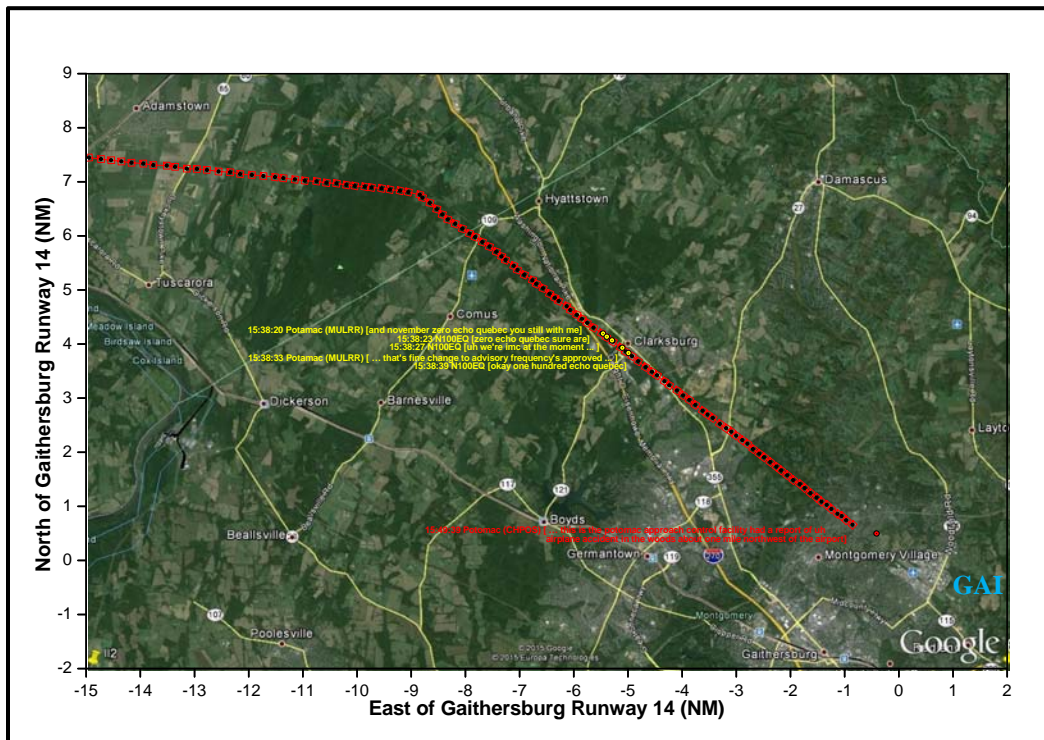
**Figure 6: Radar Ground Track and Select Radio Communications in Final Minutes**

Figures 3 and 4 show weather radar at the time of or shortly after the accident. The radar echoes in the figures combined with the flight track (shown in Figures 5 and 6) indicate that N100EQ was in instrument meteorological conditions (IMC) until approximately one mile from GAI and also in conditions that were favorable for structural icing for at least ten minutes during the approach. Multiple jet air carriers in the vicinity of the accident site reported icing conditions in the clouds with cloud tops ranging from 4,300 ft to 5,500 ft above mean sea level (msl). In addition, four minutes after the accident, there was another pilot report (PIREP) from a regional turboprop pilot who was encountering moderate mixed icing between 4,000 ft and 5,000 ft msl.

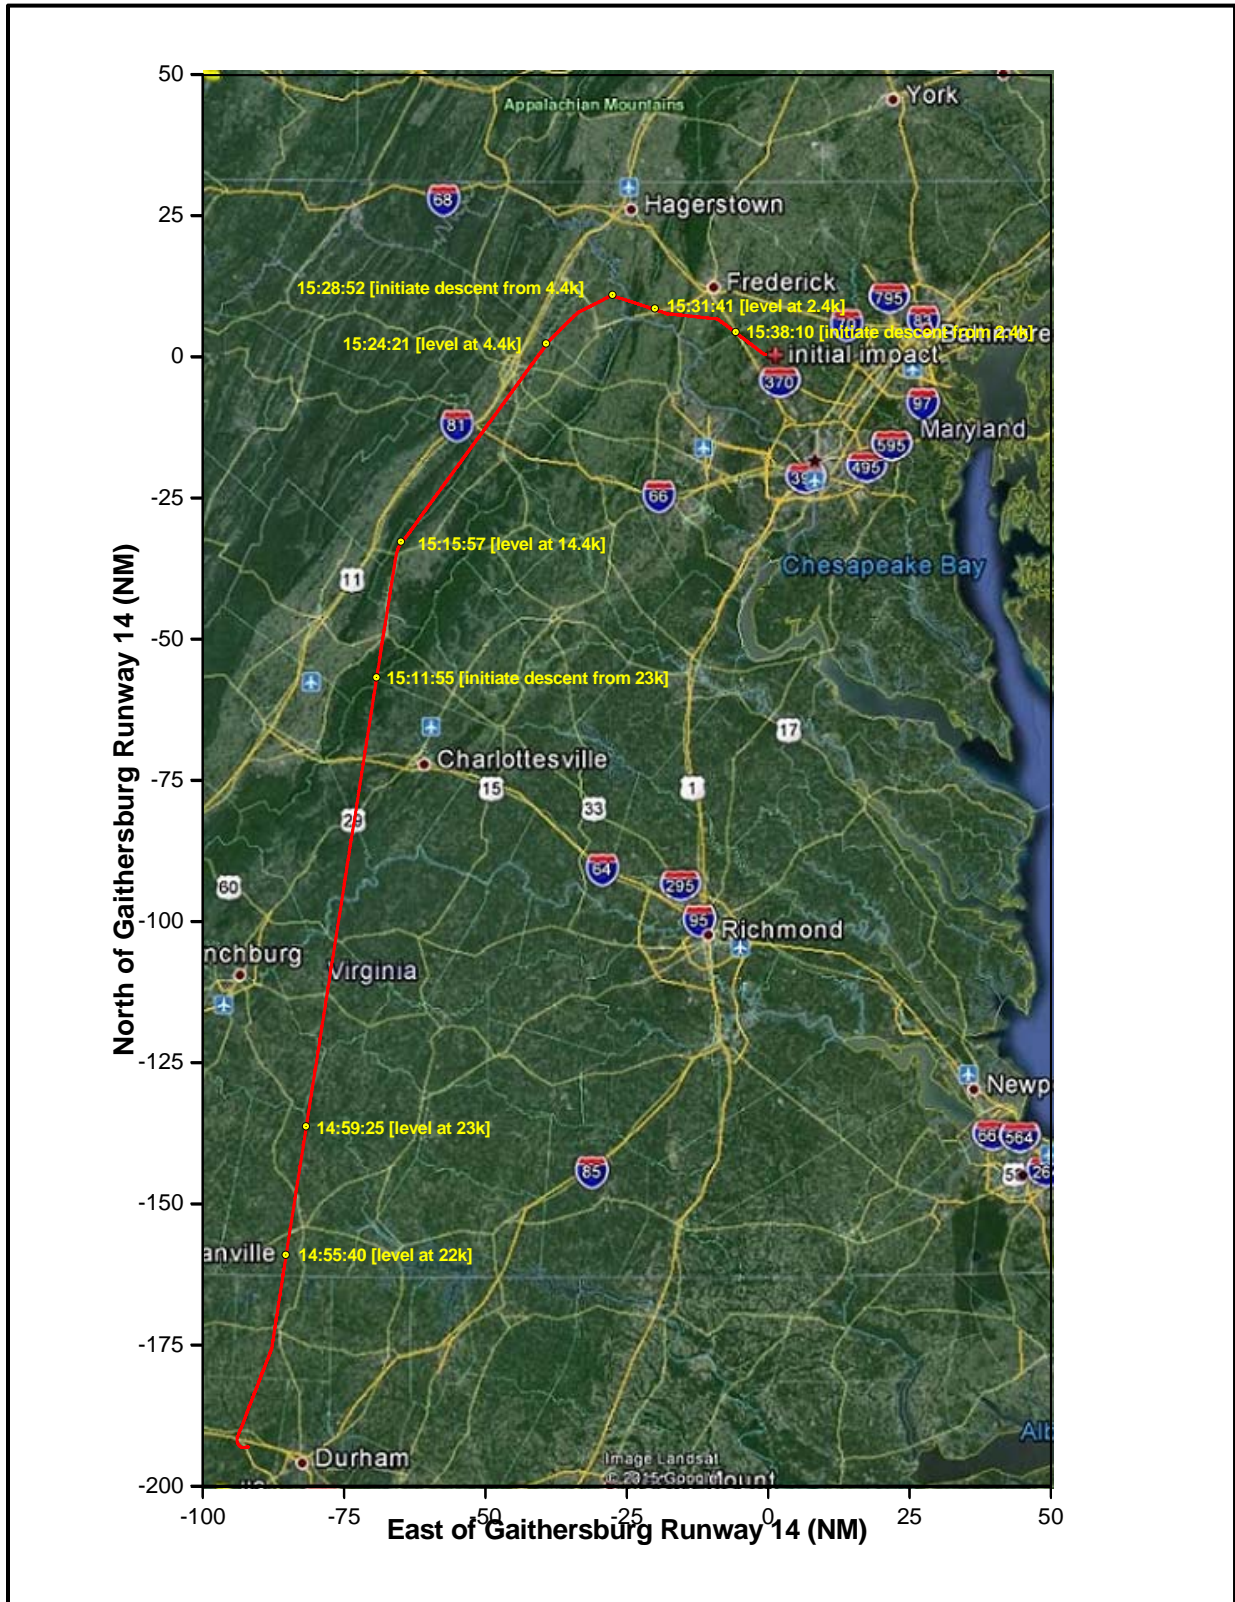
**Figure 10: CVDR Ground Track with Altitude Changes**  
**(note: Altitudes are pressure altitudes as shown in Figure 9.)**

Figures 9 and 10 show the speed and altitude profiles for the accident flight captured on the CVDR. The de-ice discrete from the CVDR indicates that de-ice was selected for 2 min 23 sec upon reaching a cruising altitude of 23,000 ft but then remained off for the rest of the flight. Figure 9 also highlights (in red) the portion of the flight where the airplane likely entered the clouds and encountered structural icing during the approach (based on PIREPs of cloud tops and the presence of ice). The airplane entered the clouds around 15:23:41 at 5,500 ft msl and, at 15:38:27 while descending through 2,700 ft msl, the pilot reported being in IMC. That puts the airplane in visible moisture, an essential element for ice, for approximately 15 min.
