**National Transportation Safety Board**  
Office of Research and Engineering  
Washington, D.C. 20594

**Performance Study**

Location: New York, New York  
Date: March 5, 2015  
Time: 1102 EST, 1602 UTC  
Airplane: MD-88, N909DL, Delta Flight 1086  
NTSB Number: DCA15FA085

**Performance Study  
DCA15FA085, MD-88, N909DL, Delta Flight 1086**

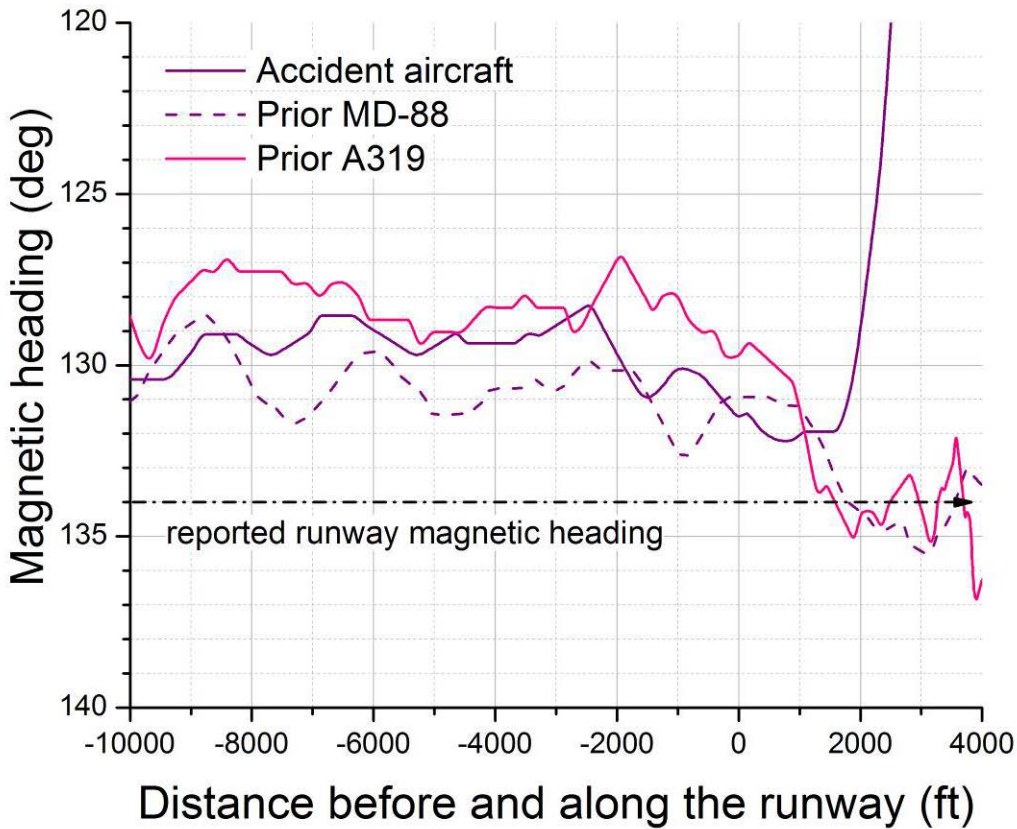
While the FDR ILS position data and the radar track show the aircraft path aligned with runway 13 (magnetic reported heading  $134^{\circ}$ , true heading  $122^{\circ}$ ), the FDR shows the aircraft approached on a magnetic heading of  $129^{\circ}$  (shown in Figure 7) and it landed on a magnetic heading of about  $132^{\circ}$ , which it maintained until diverting to the left off the runway surface. The two aircraft that landed before the accident aircraft (one of which will be discussed in greater depth in *Comparison to Prior MD-88 Landing*) approached the airport on headings of about  $129^{\circ}$  (A319) and  $131^{\circ}$  (MD-88). The accident aircraft's heading on approach was  $2^{\circ}$  left of the prior MD-88. However, upon nose gear touchdown, both of the prior aircraft aligned with to the reported  $134^{\circ}$  heading of the runway.

**Figure 7.** Magnetic headings for accident aircraft and the prior two aircraft to land at LGA.

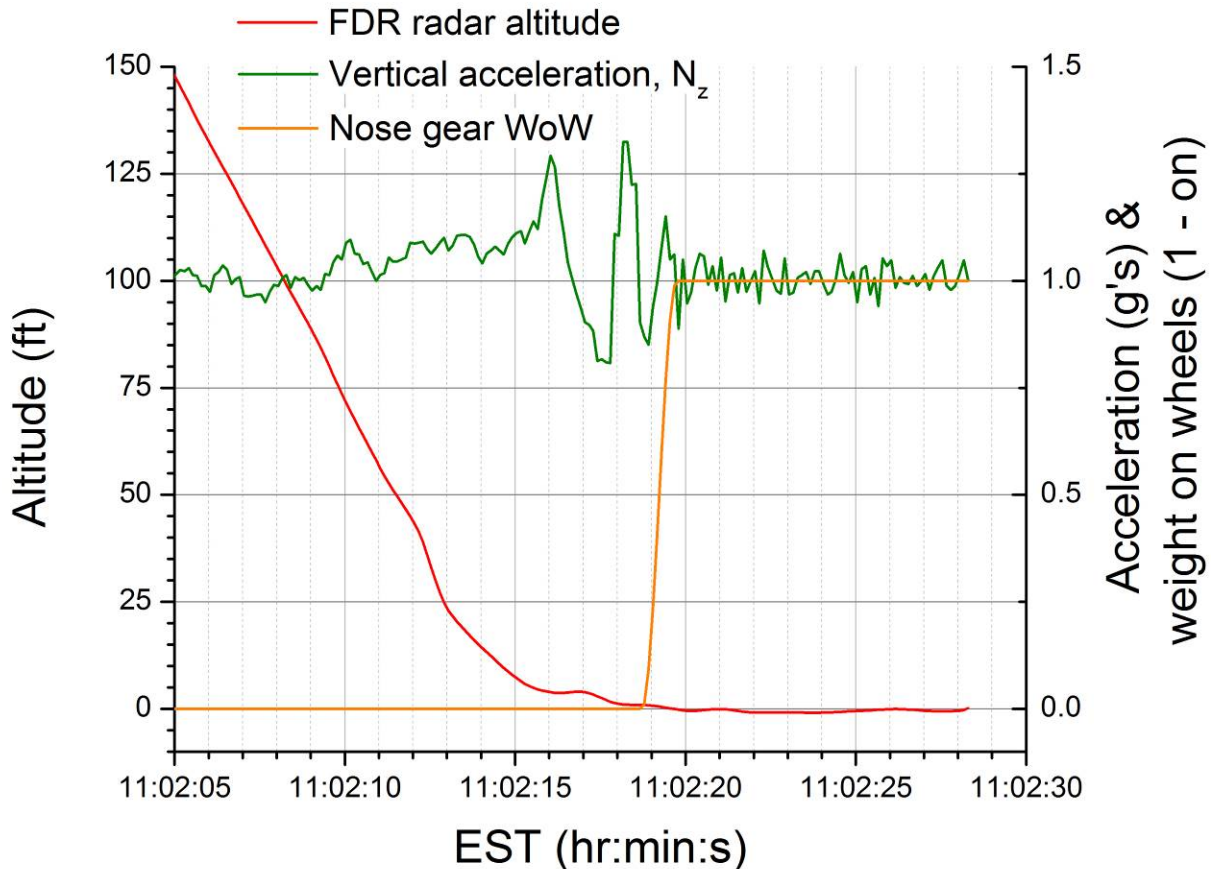
Figure 10 shows the aircraft vertical acceleration, altitude, and nose gear weight on wheels for the landing. The main gear touchdown corresponded with the initial spike in vertical acceleration at 11:02:16. At about 11:02:28.5, twelve seconds after touchdown, the vertical acceleration parameter begins displaying increasingly unrealistic values. A number of other parameters either hold their last recorded value or begin oscillating between maximum values after this time.

**Figure 10.** FDR  $N_z$ , altitude, and nose gear weight on wheels. After 11:02:27 the acceleration data become unreliable.

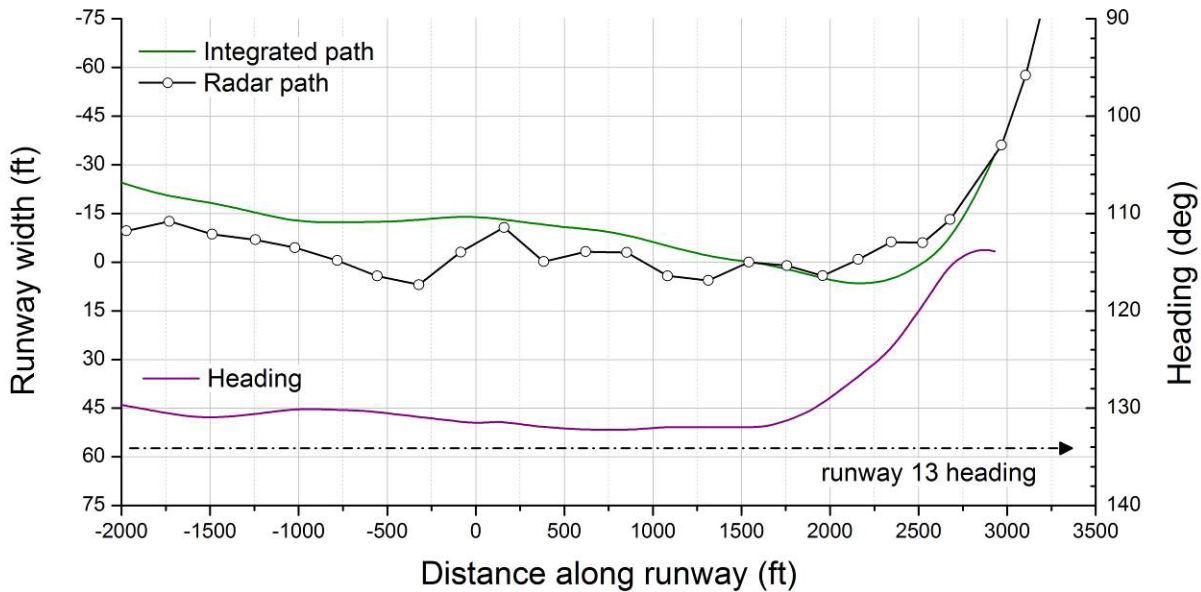
The integration showed good agreement with the radar data as shown in Figure 11. All plots of 'distance along runway' are oriented so that zero is the runway threshold and positive values are moving down the runway. At about 1600 ft down the runway, the aircraft's heading begins going towards the left with the ground path moving left between 500 and 1000 ft later. The loss of reliable FDR data corresponds approximately with the aircraft leaving the runway. As noted earlier, runways and taxiways were reported to have 3 ft snowbanks along their edges.

**Figure 11.** Radar path, integrated path, and heading versus distance along runway. The origin of the runway distance is the threshold of runway 13. The airplane's main gear first touched down about 600 ft past the threshold. The aircraft leaves runway according to SMR data and ground marks at 3200 ft.

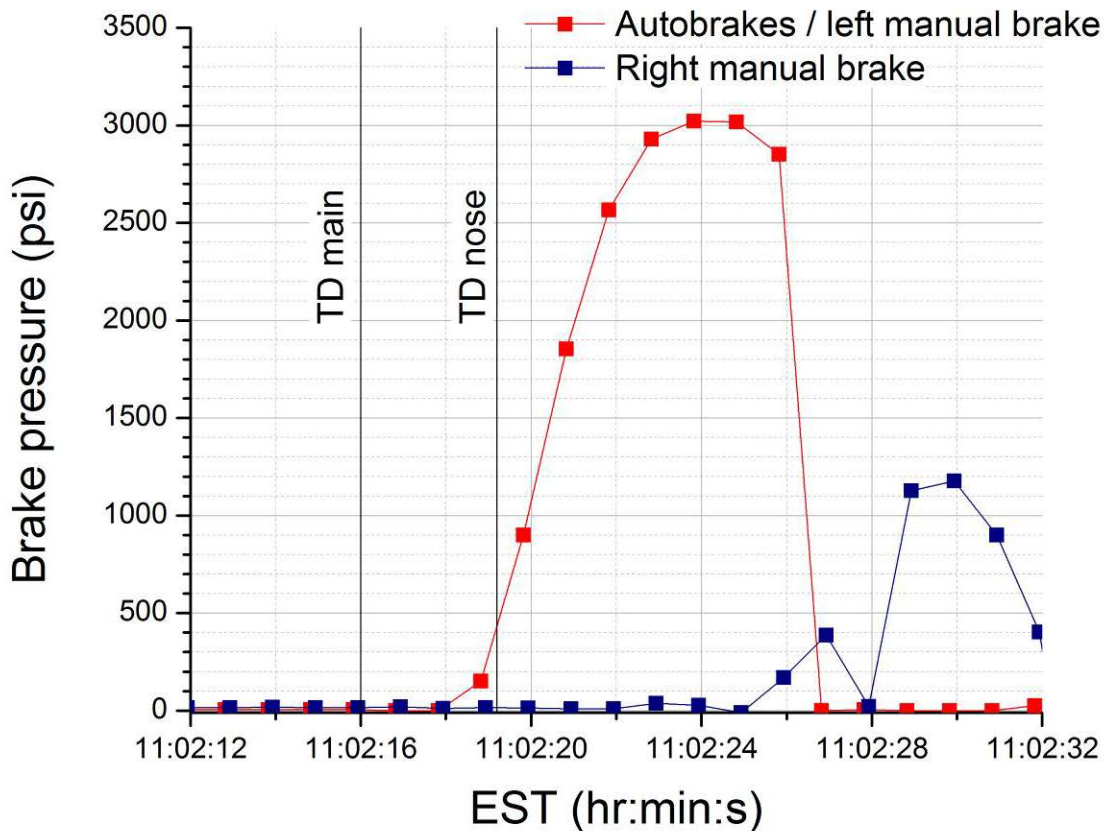
Figure 13 shows the as-sampled braking channels versus time. The red line is marked as autobrakes/left brake and the blue as manual brakes/right brake. Autobrake pressure is only recorded on the left channel when autobrakes are deployed. The initial rise in the red channel is consistent with the deployment of autobrakes (the recorded brake pressure is applied on the right and left side equally). Autobrakes were applied between 1.8 and 2.8 seconds after main gear touchdown and reached a maximum value of over 3000 psi by 11:02:23.8. The right manual

brake was depressed between 11:02:24.9 and 25.9, which is also when the autobrake/left brake pressure begins to fall to zero. On this aircraft, when the brakes are deployed manually, the autobrakes automatically disengage. The zero pressure reading on the left braking channel indicates that the crew manually applied only right brake. Braking only on the right side of the aircraft should cause it to yaw to the right.

**Figure 13.** Aircraft brakes versus time.

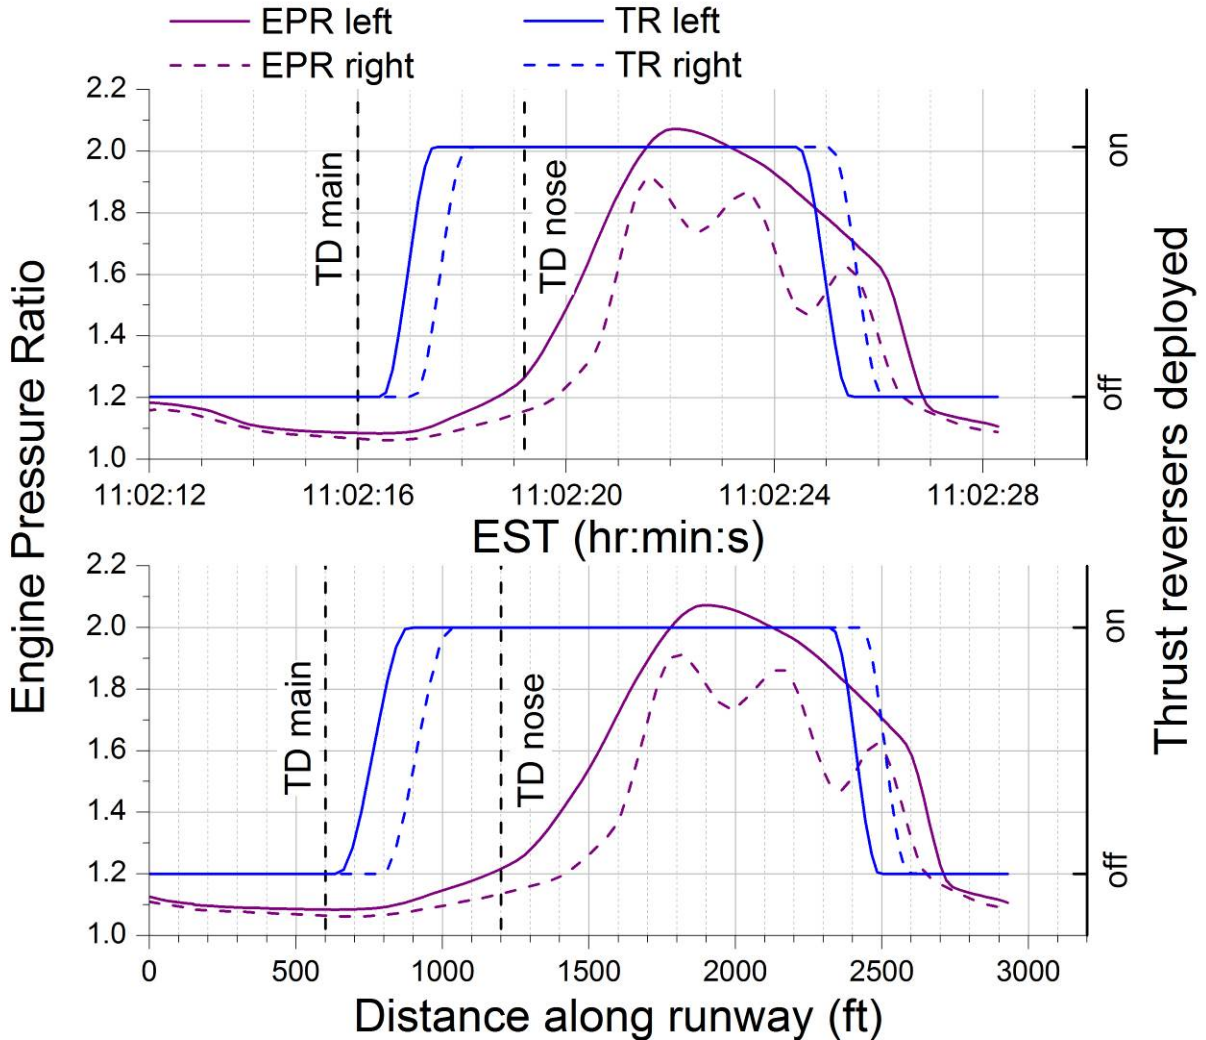
Thrust reversers were also deployed between main gear and nose gear touchdown. The left engine thrust reverser deployment parameter sampled 0.5 seconds before the right engine which may account for the right/left time offset seen in Figure 15. Between 4 and 5 seconds after deployment, the engine pressure ratio (EPR) rose above 2 for the left engine and 1.9 for the right engine. The EPR values for both engines stayed above 1.5 until after the thrust reversers were stowed at 11:02:25.

**Figure 15.** Thrust reverser (TR) deployment and engine pressure ratio (EPR) versus time and distance along runway.

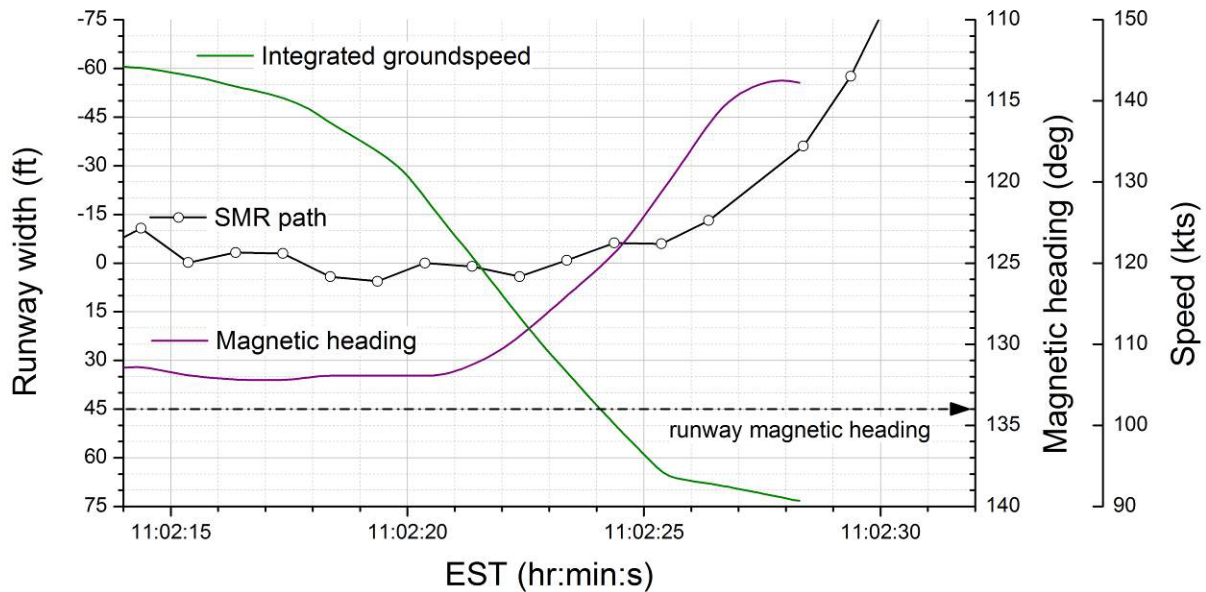
The aircraft touched down within 5 ft of the runway centerline according to SMR shown in Figure 18 and Figure 19. The aircraft did not deviate from the centerline more than  $\pm 5$  ft until 2300 ft down the runway (1700 ft and 8 seconds after main gear touchdown). At 1600 ft the heading began to move further left, leading the centerline departure by 700 ft and four seconds. The aircraft’s ground speed at touchdown was about 140 kts. Its groundspeed at 2500 ft was 93 kts. The aircraft left the runway 3200 ft from the threshold.

**Figure 19.** Radar path on runway and magnetic heading versus time. The airplane's main gear touched down at 11:02:16.

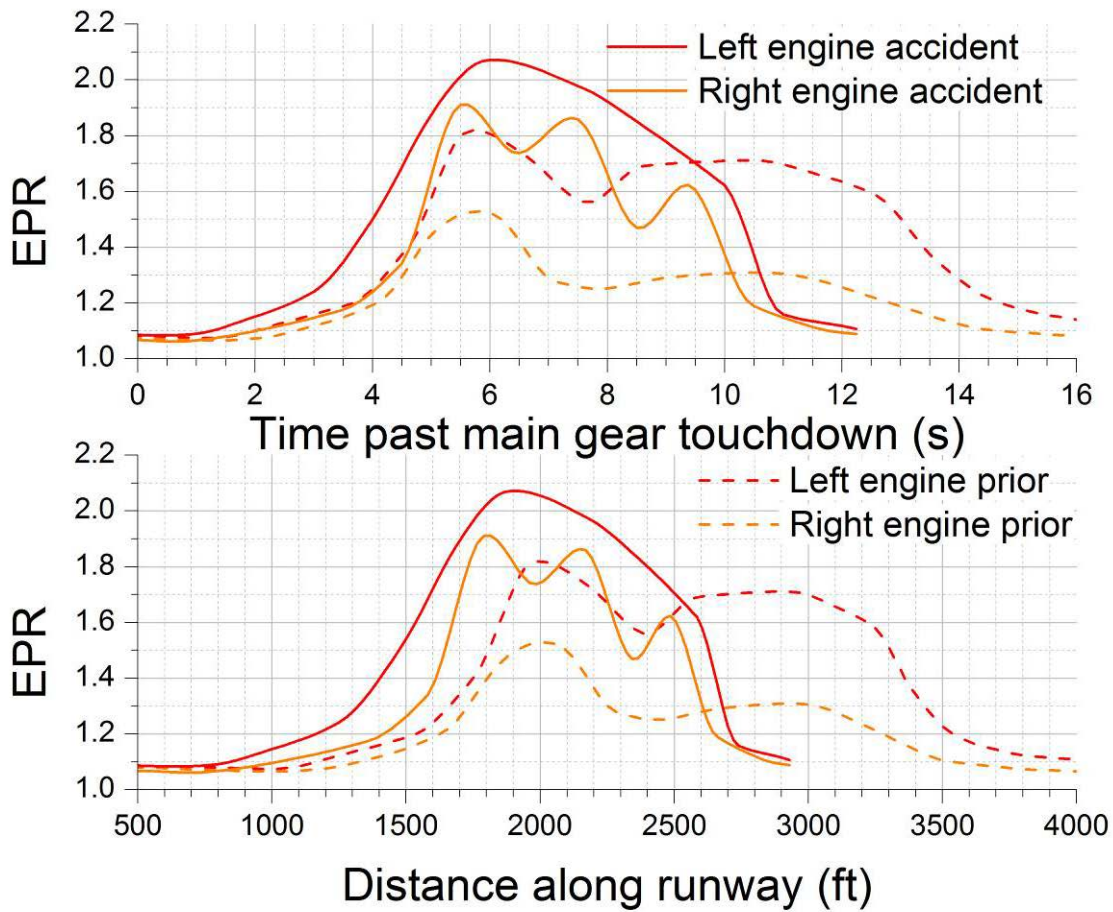
Figure 23 compares the engine pressure ratios between the two aircraft landings. The accident aircraft's EPR values were higher, greater than 2.0 and 1.9, as compared to the prior aircraft's maximum EPR values of greater than 1.8 and 1.5. The prior aircraft's left engine EPR stayed above 1.6 for 2.5 seconds longer than the accident aircraft.

**Figure 23.** Engine pressure ratios versus time and distance for accident aircraft and prior MD-88.

Boeing released guidance that operators should limit reverse thrust EPR to less than 1.6 during normal landings and less than 1.3 EPR when landing in adverse conditions [5]. This guidance was based on test data that showed that the rudder has limited directional authority for aircraft reverse thrust EPR values above 1.6 and airspeeds below 146 kts, and similarly has limited directional authority for aircraft reverse thrust EPR values above 1.3 and airspeeds below 108 kts [4]. The engine pressure ratios for the engines in reverse thrust exceeded 2.0 for the left engine and 1.9 for the right engine, and the EPR levels exceeded 1.6 for approximately five seconds. The high EPR values had the effect of blanking the rudder during the aircraft's left heading deviation and rendered rudder input ineffective. Once the thrust reversers were stowed and rudder authority was restored, application of left rudder (in conjunction with nose wheel steering and differential braking) was effective in arresting the increase in the left yaw rate. While the rudder was blanked, nose wheel steering input from the rudder pedal likely contributed to slowing the aircraft's yaw rate, but was not sufficient to redirect the airplane until used in conjunction with effective rudder. Differential right manual braking also contributed to controlling the aircraft's heading, but was also applied after the thrust reversers were stowed (4.5 seconds after the initial yaw rate increase).

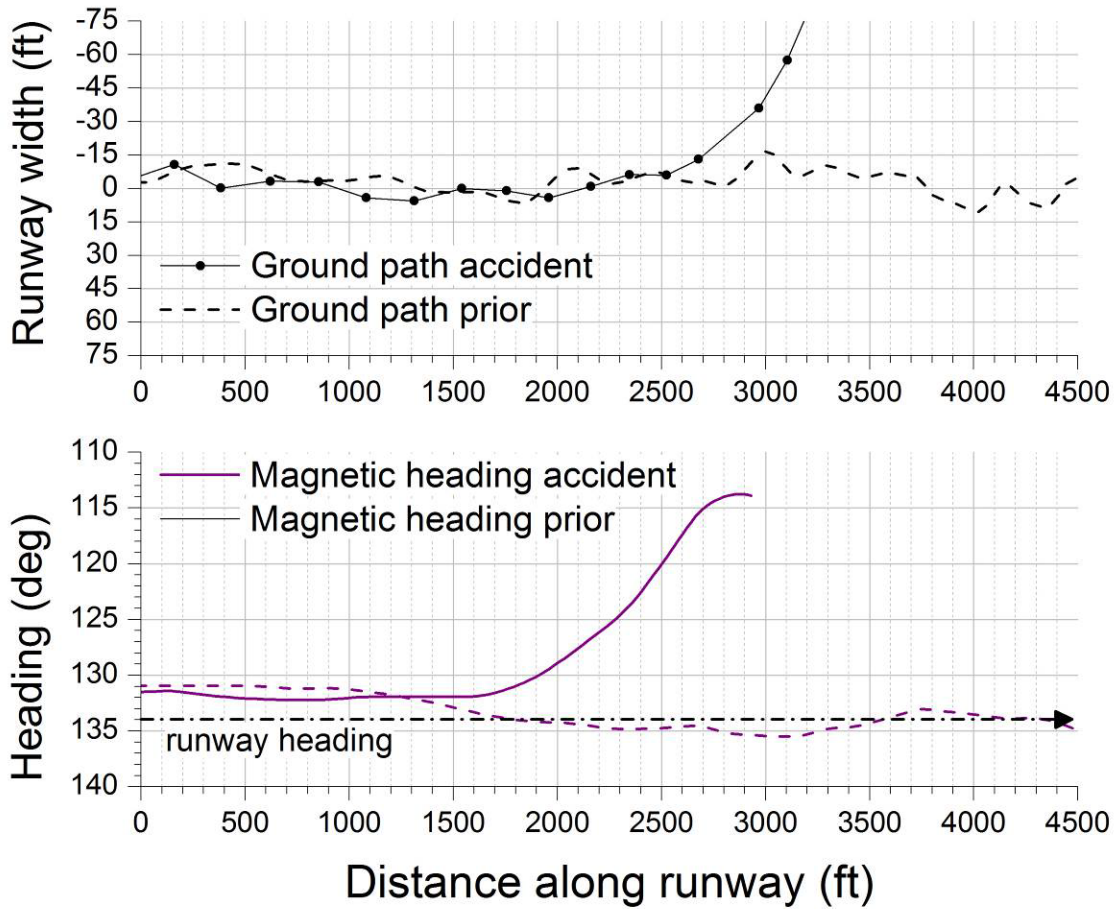
**Figure 24.** Ground path and heading versus distance for accident aircraft and prior MD-88.

The prior aircraft did not deviate from the runway heading throughout its landing roll (Figure 24). Until the accident aircraft began heading to the left, the aircrafts' ground tracks were within 10 ft of each other.

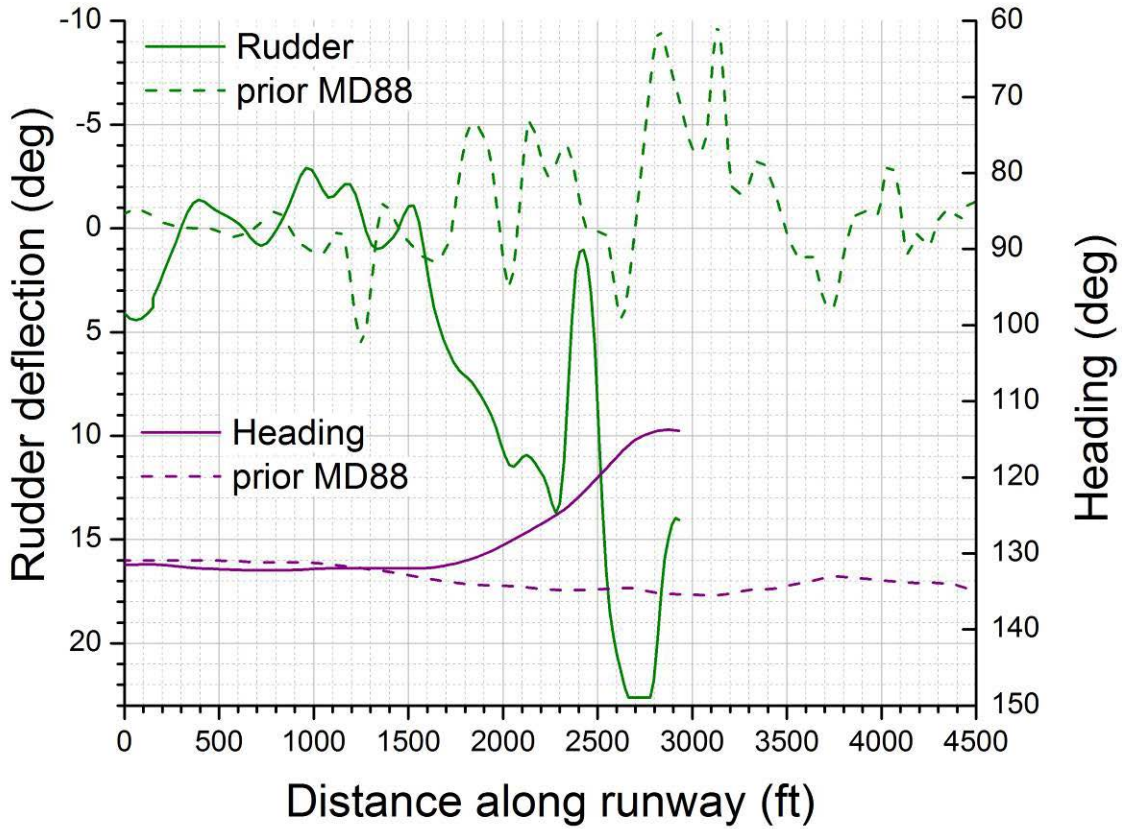
**Figure 25.** Rudder deflection and heading versus distance for accident aircraft and prior MD-88.

The prior MD-88 crew's maximum rudder input was 10° to the left. The accident crew's maximum rudder input was 23° to the right, as shown in Figure 25. The effectiveness of rudder input at EPRs higher than 1.6 will be discussed in the next section of the report.

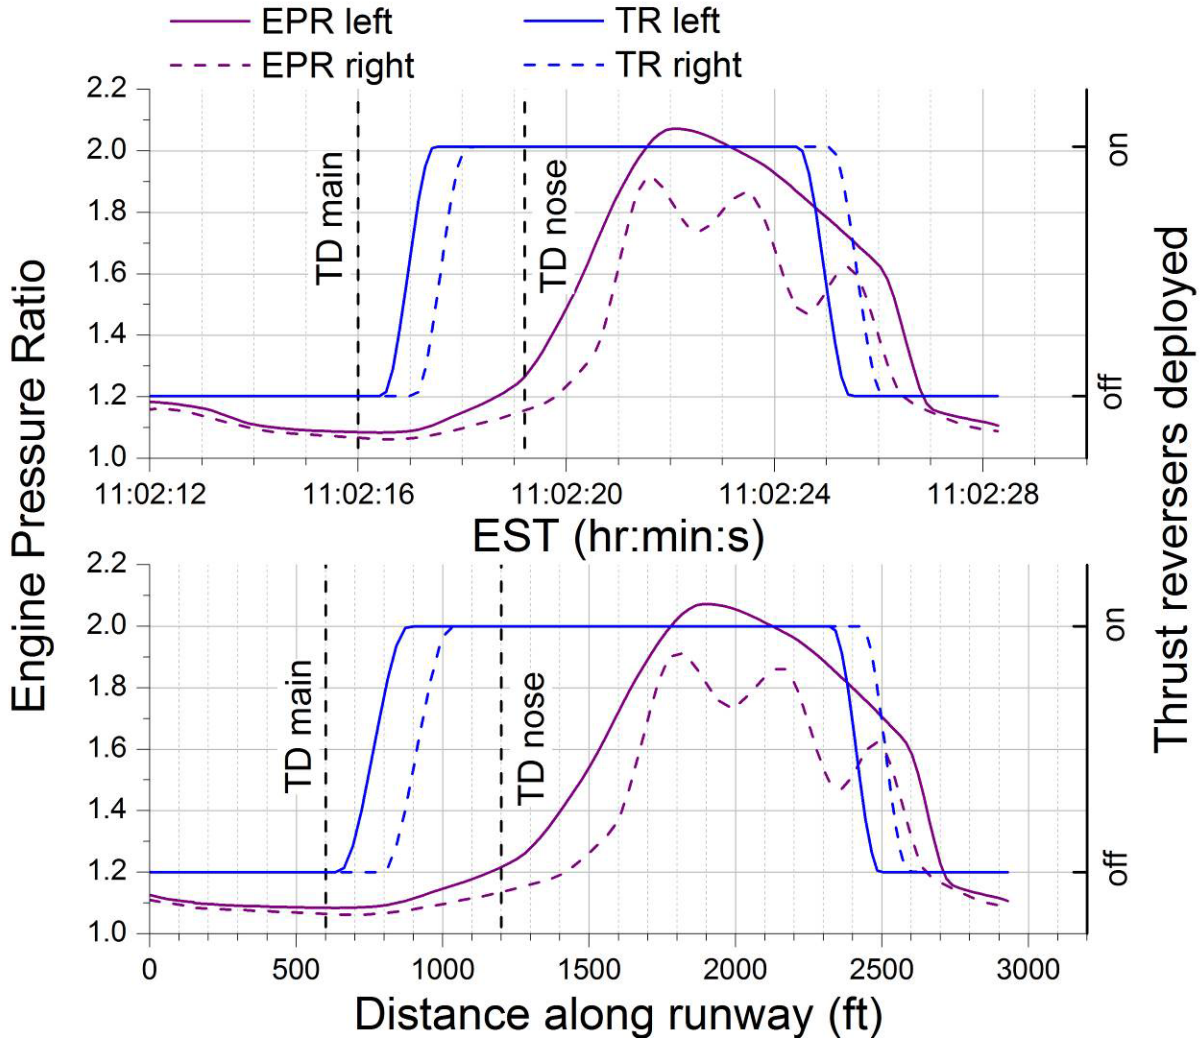
**Figure 27.** Thrust reverser deployment and EPR along runway.

Figure 27 shows the left and right EPR versus time and distance along the runway. The aircraft touched down at 133 kts, and its speed was less than 130 kts when the reverse EPR for the left engine was greater than 1.6. Because the EPR exceeded 1.6 in reverse thrust and the aircraft’s speed was less than 146 kts, test data showed that the crew could not use rudder to control heading. The aircraft’s left engine exceeded 1.6 EPR at 11:02:20.3 and the right engine exceeded 1.6 EPR at 11:02:21. From the time the left yaw began until the thrust reversers were stowed, the rudder was an ineffective means of controlling the aircraft’s heading.

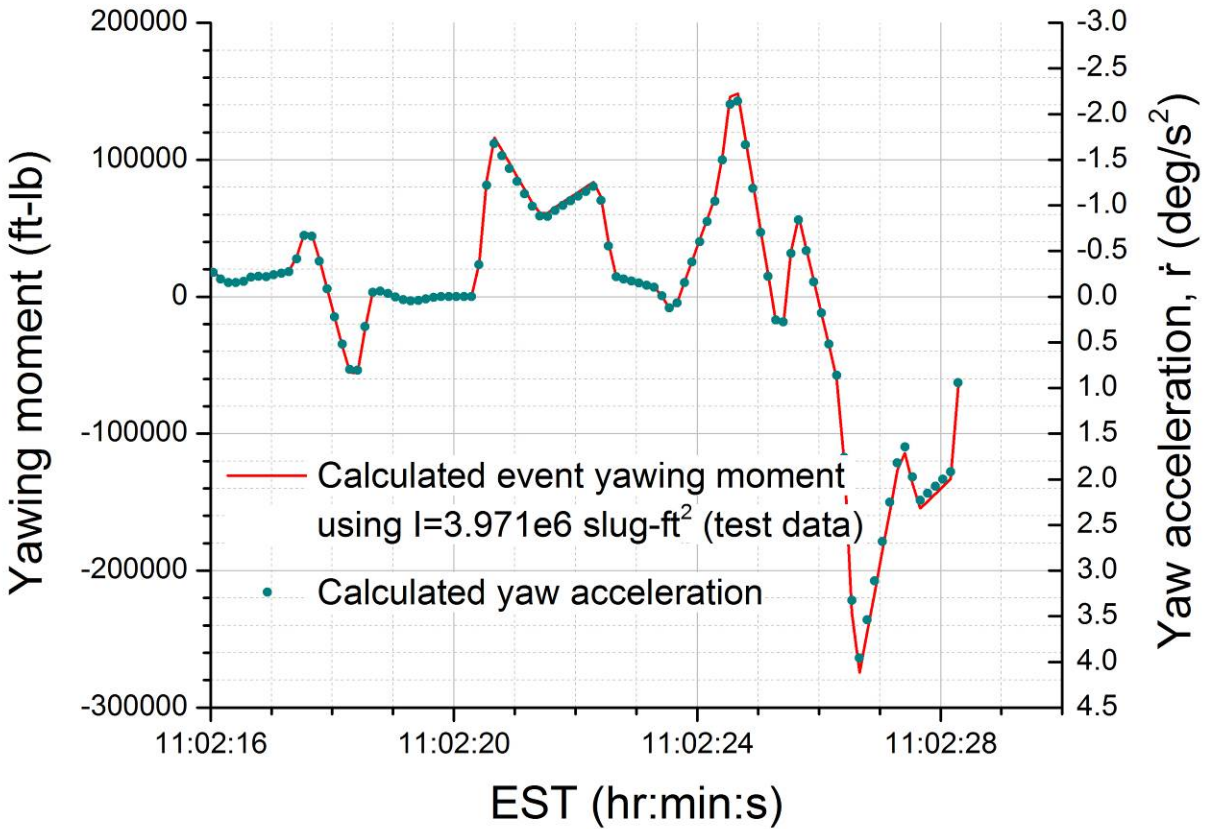
**Figure 28.** Calculated yawing moment (red line) and yaw acceleration (blue dots) of the accident aircraft.

The McDonnell Douglas report used a yawing moment of inertia of  $3.971 \times 10^6$  slug-ft<sup>2</sup> for flight test calculations. This number, while not specific to the accident aircraft, was used as a first approximation in this study. Figure 28, below, shows the calculated yaw acceleration and yawing moment of the aircraft using the FDR data and the reported yawing moment of inertia.

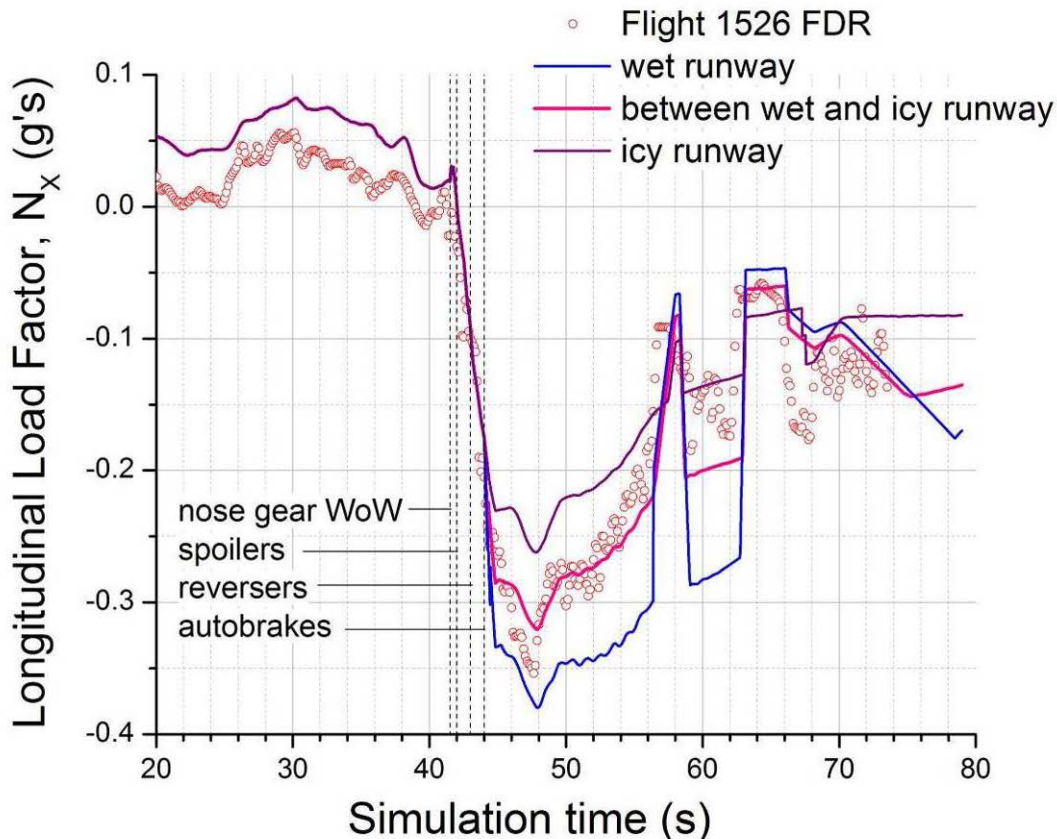
**Figure 30.** Longitudinal acceleration for Flight 1526 and three landing simulations for different runway frictions. The FDR data has been correlated to the time from each simulation run.

Figure 30 shows simulations performed for the prior MD-88, Flight 1526. When the runway performance value was set to a Boeing 'wet' value, the longitudinal deceleration was greater than what was recorded by the FDR. When the runway performance value was set to a Boeing 'icy' value, the aircraft did not decelerate enough. The intermediate value, equivalent to a wheel braking coefficient of 0.16, best correlated the aircraft's deceleration with what was recorded during the actual Flight 1526 landing.

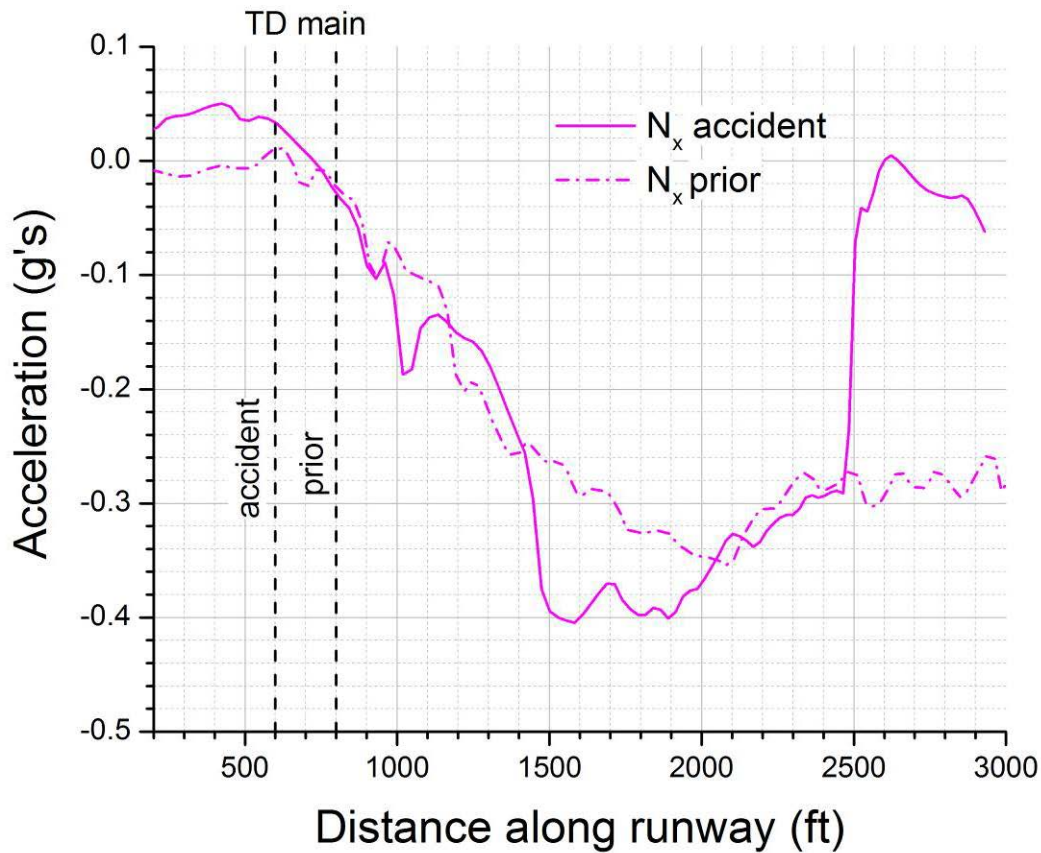
**Figure 32.** Longitudinal acceleration for the accident aircraft (solid lines) and prior MD-88 (dotted lines).

However, comparing the accident landing and the prior MD-88 in Figure 32 shows that the differing  $N_x$  occurs on approximately the same portion runway.

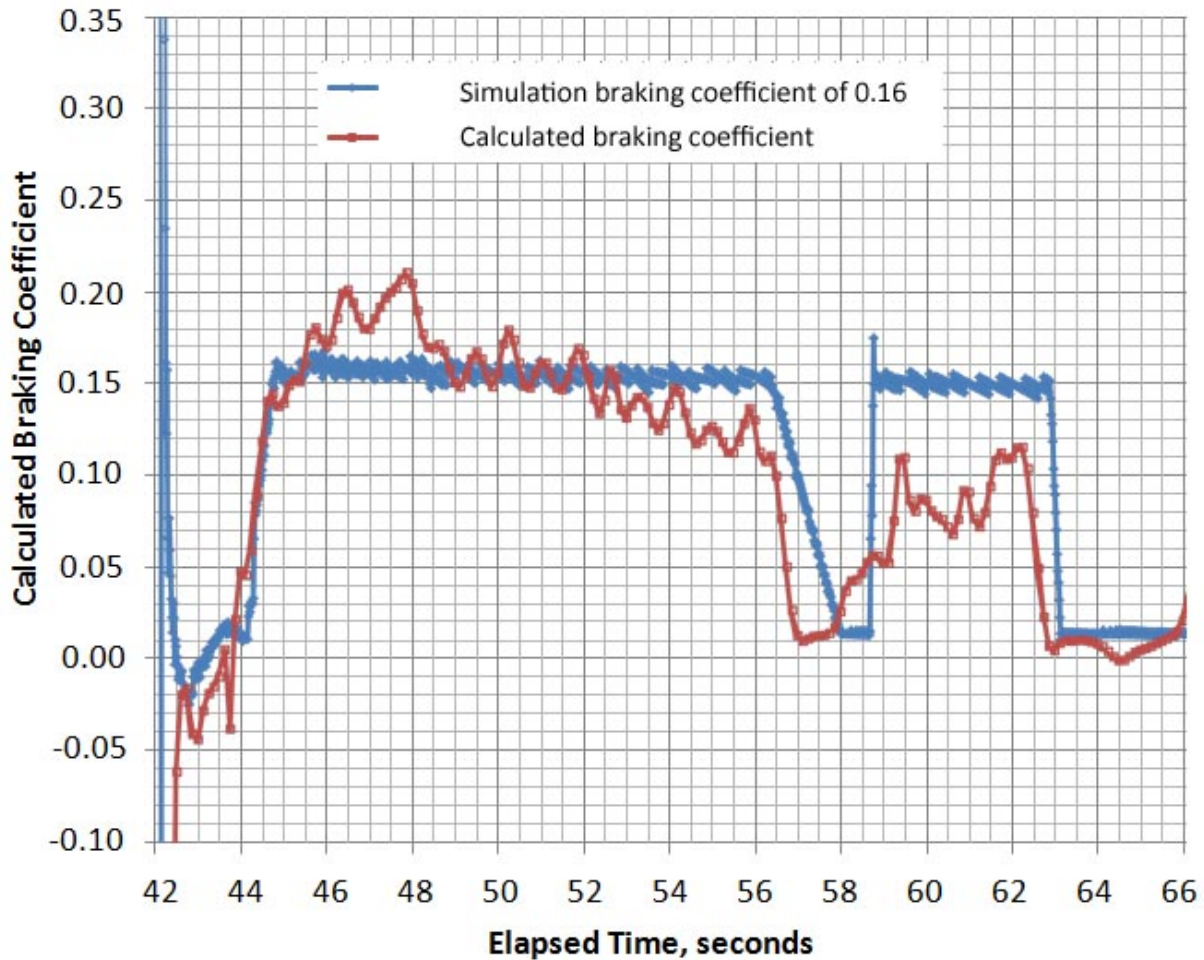
**Figure 33.** Simulated braking coefficient for intermediate runway friction and the calculated braking coefficient from the prior MD-88 landing.

The braking coefficients in the simulations were constant values while the calculated value changes, but in Figure 33 the areas under the curves for 44 s to 56 s for both evaluations were similar. The braking coefficient values from the two methods were generally in agreement. The accident landing roll was also investigated with the same calculation method. Here, in Figure 34, the braking coefficient was shown to be better than the prior MD-88 for the initial portion of the landing roll after nose gear weight on wheels. After the aircraft's heading turns to the left at about 11:02:21, the tires would experience cornering forces which would split the braking coefficient between longitudinal deceleration forces and lateral cornering forces. This interaction between longitudinal and lateral forces was not explored during this portion of the investigation. Therefore, the braking coefficient calculated in Figure 34 cannot be considered reflective of the event after 11:02:21.

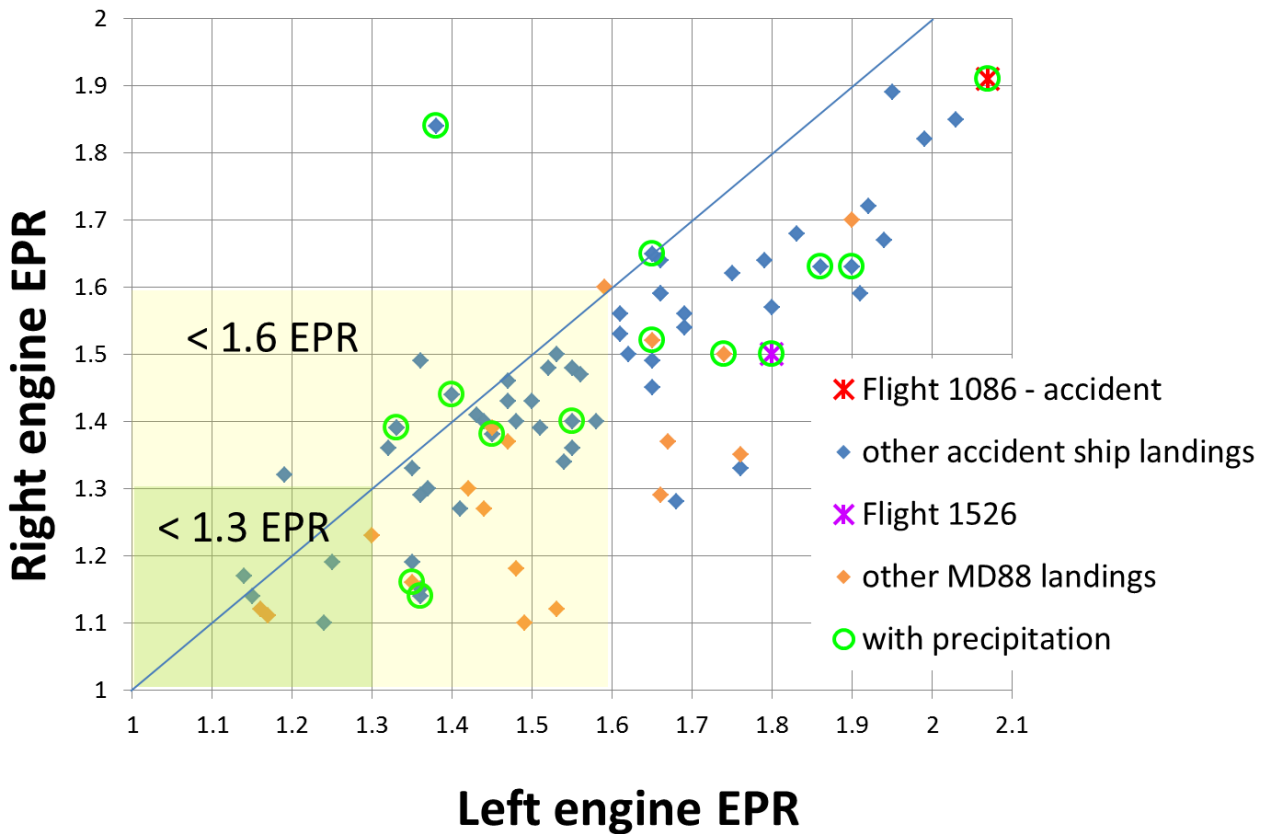
**Figure 36.** Left and right EPR for 59 previous landings of the accident ship (blue diamonds), the accident landing (red star), Flight 1526 (purple star), and 20 other MD-88 landings (orange diamonds). Landings with precipitation are overlaid with a green circle.

The left engine tended to have a higher maximum EPR than the right engine (points below the diagonal blue line in Figure 36 have a higher left EPR). For the accident aircraft, 50 of the 60 landings have higher left engine EPR values than right. For the prior MD-88, 19 of the 20 landings have higher left engine EPR values. The accident landing had the highest right and left EPR value of all the recorded landings examined.

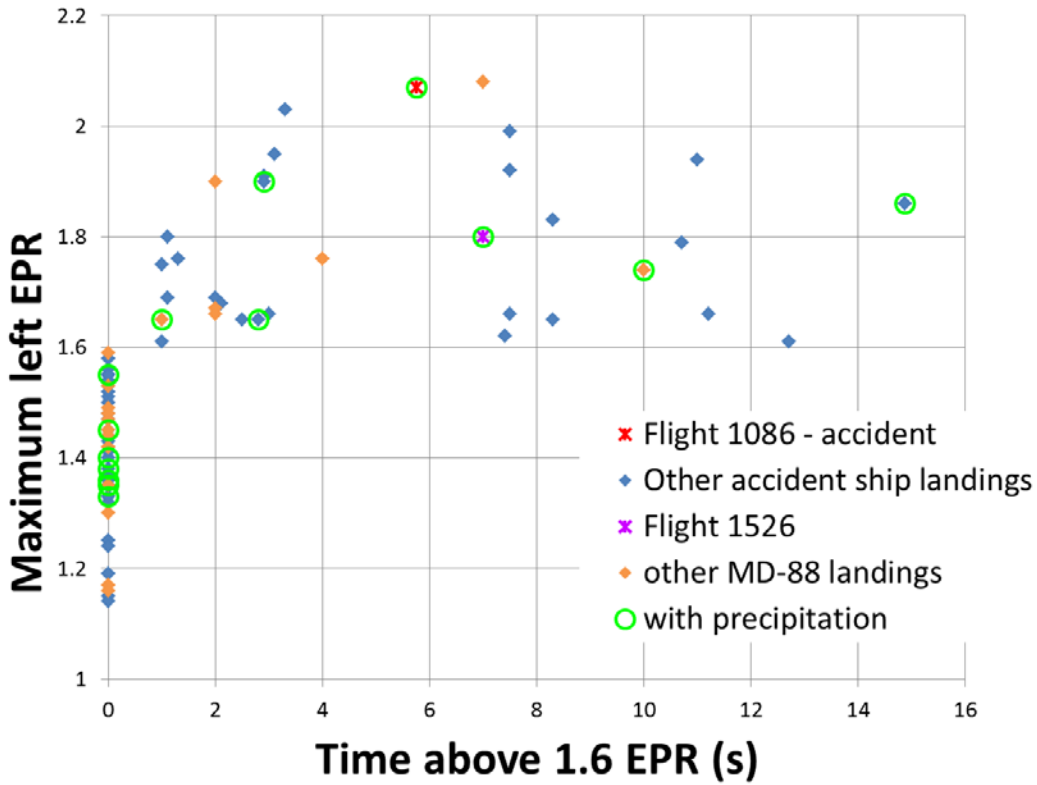
**Figure 37.** Maximum left EPR and the time spent above 1.6 EPR. The collection of points on time=0 are for EPRs that did not exceed 1.6.

Throughout the investigation it was discussed that crews advance the throttles and then pull them back to rebalance the thrust reverse EPR to the desired level. Figure 37 shows the time spent above 1.6 EPR. Half of the landings where 1.6 EPR was exceeded spent more than 4 seconds above 1.6. The aircraft during the accident did not spend more time at the higher EPR values compared to the other landings. However, the accident aircraft's EPR did rise faster than the other flights. For the 25 flights of the accident aircraft where 1.6 EPR was exceeded, the time between the left engine reaching 1.3 and 1.6 EPR was recorded. Not including the accident flight, the average time from 1.3 to 1.6 EPR was 1.25 seconds and the shortest time between those points was 0.9 seconds. During the accident landing, the EPR in thrust reverse increased from 1.3 to 1.6 in 0.5 seconds.

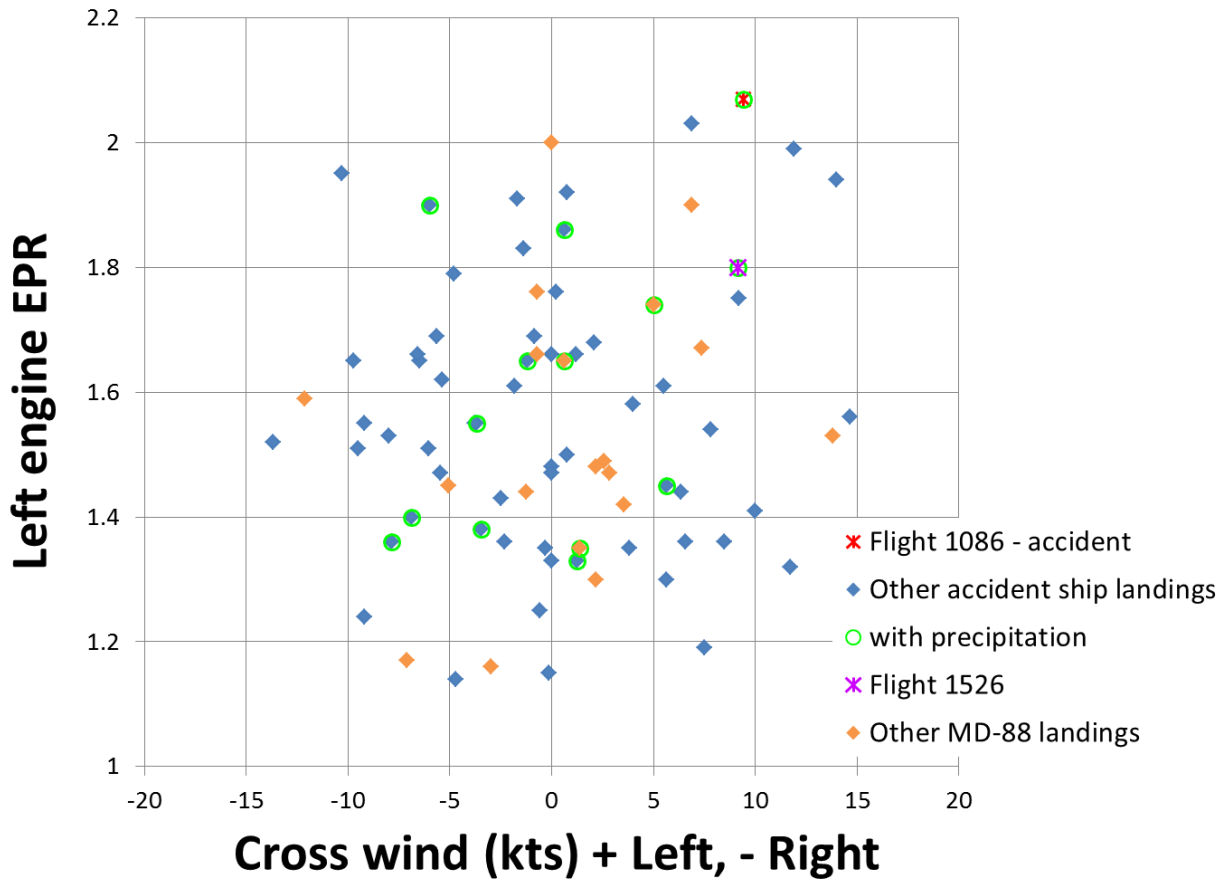
**Figure 38.** Maximum left EPR versus the crosswind at landing.

Figure 38 is the maximum left engine EPR versus the crosswinds at landing. Thirty-seven of the 80 landings had crosswinds above 5 kts and nine of those had greater than a 10 kts crosswind. The accident flight and prior MD-88's crosswind components were between 9 and 10 kts. While not an extreme outlier, the accident landing was in the upper quartile for both EPR magnitude and crosswind.

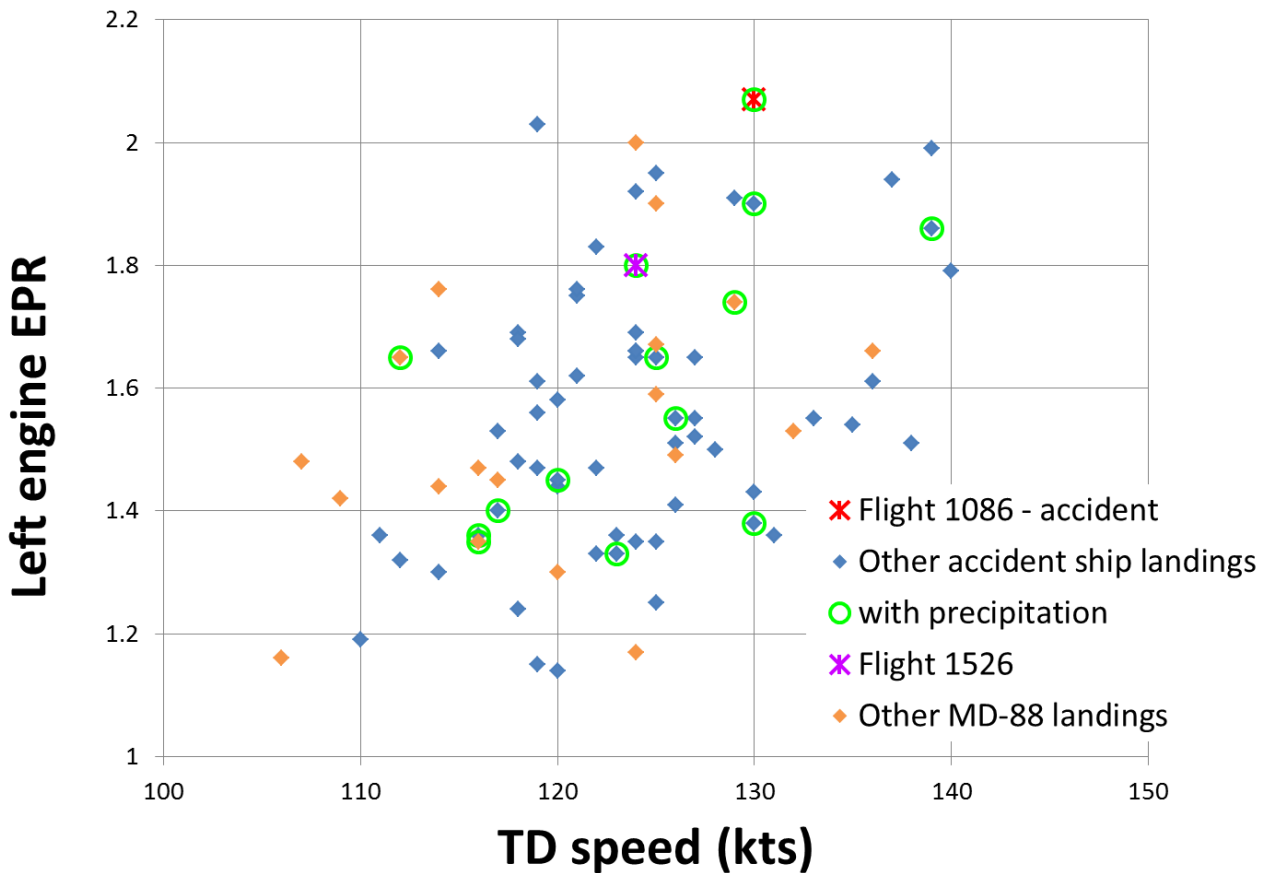
Figure 41. Maximum left EPR versus touchdown speed.

The other landings were also analyzed to try to determine what may influence a crew to input a high thrust reverse EPR. The touchdown airspeed had little effect on the maximum EPR value (see Figure 41). The accident touchdown speed (133 kts) was higher than the mean of all 80 landings (~123 kts), but not the fastest. Figure 42 shows the 34 landings for which the runway length was able to be determined. The length of the available runway does not seem to have a strong effect on the maximum EPR value. Ambient air temperature (not shown) and precipitation (noted for Figure 36 through Figure 42) showed no strong correlation with maximum EPR.
