National Transportation Safety Board

Performance Study

Location: Ypsilanti, Michigan
Date: March 8, 2017
Time: 1452 EST
Airplane: Boeing MD-83, N786TW
NTSB Number: DCA17FA076

DCA17FA076, Boeing MD-83, N786TW

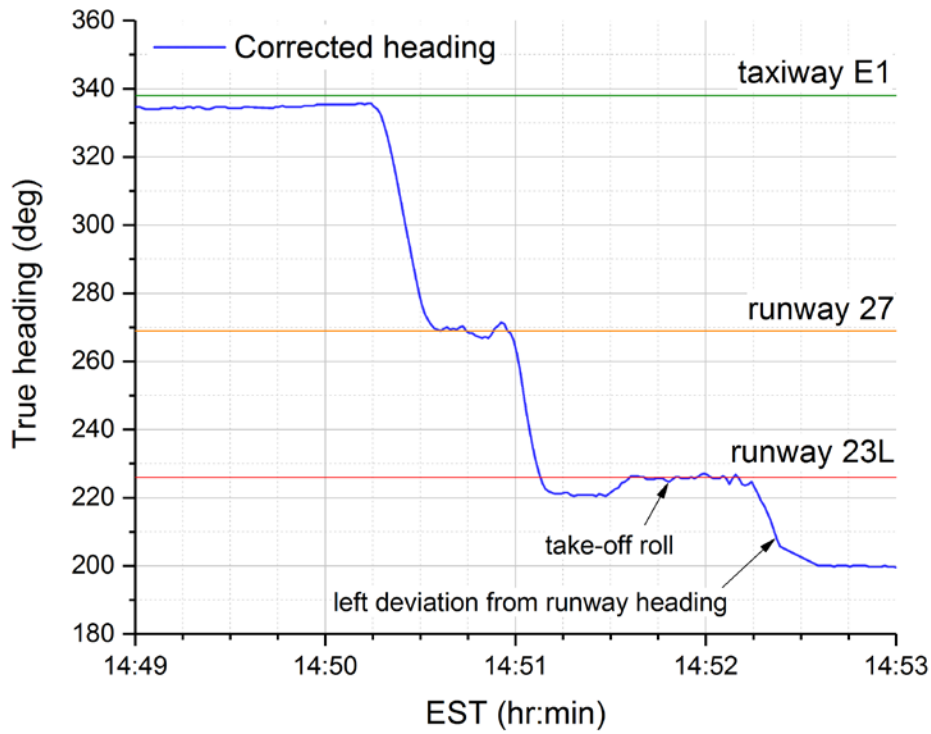
The accident airplane overran runway 23L after unsuccessfully attempting take-off. The FDR did not record latitude and longitude, so the airplane's path to 23L was determined using heading data. The recorded heading showed that the airplane traveled along taxiway E1 to runway 27 to access runway 23L (Figure 4 and Figure 5).

Figure 4. Airplane heading before take-off roll and related taxiway and runway headings.

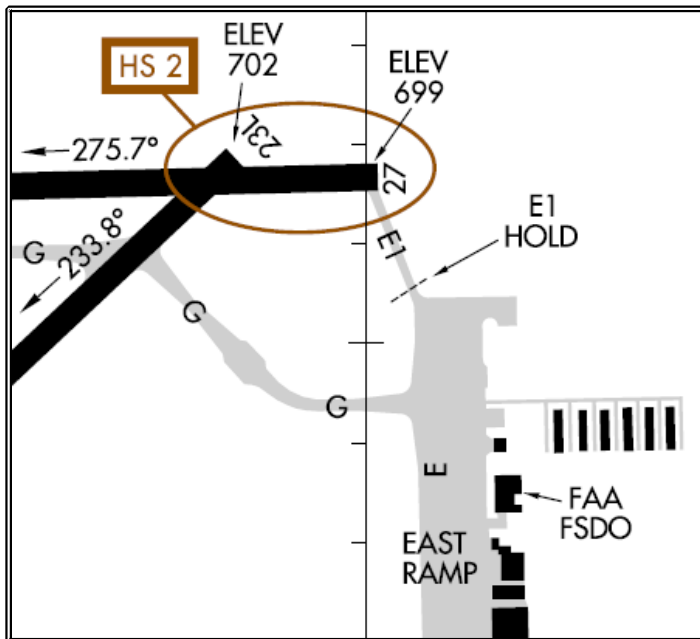
Figure 5. Excerpt from Willow Run (YIP) Airport Diagram. Magnetic variation is 7.1° west.
