NATIONAL TRANSPORTATION SAFETY BOARD

AIRFRAME AND ENGINE EXAMINATION

**NTSB Accident: WPR12GA106
Accident Date: February 15, 2012**

Location: Moran Junction, WY
Date: February 15, 2012
Aircraft: Bell 407, N407HL, Serial # 53869
NTSB IIC: Michael Huhn

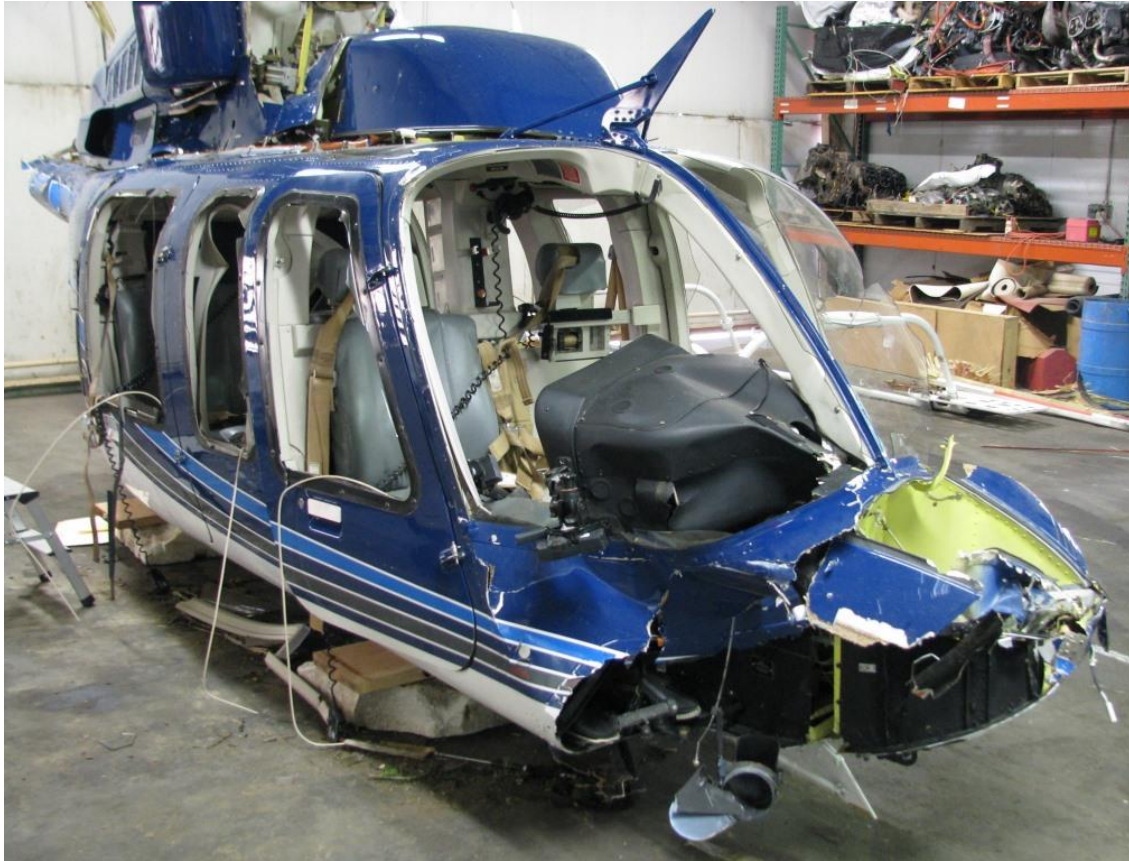
Figure 4 - Front Right View

- The skid assembly was essentially intact, except
 - The left section was twisted a few degrees nose up
 - The forward stub end of the left skid was fracture separated from the rest of the assembly

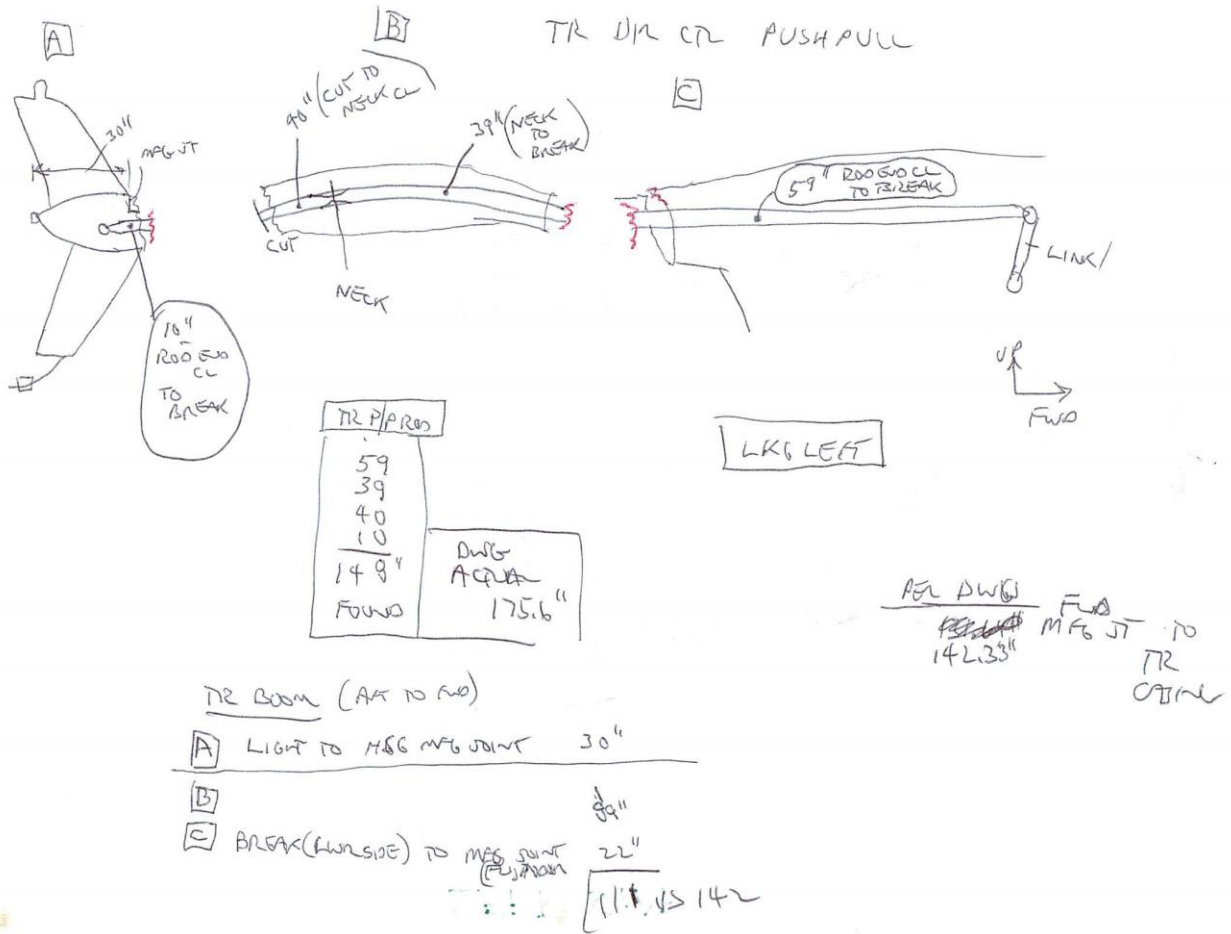
- The tail boom was fracture separated into 4 main sections
 - Approximate 2 foot stub from fuselage ('Section C')
 - Section aft of Section C to about 2 feet forward of empennage juncture ('Section B')
 - Empennage/TR section ('Section A')
 - Approximate 2 foot section between Sections A and B was not recovered
- The empennage (Section A) was fracture-separated from the tail boom at the empennage junction, but the TR drive shaft had fractured about 2 feet forward of that break

Figure 11 - Hand Sketch of Tailboom Fractures and Dimensions

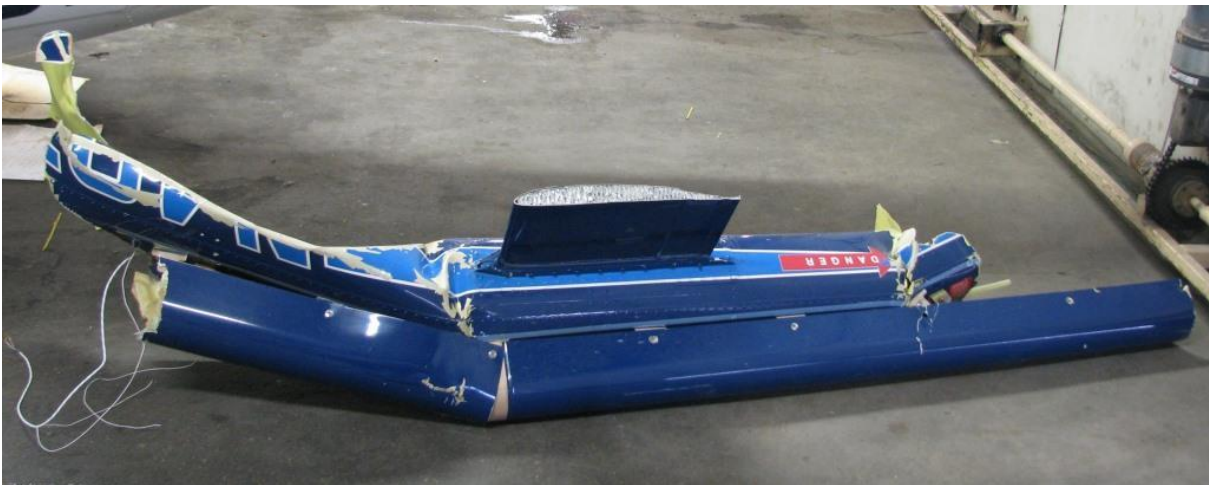
Figure 13 - Longest Tailboom Section (Horizontal cut for recovery)

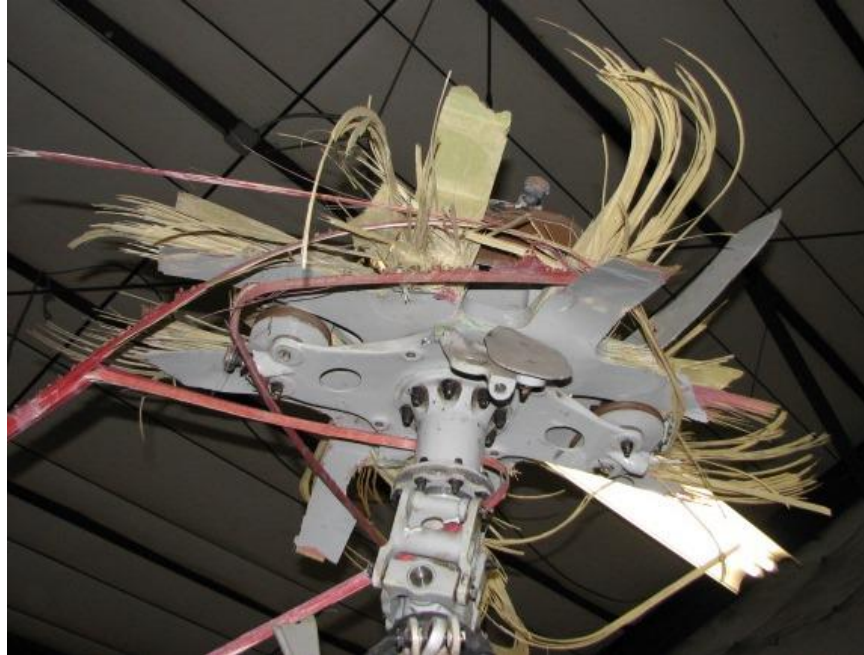
Figure 16 - MRB Hub

- The helicopter was equipped with 4 main rotor blades
- The MRB system rotates counterclockwise when viewed from above
- Normal operational rotation speed is constant, at 413 rpm
- All four blades had been fracture-separated from the hub
- The hub remained attached to the transmission & airframe
- Undamaged blade length from centerline of blade attach bolt to tip was 187"
- Undamaged blade length from blade root to tip was ~188.5"
- Control continuity for the cyclic and collective systems was established from the cockpit controls to the MRBs
