## **NATIONAL TRANSPORTATION SAFETY BOARD**

# **AIRFRAME AND ENGINE EXAMINATION**

**WPR14LA271**

Location: Big Creek, Idaho  
Date: June 29, 2014  
Aircraft: Cessna 182Q, N132K, Serial # 18266782  
NTSB IIC: Michael Huhn

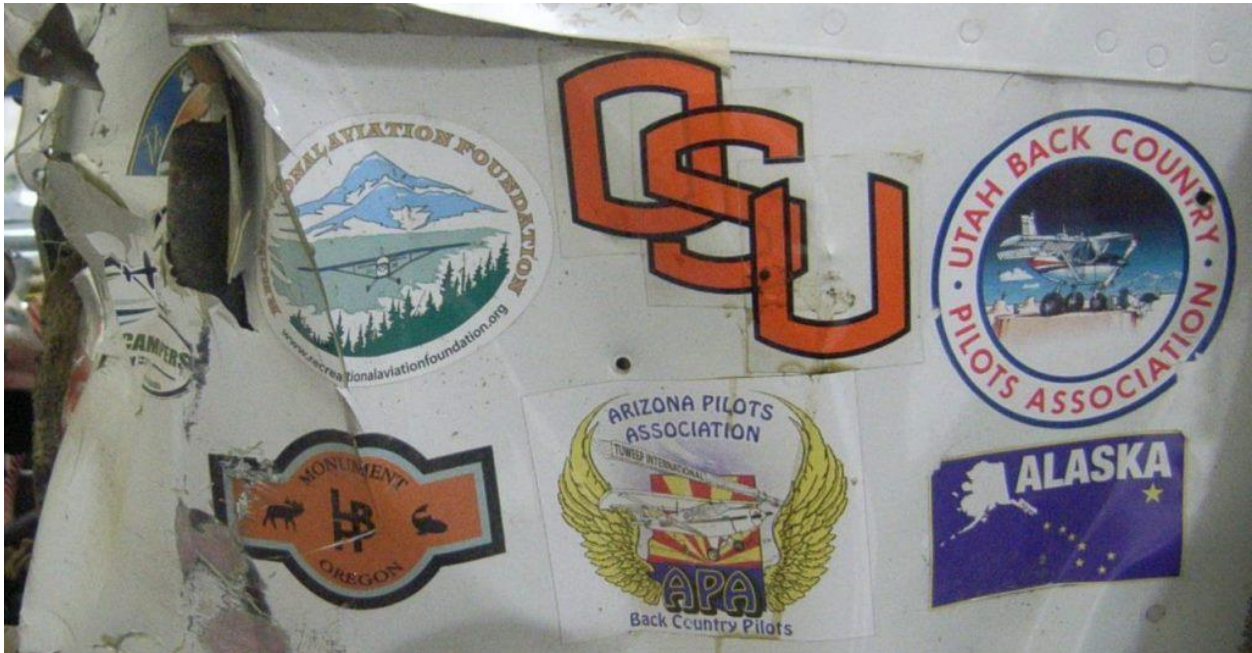
Figure 26 - Stickers on Left Cowl

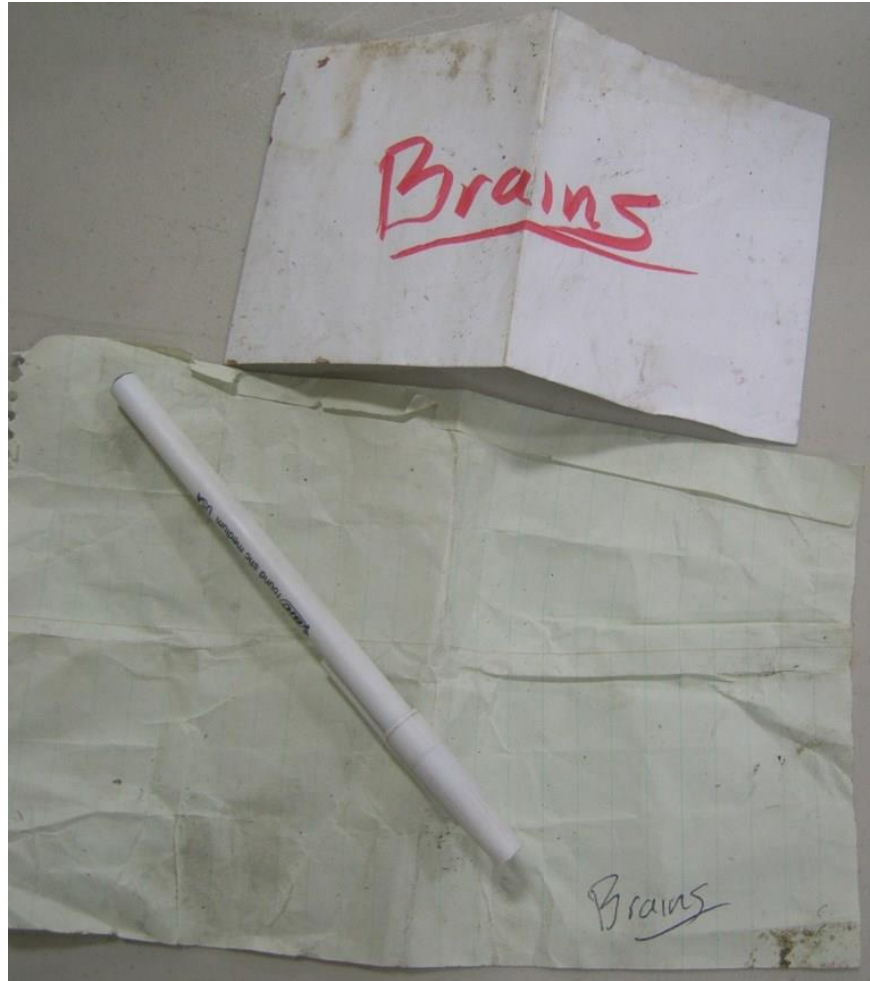
- Two separate loose papers with the handwritten, underlined annotation "Brains" were found in the recovered items. The handwriting style of the two was consistent, and appeared to be from the same person (Ref photo 1851)

Figure 28 - Two Notepages (found in loose items)
