**NATIONAL TRANSPORTATION SAFETY BOARD**

**LEFT & RIGHT ELEVATOR EXAMINATION**

**WPR12FA332**

# Airplane Examination Report

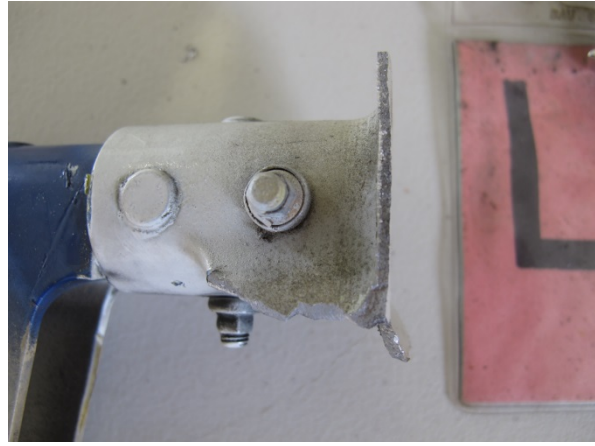
- Right elevator had been removed by an A&P Mechanic under the direction of Avantair on Sunday, July 29. The attaching hardware (bolts, bushings, & nuts) were removed and FedEx'd to Avantair's facility in Clearwater, FL.
