NATIONAL TRANSPORTATION SAFETY BOARD

Colgan Air Flight 9446 Airplane Performance Study

A. Accident: NYC03MA183 (key 57787)

LOCATION:	Yarmouth, MA
DATE:	August 26, 2003
TIME:	Approximately 15:40 EST
AIRCRAFT:	Raytheon (Beech) 1900D, N240CJ
OPERATOR:	Colgan Air (d.b.a. US Airways Express)

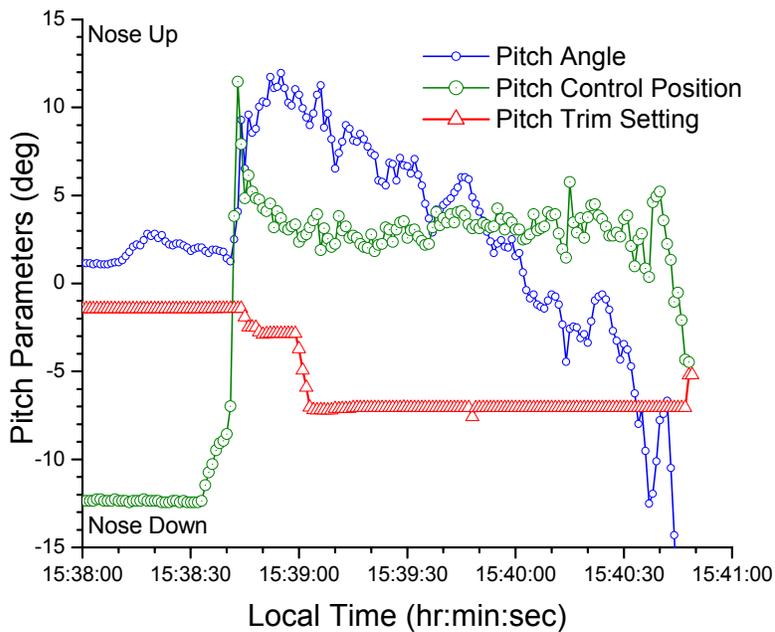
Figure 4: Pitch, pitch control and pitch trim.

FDR parameters may be offset from their true values. For this case, the FDR shows approximately a 1.1 degree pitch angle for ground operations before power comes up for the takeoff run. However, the pitch angle of a 1900D at this loading should be slightly less than 0.0 degrees. Accordingly a -1.25 deg offset was applied to the pitch data for the kinematics extraction. Similarly the FDR roll angle is 1 degree during taxi and remained constant as the airplane turned onto the runway. Accordingly, a -1.0 degree offset was applied to the roll data for the kinematics extraction. The FDR longitudinal load factor (N_x) value remains 0.05 during taxi operations. Accordingly a -0.05 offset was applied to the roll data for the kinematics extraction.
