Radar Performance Study

Specialist Report
Timothy Burtch

Location: Akron, OH
Date: November 10, 2015
Time: 1952 GMT (2:52 pm EST)
Airplane: Hawker 125B-700A, N237WR
NTSB Number: CEN16MA036

**Radar Study, Airplane Performance
CEN16FA036, N237WR, Hawker 125B-700A, 11/10/2015**

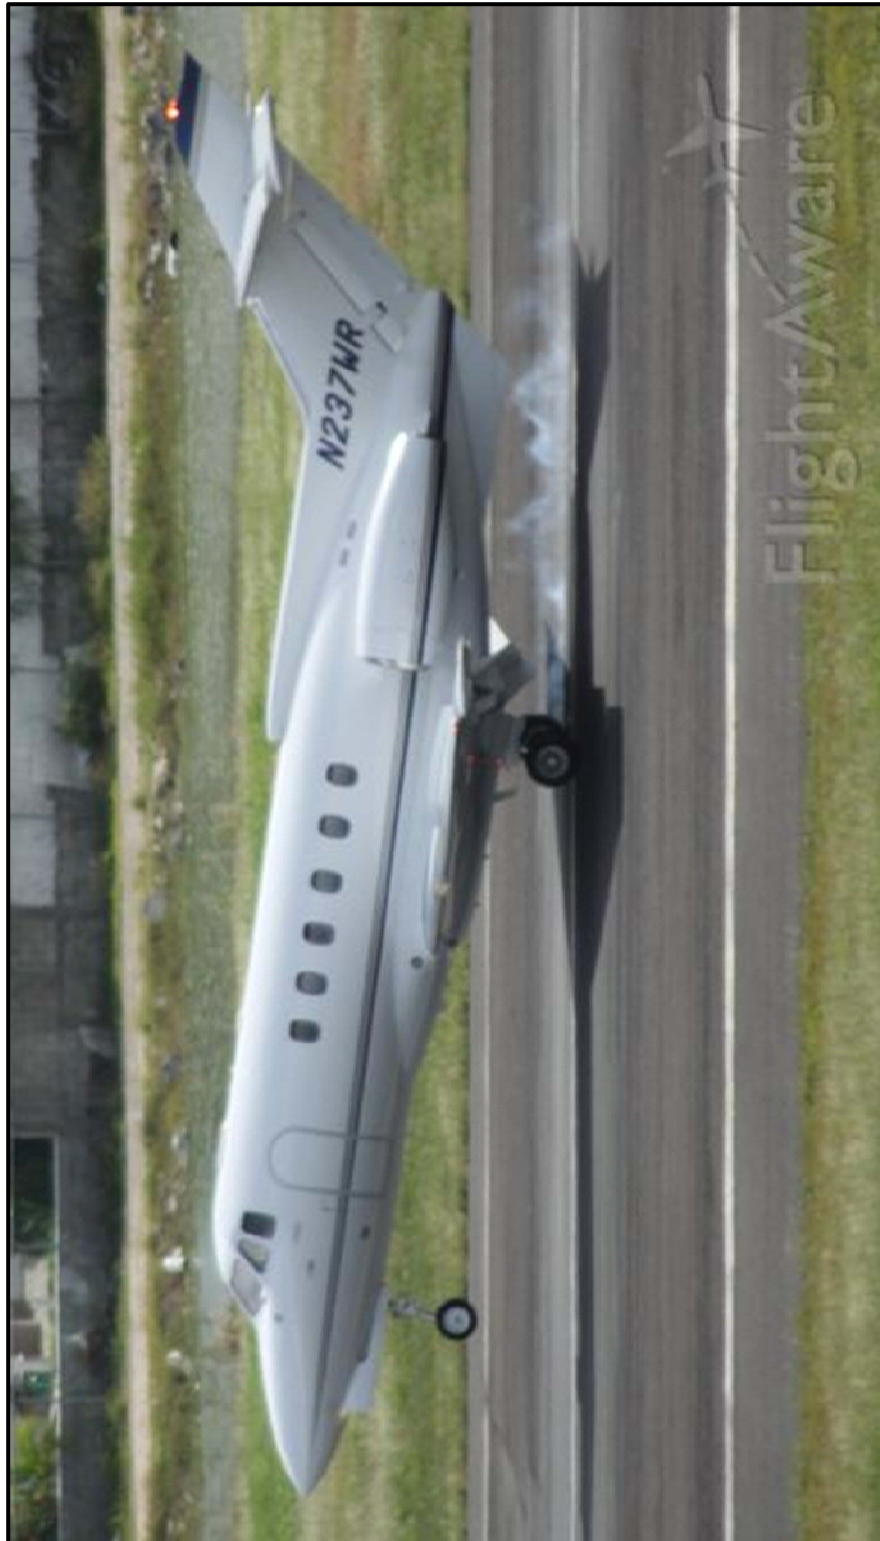
A picture of the accident airplane, a Hawker 125B-700A, is shown in Figure 1. The airplane was equipped with conventional, reversible flight controls and two Honeywell TFE-731 turbofan engines. The accident airplane was not equipped with a flight data recorder, but a cockpit voice recorder (CVR) was recovered from the wreckage.

Figure 1: Accident Airplane, N237WR, a Hawker 125B-700A

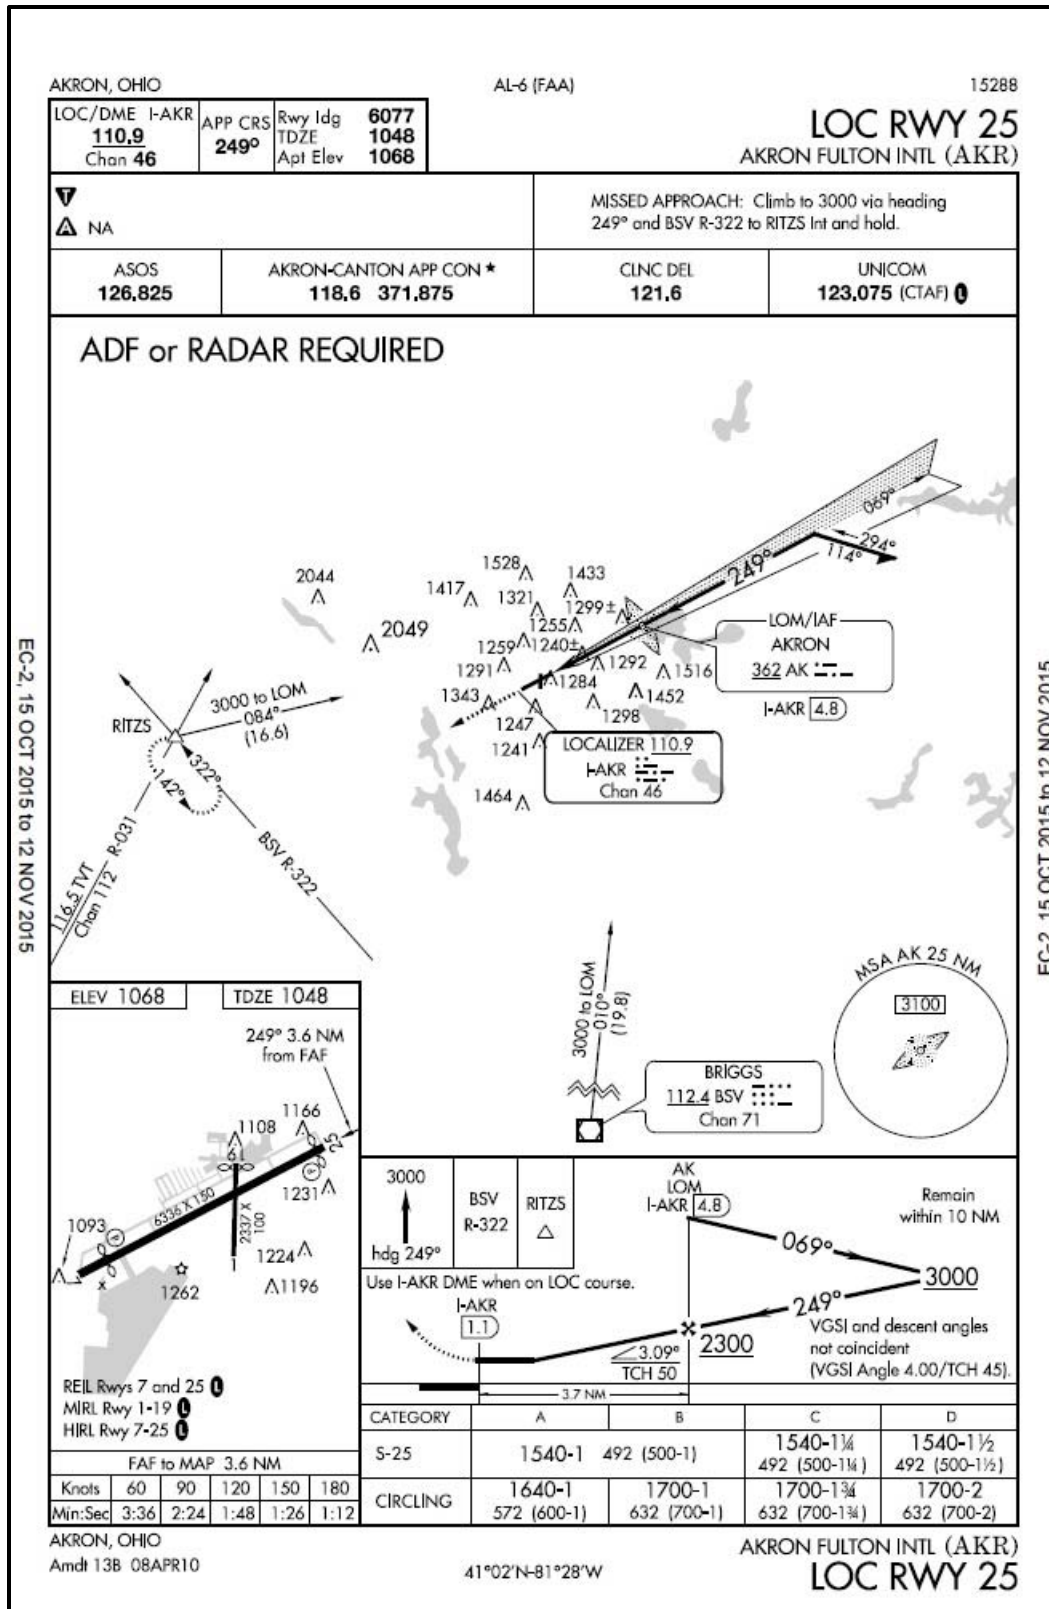
the figure². Figure 5 is the published approach for which N237WR had been cleared by ATC.

Figure 5: Published Approach for which N237WR had been Cleared
