NATIONAL TRANSPORTATION SAFETY BOARD

AIRWORTHINESS GROUP CHAIRMAN'S FACTUAL REPORT

ERA14MA271

Location: Hanscom Field, Bedford, MA
Date: May 31, 2014
Aircraft: Gulfstream G-IV, N121JM, S/N 1399

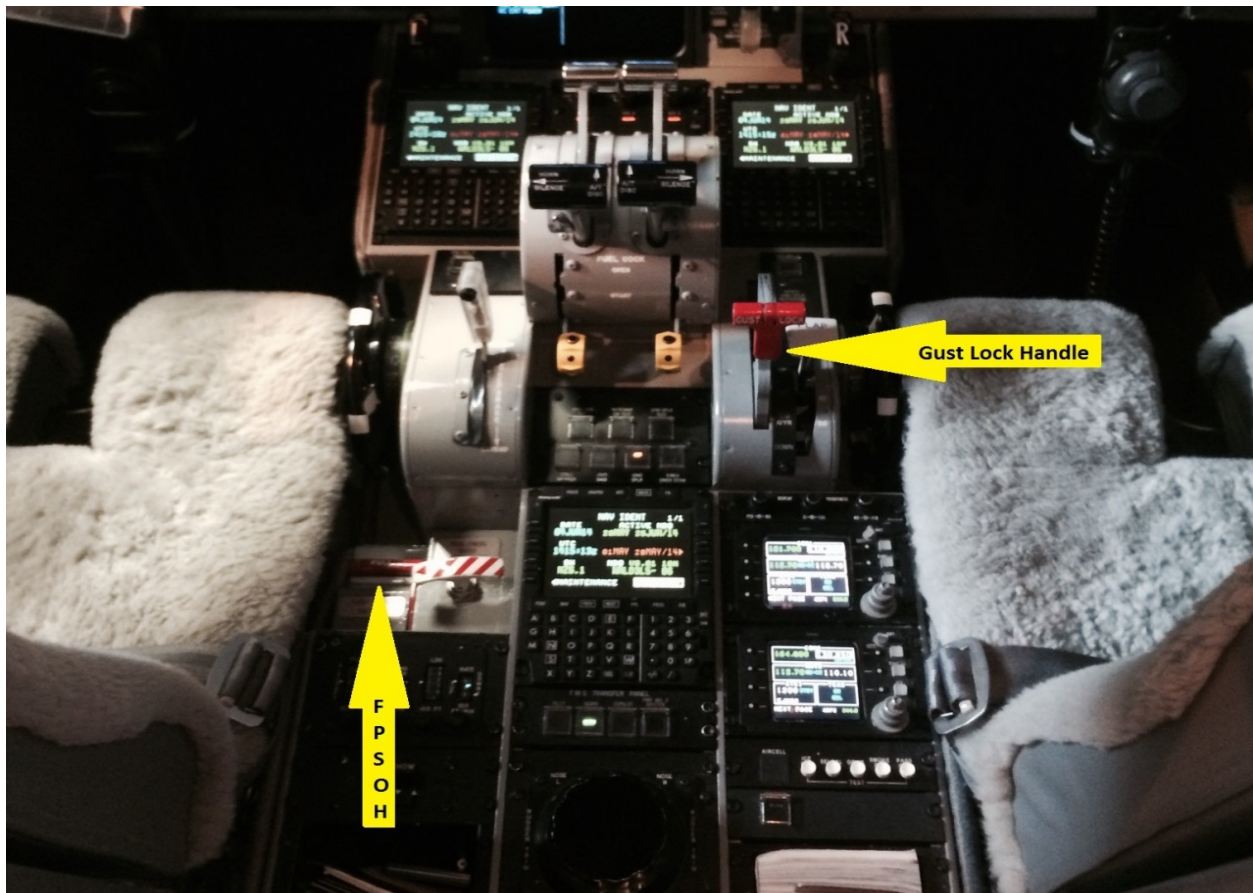
The flight power shutoff T-handle was found in the up position on the accident aircraft. The flight power shutoff valve was also located in the wreckage after removal from the initial wreckage location. The input lever was forward indicating the valve was in by-pass mode (hydraulic power disabled to the flight controls listed above). The lever moved with little applied force. The sliding cable was found severed in the wreckage.

Figure 6: Cockpit Example with Arrows Referencing the Flight Power Shutoff Handle (FPSOH) in the Stowed Position and the Gust Lock Handle in the Up and Latched Position

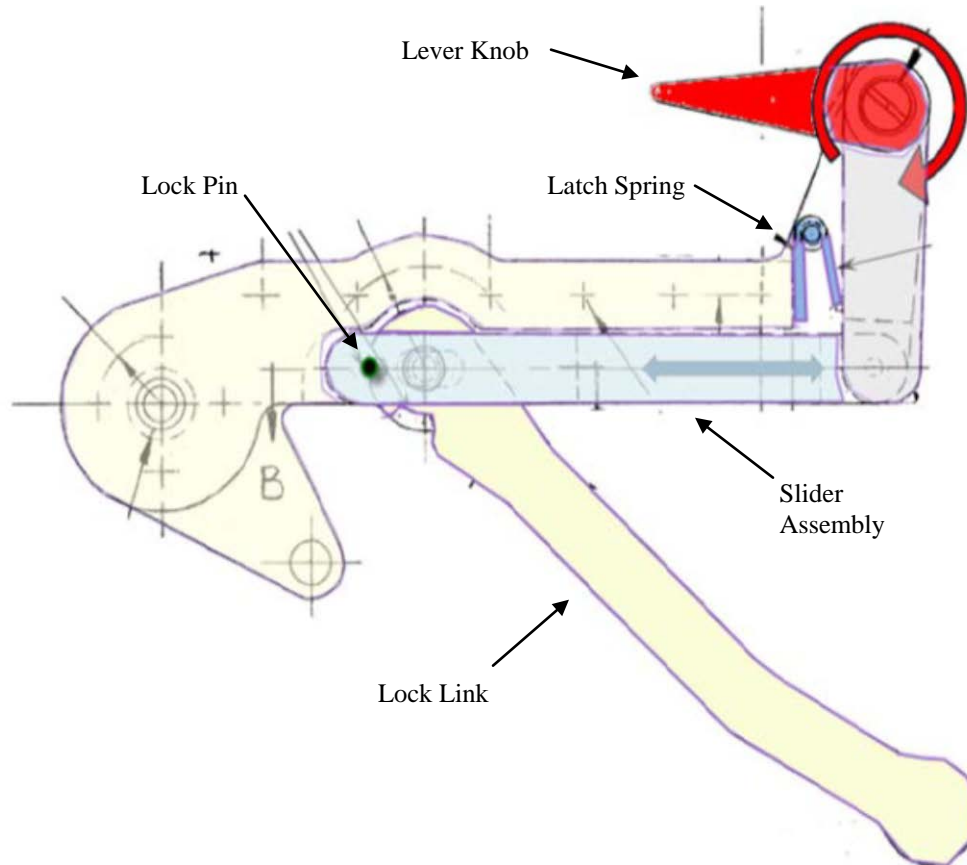
Figure 7: Gust Lock Handle Diagram

The gust lock handle was initially found in the down position. The handle was sooted and the primer was charred. The spring action of the latch was not smooth and the spring was not consistently returning the latch mechanism to the lock position when the lever knob was released. X-ray analysis later showed that the latch spring was intact.

Following wreckage recovery, the gust lock handle was moved full up and then manually moved down until a resistance was met (the forces normally provided by the return springs were absent due to the severed control cables). This resistance was thought to be the lock pin slot engaging with the lock pin. It was noted that with increased force the handle could be pushed past the lock pin, and it was later discovered that the pin was severed and only stubs remained on both sides of the slider assembly. NTSB lab analysis revealed that the pin material remaining on the right side of the slider assembly as installed on the aircraft was significantly deformed with smearing damage having pushed the pin material in the direction consistent with the lever going from the up position to the down position (see Figure 8). The material remaining on the left side of the slider assembly was small enough to be inside the pin hole. The middle section of the pin was never found. By design, the pin will either free float in the restraint holes in the slider assembly or have a slight interference fit. During lab analysis, the stub from the left side fell out of the slider assembly.

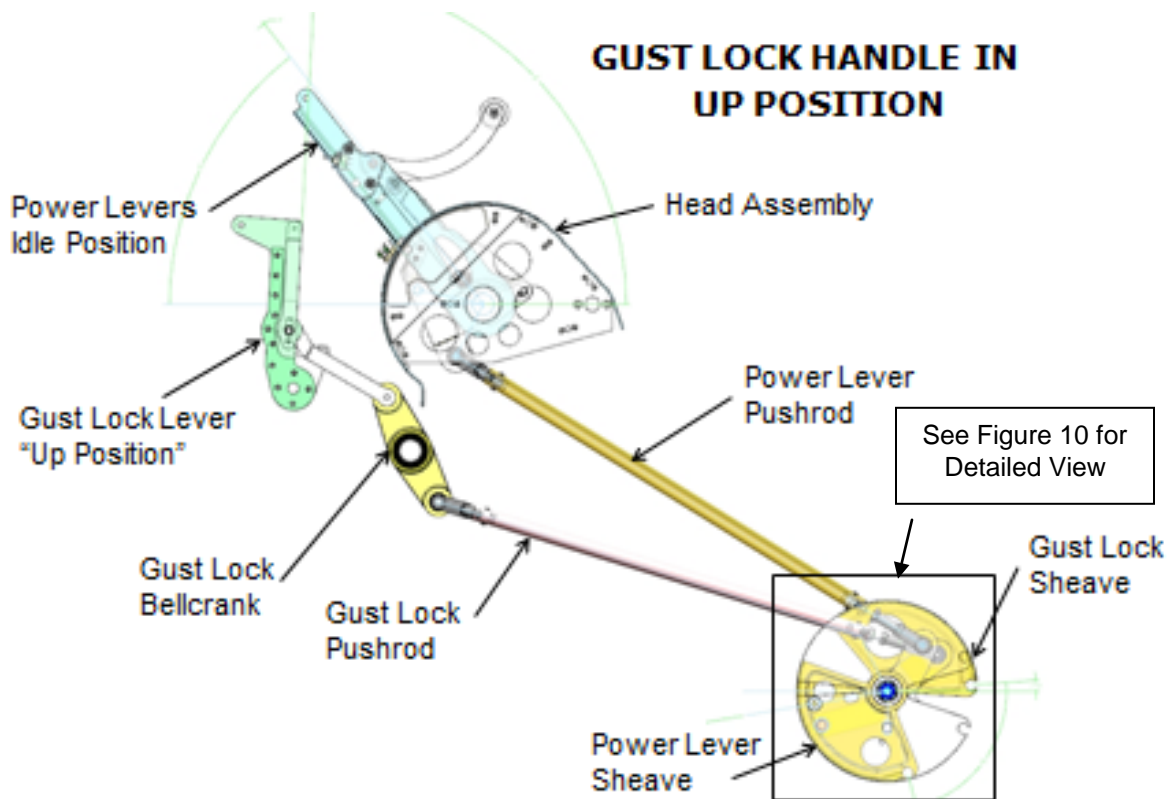
Figure 9: Gust Lock/Throttle Lever Interlock Mechanism

The G-IV pedestal assembly includes the interlock mechanism and is a modified version of the G-II/III pedestal assembly. Due to some aspects of the modification, the G-IV interlock design could allow for as much as approximately 5 additional degrees of throttle lever movement with the gust lock lever up and latched as compared to its predecessor (See System Safety and Certification Group Chairman's Factual Report in the public docket for this accident for further details). Rockwell Collins (the pedestal manufacturer) stated that the interlock mechanism provides for approximately 6.9° of throttle lever movement nominally when the gust lock lever is in the up position; however, using the worst case manufacturing tolerance stack up and kinematic effects the thrust levers could move as much as 23°. If incorrect rigging procedures were followed (see Section F.7.3) in addition to the worst case manufacturing tolerance stackup and kinematic effects, Rockwell found that the thrust levers could move as much as approximately 26° when the gust lock handle is in the up and latched position. Gulfstream performed an informal technical evaluation of 9 in-service G-IV's and found that with the gust lock handle in the up and latched position, the forward throttle lever movement varied from 18.2° to 24.2° from the levers' full aft positions. Gulfstream also stated that they have not received any service reports of excessive throttle movement from the G-IV fleet. On the accident airplane, the gust lock handle was moved full aft and then manually moved forward until a resistance was met (the forces normally provided by the return springs were absent due to the severed control cables). This resistance was thought to be the lock pin slot engaging with the lock pin. At this position, the throttle levers could be moved forward approximately 27° from their full aft positions (at the throttle levers' internal stops) before the interlock mechanism restricted further movement. As previously stated, it was later discovered that the internal lock pin in the gust lock handle was severed and only stubs remained on both sides of the slider assembly. These stubs provided enough contact force to prevent gust lock handle travel to the down position using light to medium force. As greater force was used the handle could move further forward and eventually pushed through the pin stubs to the down position. During subsequent testing on the accident aircraft, a similar gust lock handle with an intact lock pin was installed. The throttle levers could then move forward approximately 22° from their full aft positions (at the throttle levers' internal stops) with the gust lock handle in the up and latched position. Although not exactly linear, it can be roughly estimated that one degree of forward gust lock lever travel will result in approximately one more degree of throttle lever movement allowed by the gust lock/throttle lever interlock mechanism.

The gust lock/throttle lever interlock was examined in detail at the wreckage storage facility. Covers and panels were removed from the pedestal. A yellow marker with burn patterns was found between the elevator trim chain and the structure resting above the trim sensor. An orange marker was found on the floor to the right of the sector assembly. A charred piece of folded paper was found on the floor and dated JULY 29, 2012. Sun glasses were found on the floor near the aft side of the sector assembly sheaves in the direct vicinity of the left throttle lever sheave and the gust lock sheave. The sheaves rotated freely with the exception of the interference caused by the sun glasses (see section F.7.4). The control rods connected to the sector assembly were straight and secured. A maintenance protractor was installed between the throttle levers. With the gust lock handle in the down position, the throttle levers (as measured from the aft side of the lever) could move freely from approximately 46° (internal aft stop) to 104° (forward stop). By design, the throttle levers have a 58° range of rotation from idle.

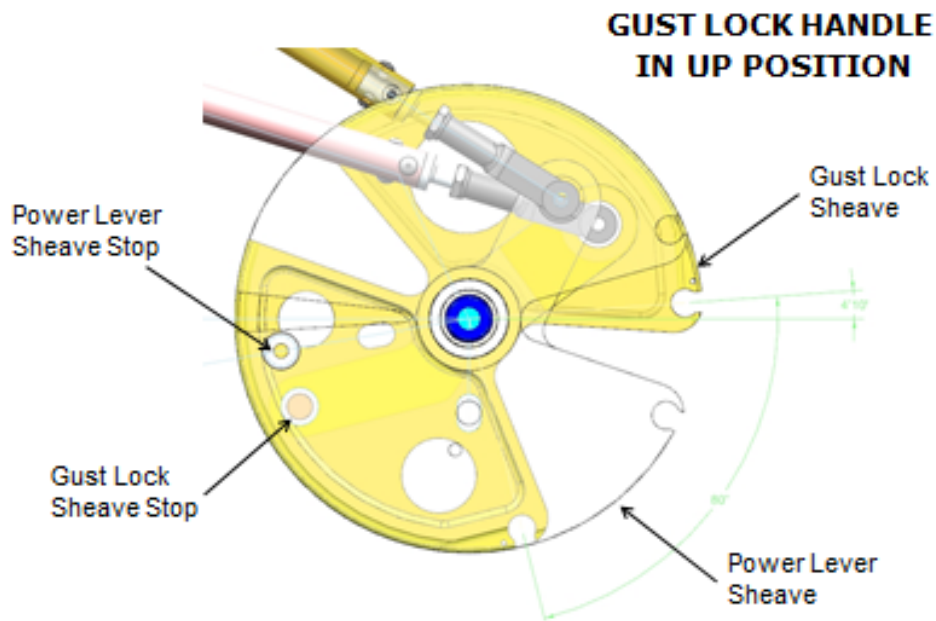
Figure 10: Gust Lock and Throttle Lever Sheave Assemblies

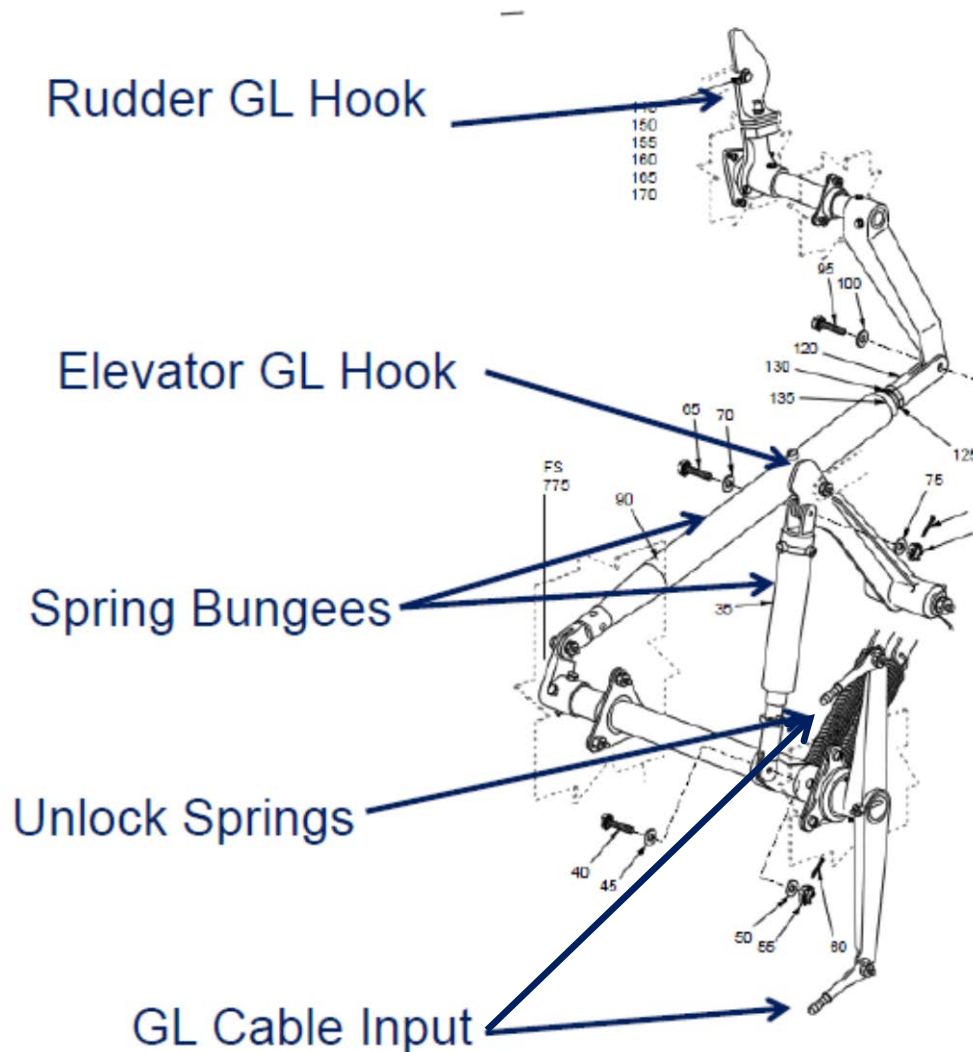
Figure 12: Diagram of the Elevator and Rudder Gust Lock Hook Mechanism

All observations regarding the gust lock components in the FS 775 area were made after the structure was removed from the ravine. The rudder and elevator gust lock hooks were not engaged with the gust lock pins when found. The two rudder/ elevator gust lock return springs were intact and provided return force to the torque tube in the direction to disengage the gust lock hooks. The cable input crank was fractured at both cable attachment lugs and both fracture surfaces contained soot. The elevator gust lock hook bungee moved freely back and forth but without any resistance from the internal spring. The elevator hook remained attached to the bungee and was straight. The inside surface of the elevator lock hook capture slot appeared sooty and/or corroded. The elevator gust lock locking pin attach bracket was intact. The locking pin was mostly sooted but had a small shiny area that spanned the length of the roller on one side. The shape could not be correlated to the shape of the gust lock hook, and it could not be determined if the area was caused by shielding during the fire or by contact after the fire. The soot could be removed easily from the roller.

The rudder gust lock bungee was severed aft of the bungee spring retention screws with one section remaining attached to the torque tube and one attached to the rudder hook crank. The fracture surface appeared shiny and clean. The remaining rudder hook bungee had some return spring action. The rudder lock hook was intact and straight. The rudder locking roller and rudder gust lock hook capture slot surfaces were heavily sooted. The hook lever could be moved and the hook and lock roller did not appear to be aligned. No damage was identified to the structure adjacent to the gust lock hook that could be positively attributed to the gust lock hook being engaged under load.
