**NATIONAL TRANSPORTATION SAFETY BOARD**  
**Office of Aviation Safety**  
**Washington, D.C. 20594**

**Airworthiness Group Chairman's Factual Report**

**NTSB No: CEN13FA192**

Operator: Era Helicopters LLC  
Aircraft: Sikorsky S-76A++, Registration N574EH  
Location: Grand Lake, Louisiana  
Date: March 15, 2013  
Time: 1147 central daylight time

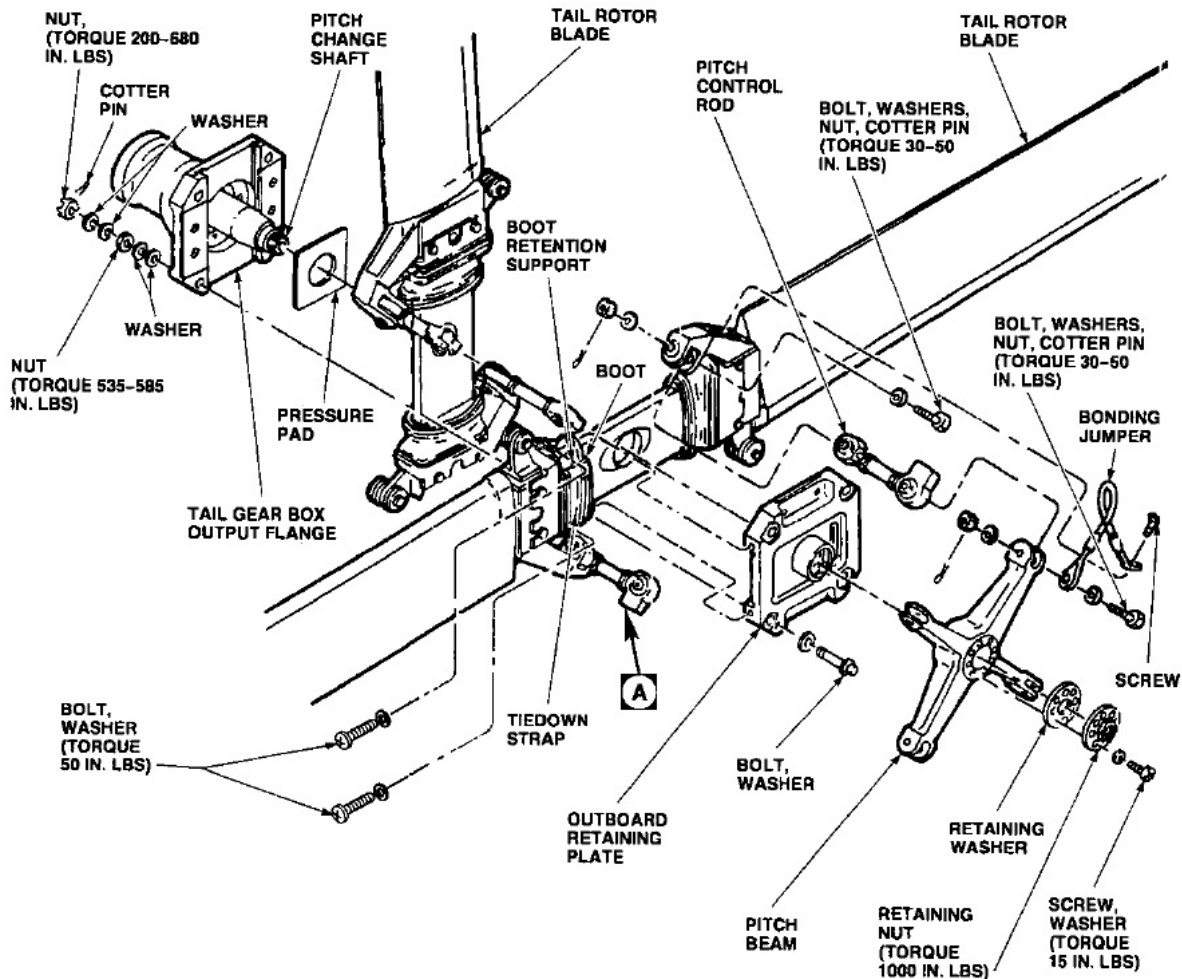
The S-76A++ TGB is mounted near the top of the vertical stabilizer with the tail rotor on the left side of the helicopter.<sup>3</sup> The tail rotor consists of two blade assemblies that are secured between two retention plates that provides a compressive clamp-up of the tail rotor spars (**Figure 1**). The retention plates contain two channels, orthogonally offset from each other, which accommodate the spar of the blade assembly.

**Figure 1. Sikorsky S-76A++ tail rotor assembly.** [image courtesy of SAC]
