**NATIONAL TRANSPORTATION SAFETY BOARD**  
**Office of Aviation Safety**  
**Washington, D.C. 20594**

**Airworthiness Group Chairman's Factual Report**

**NTSB No: DCA12FA024**

Operator: AAR Airlift Corporation  
Aircraft: Bell 214ST, Registration Number N5748M  
Location: 7 miles south of Camp Bastion, Helmund Province, Afghanistan  
Date: January 16, 2012  
Time: 1045 local time<sup>1</sup> (0615 coordinated universal time)

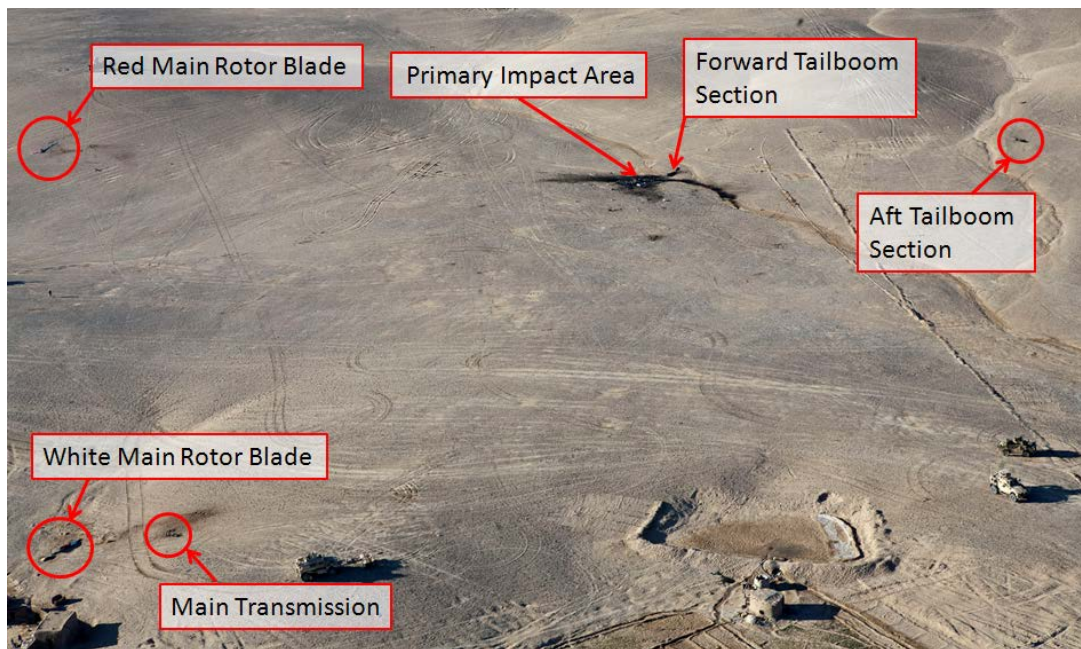
Detailed information and photographs of the accident site were provided to the NTSB by the US military and AAR Airlift Corporation's Director of Ground Support Operations in Afghanistan. The accident site consisted of a primary impact area and a scattered debris field. The debris field was measured by a laser range finder to be about 1,575 feet north-south by 656 feet east-west. The primary impact area consisted of the main fuselage. The forward end of the tailboom was found separated from the fuselage about 49 feet north of the primary impact area and the aft end of the tailboom (containing the vertical fin) was found about 279 feet north of the primary impact area. The main debris field was located in a southerly direction from the primary impact area at an undefined distance; it comprised of various parts including an engine cowling, door, Plexiglas, and the 'white'<sup>2</sup> main rotor blade. The 'red' main rotor blade was found about 426 feet south-west of the primary impact area. **Photo 1** shows an aerial view of the accident site. The primary impact area was reported to have been fully consumed by the post-impact fire. The wreckage was collected and shipped to the NTSB Training Center for further examination.

**Photo 1. Aerial view of the accident site.** [image courtesy of USTRANSCOM]

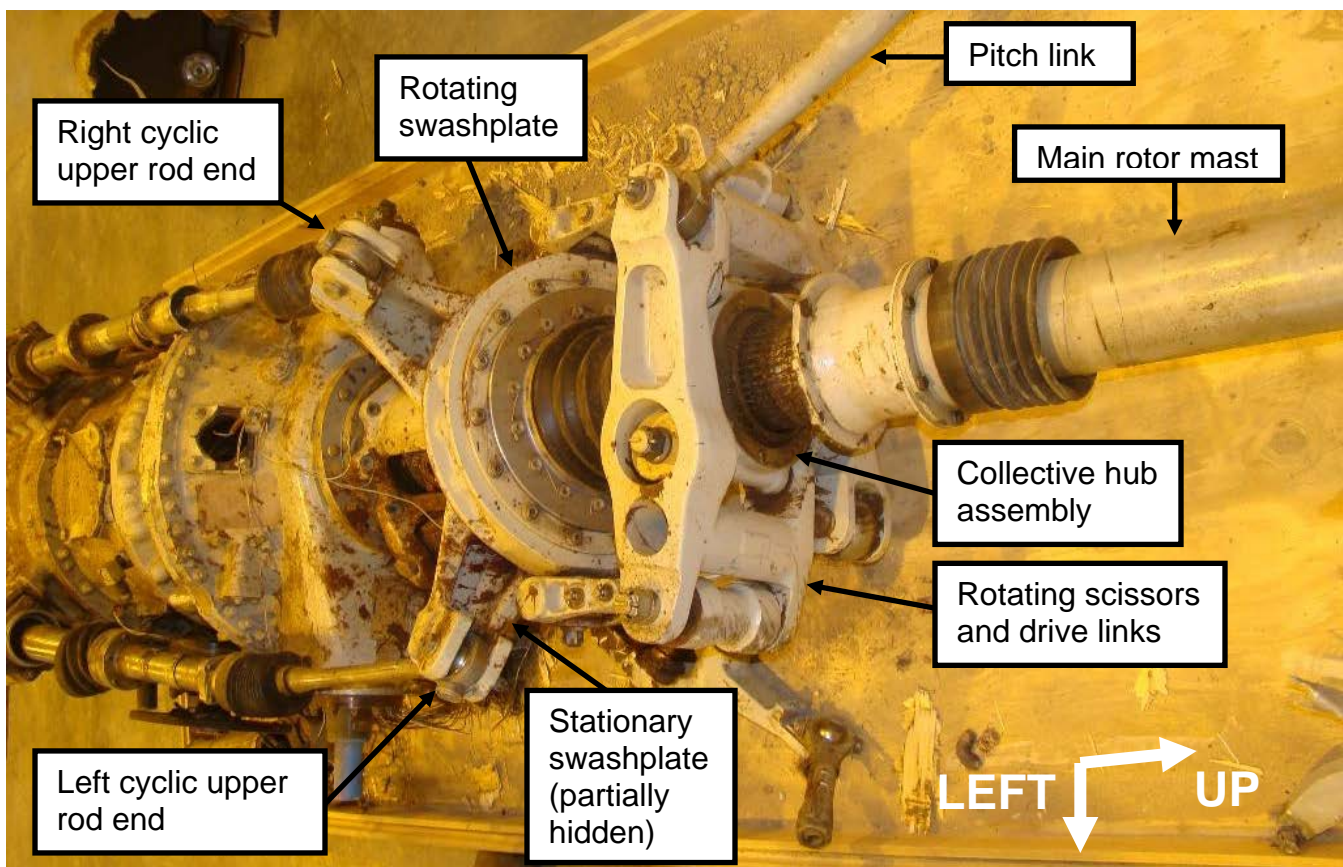
The stationary and rotating swashplates both remained installed on the main rotor mast. The upper rod end from the output piston of both cyclic hydraulic actuators remained installed on the stationary swashplate with their attaching hardware intact (**Photo 10**). Both rotating scissors assemblies and their drive links remained installed on the collective hub assembly. The rod ends and the entire length of the control tubes of both pitch change links remained attached to their respective rotating scissor link. Damage observed on the aforementioned parts was consistent with ground impact forces.

**Photo 10. Upper end of the main transmission with rotating flight controls installed.**

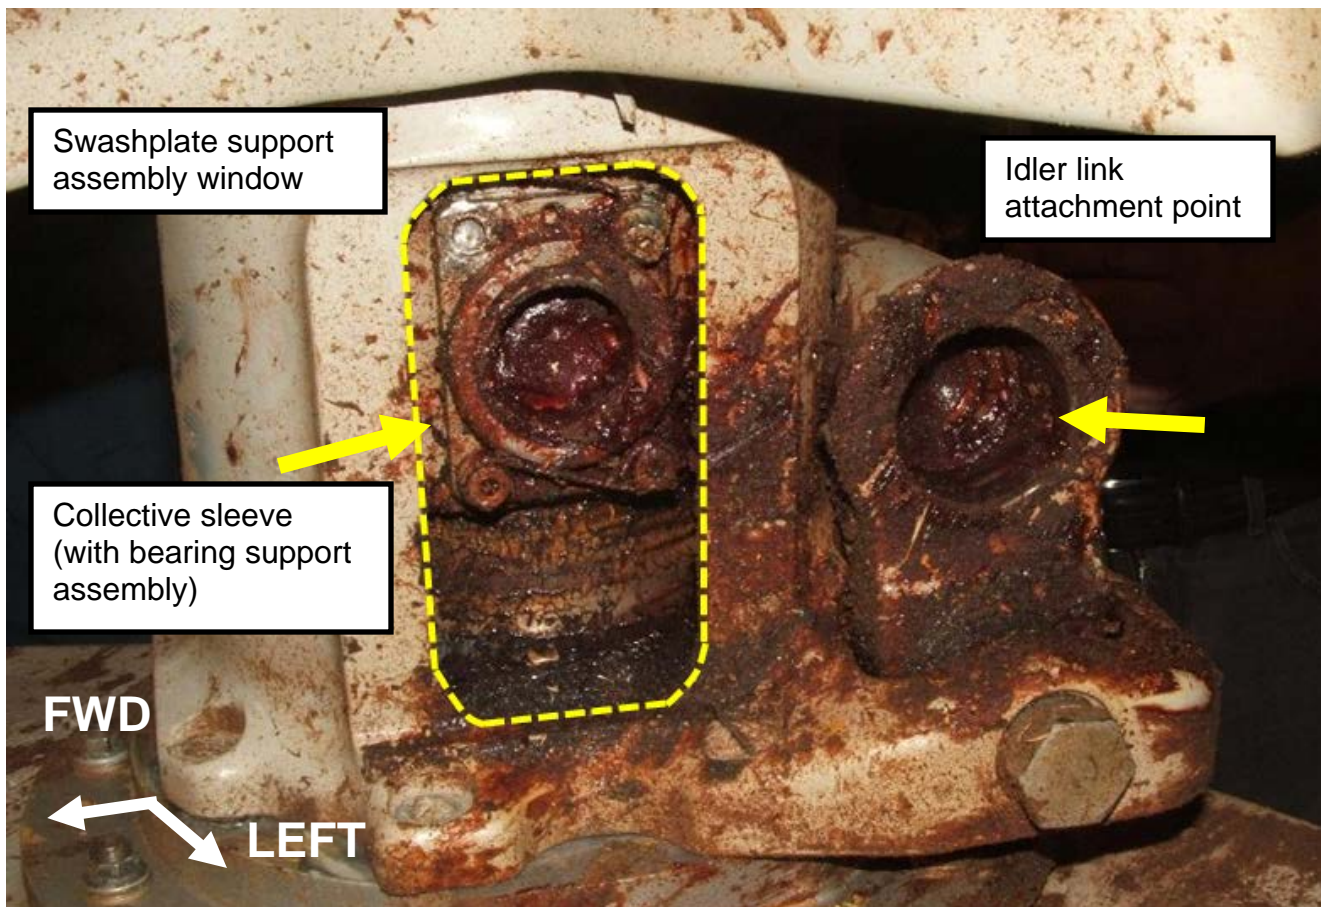
**Photo 11. The collective sleeve (left arrow) and idler link (right arrow) attachment points for the collective lever (not seen). The swashplate support assembly window is marked by dashed lines.**

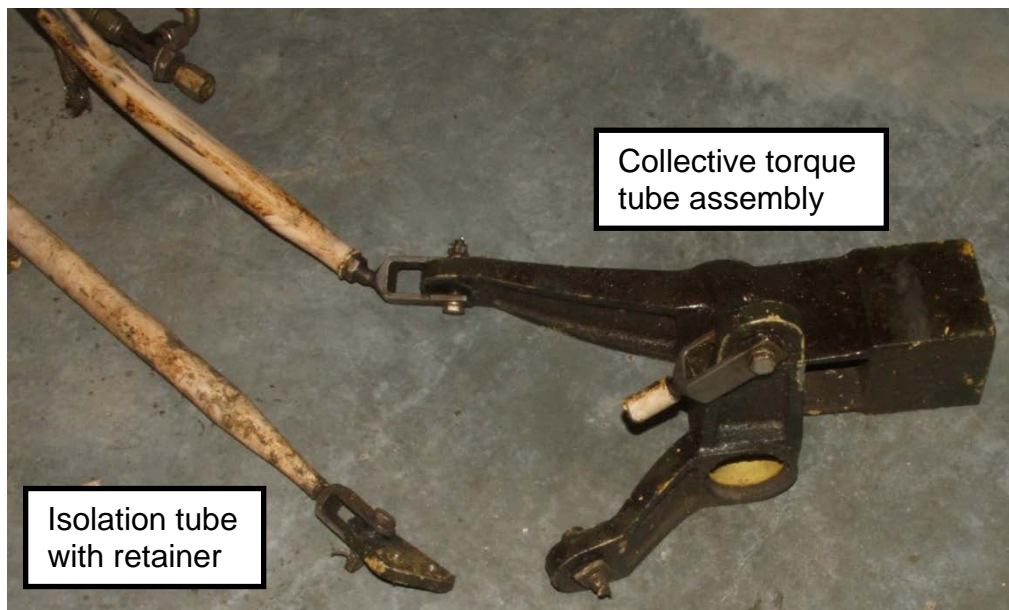
**Photo 20. Collective torque tube assembly (right) and isolation tube with retainer (lower left).**

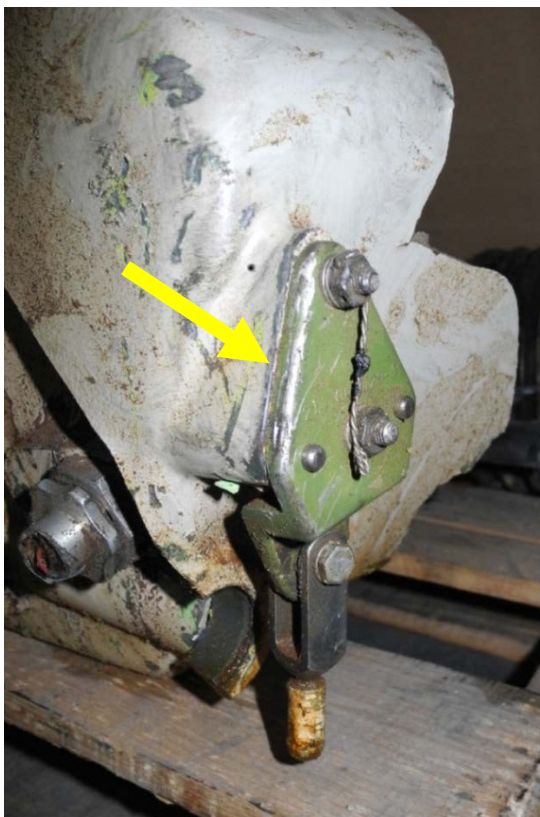
**Photo 21. Isolation tube mount and clevis connection on the main transmission sump case.**

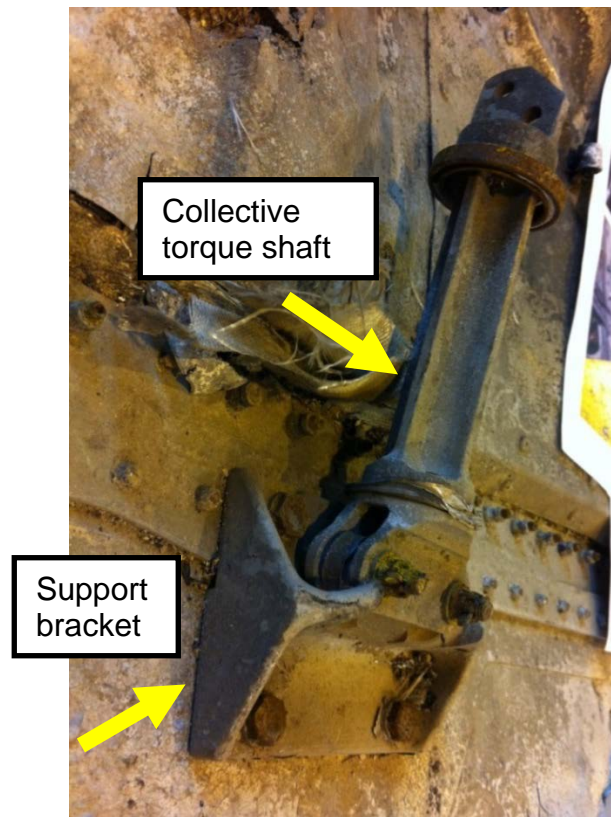
**Photo 22. The collective torque shaft (upper arrow) and support bracket (lower arrow).**

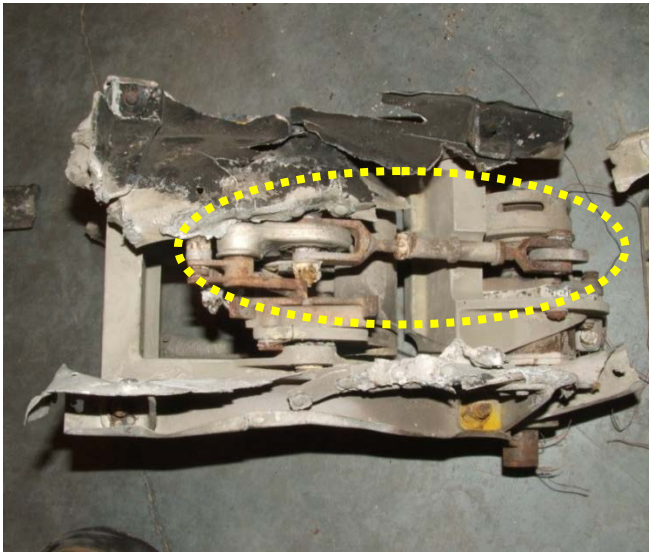
The SCAS pitch and roll actuator assemblies were recovered in the wreckage. It could not be determined which assembly was for pitch and which assembly was for roll. One SCAS assembly was mostly intact as recovered: the connecting rod between the drive and centering assembly and the walking beam was bent but intact with all attachment hardware in place (**Photo 23**). The clevis connection for the SCAS

**Photo 23.** The connecting rod between the walking beam and the drive and centering assembly on the mostly intact SCAS assembly.

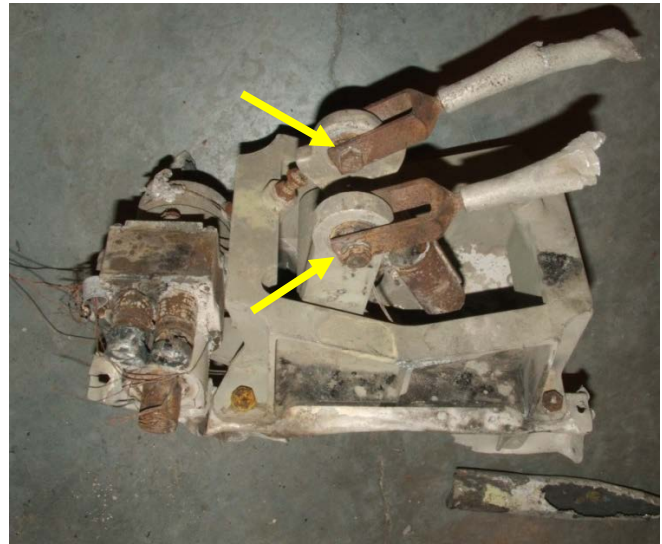
assembly's output control tube was found installed on the walking beam with the associated attachment hardware in place (**Photo 24**). The clevis connection for the SCAS assembly's input control tube was found attached to the SCAS idler (**Photo 24**). The other SCAS assembly was incomplete as recovered: the connecting rod between the drive and centering assembly and the walking beam was bent but intact with all attachment hardware in place (**Photo 25**). The clevis connection for the SCAS assembly's output control tube was attached to the walking beam with the associated attachment hardware in place (**Photo 26**). However, the idler had fractured and the section of the idler which was connected to the input control tube was not recovered. All fracture surfaces examined on both SCAS assemblies showed signatures of overstress failures with no evidence of fatigue fractures.

**Photo 24.** The clevis connections on the idler (lower arrow) and the walking beam (upper arrow) from the mostly intact SCAS assembly.

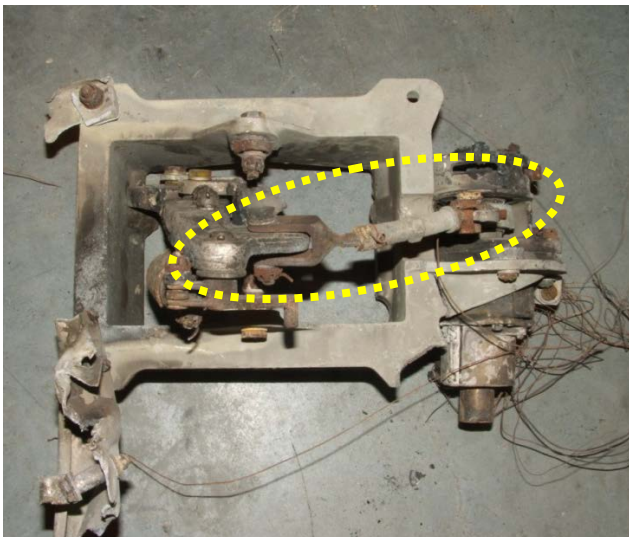
**Photo 25.** The connecting rod between the walking beam and the drive and centering assembly on the incomplete SCAS assembly.

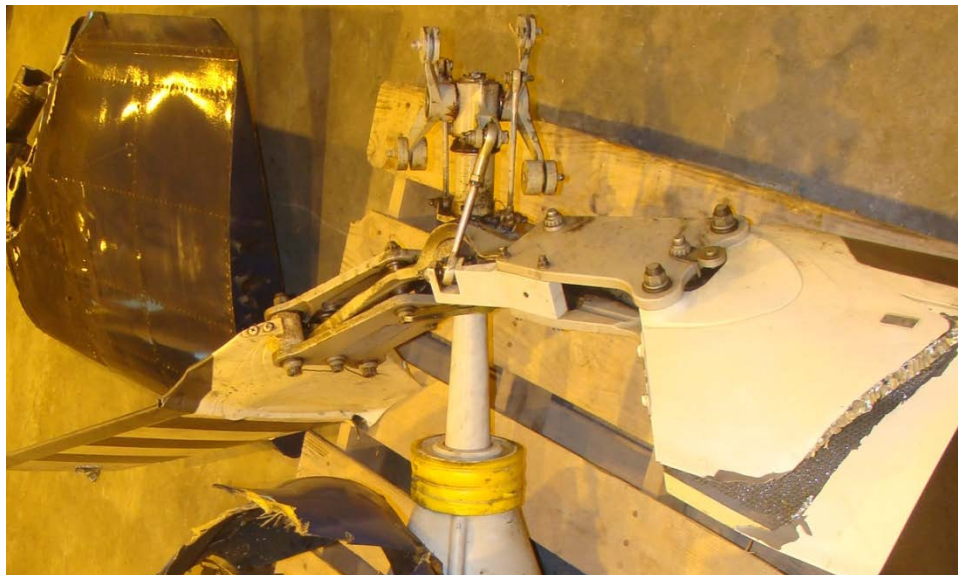
Continuity of the control tubes that provide tail rotor anti-torque and directional control could not be established due to breaks in the system and a loss of components due to exposure to the post-impact fire. The tail rotor pitch control system at the upper end of the vertical fin remained intact (**Photo 28**). This section of the pitch control system showed no evidence of binding and corresponding tail rotor pitch changes were manually performed using the pitch change links. The tail rotor pitch control hydraulic actuator was recovered intact but found loose in the wreckage debris. The hydraulic actuator's input and output rod ends and associated attachment hardware were attached and intact.

**Photo 28. Tail rotor rotating flight controls.**

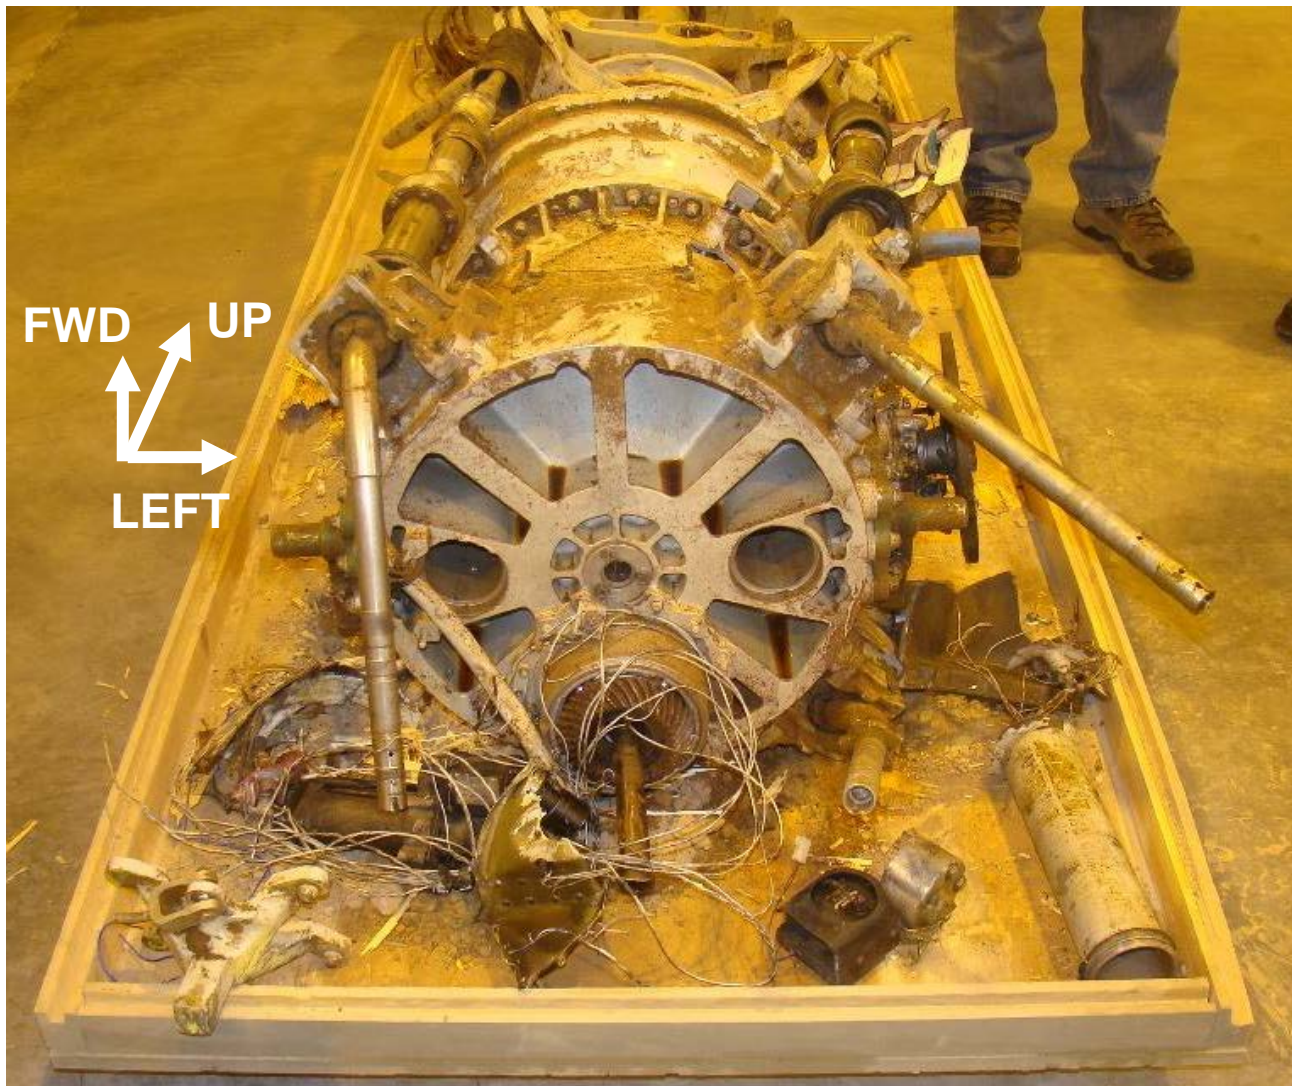
The main transmission assembly was recovered mostly whole from the transmission assembly's lower pylon restraint case up to the main rotor head. The tail rotor drive case, sump case, and both oil transfer tubes were not attached to the main transmission assembly (**Photo 31**). The lower pylon restraint case had both right and left transmission stops and all three hydraulic actuator output piston bearing housing assemblies<sup>7</sup> still attached. The main transmission's main bevel gear case had a circumferential fracture adjacent to the attaching point of the ring gear case to the main bevel gear case. The rotor brake quill assembly and the spiral bevel input pinion assembly remained installed in the main bevel gear case. The oil filler tube assembly had completely fractured from the top case. All observed fracture surfaces on the aforementioned components exhibited signatures consistent with overstress failure.

**Photo 31. The recovered main transmission assembly looking upward from the lower pylon restraint case.**

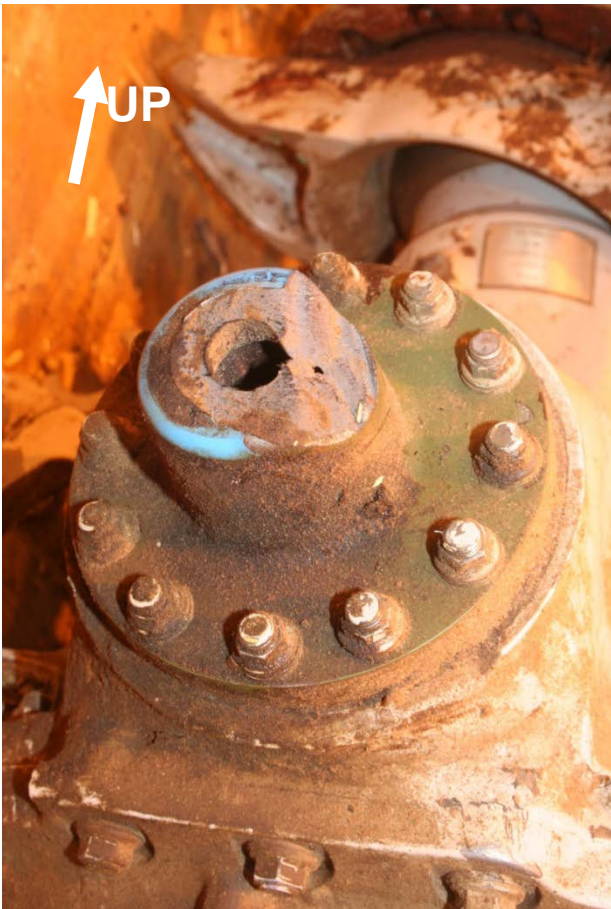
right nodal beam spherical bearing still contained a fractured portion of the transmission mounting spindle (**Photo 33**). Examination of the right transmission mounting spindle still installed on the main transmission revealed the fracture surface to mirror that of the piece found in the right nodal beam (**Photo 34**). Both fracture surfaces exhibited signatures consistent with overstress failure. The retaining hardware for the right spindle was found in place in the right nodal beam. The left transmission mounting spindle remained installed and intact on the main transmission (**Photo 35**). The retaining hardware for the left spindle was located in the wreckage and retained by the NTSB for further examination at the NTSB materials laboratory in Washington, DC. Lab examination found the damage to the hardware was consistent with the bolt being pulled outward while the threads were still engaged. For complete details of the lab findings, see NTSB Materials Laboratory Report 13-031, dated July 17, 2013.

**Photo 34. Right transmission mounting spindle.**

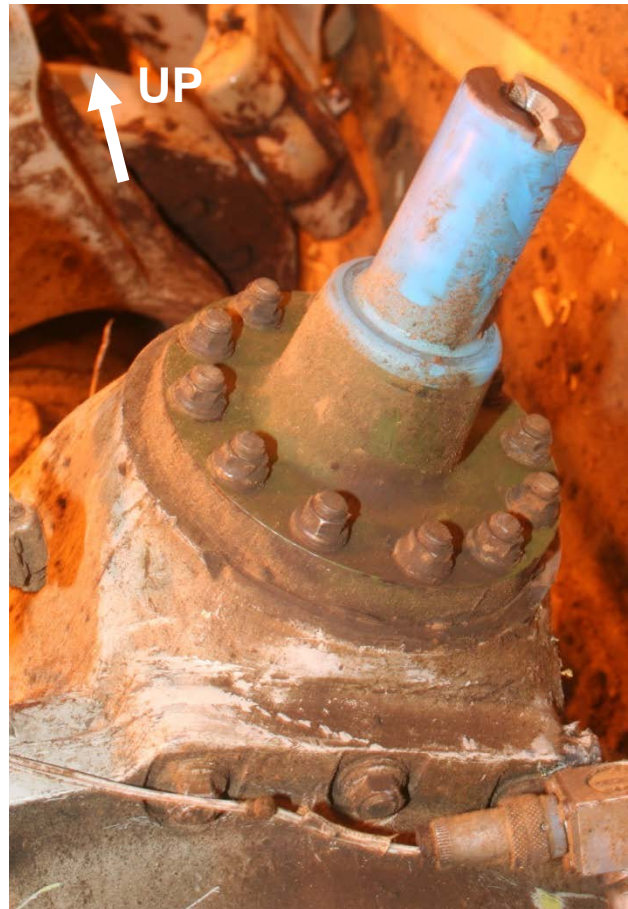
**Photo 35. Left transmission mounting spindle.**

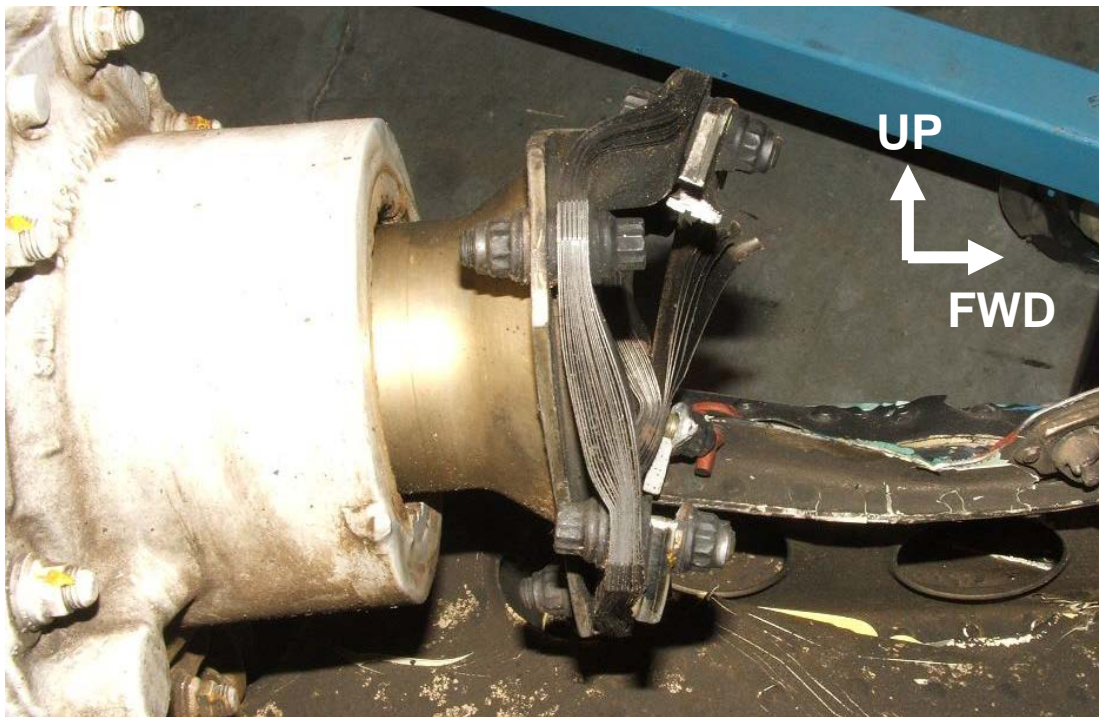
The intermediate and tail rotor gearboxes were found intact and still attached on the severed aft tailboom and vertical fin section. Continuity of drive was established through both the intermediate and tail rotor gearboxes. Continuity of tail rotor drive could not be established forward of the intermediate gearbox due to breaks in the drive system in the tailboom. However, all flexible couplings between driveshafts in the tailboom section were recovered. The flexible coupling that remained attached to the intermediate gearbox input flange exhibited a slight serpentine deformation with the coupling laminates opening up between bolted connections (**Photo 36**). A separated tail rotor driveshaft section exhibited curling in the shape of the main rotor blade leading edge (**Photo 37**). All examined fracture surfaces exhibited signatures consistent with overstress failure.

**Photo 36. Intermediate gearbox flexible coupling.**

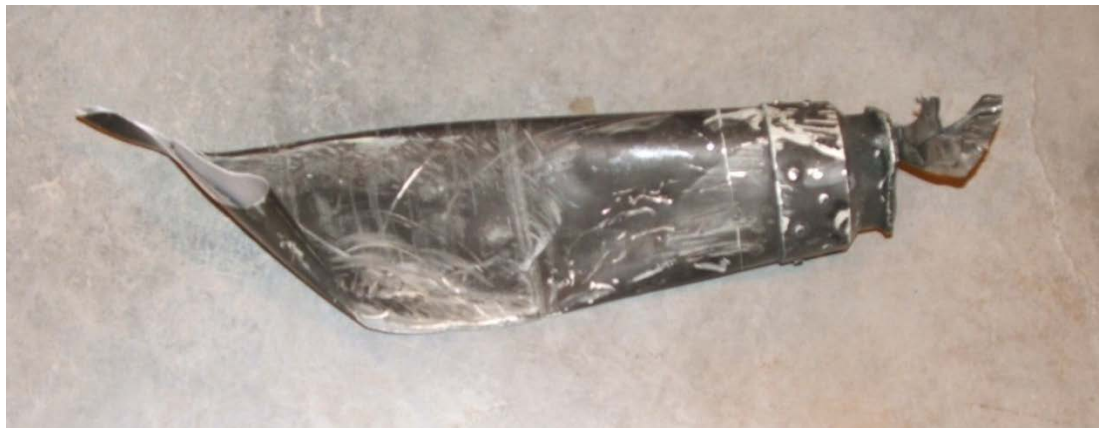
**Photo 37. A severed section of tail rotor drive shaft.**

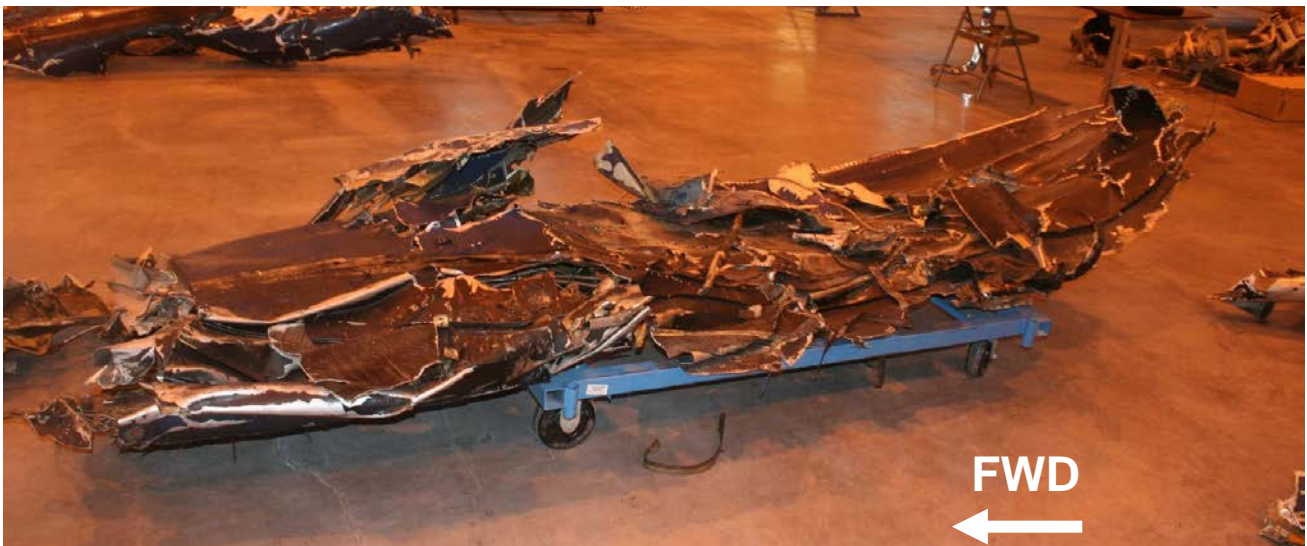
A large forward section of the tailboom, beginning at the interface with the main fuselage and measuring approximately 15 feet long by 4 feet wide, was recovered from the accident site ([Photo 39](#)). Beginning from the forward end, the first 4 feet of this tailboom section was a complete barrel section comprised of the left, right, upper, and lower skin panels, where the left and right skin panels were crushed flat onto one another. The remaining 11 feet of this tailboom section was comprised only of the right and upper skin panels and was crushed. Sections of the tail rotor drive system, the tail rotor flight control linkages, and the elevator mounting points were found within this tailboom section. The helicopter’s registration number, “N5748M”, was seen painted on the right skin panel on this tailboom section. A skin panel matching the left side of this tailboom section was recovered; it measured approximately 8 feet long by 3 feet wide. This skin panel had the marking “48M” and had forward-to-aft scuff marks and scratches in a 45° direction. Examination of the various fracture surfaces on both the tailboom and the matching skin panel revealed no evidence of fatigue fractures, but contained features consistent with overstress failure and crushing consistent with ground impact forces. Additional information of the tailboom can be found in section 7.0 of this report.

**Photo 39. The recovered forward tailboom section (left-side outer skin is visible).**

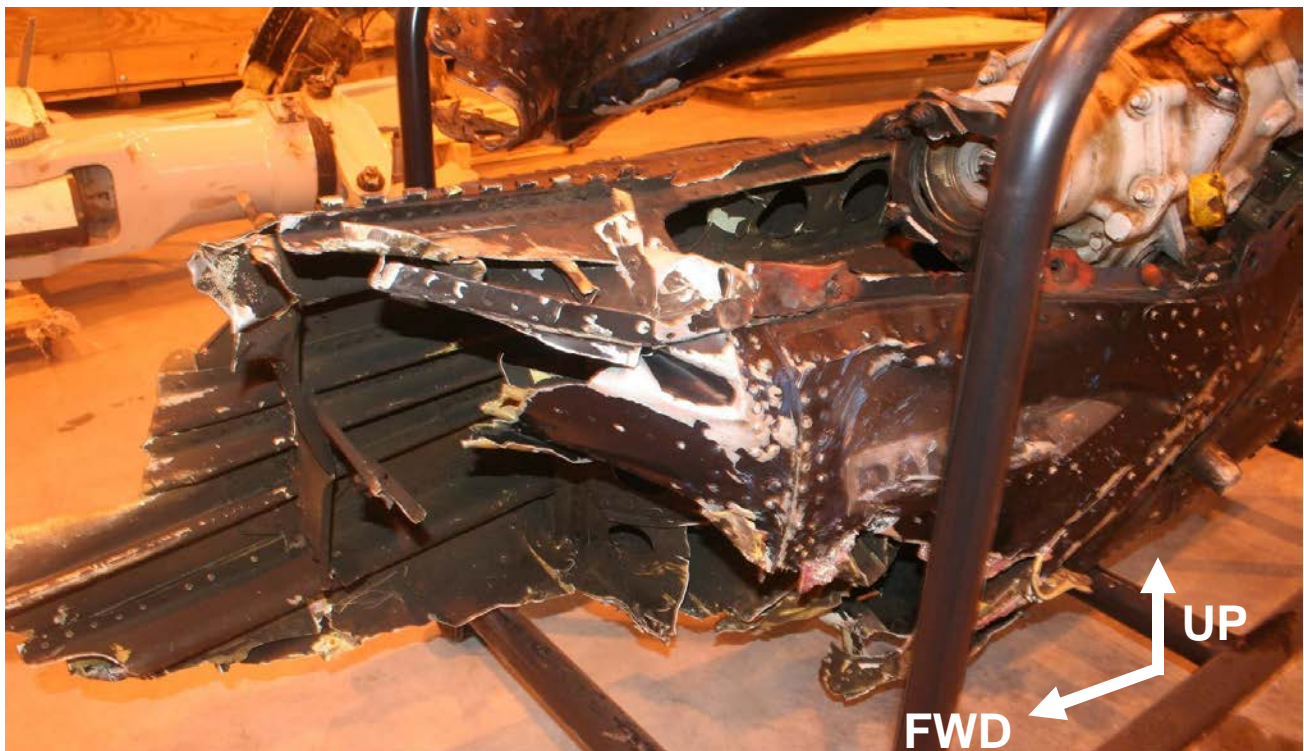
The aft end of the tailboom, containing the vertical fin, was recovered with the intermediate gearbox, the no. 6 tail driveshaft, the tail rotor gearbox, and the tail rotor assembly still installed. The left skin panel adjacent to the fractured area exhibited patches of transferred red paint and the fracture exhibited a left-to-right directionality and characteristics consistent with a main rotor blade strike ([Photo 40](#)). Examination of the fracture surfaces revealed signatures consistent with overstress failure.

**Photo 40. Forward section of the severed tailboom and vertical fin.**
