NATIONAL TRANSPORTATION SAFETY BOARD

AIRWORTHINES GROUP CHAIRMAN'S FACTUAL REPORT

NTSB Accident Number: DCA07MA003
Location: Manhattan, New York
Date: October 11, 2006
Time of Accident: Approximately 1442 Eastern Daylight Time
Aircraft: Cirrus SR20

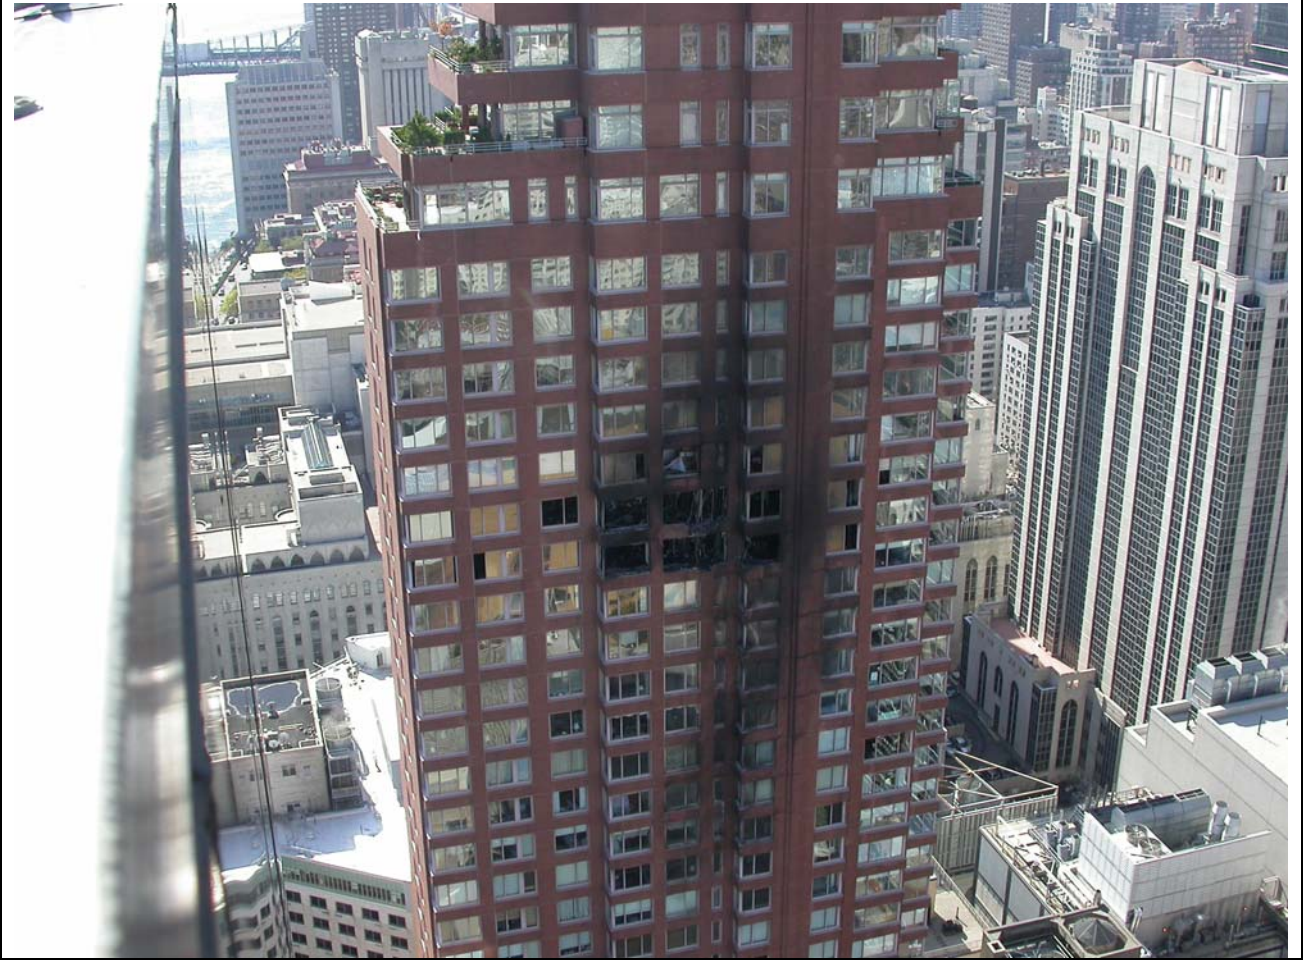
Figure 3

View of the 32nd and 33 floor on the North face of the Beldaire Condominiums located at 524 East 72nd Street Manhattan, New York.

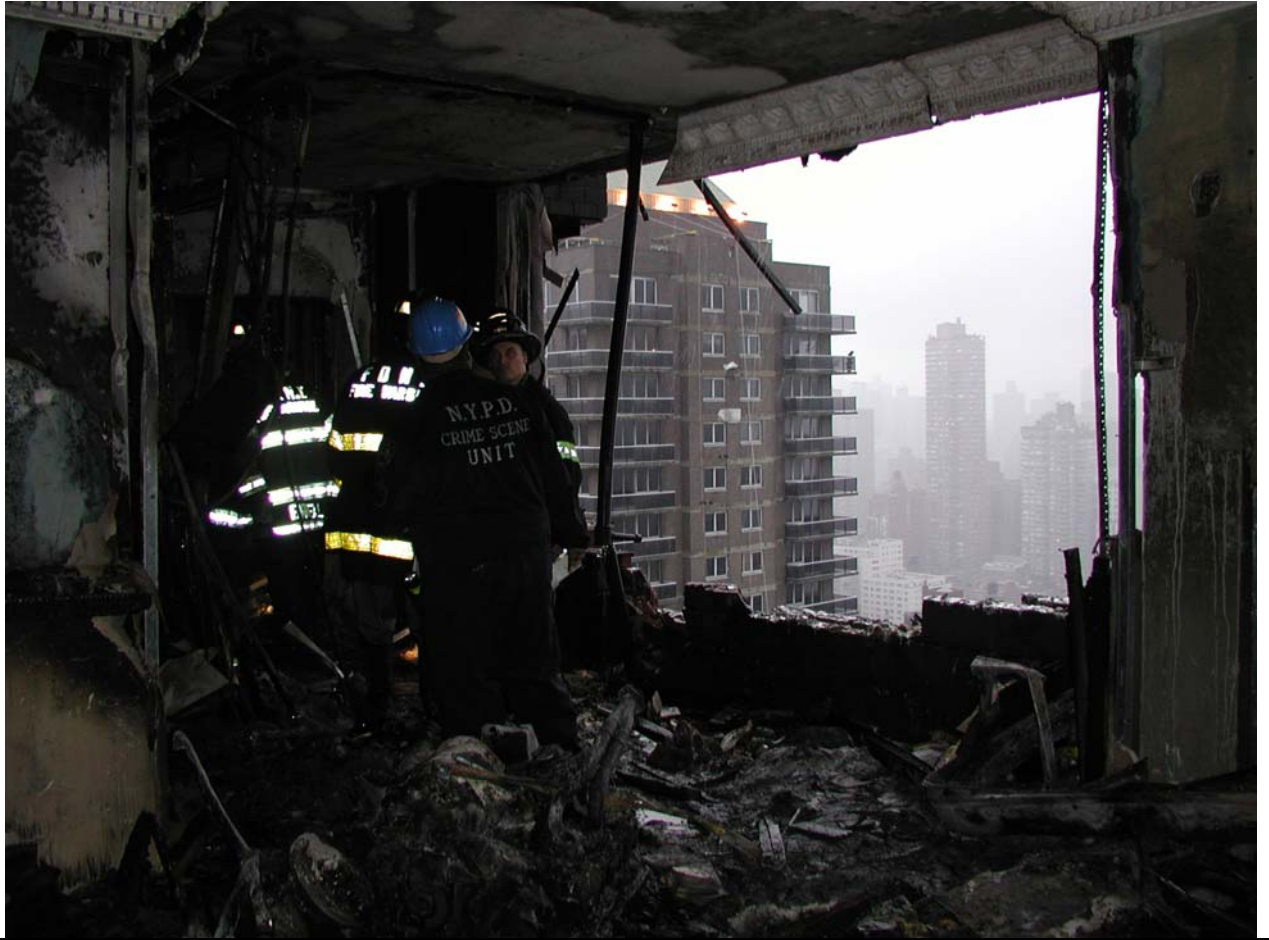
Figure 5

View looking down from apartment 40 A/B/G in the Belaire Condominiums located at 524 East 72nd Street Manhattan, New York.

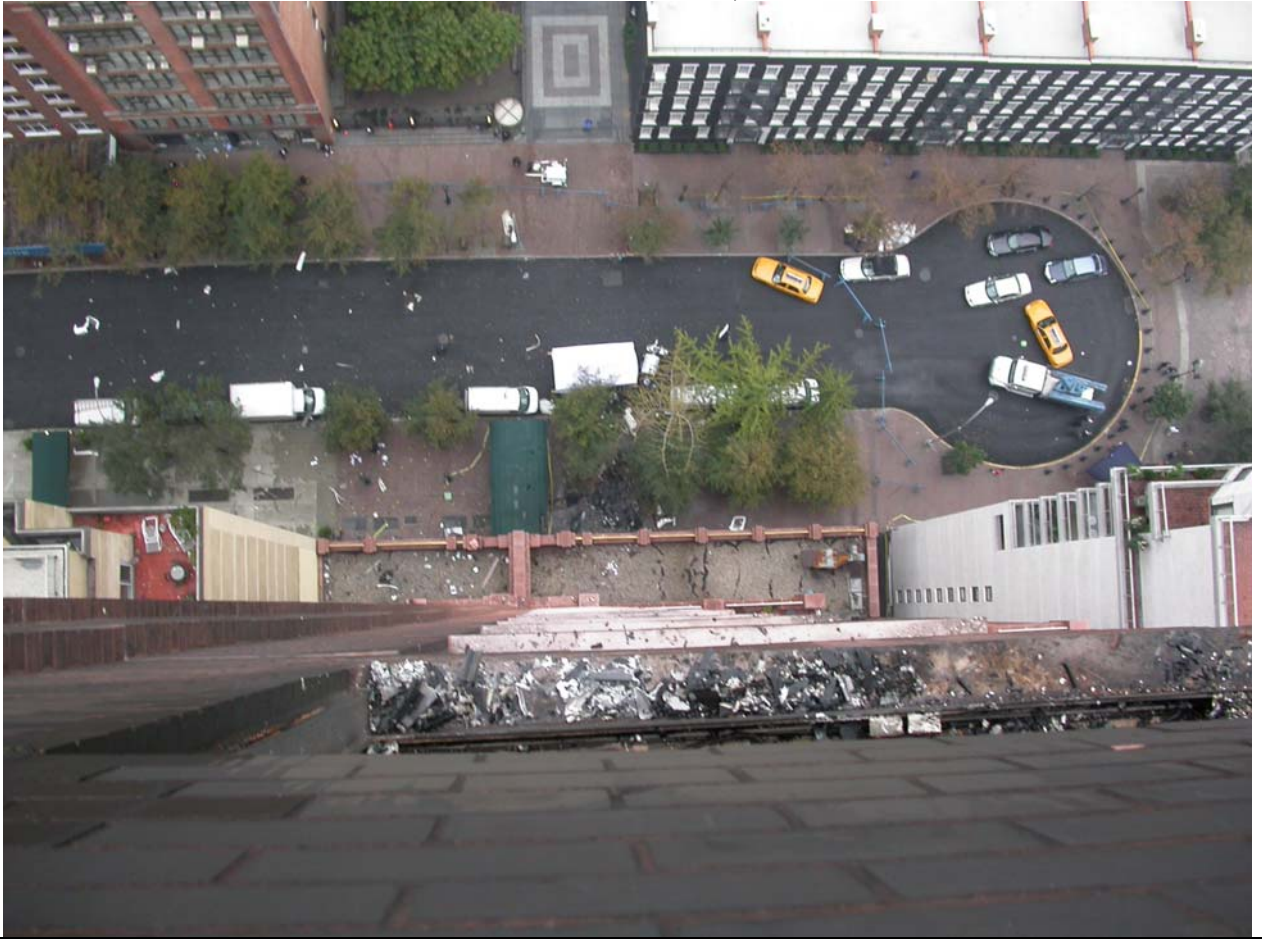
Figure 6

View of the main debris field located on the sidewalk directly in front of the North face of the Belaire Condominiums located at 524 East 72nd Street Manhattan, New York.

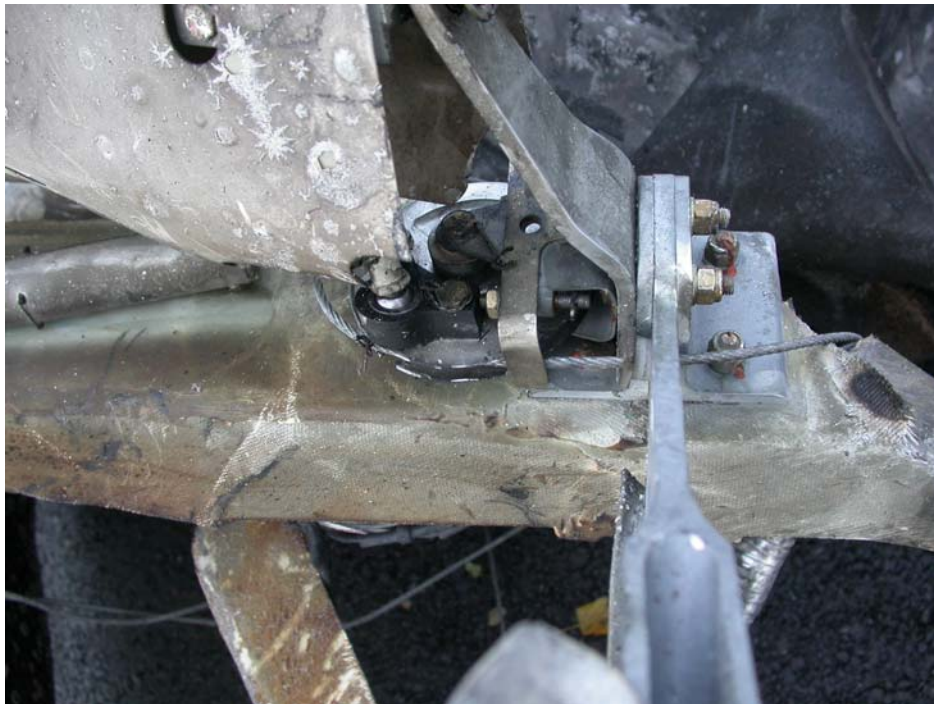
Figure 11

Aircraft N929CD - Left aileron showing position of roll trim motor

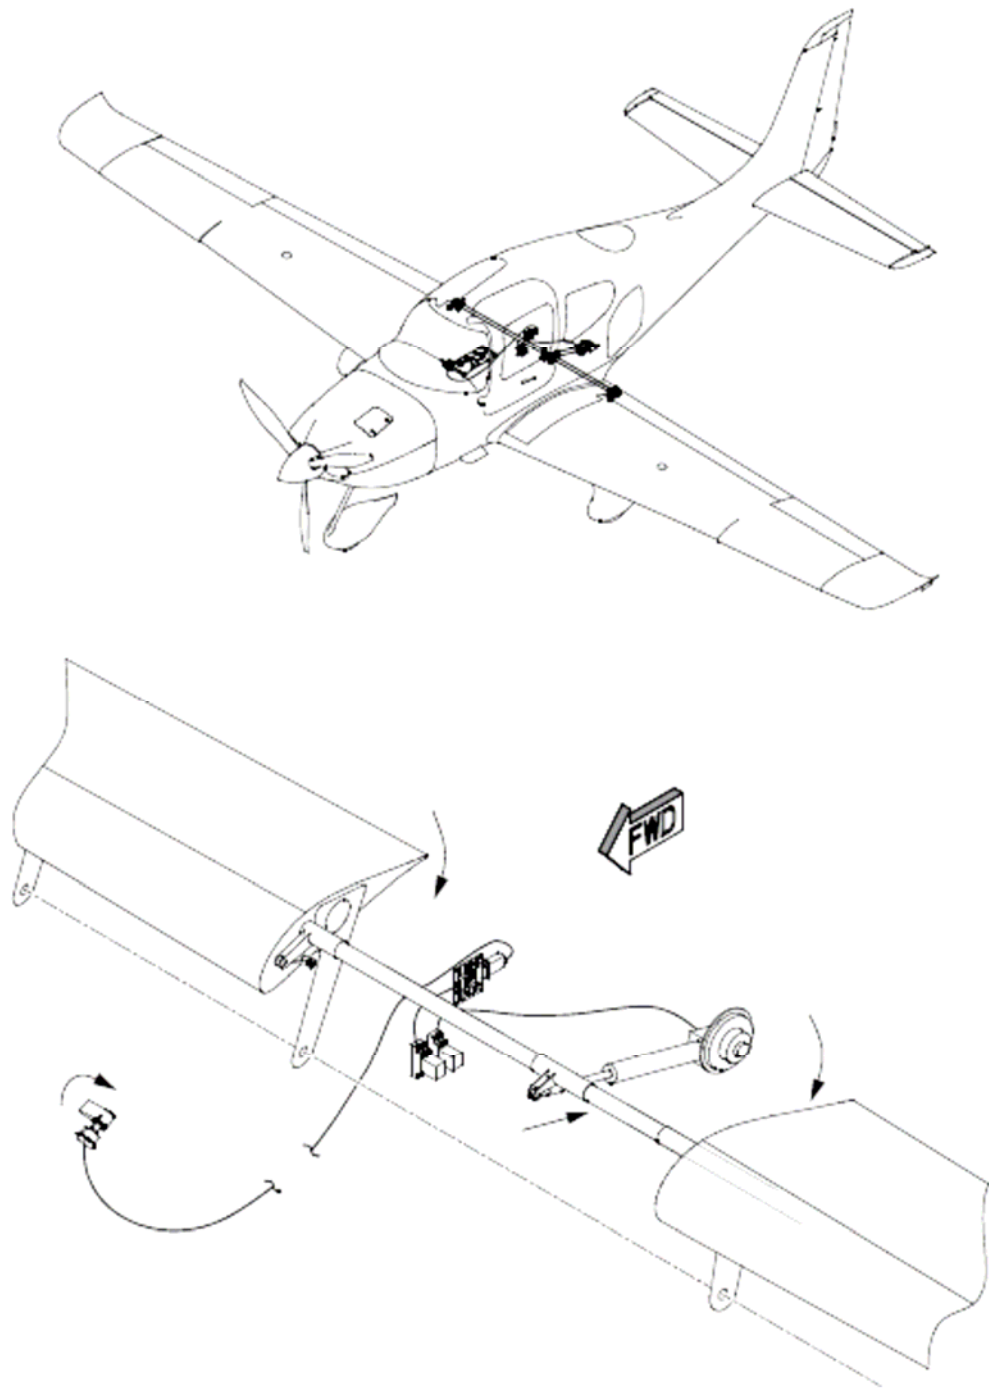
Figure 22

The left flap was located within the main wreckage debris field; it exhibited mechanical damage. The right flap was located within the main wreckage debris field. The right flap exhibited leading edge impact damage. The right flap was buckled upward approximately 90 degrees, at a point 3-feet in from the outboard end (Figure 22).

Aircraft N929CD View of right flap

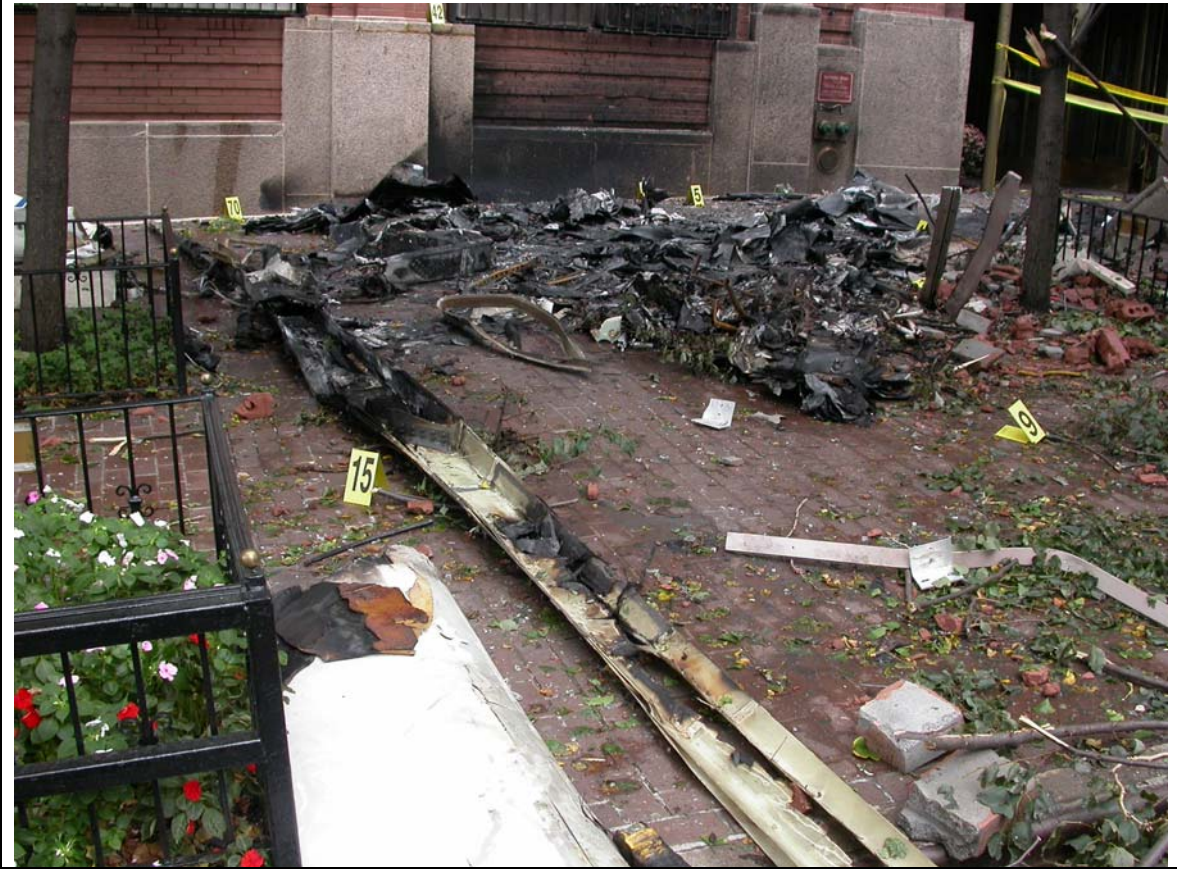
Figure 26
Wing Spar in street

The main wing spar was located within the main debris field on the sidewalk (**Figure 25**). The wing spar was removed from the wreckage and placed in the street for examination (**Figure 26**). A visual examination revealed that the spar face was fractured from the right tip, inboard approximately 9 feet (**Figure 27**). The right tip of the spar was not thermally damaged. The center section and the left wing side of the spar were thermally damaged but remained intact.

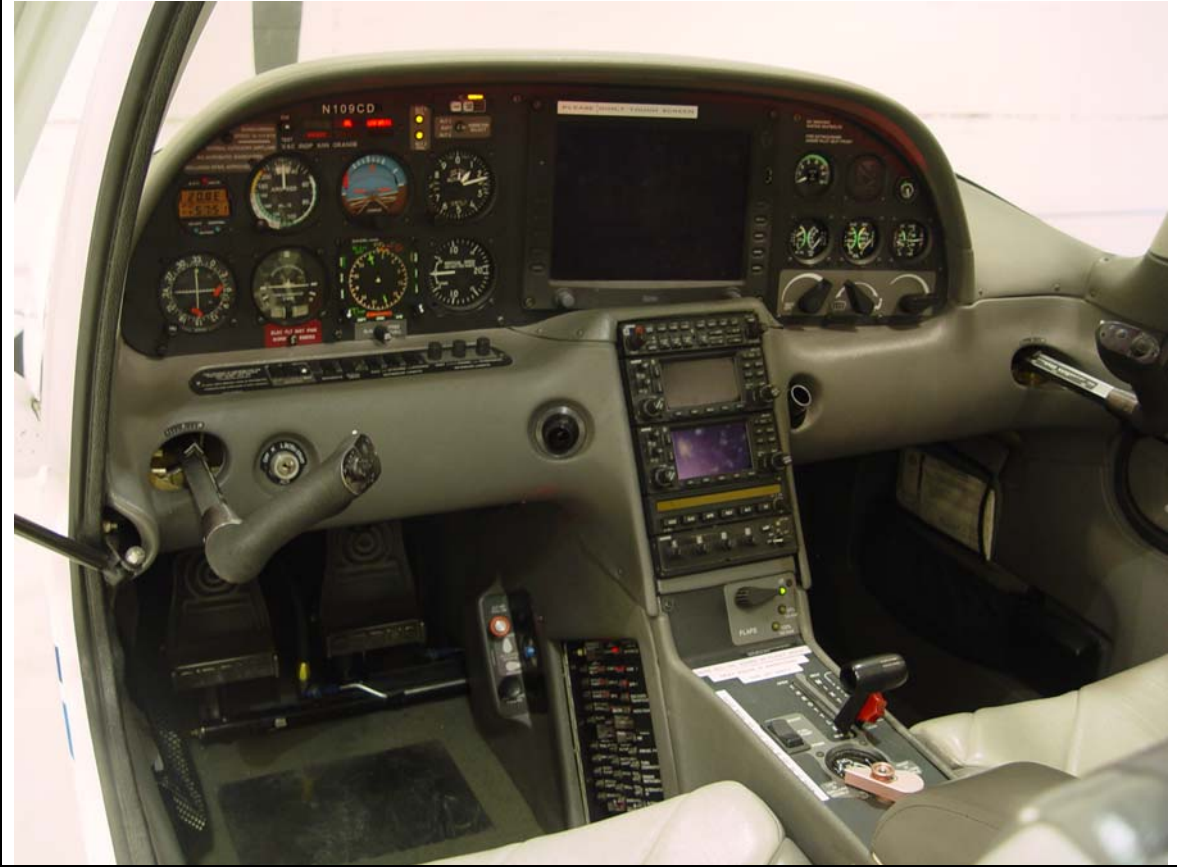
Figure 30
Aircraft N929CD instrument panel

mechanically damaged; its faceplate was missing and was not located. The unit exhibited impact damage. (Figure 30)

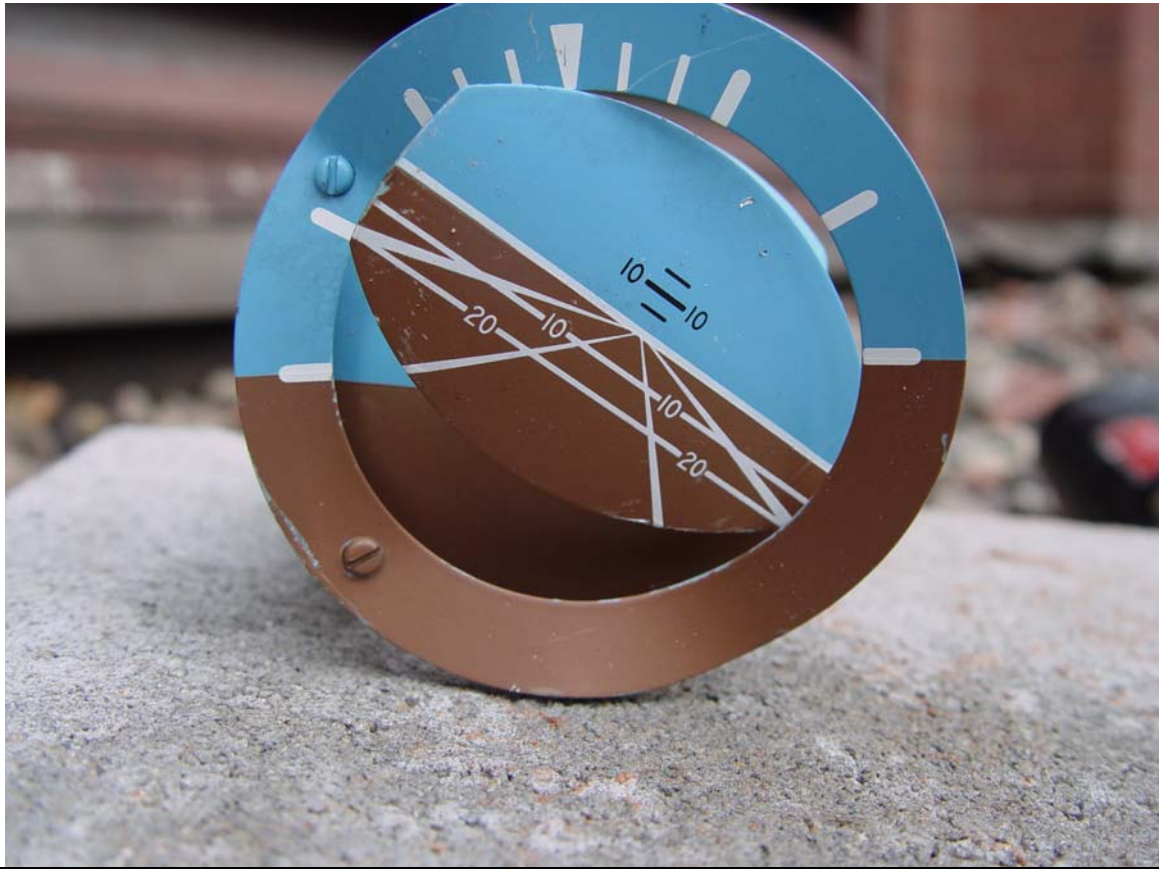
Figure 34
Side View of Attitude Indicator

The attitude indicator was separated from the instrument panel; it exhibited mechanical damage. As initially found, the majority of the components (Yoke assembly, Rotor, housing, mask assembly, and indice ring) remained inside the can (Figure 32). Upon picking the unit up, all components fell out of the can assembly. The internal components were placed on a cement block and photographed (Figure 33, and Figure 34). The bezel assembly and airplane indicator remained within the instrument panel (Figure 36).

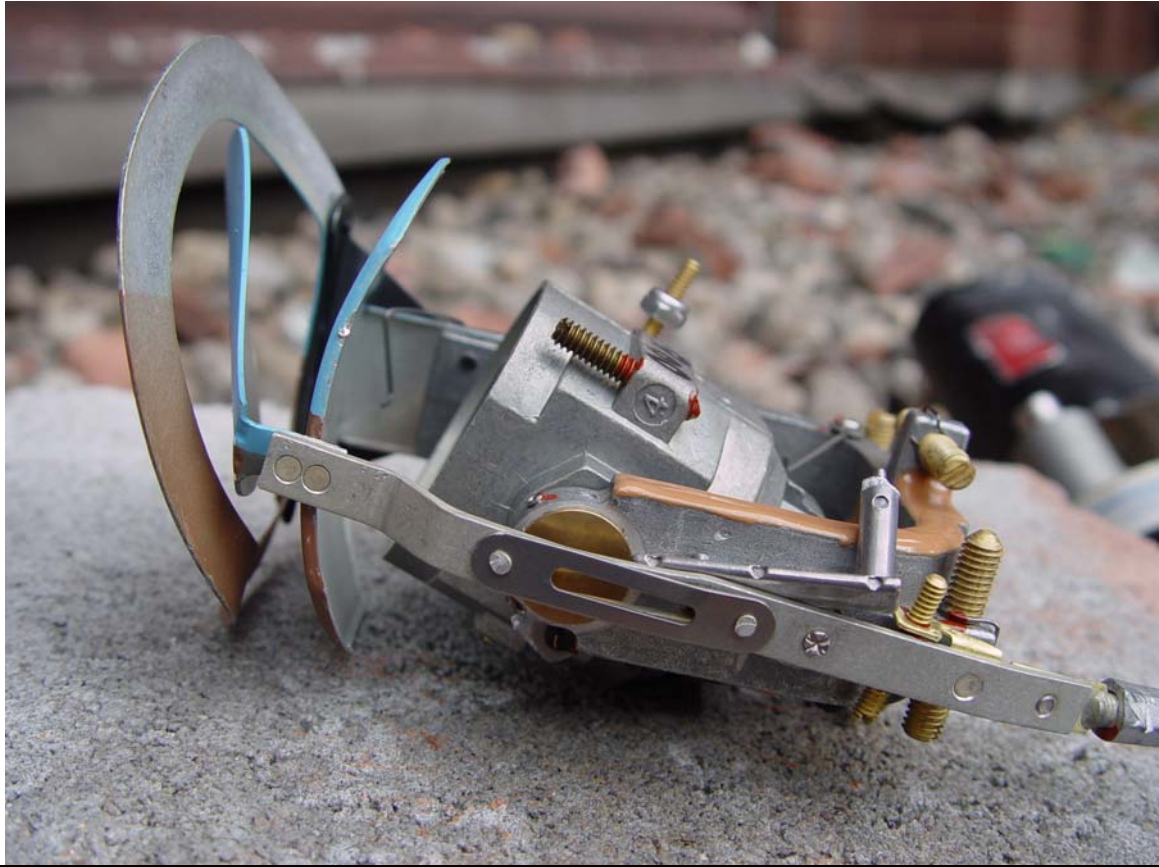
Figure 35
Airspeed Indicator

The airspeed indicator was separated from the instrument panel; it indicated 0.0 knots. The unit sustained impact damage and exhibited mechanical damage (Figure 35).
