**AIRWORTHINESS GROUP CHAIRMAN'S FACTUAL REPORT**

**CEN13FA192**

**Sikorsky Aircraft Corporation Tail Gearbox Materials Engineering  
Report No. MER-MI1308142 (8 Pages)**

# Materials Engineering Report S-76 Tail Rotor Gearbox Components from Mishap, ERA 369

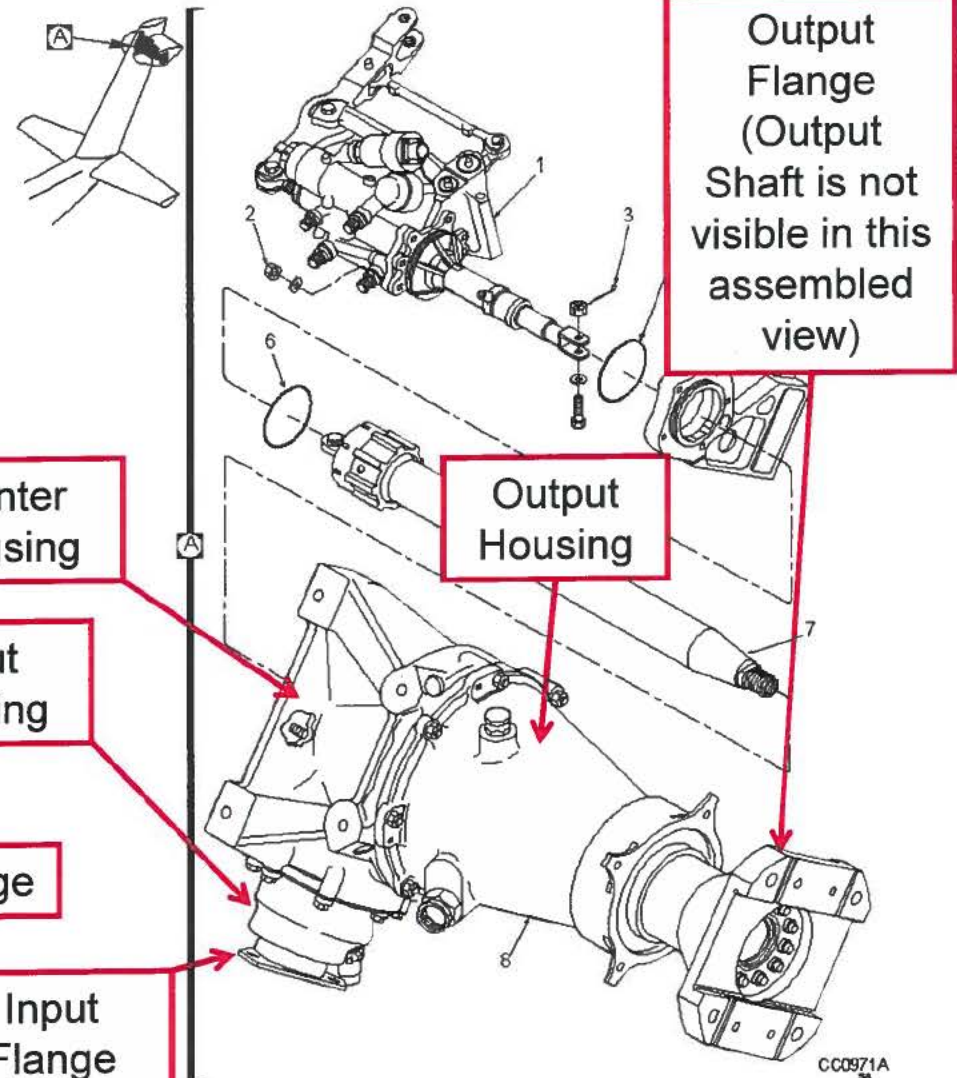
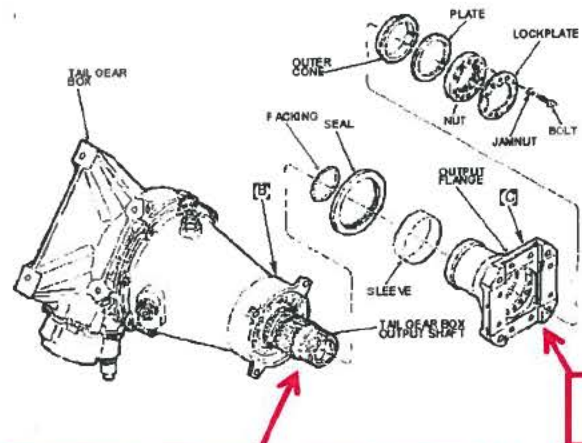
**Background** – The images at the right and below are from an S-76 IETM, and provide diagrams of the tail rotor gear box, including some of the components that are documented herein. The components shown on the next slide were those examined.
