**AIRWORTHINESS GROUP CHAIRMAN'S FACTUAL REPORT
ATTACHMENT III: Honeywell, Inc. (Engine) Teardown
Report No. 21-11090**

**Sunjet Aviation, Inc.
Mina, South Dakota
October 25, 1999**

**TEARDOWN REPORT
OF TWO TFE731-2-2B TURBOFAN ENGINES
SERIAL NUMBERS P-74264 AND P-74265**

21-11090

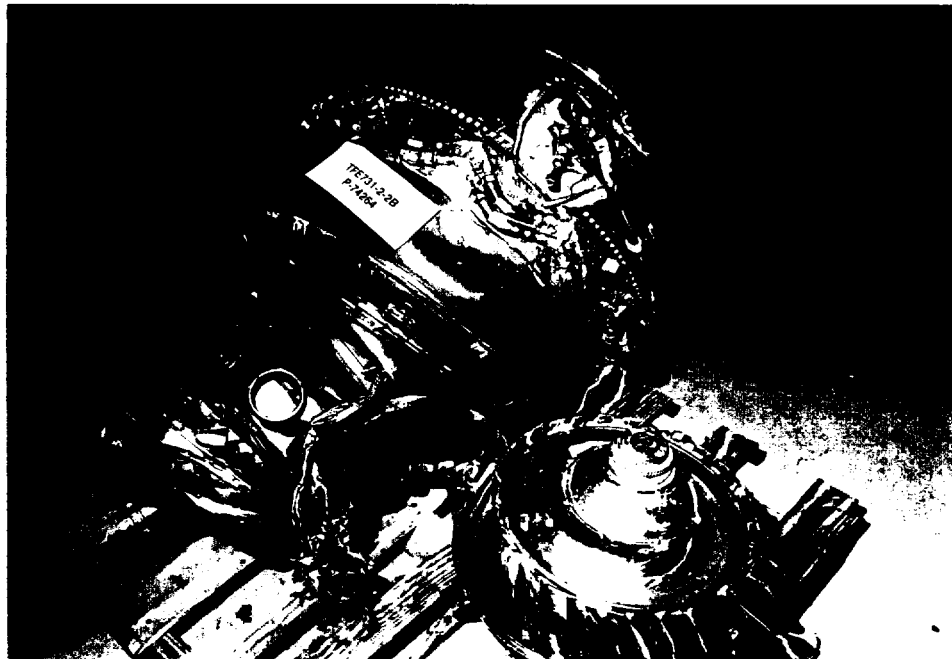
- (k) LP compressor case:
- Sheet metal was buckled and torn (Figures 6 and 52).

Figure 6. (Photo No. 29-5) Engine S/N P-74264, After Decontamination.

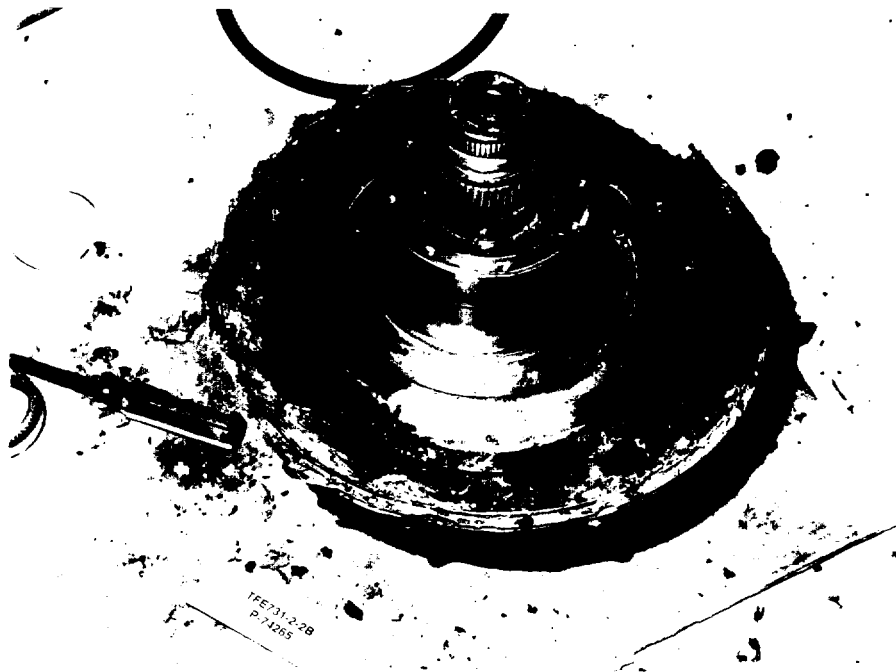
Figure 11. (Photo No. 40-20) Fractured Fan Support Housing.
(Part of Engine S/N P-74264 - S/N P-74265 on Placard in Photo is in Error.)

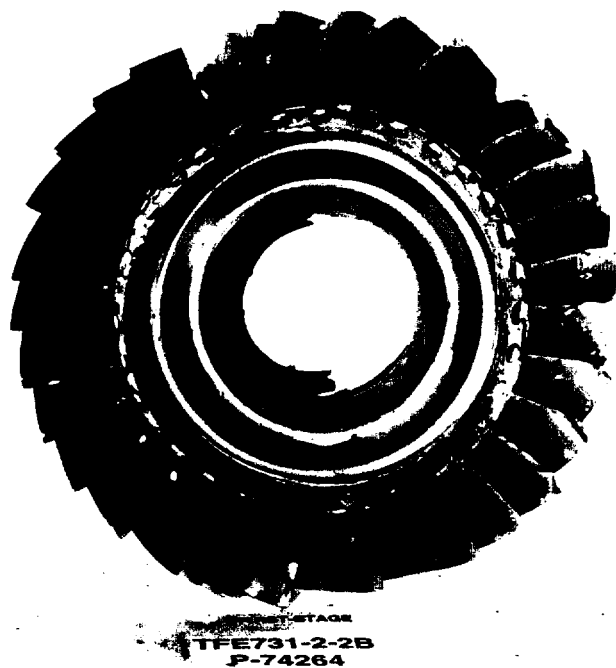
Figure 15. (Photo No. 32-26) Damaged First-Stage LP Compressor.

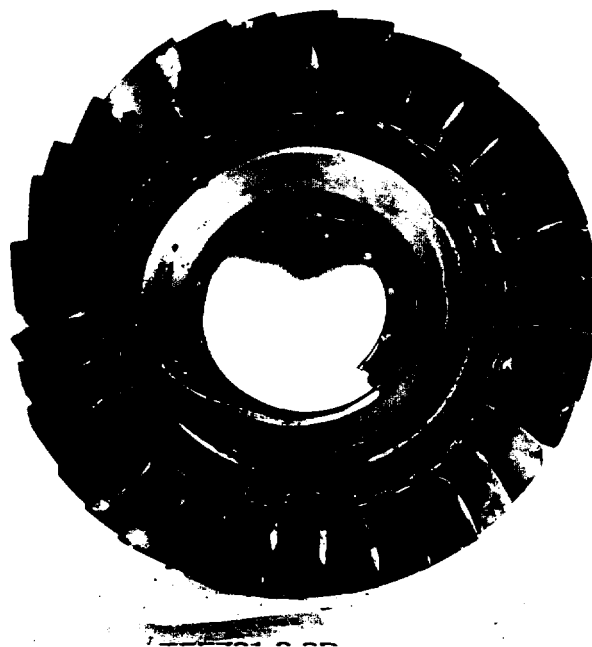
Figure 16. (Photo No. 32-27) Damaged First-Stage LP Compressor.

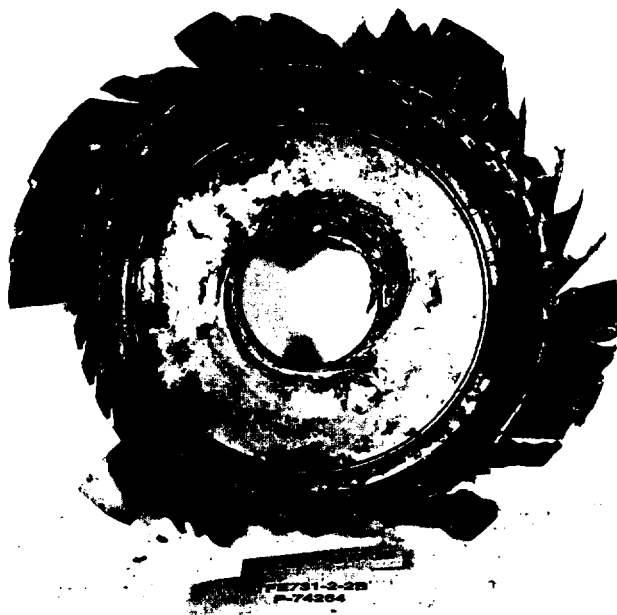
Figure 24. (Photo No. 36-25) Damaged Second-Stage LP Compressor.

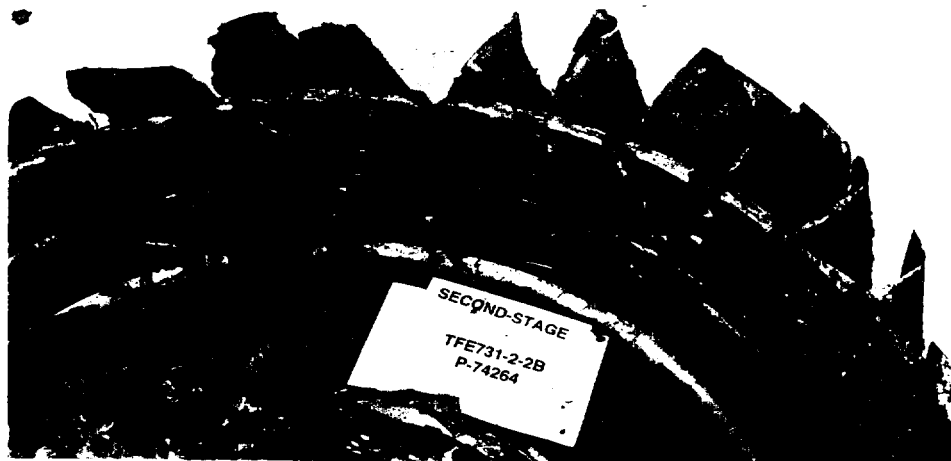
Figure 26. (Photo No. 36-27) Damaged Second-Stage LP Compressor Rotor Blades, with Platform Rub.

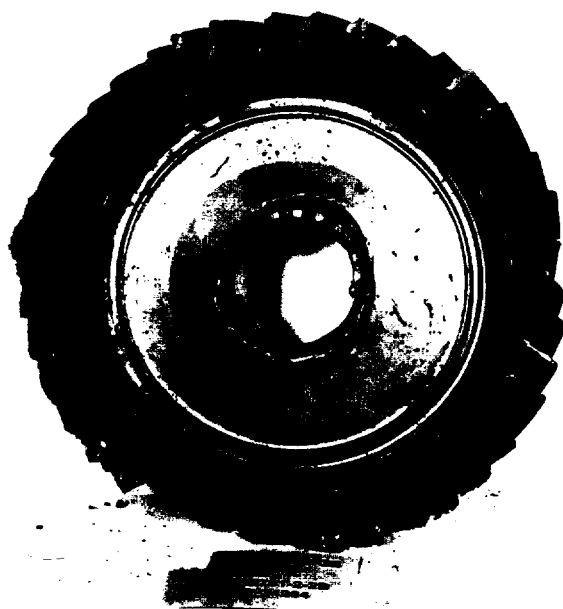
Figure 31. (Photo No. 36-31) Damaged Third-Stage LP Compressor.

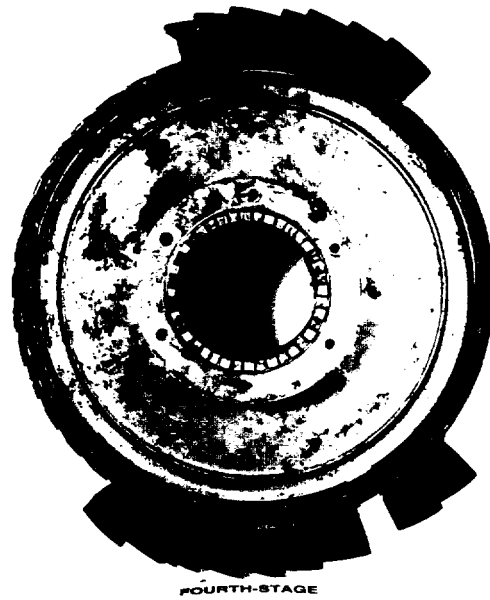
Figure 37. (Photo No. 33-16) Damaged Fourth-Stage LP Compressor.

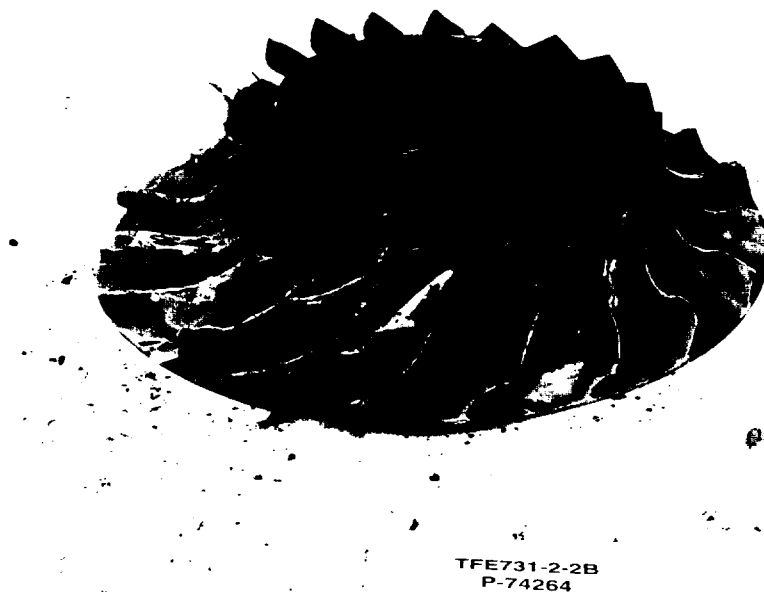
- Dirt and debris was packed between impeller blades (before decontamination).
- All of the impeller blades were bent opposite to the direction of rotation (Figures 53 through 57). Some of the impeller blades were broken at the blade platform (Figures 53 through 57).

- The shroud-line edge of all the impeller blades was heavily rubbed (Figures 53 through 57), with corresponding rotational score marks on the HP impeller shroud parent metal (Figure 56).

- The shroud contour displayed rotational score marks, in the parent metal, with corresponding rub marks on the shroud-line edge of all the impeller blades (Figures 53 through 57).
- The shroud was crushed from impact forces, and all of the abrasion-resistant coating had separated from the parent metal.

Figure 53. (Photo No. 42-16) Damaged HP Compressor Impeller Blades.

Figure 54. (Photo No. 42-17) Damaged HP Compressor Impeller Blades.

Figure 55. (Photo No. 42-18) Damaged HP Compressor Impeller Blades.

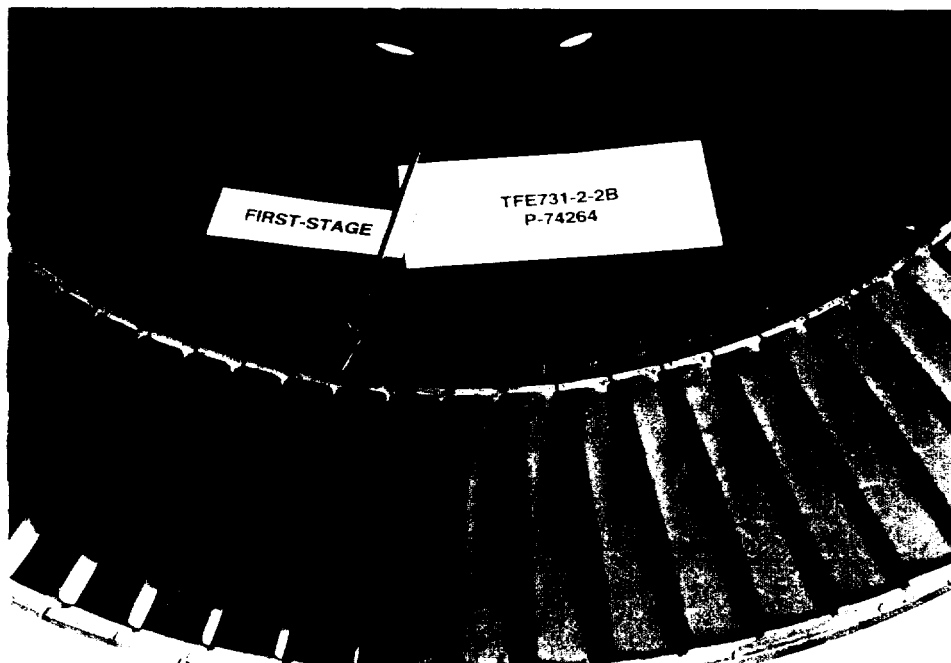
- There were rotational score marks on the inboard leading-edge of the stator vanes (Figure 92), with a corresponding platform rub on the aft side of all of the first-stage turbine rotor blades (Figure 91).
- There were rotational score marks on the aft side of the stator vane inner support (Figure 98), with a corresponding platform rub on the forward side of all of the second-stage turbine rotor blades (Figure 97).
- There were rotational score marks on the blade-tip shroud (Figure 102), with a corresponding blade-tip rub on all of the second-stage LP turbine rotor blades (Figure 101).
- The honeycomb seal was undamaged (Figure 102).

Figure 91. (Photo No. 37-8) Platform Rub on the First-Stage LP Turbine Rotor Blades.

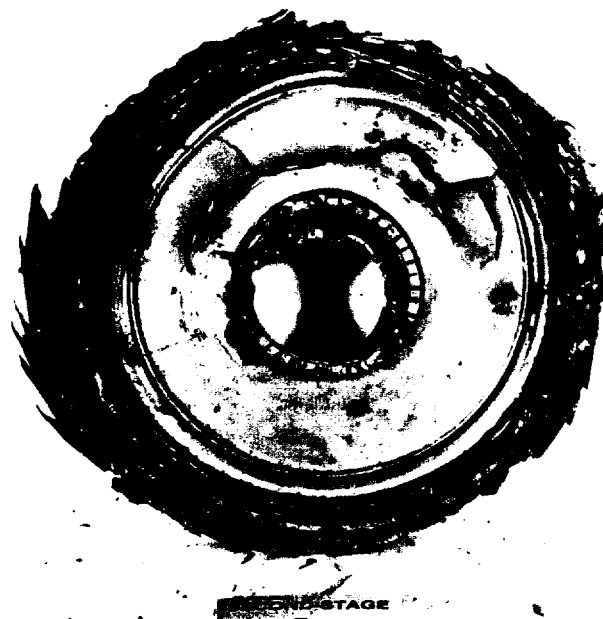
- The rotor disk was fractured (Figures 153, 154, and 156).
- The forward Curvic coupling teeth were damaged (Figure 156). The aft Curvic coupling teeth were damaged.

Figure 153. (Photo No. 41-16) Damaged Second-Stage LP Compressor.

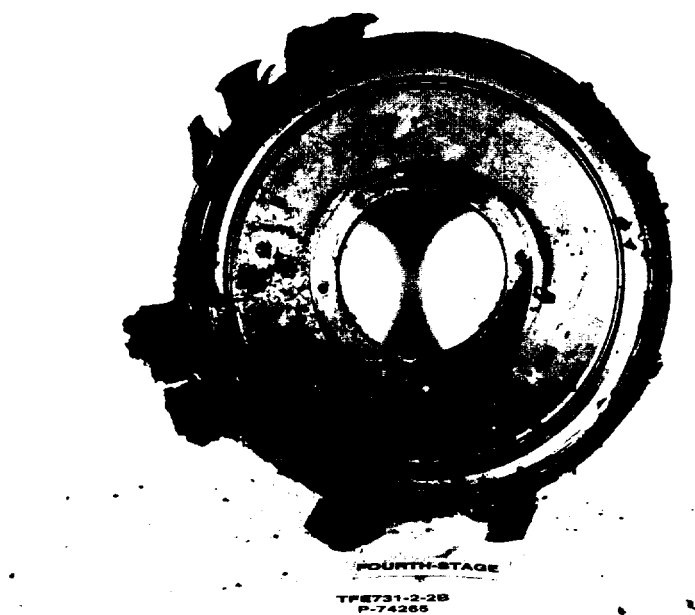
- Dirt and debris was packed between rotor blades (before decontamination).
 - Thirty-one rotor blades were displaced out of their dovetail slots (Figures 161 and 162).

- Eleven rotor blades were bent opposite to the direction of rotation (Figures 161 through 163).
 - The leading-edge and trailing-edge of all 11 of the retained rotor blades were damaged (Figure 163).

- The aft shaft mount flange was damaged (Figure 167) and separated from the forward flange/coupling (Figure 161). The OD of the aft shaft displayed rotational score marks (Figures 167 and 168), with corresponding rotational score marks on the ID of the HP shaft (Figure 166).

Figure 161. (Photo No. 41-24) Damaged Fourth-Stage LP Compressor.

Figure 162. (Photo No. 41-27) Damaged Fourth-Stage LP Compressor.

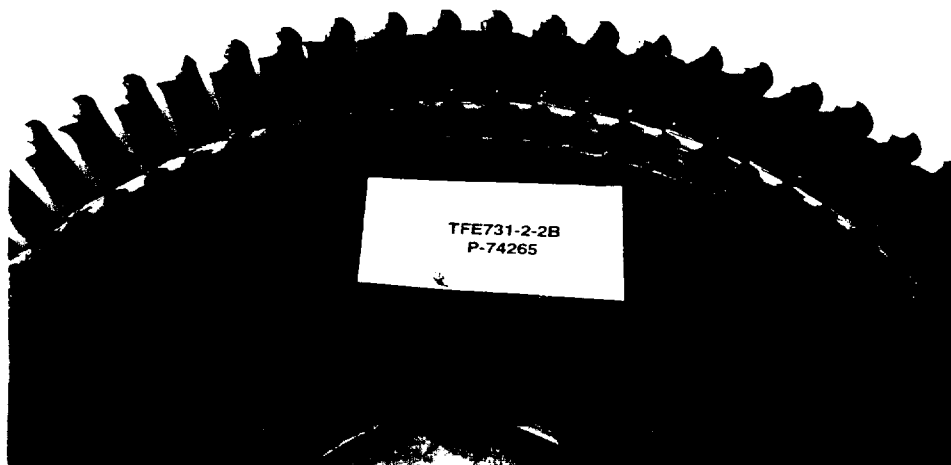
- (a) HP turbine rotor:
 - There was a platform rub on the aft side of all of the rotor blades (Figures 190 and 191), with corresponding rotational score marks on the forward face of the interstage transition duct (Figure 192).

- There were rotational score marks on the forward face of the inner structure (Figure 192), with a corresponding platform rub on the aft side of all of the HP turbine rotor blades (Figure 191).

Figure 191. (Photo No. 44-24) Platform Rub on the HP Turbine Rotor Blades.

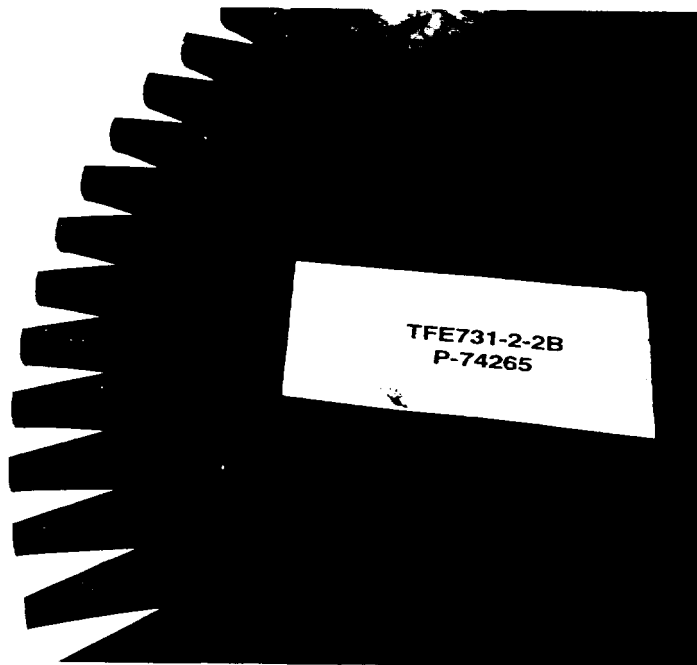
- There were compressor-shroud metal-spray deposits adhering to the suction side of all of the rotor blades (Figure 195). The trailing-edge of all of the rotor blades was battered and broken (Figure 196).

Figure 195. (Photo No. 44-28) Metal-Spray Deposits on the HP Turbine Rotor Blades.

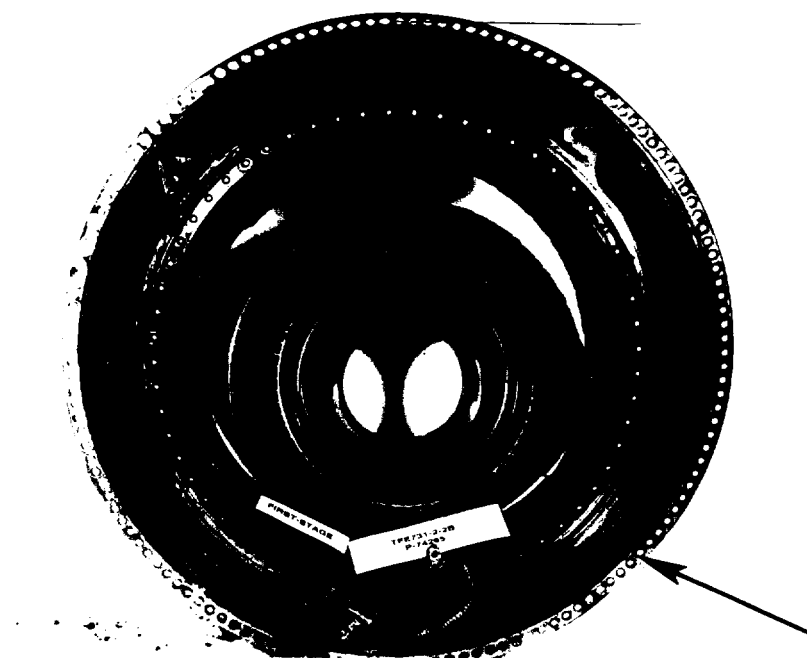
Figure 239. (Photo No. 39-12) Broken Mount.
