DOCKET No.: SA-521
EXHIBIT No. 7E

AIRWORTHINESS GROUP CHAIRMAN'S FACTUAL REPORT
ATTACHMENT IV: Douglas SB No. 27-262

Bulletin 27-262

FLIGHT CONTROLS - Elevator And Tab - Modify Elevator Geared Tab Mechanism.

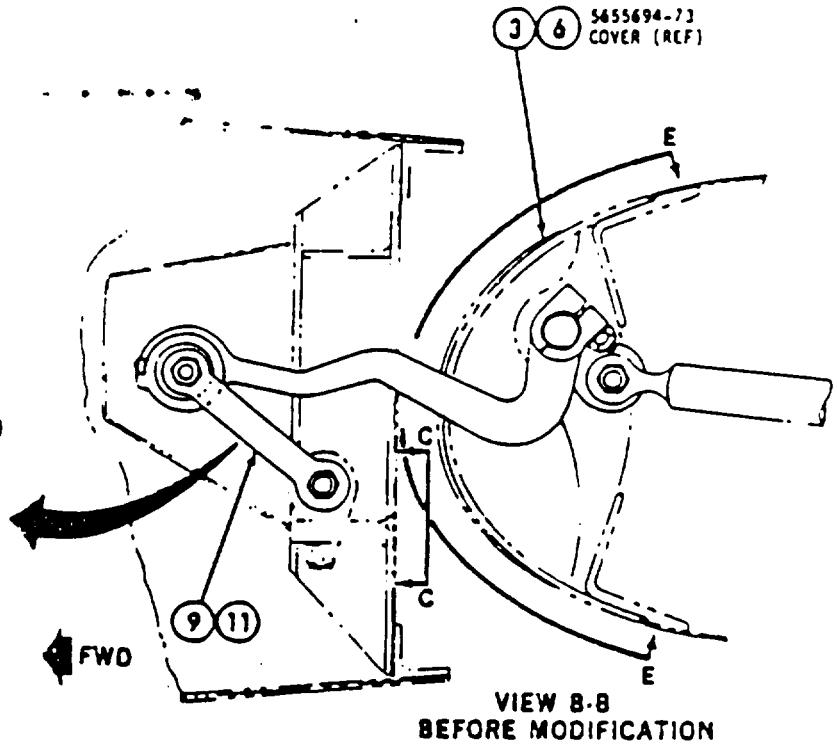
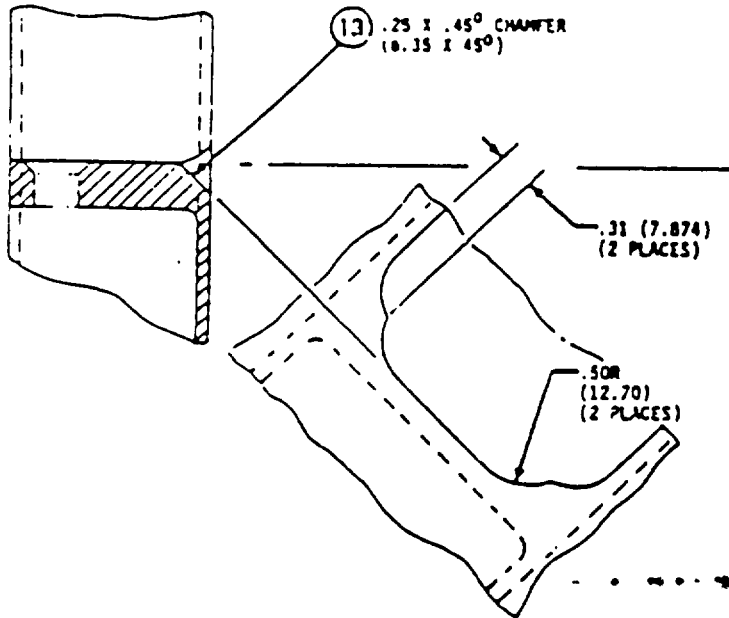
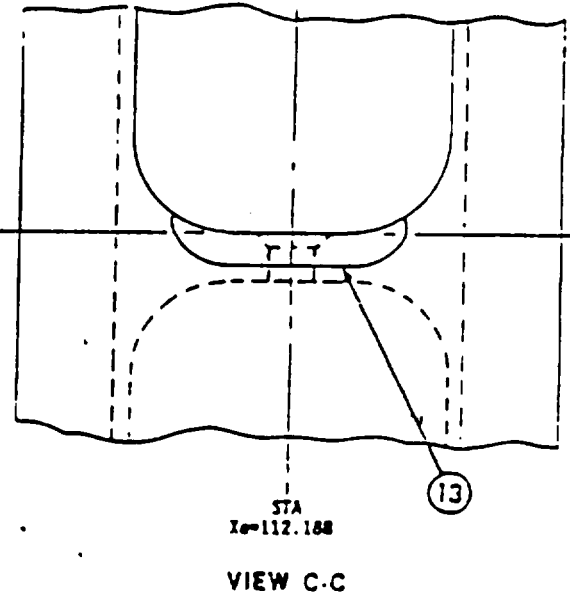
NOTE: LINKS MAY HAVE BEEN MODIFIED BY DC-8 SERVICE BULLETIN 27-155 OR PRODUCTION EQUIVALENT. OPERATORS SHOULD VERIFY THAT ALL LINKS CONFORM TO DIMENSIONS SHOWN.

Modify elevator geared tab mechanism as shown on Figure 2.
