NATIONAL TRANSPORTATION SAFETY BOARD

AIRWORTHINESS GROUP CHAIRMAN'S FACTUAL REPORT

AIRWORTHINESS GROUP CHAIRMAN'S REPORT
CEN09MA142

Operator: Empire Airlines, Inc.
Location: Lubbock, TX
Date: January 27, 2009
Time: 0437 central standard time
Aircraft: N902FX, ATR-42-320

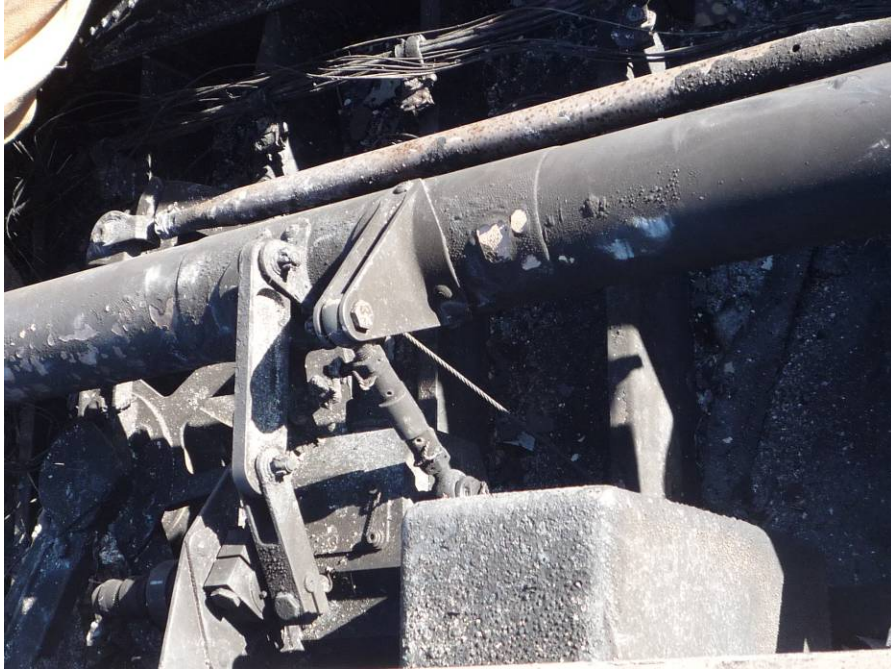
Photo 16. Flap Position Feedback Unit

The flap interconnecting torque tube, electro-hydraulic flap valve, the flap position feedback unit, and the flap asymmetry detector sustained burn damage, but all remained structurally intact and connected to their respective attachment points with the exception of the torque tube rods, which were both broken.

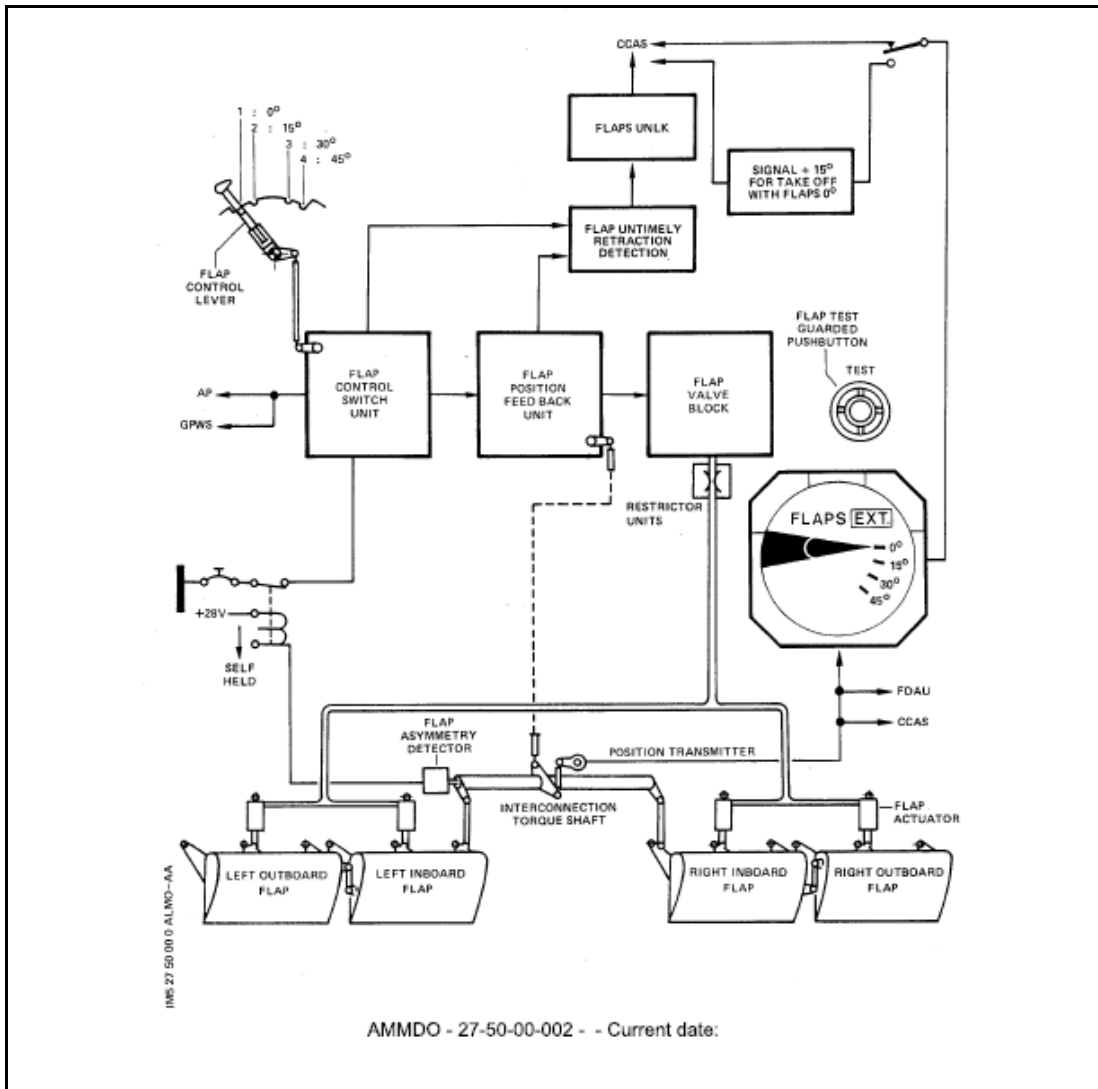
Figure 2. Flap System Schematic (ATR AMM)

When the flap control lever is placed in notch n, S_n microswitch is closed allowing electrical supply via the closed S_nE or S_nR microswitches. If the flaps do not extend sufficiently, electrical is supplied to the extension or retraction solenoid valves causing flap extension.

Interruption of extension or retraction is obtained by cutting off of the electrical supply to the extension (or retraction) solenoid valve caused by opening of the S_nE (S_nR) microswitch, which is commanded by the flap position feedback rod when the selected position is reached.
