NATIONAL TRANSPORTATION SAFETY BOARD

Group Chairman's Factual Report

WPR11MA454

Attachment 10 – Technical Orders
(30 pages)

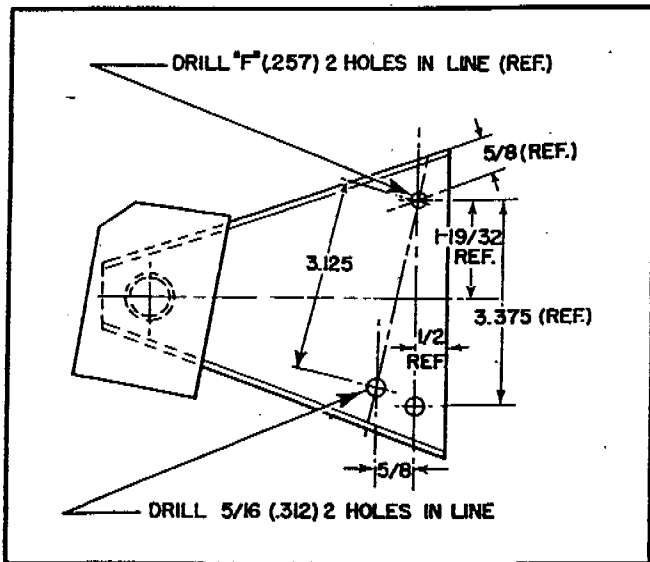
Figure 4A - View Showing Location of Additional Hole to Be Drilled in the Elevator Inertia Weight Assembly for Use on P-51B, P-51C, and F-6C Airplanes

(2) Since there is no provision in the bell crank for installing the lower attaching bolt for the elevator inertia weight assembly, it will be necessary to drill through the casting. Mark the hole to be drilled in the center of the bell crank at a point 3.375 inches below the top hole in P-51D and F-6D airplanes (3.125 inches in P-51B, P-51C, and F-6C airplanes) as shown in figure 3. Drill a 5/16 (.312) inch diameter hole using a snake drill. It is important that the hole be drilled in the center of the web of the bell crank since the location of the hole affects the position of the bob weight.
