K & I FIELD SERVICES, LLC

Observations of N606SP Wreckage during Salvage

6/25/2009

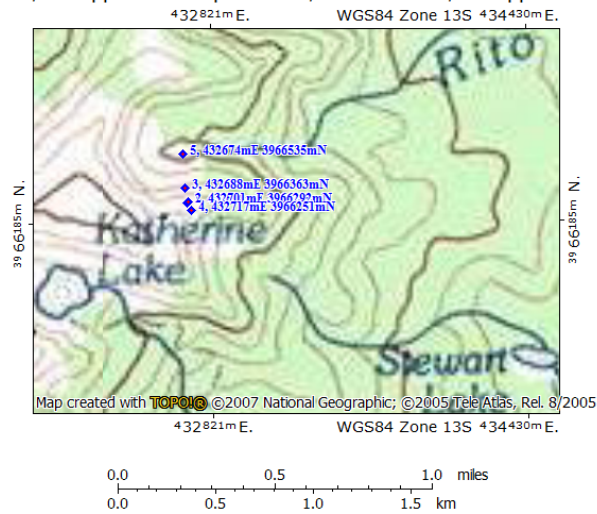
#1 uppermost piece of aircraft debris; #2 uppermost impact divot; #3 tail boom; #4 uppermost piece of crew debris (kneeboard)

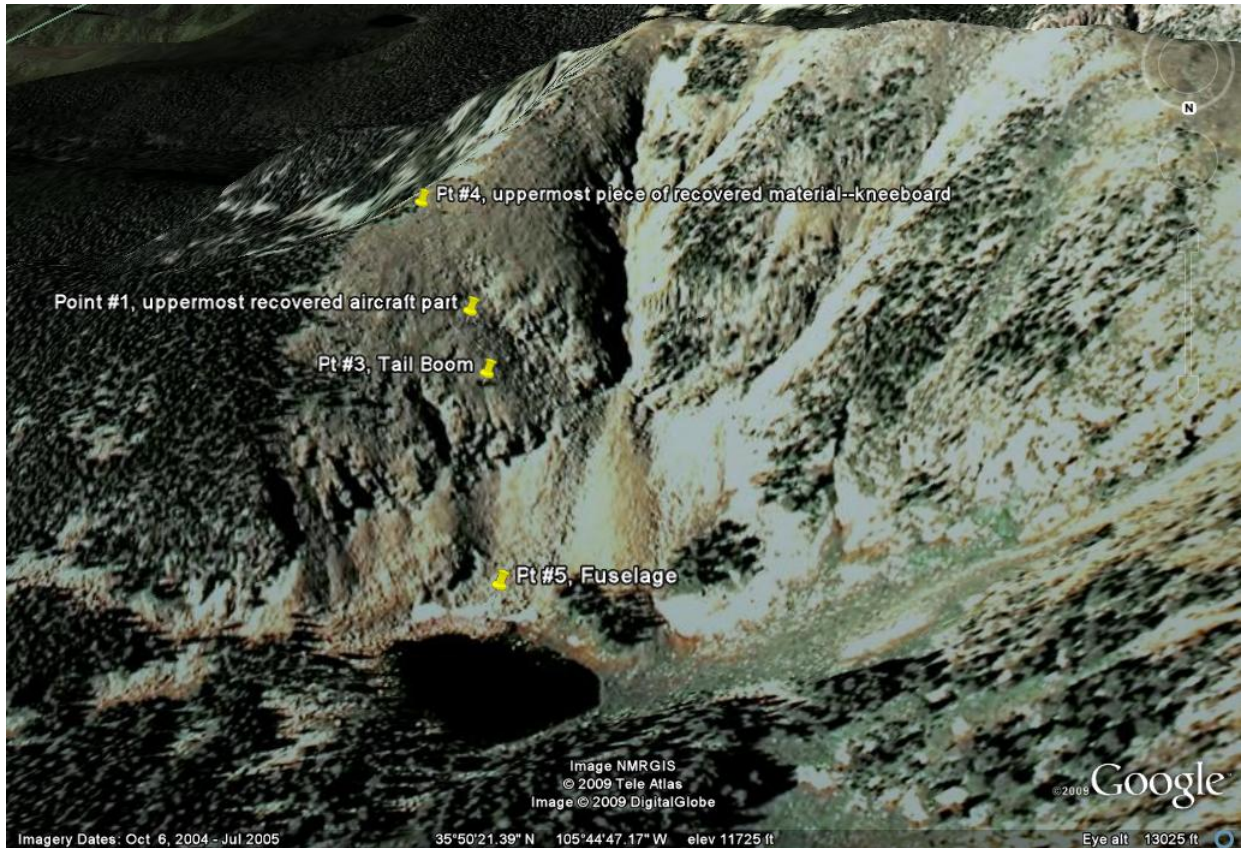
To improve the reader's geospatial view of the scene, the image below, courtesy of Google Earth, shows a terrain overview of the crash site. The points depicted here are located simply by the author's familiarity with the site, not necessarily the GPS coordinates listed in the table above.

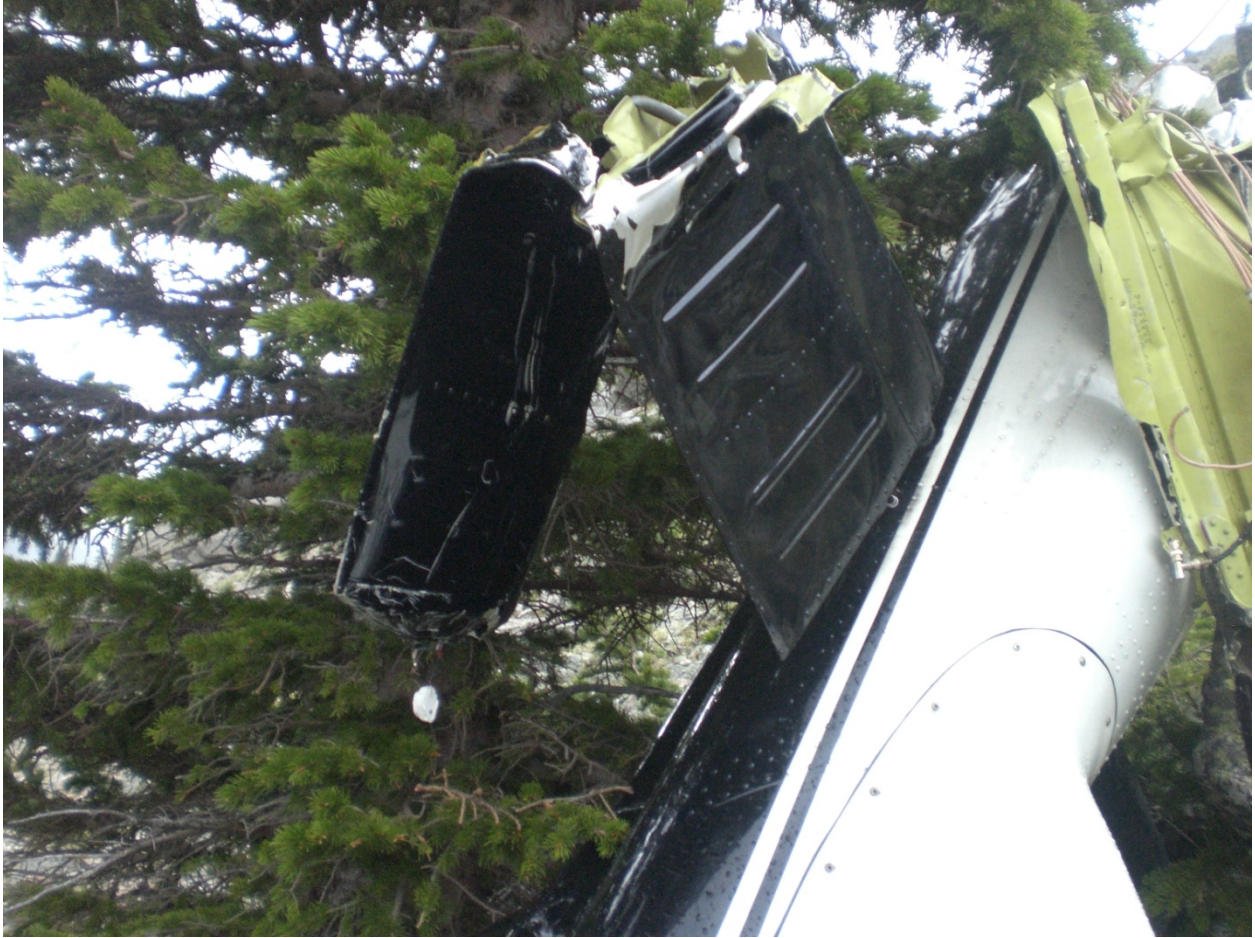
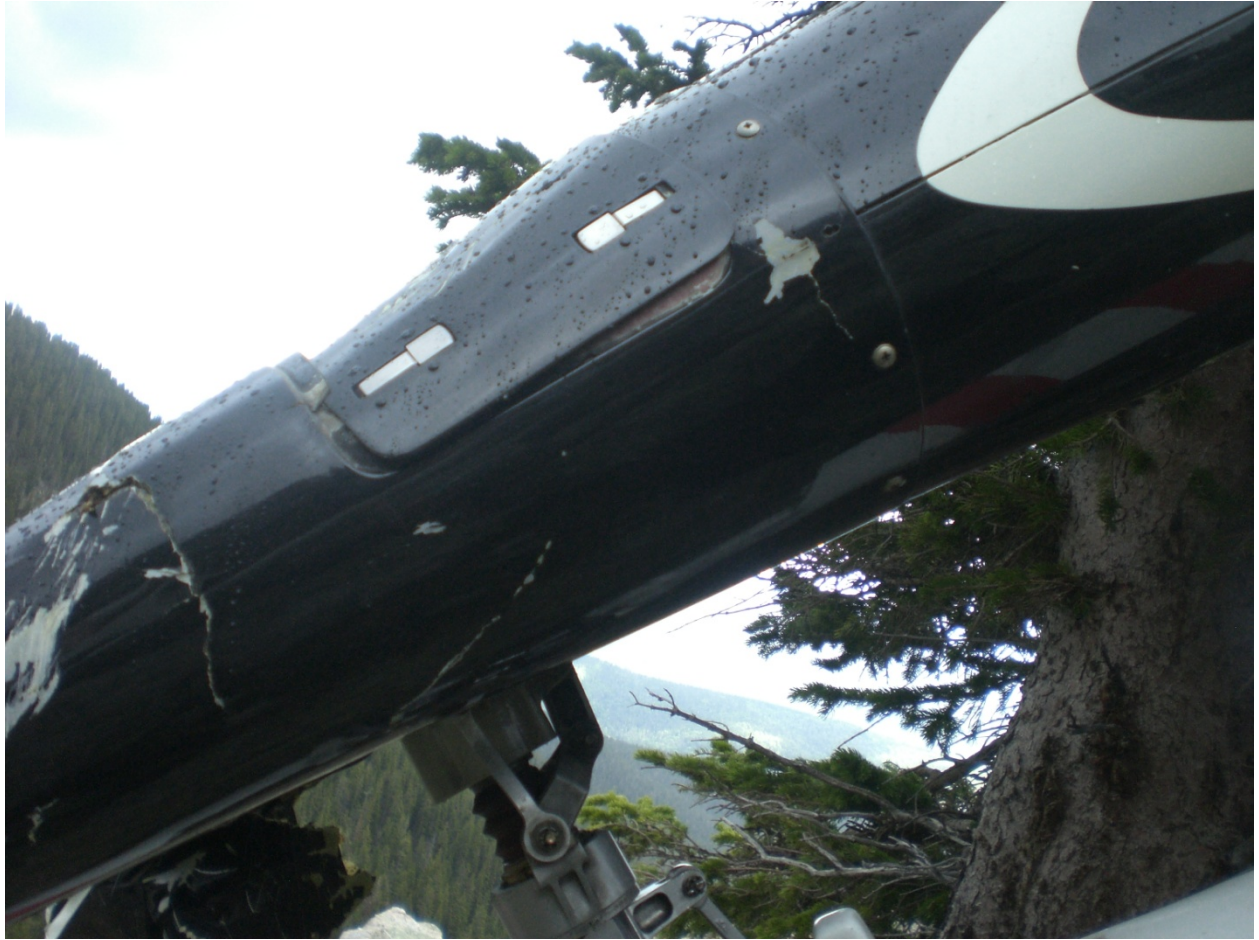
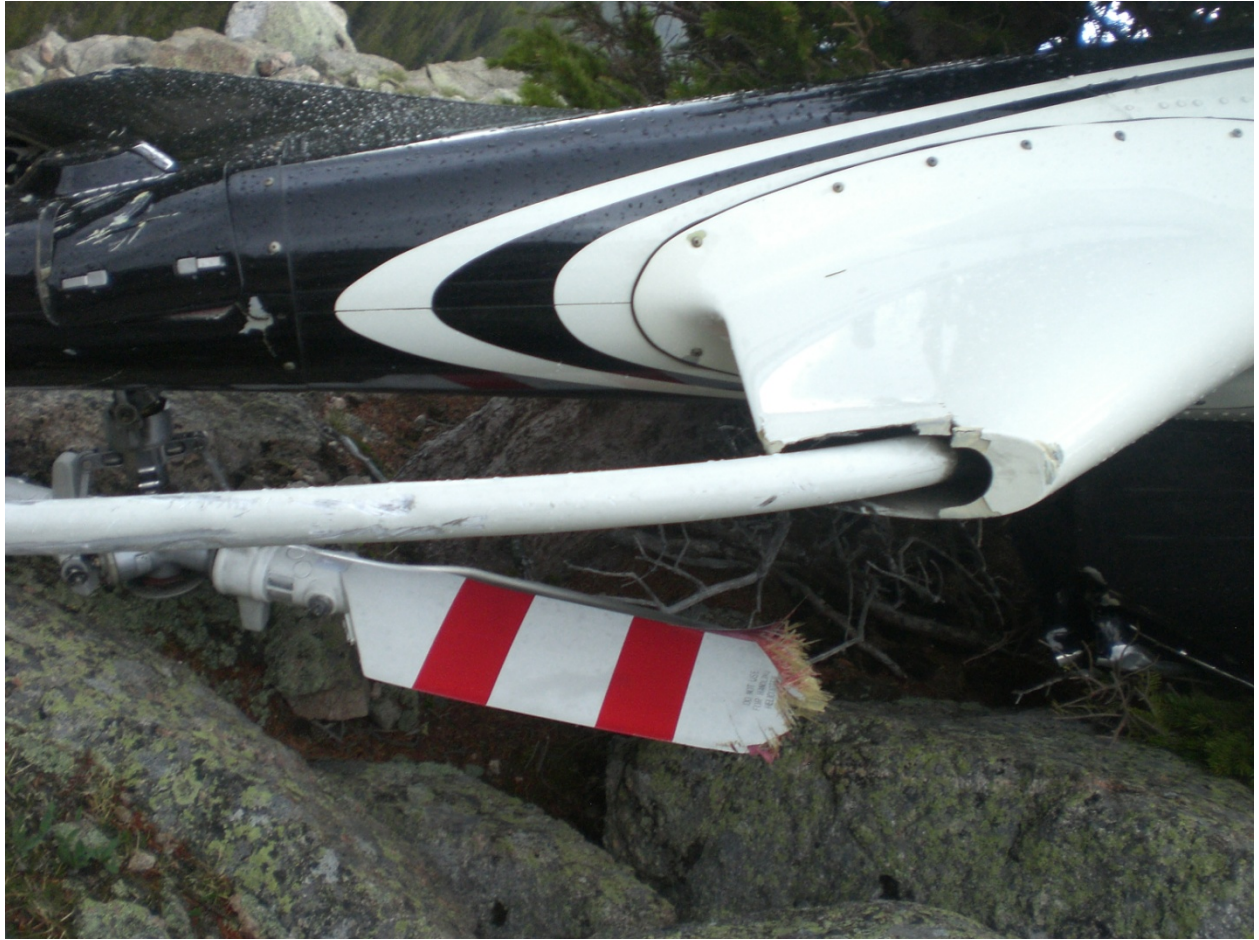
At point #3, we photographed the tail boom prior to disturbing it—seven following photographs. There was no indication the tail boom had been disturbed since the crash. (If it is important to definitively determine that the tail boom was undisturbed between the crash time and this photo, I recommend contacting Mr. Rich Seemer, Atalaya SAR, who was first on the scene of the tail boom and turned off the ELT located within the tail; ask him if the photos depict the condition in which he found the site.) The tail boom lies on the west side of the tree.
