**NATIONAL TRANSPORTATION SAFETY BOARD
Office of Aviation Safety
Washington, D.C. 20594**

Airworthiness Group Chairman's Factual Report

NTSB ID No.: LAX08PA259

Location: Weaverville, California
Date: August 05, 2008
Time: About 7:41 PM Pacific Daylight Time (PDT)
Aircraft: Sikorsky S-61N Helicopter

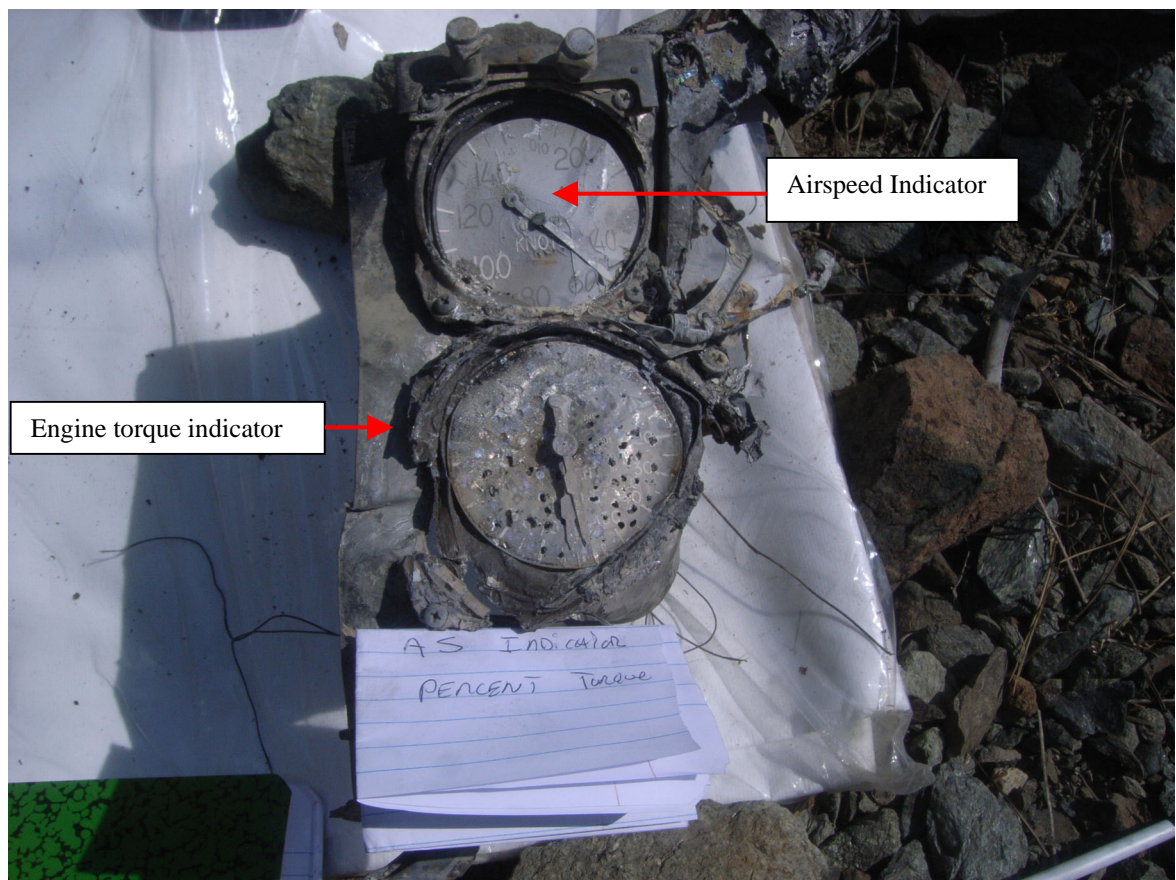
Figure 10 Photograph of an airspeed indicator and a cockpit engine torque indicator at the wreckage site

One airspeed indicator was located with the wreckage, it remained mostly intact and its airspeed pointer indicated about 50 knots (Figure 10).

1. Cockpit Torque Indicator: (Figure 10)
 - a. The Number 1 needle indicated a torque of approximately 62%.
 - b. The Number 2 needle indicated a torque of approximately 58%.
2. Cockpit Torque Indicator: (Figure 11)
 - a. The Number 1 needle indicated a torque of approximately 62%.
 - b. The Number 2 needle indicated a torque of approximately 50%.

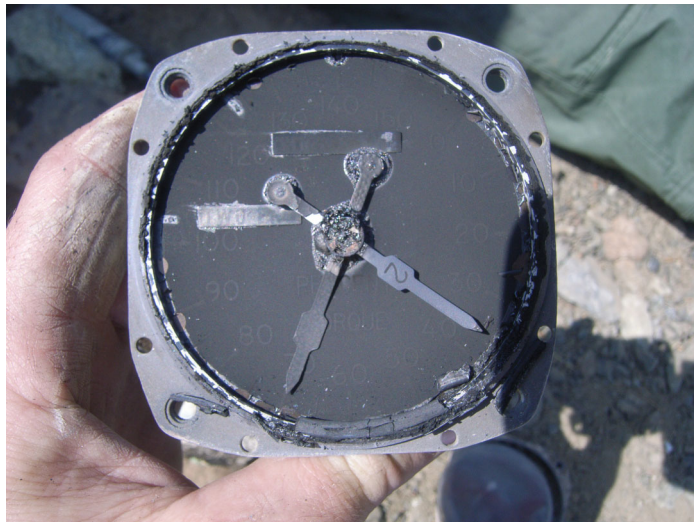
Figure 12 Photograph of the exterior mounted engine torque indicator at the wreckage site

3. Externally-Mounted Torque Indicator: (Figure 12)

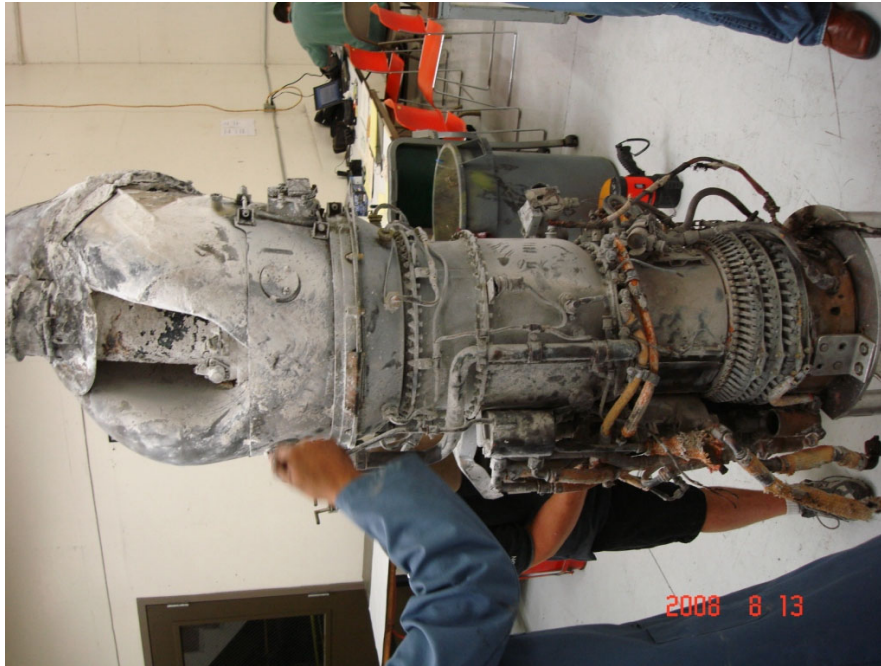
There was no evidence of casing penetrations. The exterior portion of each engine had experienced exposure to high thermal temperatures, with most accessories and external components thermally damaged. Most of the external fuel, oil lines and electrical harnesses were found compromised due to the thermal exposure. P₃ air-lines were found thermally damaged however the remaining portions appeared to be properly attached to the respective locations.

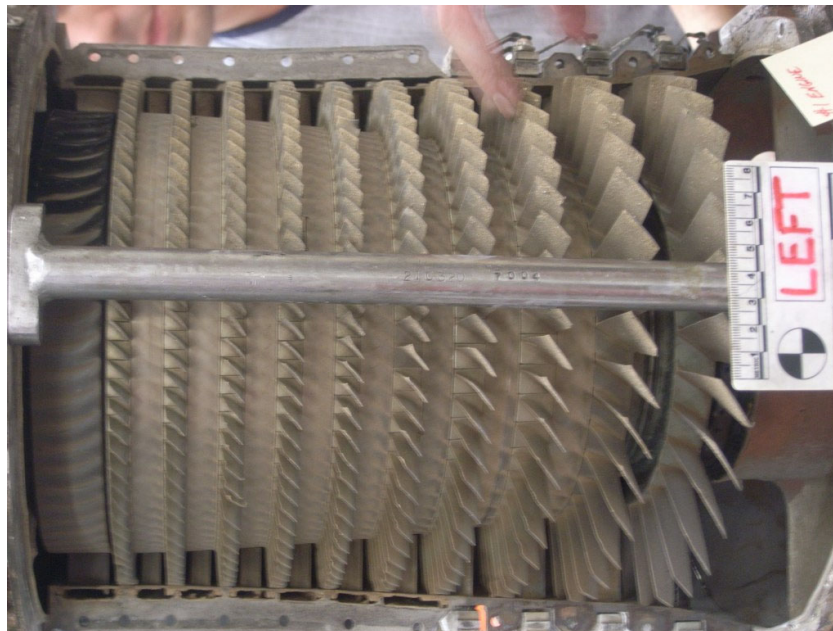
Figure 19

Inspection of the compressor blades was conducted to check the integrity and condition of the blades. All of the compressor blades were present and remained connected to the compressor disk. Loose fine light brown dirt was observed throughout the entire compressor (Figure 19) and there was evidence (dirt, bent blades) of FOD ingestion. After the turbine section was disconnected, the compressor section was rotated (by hand) about 1/4 turn and rubbing was observed.

Examination of the first stage compressor wheel blades revealed that the blades exhibited leading edge impact damage. Eight of the blades exhibited tearing damage to their leading edge tips associated with loss of blade material (the tearing direction was opposite of rotation). The leading edges of nine blades were found dented. There was minor rotational scoring on the front half of the blade tip chord. The trailing edges of all the second stage compressor blades were found dented near the blade tip; the denting was in the direction opposite of rotation. Five of the second stage compressor blades exhibited tearing damage to their leading edge tips associated with loss of blade material. Examination of stages 3 – 10 of the compressor wheel revealed that about 5 % of the blades exhibited tearing on the leading and trailing edges and about 60% of the blades were dented and deformed on their leading and trailing edges (all deformation was in the direction of rotation). About 5 % of the blades exhibited leading edge deformation near the outer edges of the vanes. All blades were evenly coated with a light brown colored powdery (very fine) material that could easily be removed by finger rubbing.

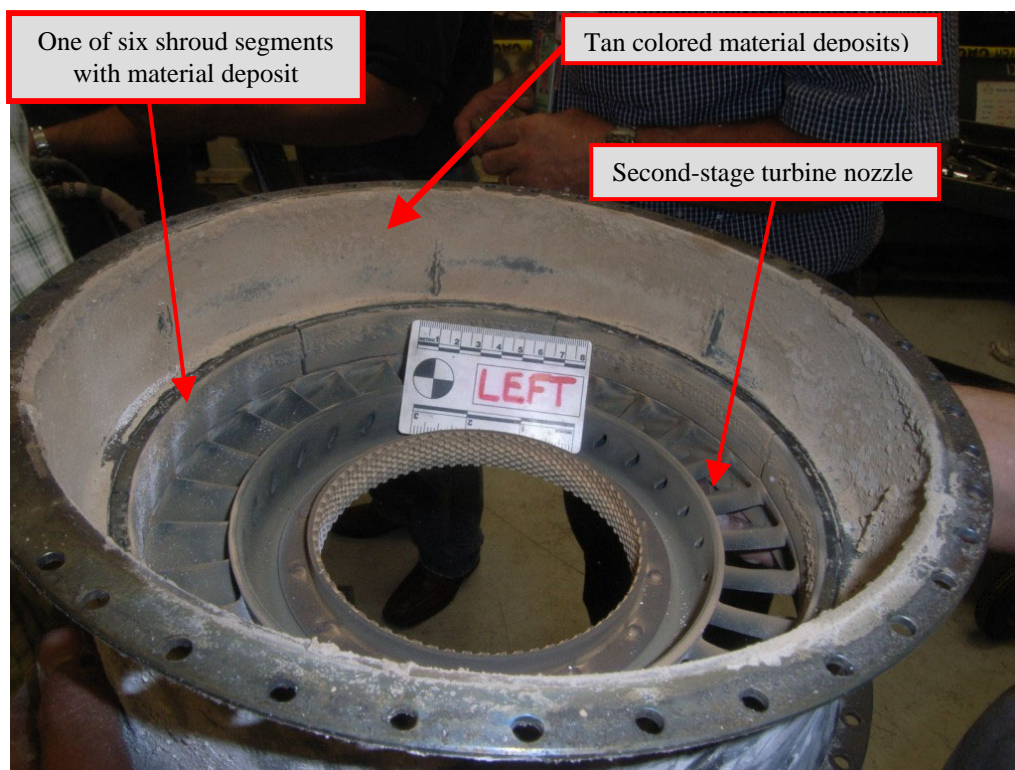
Figure 20

The first stage turbine nozzle was undamaged and all of the vanes remained intact. The convex side of all the vanes was coated with a light brown colored material. A light white powdery coating covered the light brown colored material on convex side of the vanes for approximately 180 degrees. The turbine casing appeared to be undamaged and intact. The exterior and interior surface was found covered with light brown material (Figure 20).

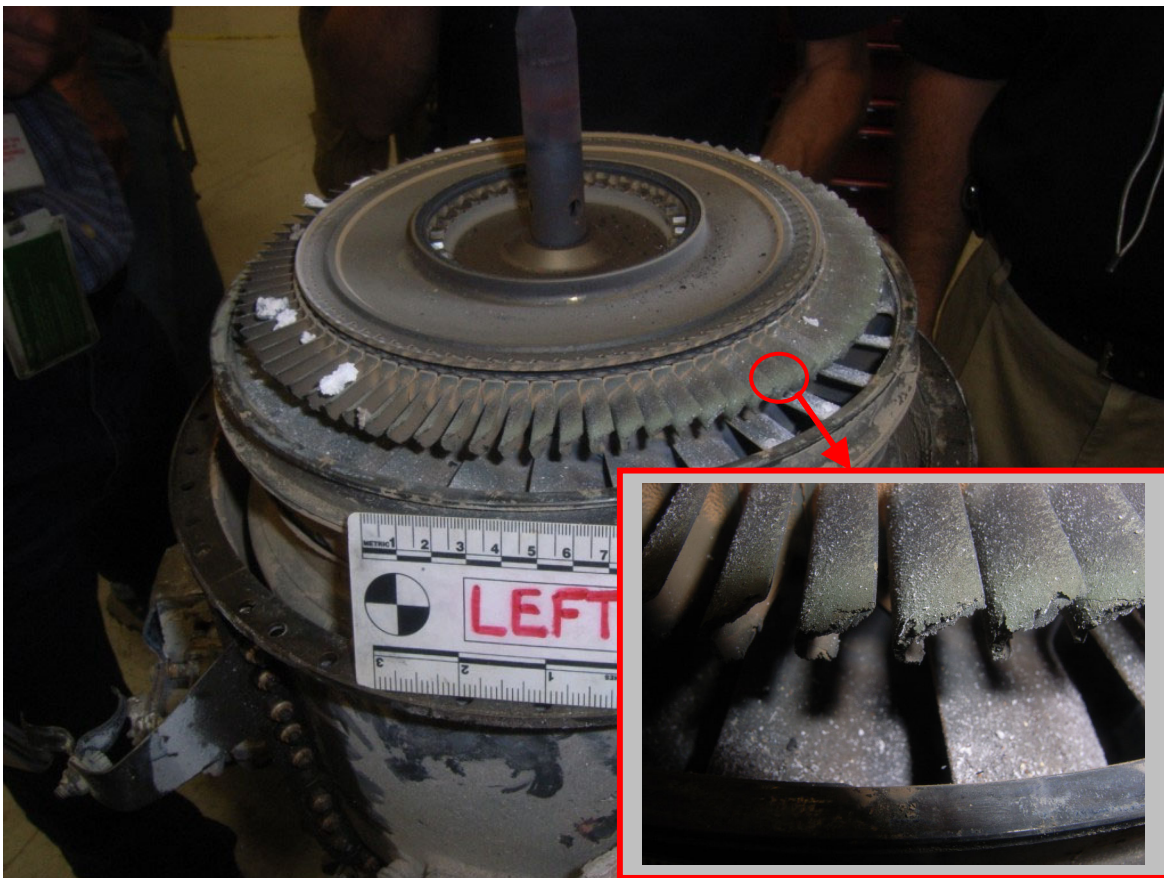
Figure 21

Examination of the first stage turbine wheel revealed that its wheel hub appeared to be undamaged (Figure 21). A spiral shaped cooling pattern was observed on the forward face of the hub and the forward curvic appeared to be undamaged. The aft face of the hub appeared to be undamaged. All of the blades exhibited a coating of light brown material on their concave surfaces, and a coating of the same material on about thirty percent of their convex surface. All blades tips were found fractured at approximately 2/3 their length. The wheel diameter measured about 9.2 inches vs. 9.7 inches nominal (as compared to the Number 2 engine wheel). The aft curvic coupling appeared to be undamaged. The Airworthiness Group submitted the first stage turbine wheel to the National Transportation Safety Board Materials Laboratory for metallurgical examination (Reference NTSB Materials Laboratory Factual Report number 09-013 in the Safety Board's public docket for accident number LAX08PA259).

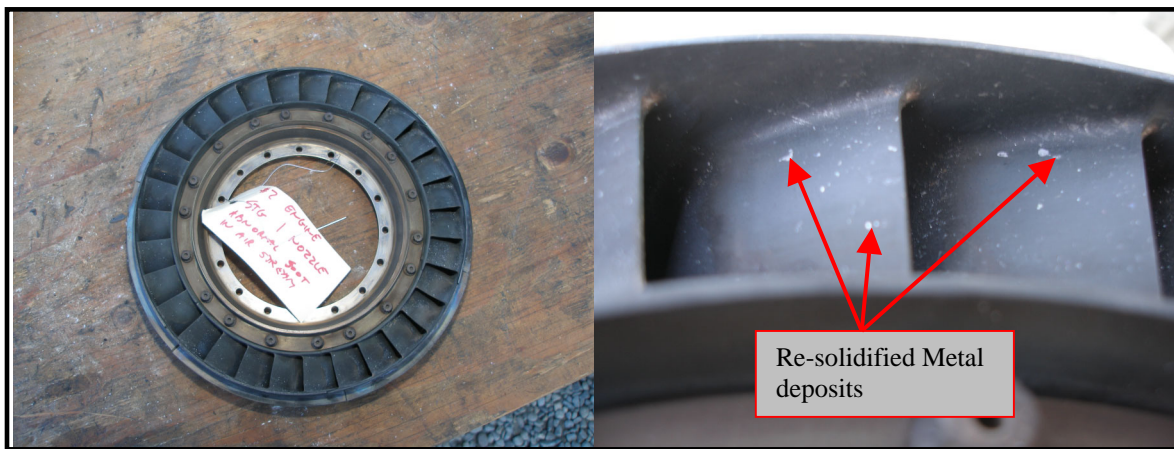
Figure 25

The first stage nozzle and all vanes were found intact, undamaged and coated with black soot (Figure 25). Multiple vanes were found with light metal deposits on their convex side. The Airworthiness Group submitted the first stage turbine nozzle to the National Transportation Safety Board Materials Laboratory for metallurgical examination (Reference NTSB Materials Laboratory Factual Report number 09-013 in the Safety Board's public docket for accident number LAX08PA259).

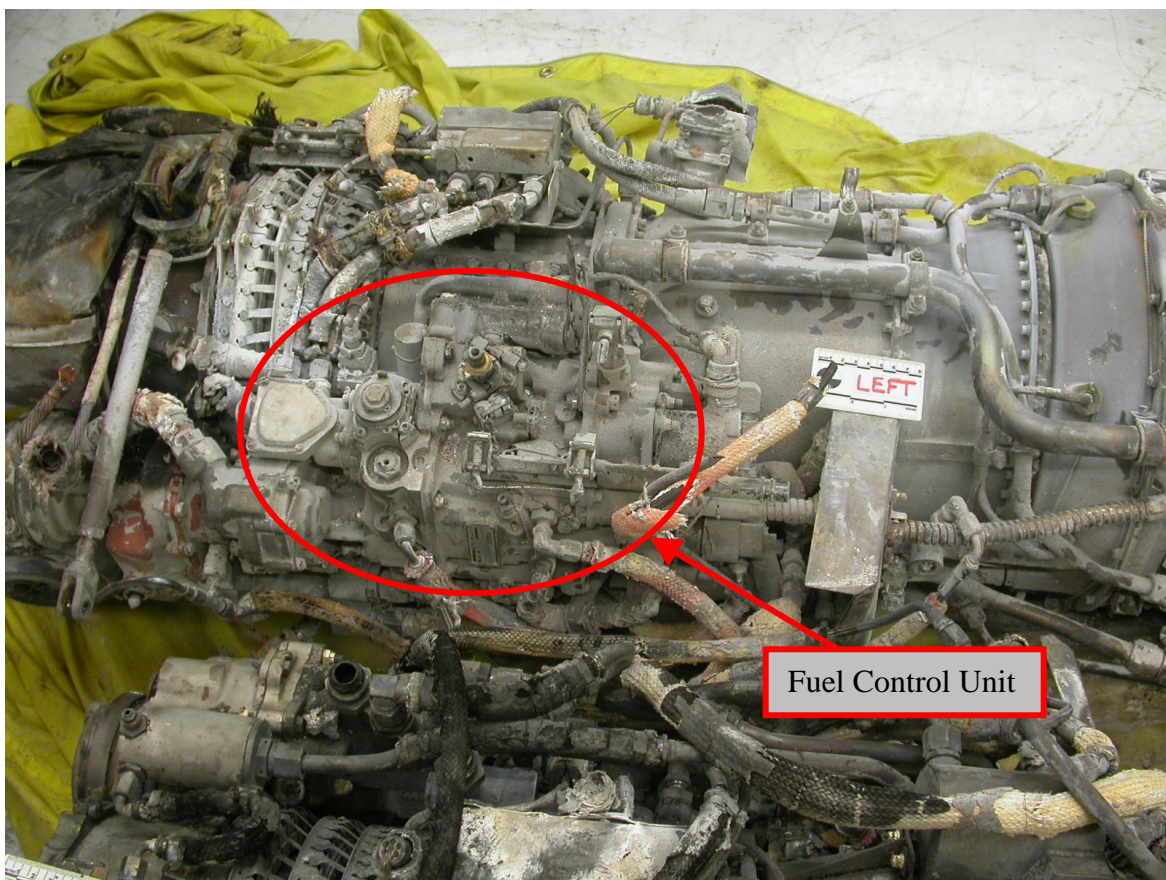
As received at Columbia Helicopters Inc., FCU having S/N 72835BR remained intact and attached to the left engine (Figure 30). The FCU was removed from the engine and placed on a bench for further examination. The Airworthiness Group determined that this FCU could not be functionally tested (mechanically or hydraulically) due to the thermal damage it sustained during the post-crash fire. The Airworthiness Group visually examined and documented the following features on the units: physical and structural condition, position of control inputs, cleanliness of filters, and condition of mechanical linkages.

Overall, the FCU remained intact, all attachment hardware and safety wire were present and secured, and all of its external component visually appeared intact and in place. White oxide residue was present on the exterior of the main housing including within the T₂ aspirator supply tubes. Upon disassembly of the unit, the inside of the FCU was found dry (no fuel present) and coated with a thin layer of black material consistent with residue from coked fuel. Charred remnants of elastomer and polymer seals remained in the areas where seals would normally be present. No metal contamination was visually observed within the upper or lower control housings and all of the internal components

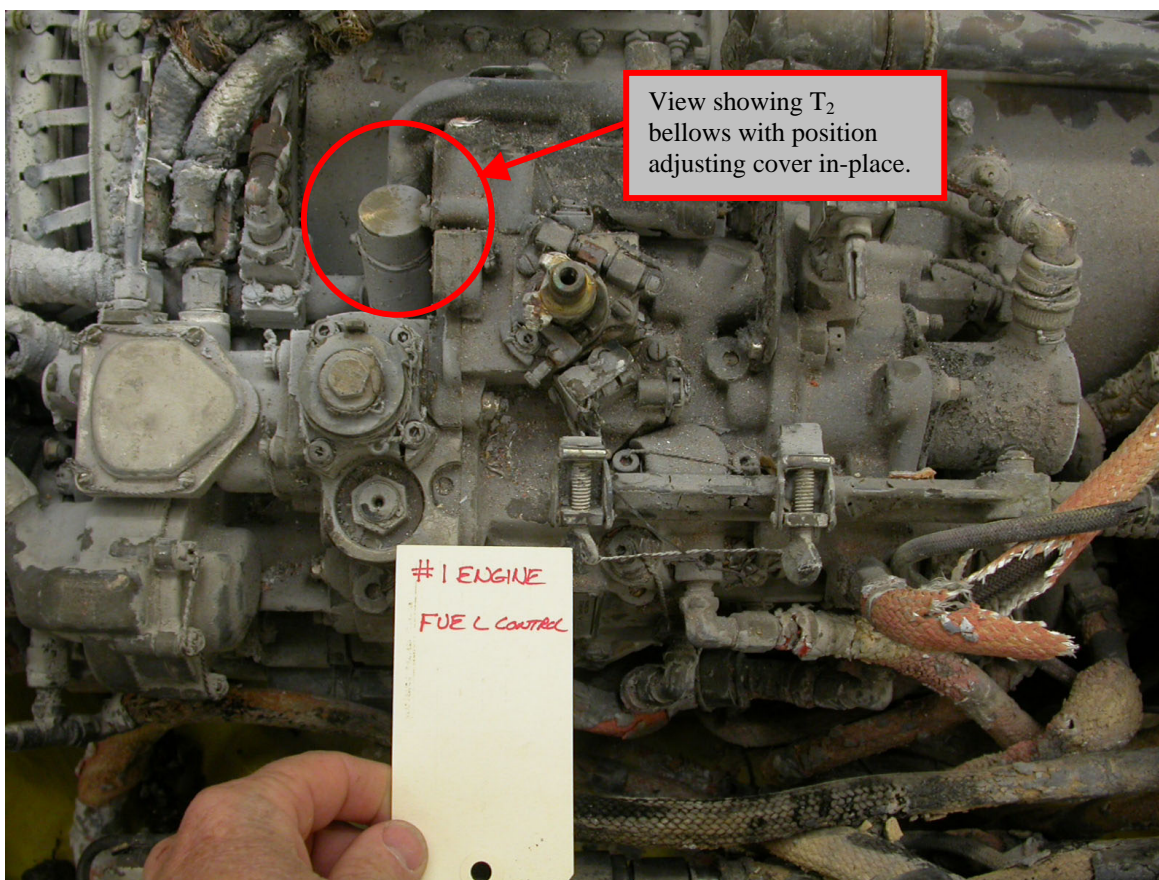
Visual examination of the T₂ servo assembly was conducted at Columbia Helicopters Inc. The examination revealed that its position adjusting cover (metal) remained intact and lock wired in place (Figure 32).
