# **AIRWORTHINESS GROUP CHAIRMAN'S FACTUAL REPORT OF INVESTIGATION**

November 5, 2011

- A. ACCIDENT ID:** DCA11IA040
- LOCATION:** Louis Armstrong New Orleans International Airport (MSY),  
Louisiana
- DATE/TIME:** April 4, 2011, at about 0725 am (CDT/Local)
- AIRCRAFT:** Airbus Model A320-232, registration N409UA  
Operating as United Airlines Flight 497

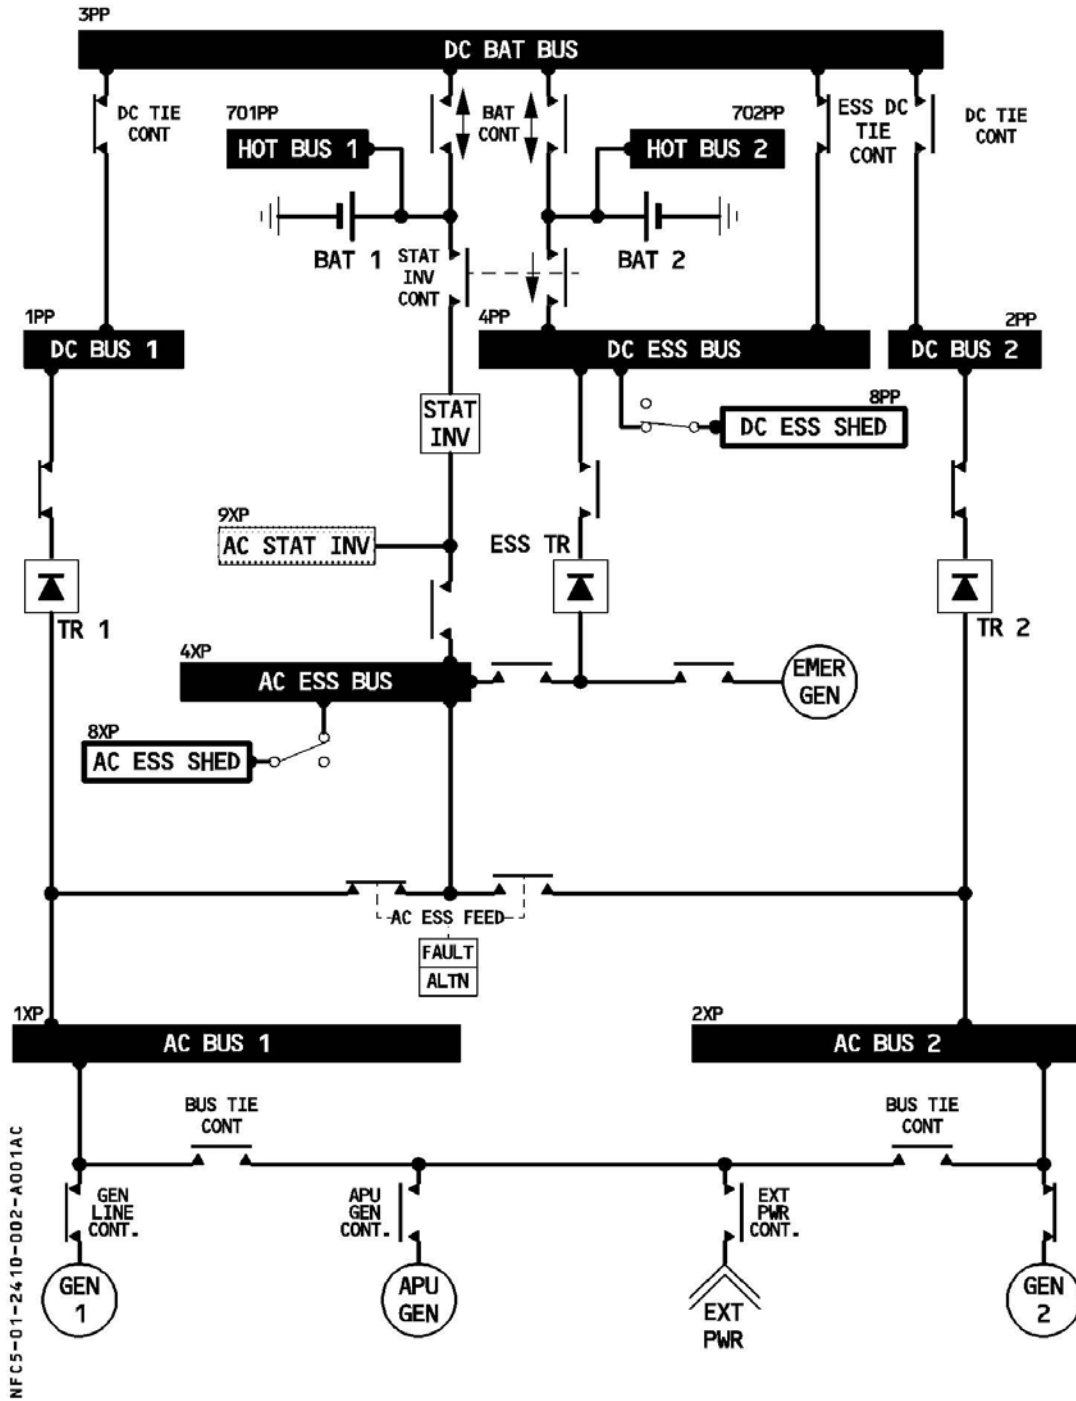
Fig 8A. Simplified electrical system architecture, as shown in the Flight Crew Operating Manual.

The airplane is equipped with a pair of batteries that may power essential components for flight when no alternating current is available. (See Figures 8A and 8B)

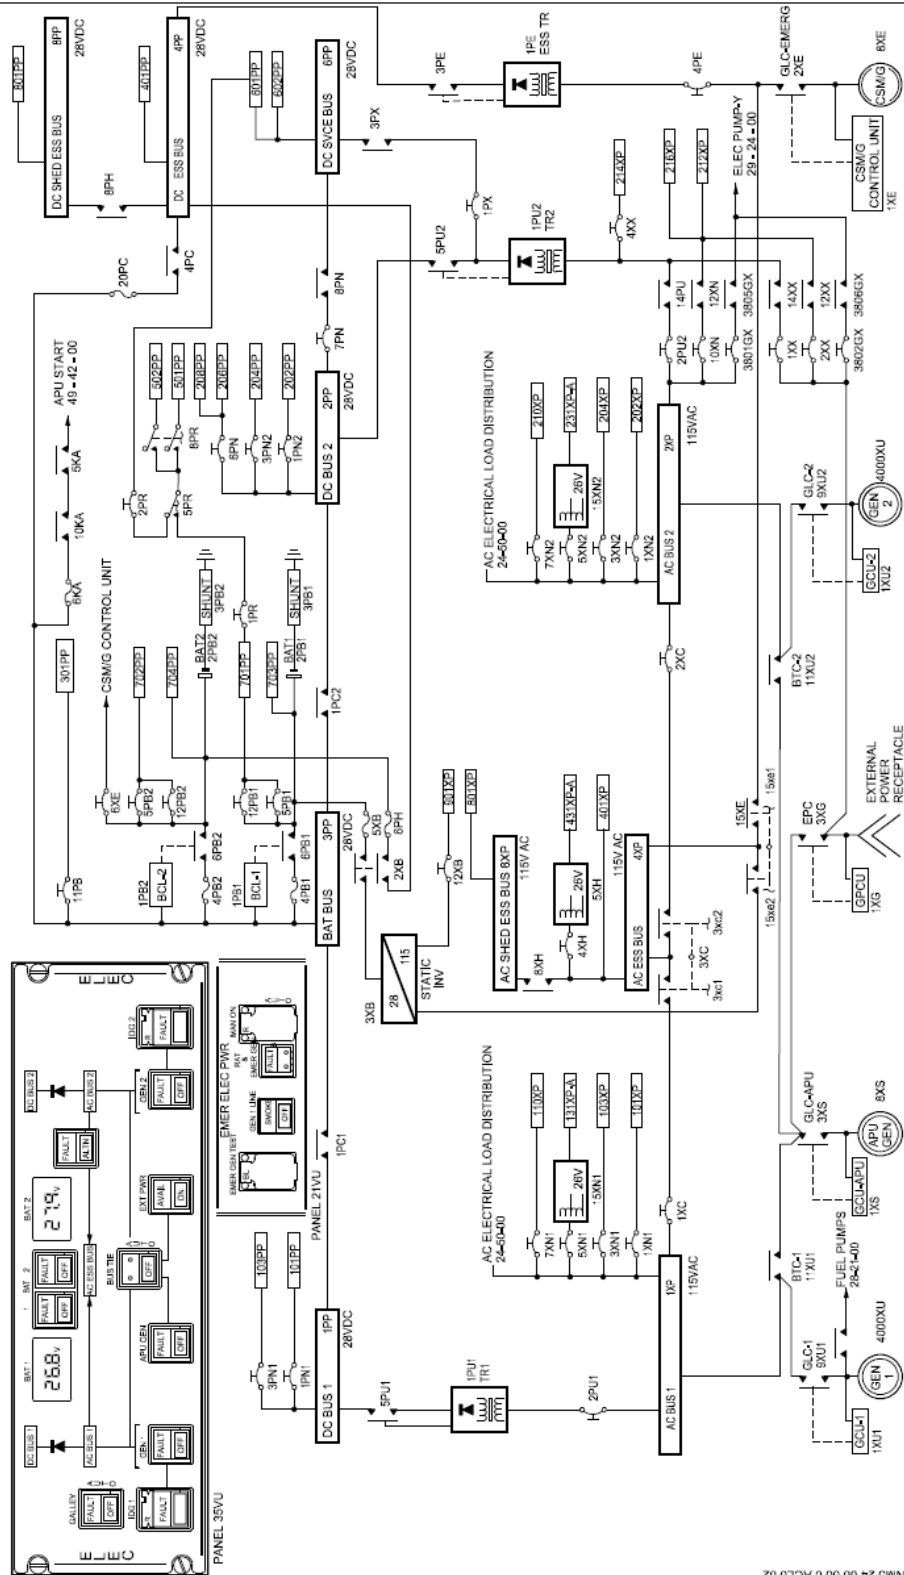
Figure 8B. General electrical schematic shown in Aircraft Maintenance Manual lists individual busses.

An aircraft electrical schematic showed that the indicating and recording systems were powered by the 28 VDC Bus 2 and by 115 VAC Bus 2. The schematic indicates that the 115 VAC Bus 2 is not powered when TR2 is switched to off and the cross tie is open. (Ref: ASM-31-36-00 SCH 01 P 101 Fig 1 INDICATING/RECORDING)

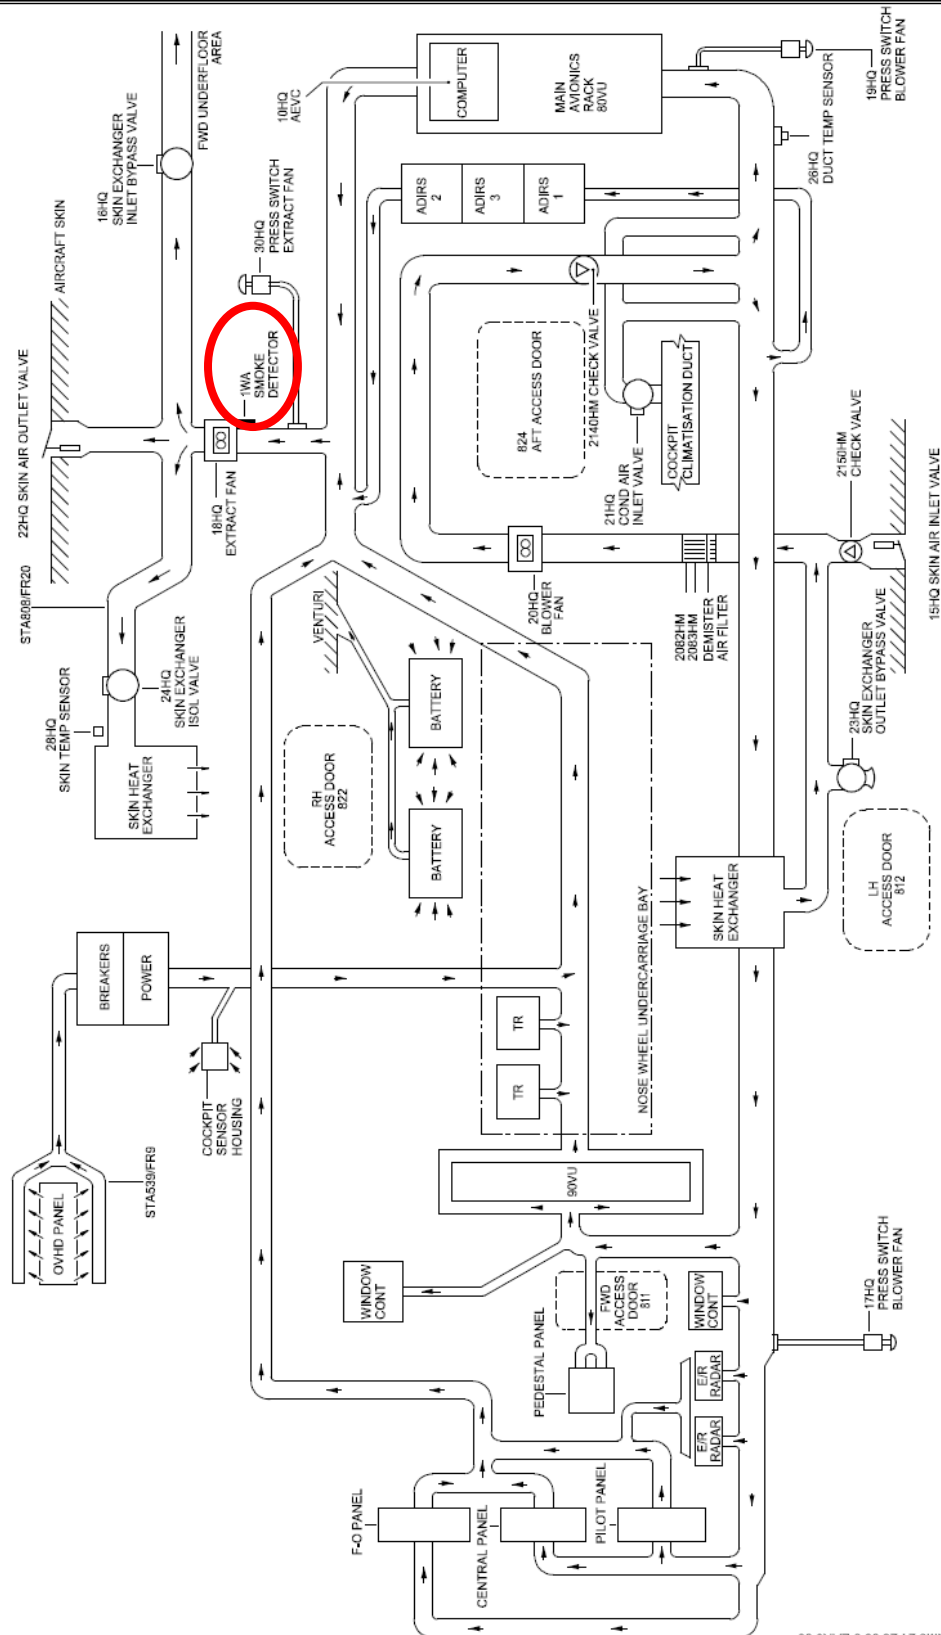
Figure 10. Avionics ventilation and components, as shown on AMM 21-26-00, with the avionics smoke detector circled

No ventilation components were found to have failed in the airplane. The three circuit breakers (D5 & D6 overhead, Z17 & AE2 aft) for avionics ventilation were found engaged. When the airplane was powered, both avionics ventilation fans operated.

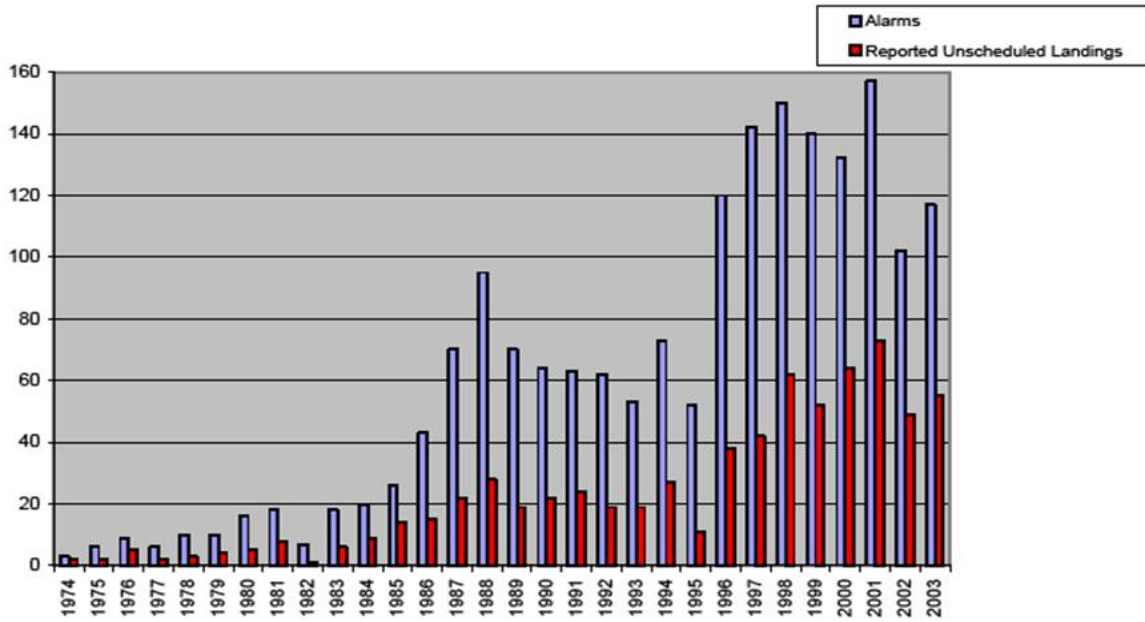
Figure 13. Smoke detector false alerts and unscheduled landings.

In 2004, the FAA Fire Safety Branch compiled Service Difficulty Reports occurred during the period of 1974-2003. The reports were individually read and while avionics smoke reports were not included, the cargo and avionics systems use similar detector units. The false alarms were then plotted against unscheduled landings, as shown in Figure 13:

The data revealed 1,866 alarms 1974-2003, with an increasing trend (more alarms per year on average). These alarms had been recorded in airplane models from the manufacturers of all major transport and business aircraft, including Airbus, Boeing, Bombardier (also Canadair), Dassault, DeHavilland, Douglas, Embraer, Lockheed, Saab, and Shorts. The types of airplanes ranged from early Boeing 727s to new Airbus 340s. The phases of flight for the 1,866 records were:

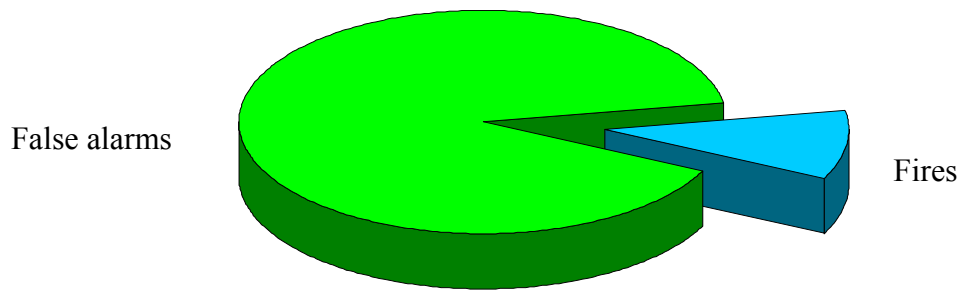
Figure 3 : Ratio fire/false alarm

In this graphic, regional aircraft are very few represented, the overall ratio (90% of false fire warnings) would be higher if this aircraft category was totally included [4].

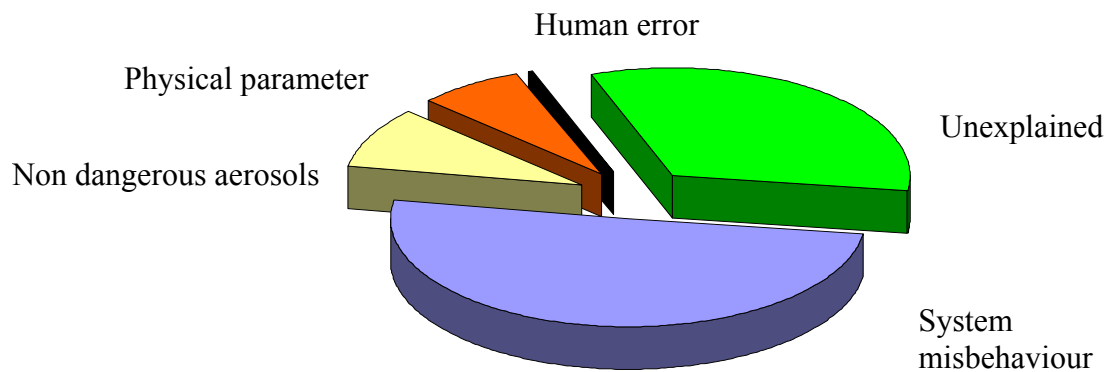
Figure 4 : False alarm analysis

In most of the cases, the conditions in the cargo compartment at the time of the alarm were not exactly known by the pilots or the crew, therefore false alarm events were often considered unexplainable or attributed to a system malfunction whereas a better knowledge of these conditions would have led to a different classification.

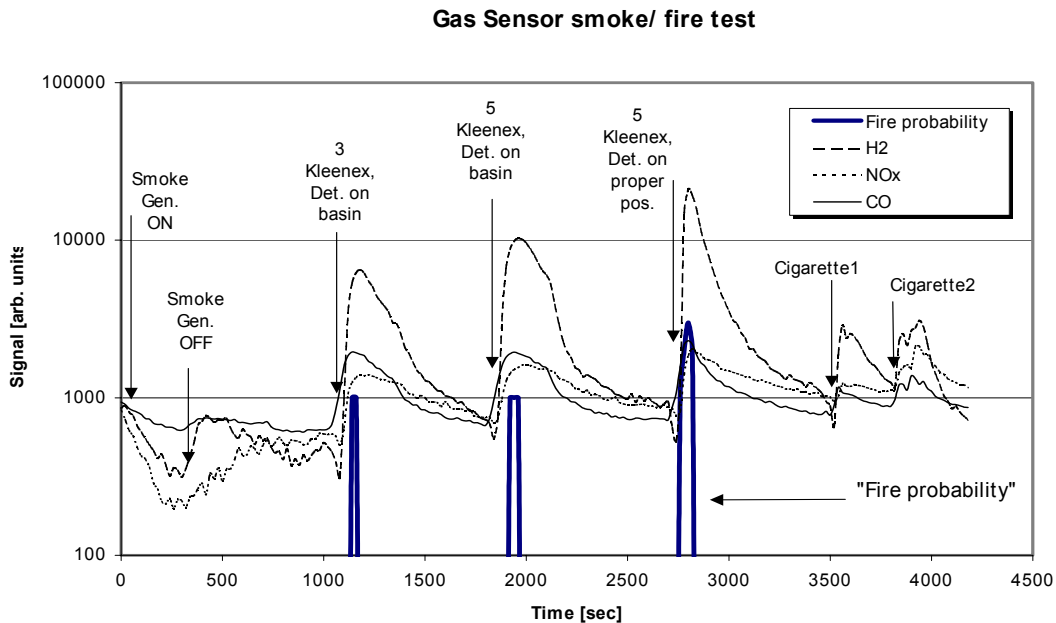
*Fig. 5: Comparison of a smoke detector test with a real fire for a gas sensor based fire detection system*

Fig. 5 shows a test that has been conducted to compare the response of gas sensors to a currently used smoke generator in Airbus (AX1000) and a real fire of Kleenex tissue towels. The test was carried out in a standard-layout lavatory. As sensing device a GSME smouldering fire detector as it is used for lignite power plants was examined [14]. This device comprises 3 semiconducting metal oxide gas sensors with optimized selectivity for H<sub>2</sub>, CO and NO<sub>x</sub>. The GSME detector and its signal processing algorithm had not been

modified for this test. First, the smoke generator was switched on, producing an amount of smoke labeled equal to 5 kleenex tissue paper towels. It can be seen that the gas sensor device responds very poorly with all its 3 sensors and shows a slightly decreasing signal. The aircraft optical smoke detector which was also installed, reacted after 35 seconds. The GSME was positioned near the basin, which means it was not installed where the current detector is installed. By burning 3 Kleenex, the detector showed a significant signal and the internal processing algorithm predicted a certain “fire probability” which can be used for defining an alarm threshold. Not being on its proper position yet and burning 5 Kleenex resulted in a higher signal but a similar fire probability. Afterwards, the sensor was installed into the position of the current detector and again, 5 Kleenex were burned. This time, the signal shape looked different due to changed airflow conditions the sensor was exposed to and the fire probability had a higher value. The final two peaks are two cycles of cigarette smoke, the first just normally smoking and the second smoking and blowing at the detector. Cigarette smoke shows a different signal shape than Kleenex towels and it can be seen that cigarette smoke does not result in any value for the fire probability.

This example shows that the common smoke generator integration test is not suitable for this kind of fire detector because these types of gas sensors will never respond to this specific kind of smoke.

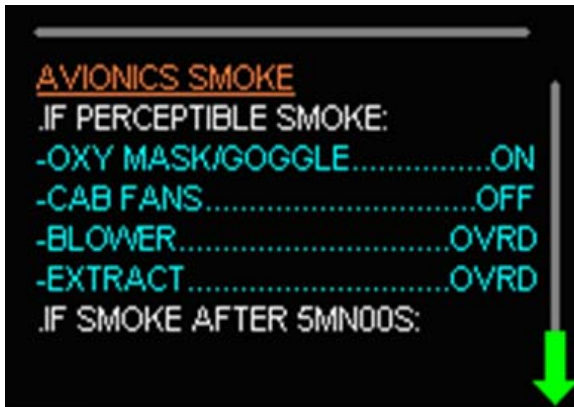
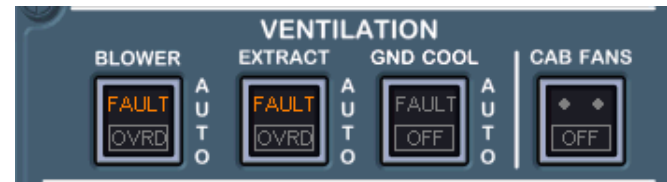
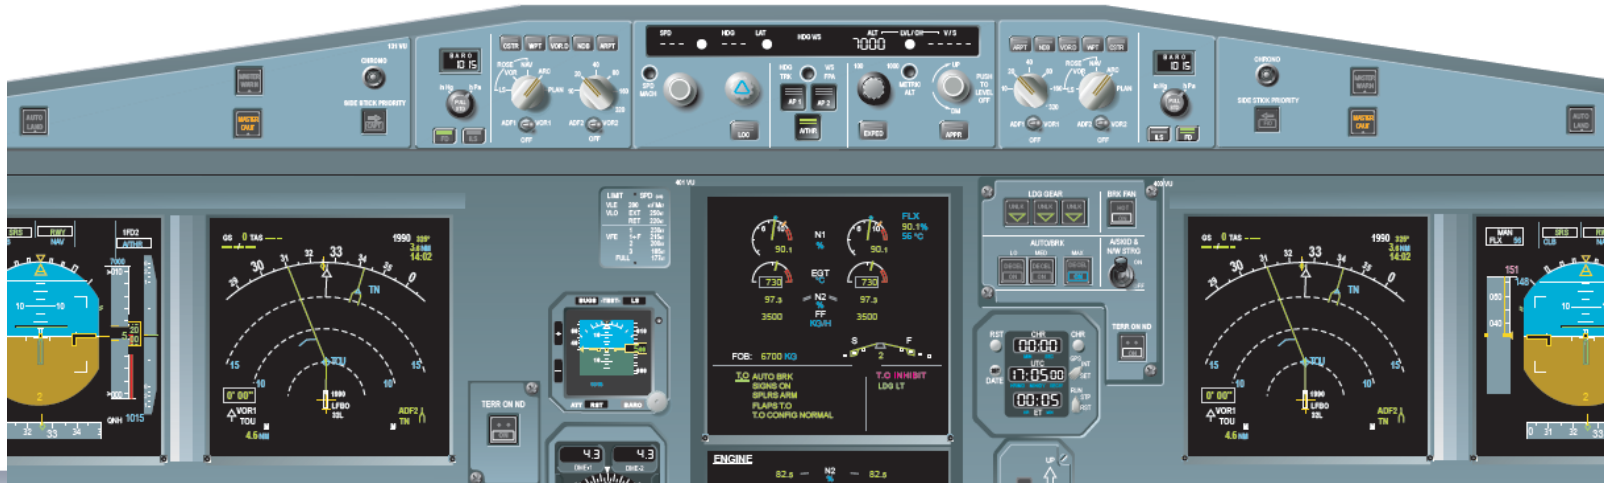
- Aircraft parked at MSY (powered)
- “AVIONICS SMOKE” caution triggered (No Go item)

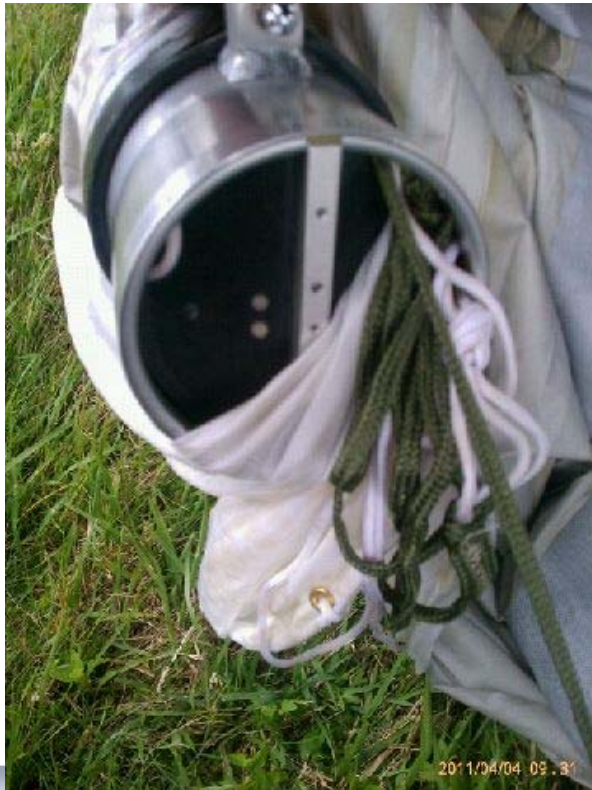
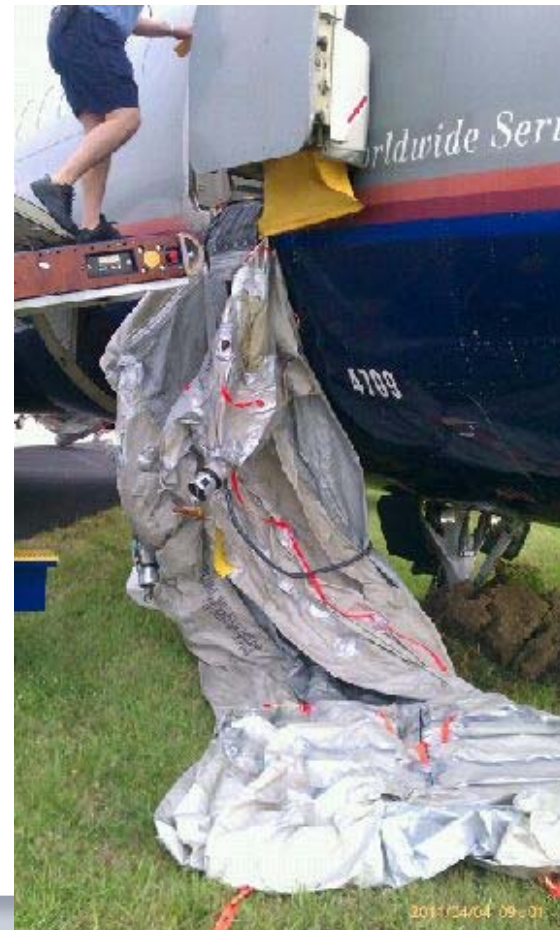
- Evacuation
  - Slide 1R started to inflate (frangible links broken) but deflated due to aspirator flap blocked.
    - Packing issue suspected

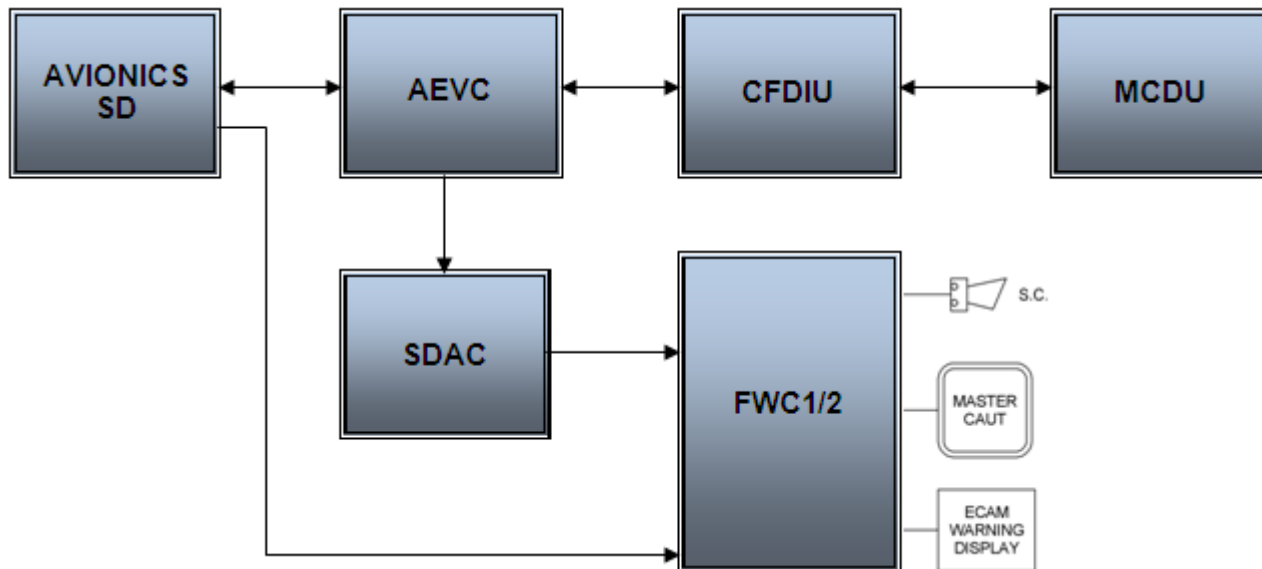
- Troubleshooting as per TSM:

- TSM TASK 26-15-00-810-803 : “Smoke Warning without smoke”
  - Do a reset of the AEVC 10HQ (open C/B 5HQ and close after 5 seconds).
  - If the fault continues, replace the avionics Smoke Detector (SD) 1WA
  - Reset the FWC1 and FWC2 (C/B 2WW and 3WW) to clear the fault
  - Do the ground scanning of the Central Warning System

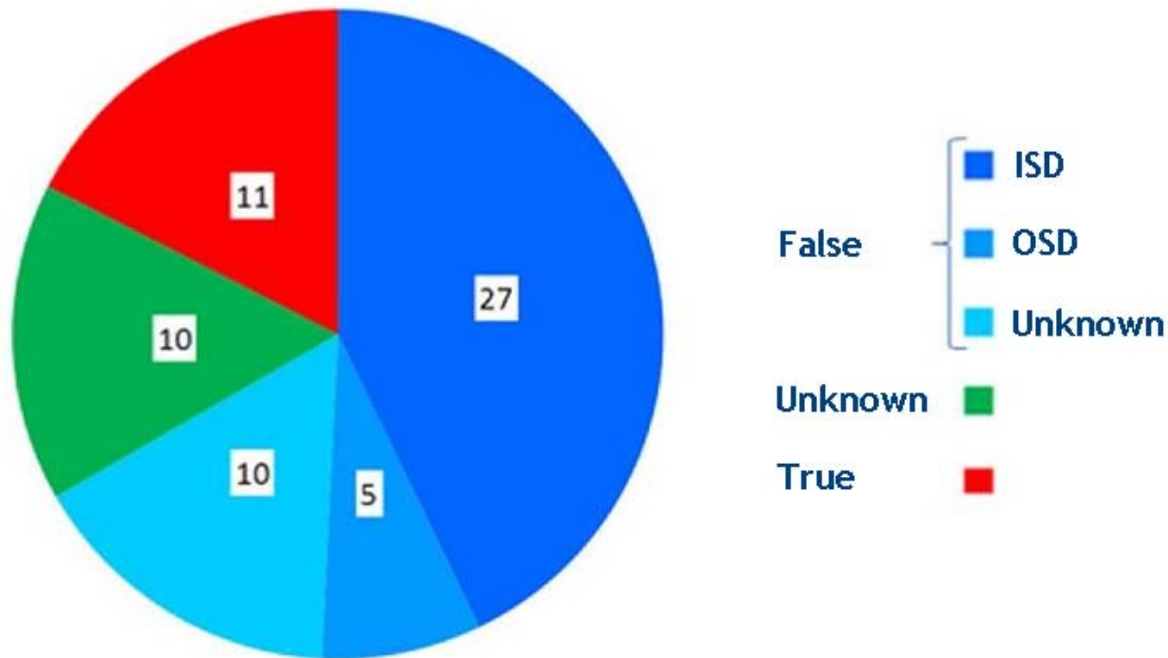
# AVIONICS SMOKE CAUTIONS KNOWN TO AIRBUS

63 cases of avionics smoke caution have been reported on A320 family aircraft since 1996. The repartition between true and false detections is given in the chart below. For false detections, the type of detector, ionic (ISD) or optical (OSD) is also given.

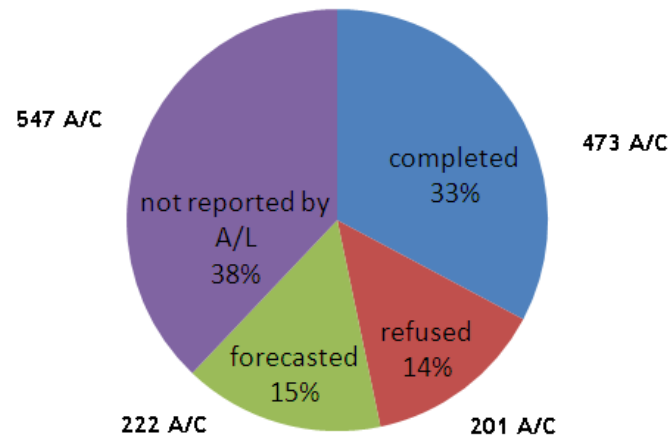
## Retrofit Status known to Airbus

- Optical Smoke Detector (OSD) PN CGDU2000-00 was introduced in production on MSN 1523 (delivery July 2001) to replace former Ionic Smoke Detector.

- Optional SB 26-1052 “FIRE PROTECTION – AVIONICS COMPARTMENT SMOKE DETECTION – INSTALL AN OPTICAL SMOKE DETECTOR”:
- Covers the installation of OSD by retrofit fleetwide (1443 aircraft)
- Issued 30-Aug-2001

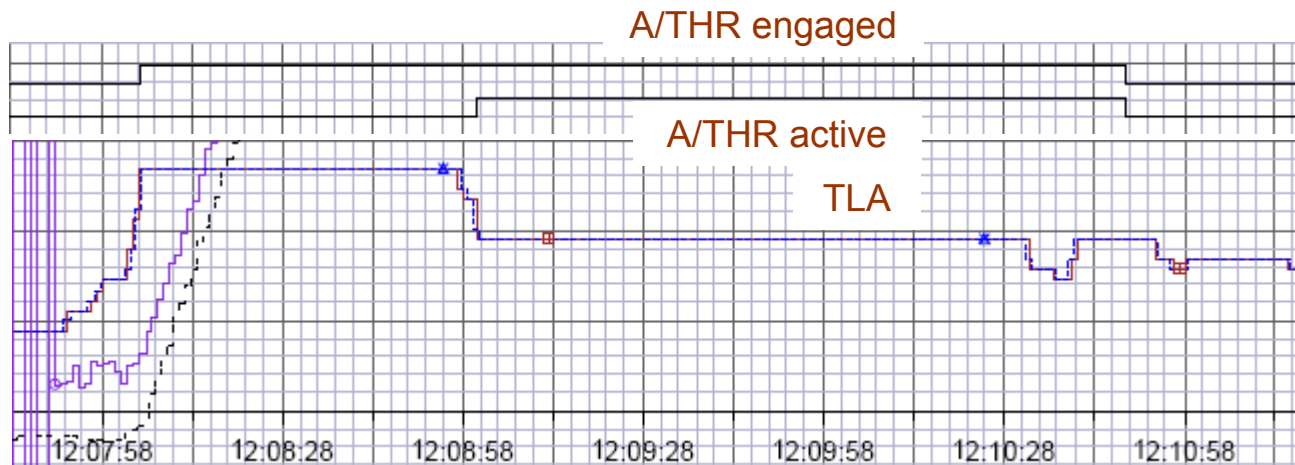
- During the incident flight:
  - ATHR engaged when the thrust levers were advanced to FLEX.
  - A/THR became active when the thrust levers were moved to CLIMB.
  - Both A/THR engaged and A/THR active switched to 0 at the same time.
  - DFDR data alone cannot confirm the reason of disengagement.
    - Manual disconnection suspected due to actions on the thrust levers.
