ATTACHMENT 3

AIRWORTHINESS GROUP CHAIRMAN'S FACTUAL REPORT

LAX-02-GA-201

NON-DESTRUCTIVE INSPECTION OF WING SECTION AREAS OF EXTERNAL DOUBLER PANELS LOCATED TO EITHER SIDE OF CENTER WING STATION 61 LEFT

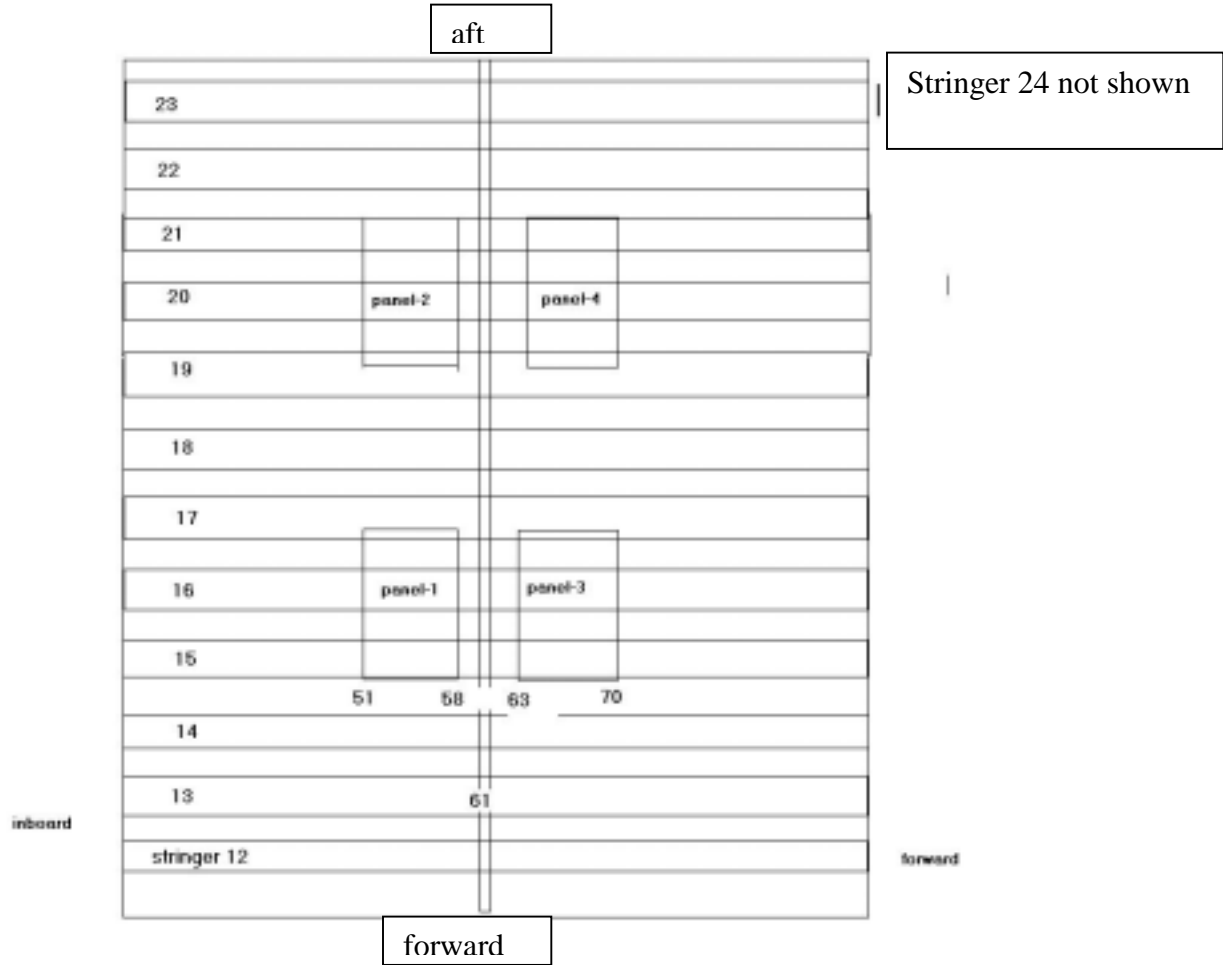
Approximate panel locations looking downward from side of stringers

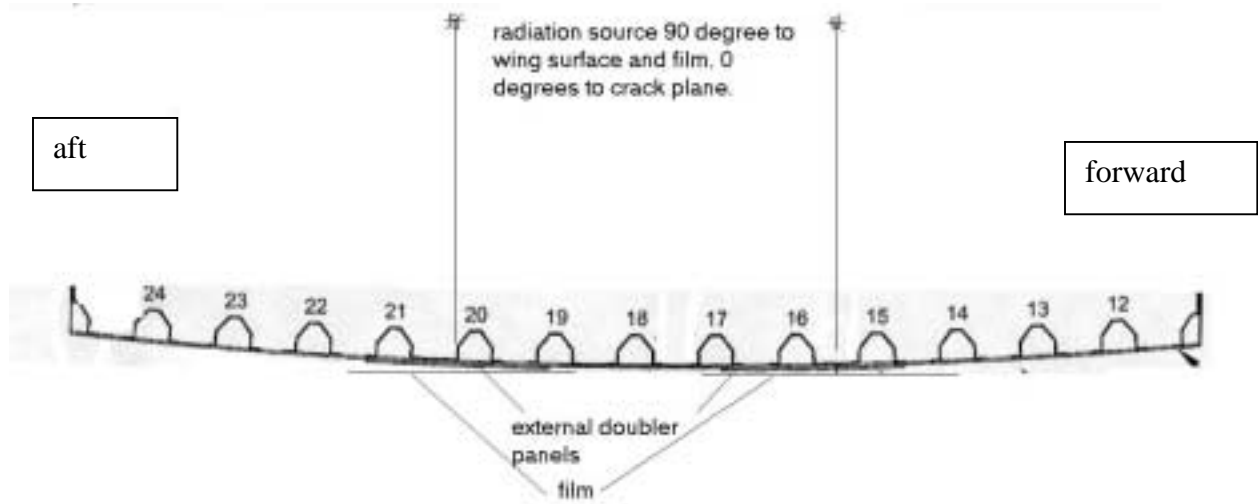
Figure 1

Radiographs were taken with the film in contact with the lower wing skin panels on the under side of the wing. The X-ray tube was positioned on the stringers side. (See Figure-1 and photo-1) Focal film distance was from 48" – 52". All exposure values are as follows. (See Table-1)

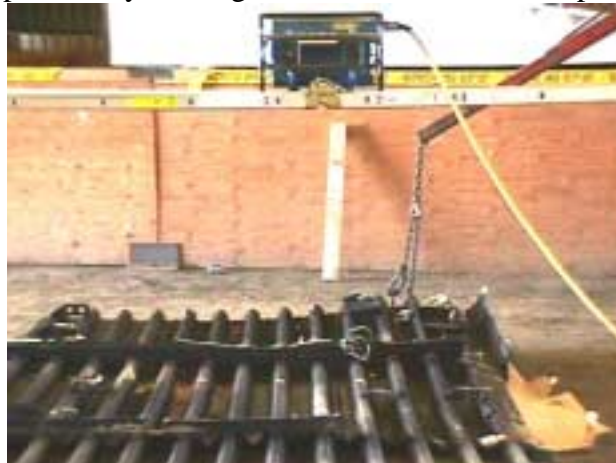
Photo-1 typical set up for x-ray of wing skins at external doubler panels

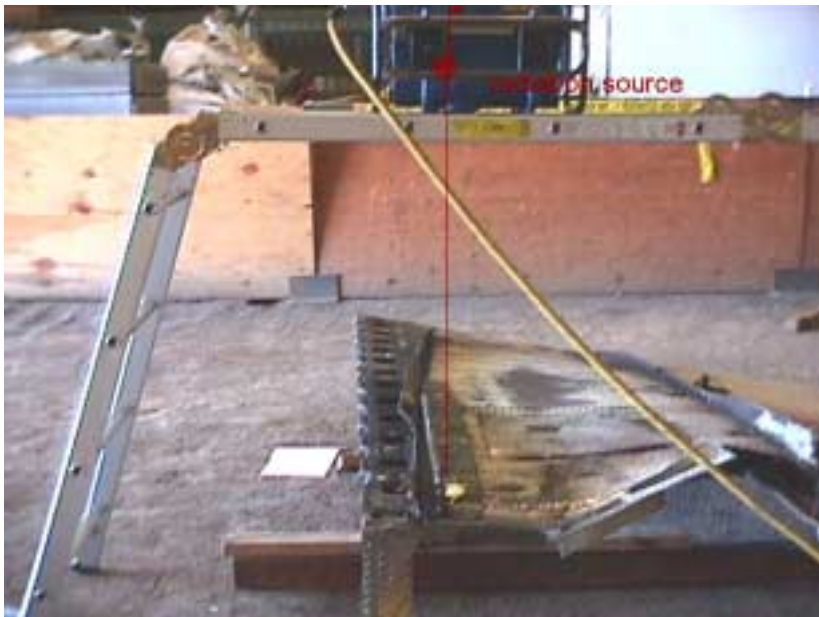
X-rays were taken to each side of the attach drag angle at wing station 213L from the forward edge back to the end of the external doubler at stringer 18. X-ray film was placed on the stringer side of the wing surface against the stringer flanges and the wing panel. The x-ray source was placed below the wing surface at a source to film distance of 48" to 52" and at near perpendicular 90 degrees to the surface and the film along each side of the attach drag angle. X-ray exposure parameters were 105 – 125 KV for 4 minutes 5ma (20 milli ampere minutes) This procedure was repeated on each side of the attach drag angle and between every pair of stringers from the leading edge and stringer 12 to the forward flange of stringer 18. (See Photo 10 and Figure 7)

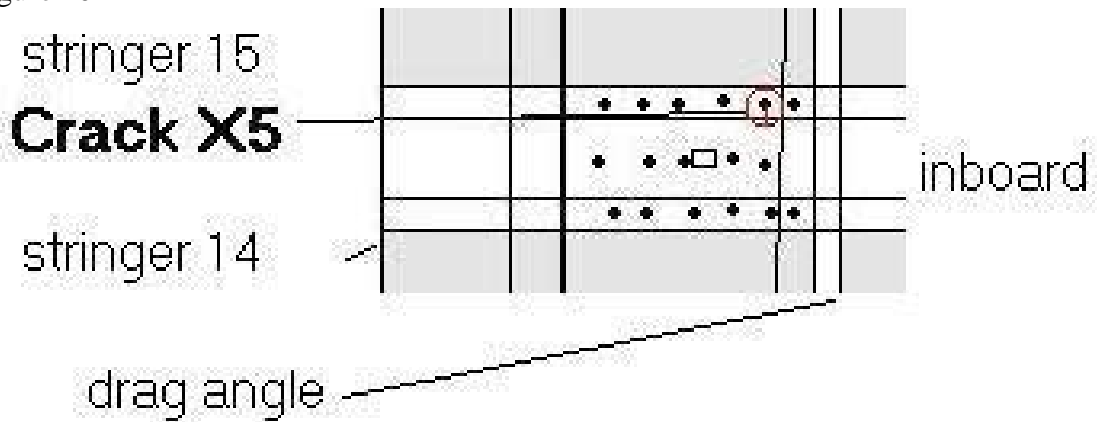
Figure 10

Crack X5 extends from forward from the second fastener hole outboard of the attach angle under stringer 15 flange. Crack length is .120" (see Photo 11 and Figure 8 and 10)

Additional work proposed for the area of the doubler around wing station 213L The drag angle should be removed and further inspection be performed to determine if the cracks are in the wing panel or the doubler.
