NATIONAL TRANSPORTATION SAFETY BOARD
Office of Aviation Safety
Washington, D.C. 20594

AIRWORTHINESS GROUP CHAIRMAN'S FACTUAL REPORT

NTSB No: LAX-02-GA-201

Location: Walker, California
Date: June 17, 2002
Time: 1445 Pacific Daylight Time
Aircraft: United States Department of Agriculture Forest Service Lockheed C-130A
"Hercules", N130HP

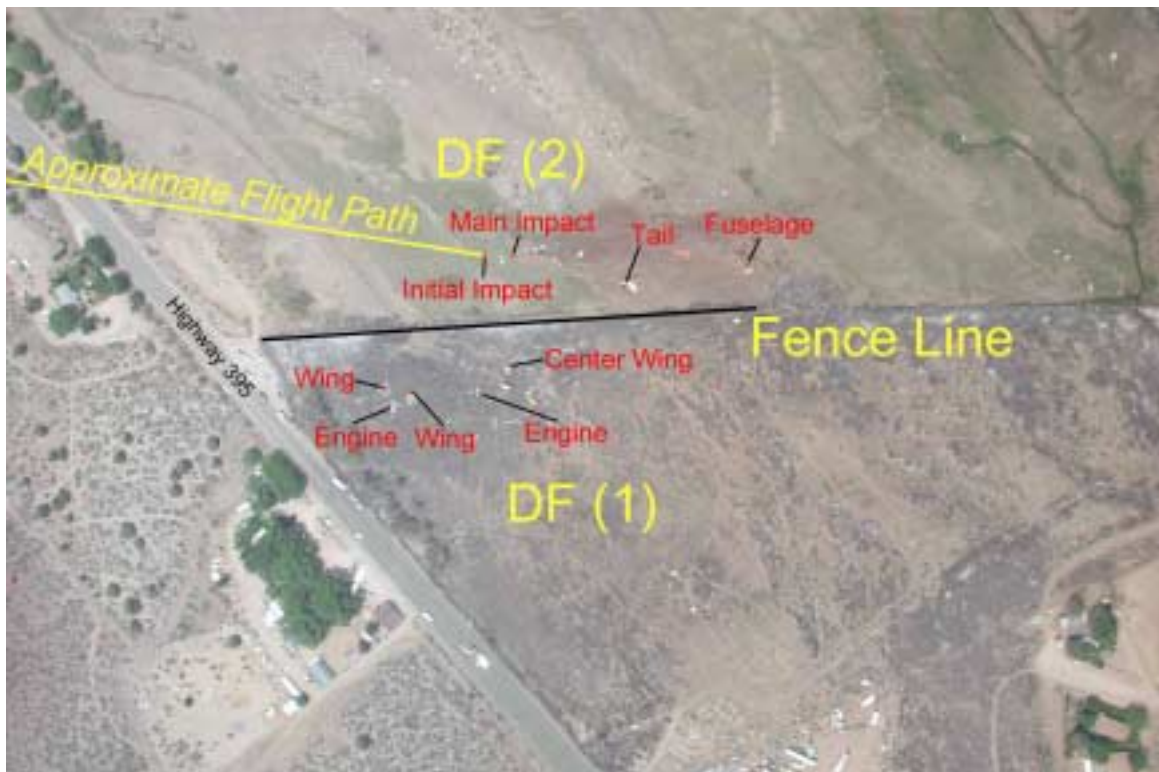
PHOTO 1: AERIAL VIEW OF WRECKAGE SITE — DEBRIS FIELDS (1) AND (2)

Using a hand held Global Positioning Satellite (GPS) receiver, the location of the crash site was determined to be at a latitude of 38° 31' 13.53" N (north) and longitude of 119° 28' 53.33" W (west) at a field elevation of 5,350 feet mean sea level. The majority of the airplane came to rest east of Highway 395 spread over two distinct debris fields (DF), DF (1) and DF (2), that were divided by a property fence line (Photo 1). The more southerly debris field, DF (1), was where the engines, the propeller assemblies, the outer wings, and the majority of the recovered center wing pieces came to rest. The trees, shrubs, and bushes within DF (1) exhibited fire damage and the soil was scorched. The more northerly debris field, DF (2), was where the cockpit, fuselage, and empennage came to rest. The trees, shrubs, bushes, and soil within DF (2) exhibited little signs of fire damage and were covered with the red fire retardant slurry. No large pieces of the fuselage or cockpit area were recovered except for a section cargo of flooring identified to have been located just aft of the cockpit.

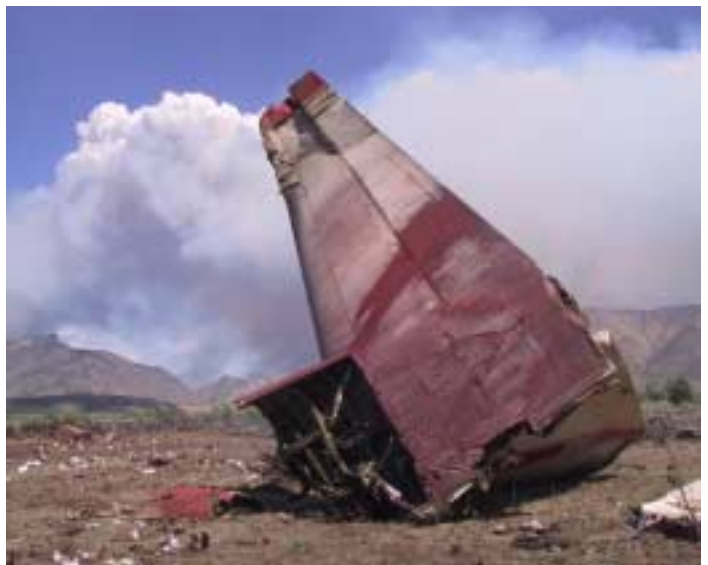
PHOTO 7: EMPENNAGE/TAIL SECTION

The empennage/tail section was found separated from the rest of the airplane and was lying on its' right side (Photo 6). The empennage/tail section had separated in-line with the upper escape hatch attachment. Both the cargo door and the ramp were found detached from the airplane structure. The right horizontal stabilizer was fractured at the root of the vertical stabilizer while the left horizontal stabilizer remained intact, with the counterweight still attached, but the outer tip exhibited impact damage (Photo 7). The entire left horizontal stabilizer tip was bent downwards and the leading edge of the outer tip was bent aft and the skin was compressed. The vertical tail was intact but exhibited some impact damage. A hole was observed on the right side near the middle of the rudder; however, the hole did not pass through to the left side. The lower rudder surface near the horizontal stabilizers was pushed forward and deformed. Still attached to the empennage were the two elevator and rudder boost packs.

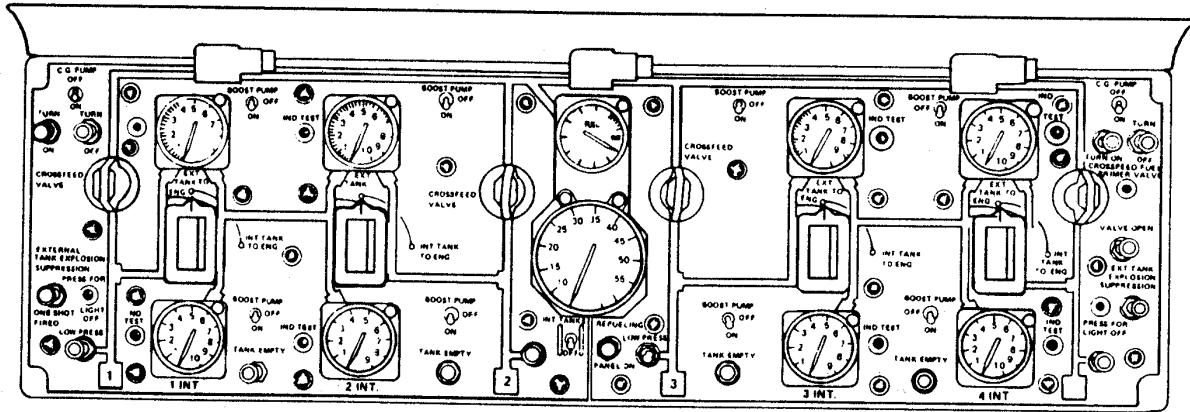
FIGURE 4: MAIN FUEL CONTROL PANEL

The main fuel control panel (Figure 4) was recovered heavily damaged with many of the gauges and switches missing and/or broken. The main fuel control panel is located on the cockpit overhead control panel. Fuel quantity gauges for the auxiliary tanks (external) are installed across the top of the panel. This airplane did not have any auxiliary tanks installed; therefore, the gauges were inoperative (covered). The fuel quantity gauges for the four main fuel tanks, the internal tanks, are installed across the bottom of the panel. There are four internal tanks, one tank located outboard of each engine. The tanks are integral units of the wings, using the upper and lower skin surface as tank walls. Each one of these main tank fuel quantity gauges are operative. The large gauge in the center of the main fuel control panel is the fuel totalize for the main fuel tanks. Table 1 lists the fuel quantity gauges still installed in the main fuel control panel and the quantity indicated. All the glass covers for those gauges that remained installed in the panel were either missing or broken.
