**NATIONAL TRANSPORTATION SAFETY BOARD
OFFICE OF AVIATION SAFETY
WASHINGTON, D.C. 20594**

**AIRWORTHINESS GROUP CHAIRMAN'S FACTUAL REPORT OF
INVESTIGATION**

NYC03MA183

Operator: Colgan Air
Aircraft: Raytheon Model 1900D
Location: Yarmouth, MA
Date: August 26, 2003
Time: 15:40 EDT

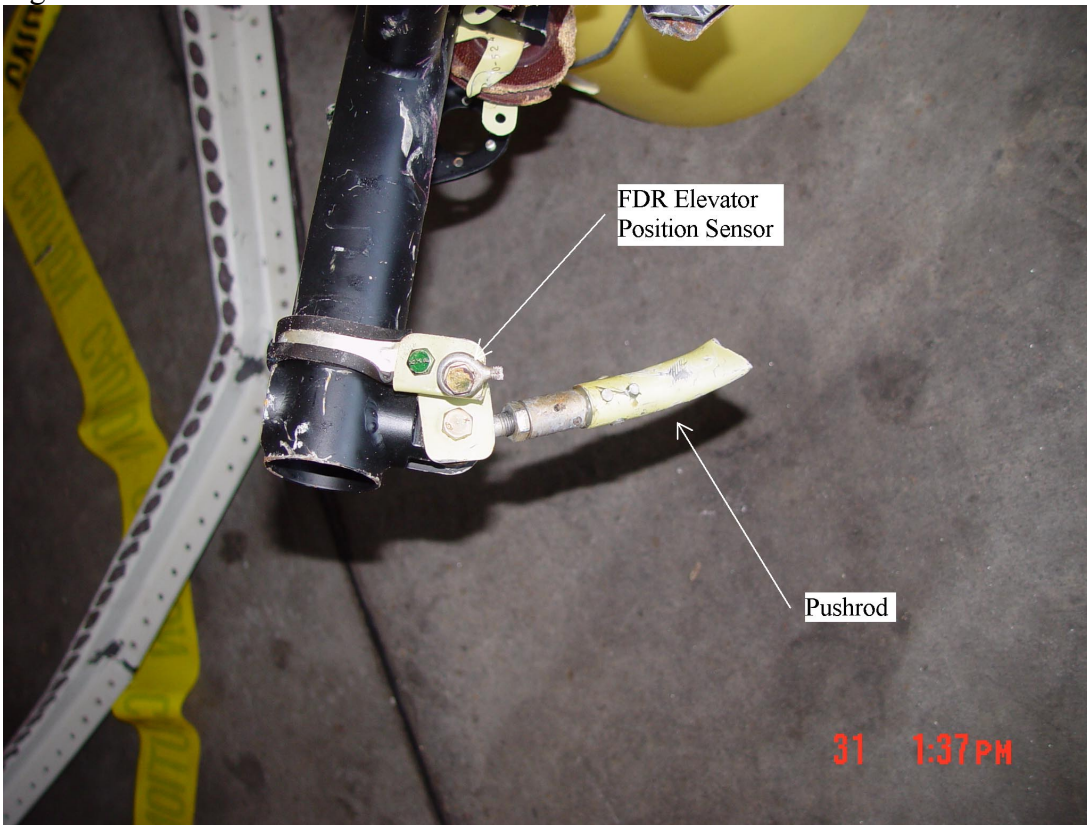
Figure 5. Elevator Pushrod and FDR Sensor.

The control column was recovered from the wreckage (Figure 4). The pushrod that connects the column to the forward bell crank was fractured, but a short segment remained attached to the column (Figure 5). The Flight Data Recorder (FDR) elevator position sensor rod was fractured. The rod end remained attached to the column. The position sensor and the other segment of the rod was found intact, attached to structure in the pedestal (Figure 6).

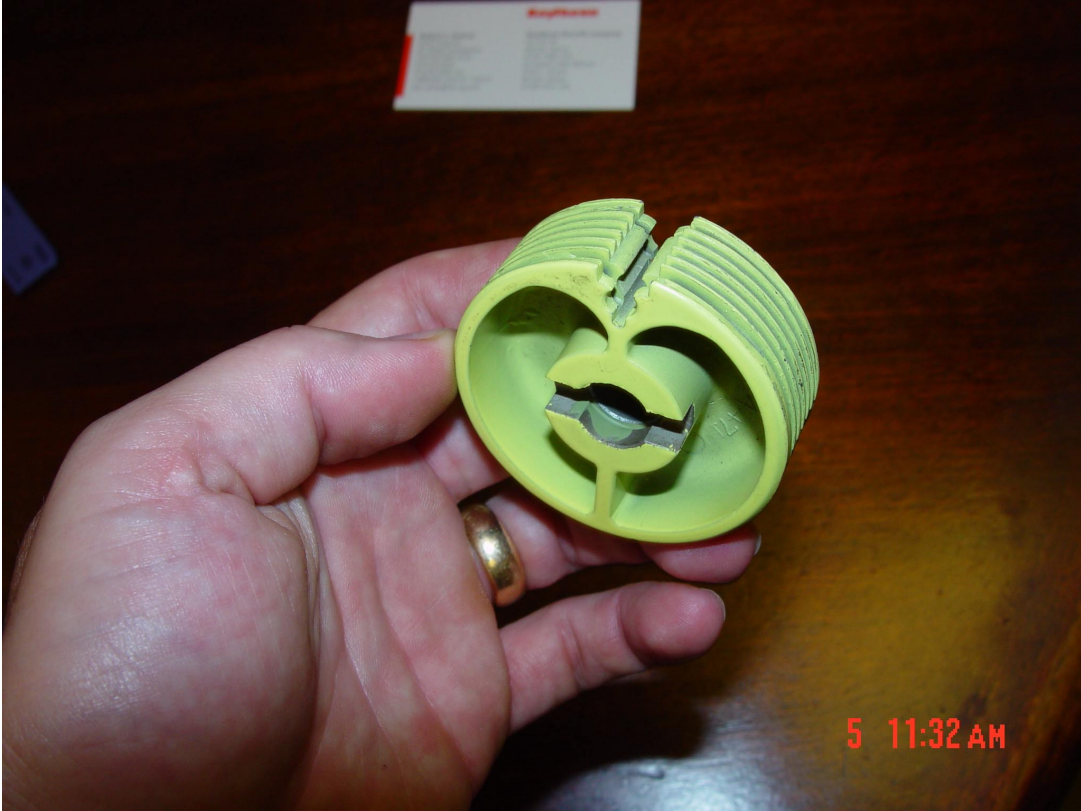
Figure 13. Picture of Slotted Side of a New Cable Drum.

It was observed that the Figure 15, maintenance illustration did not accurately depict the cable drum part. The illustration appeared to indicate that with the slotted side of the cable drum facing the installer, the cable with the LH threaded turnbuckle should start to the right in the illustration. If installed in this manner, the cable with the LH turnbuckle would come off the aft portion of the cable drum. The cable coming off the aft portion of the cable drum provides a nose down command to the actuator. However, Figure 17 showed that the LH threaded turnbuckle is on the “Nose up” side of the cable. Installing the cable on the drum in this manner would reverse the control to the trim actuator. Note that to reverse the control, the cables would have to

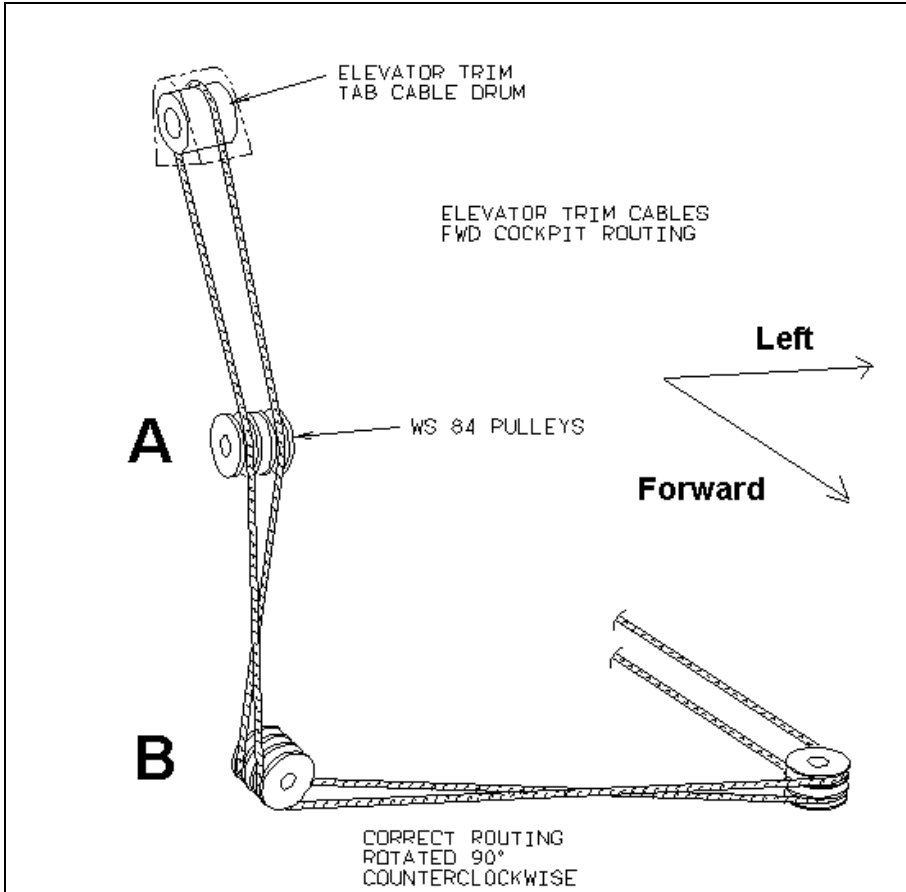
Figure 27. Correct Routing of Cables From the Pedestal.

Segments of the elevator trim cables were observed to exit the pedestal and pass through a set of pulleys shown in Figure 26. It was determined that these pulleys were the second set of pulleys from the cable drum shown in Figure 27, location B. The forward cable exiting the cable drum was routed over the aft pulley at location B. The pulleys at location A were not identified in the wreckage.

The cables were now observed to cross and rub in the area between the pedestal drum and the first set of pulleys. This 'cable cross' was worked past the first and second sets of pulleys. The cable cross was located between the second and third sets of pulleys for this evaluation (Figure 27). While attempting to connect the cable ends to the turnbuckles it was noted that the cable length did not allow one terminal end to reconnect. The forward cable system was moved a little and the connection was made. The cables were tensioned and the aft cable system block was removed.

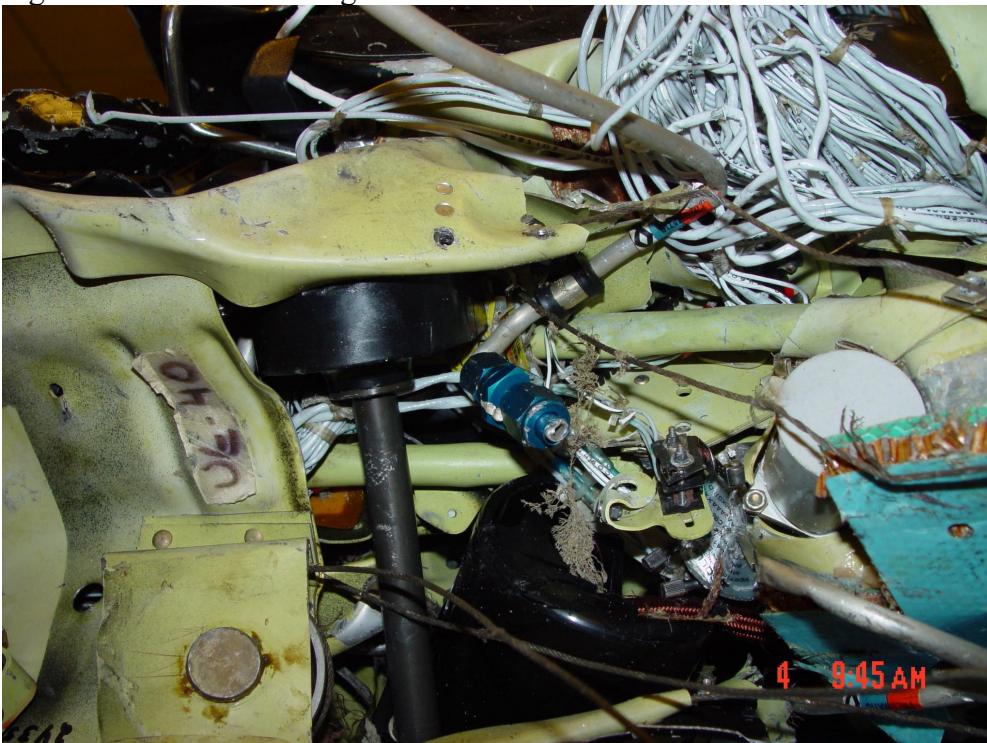
Figure 28. Elevator trim cable drum support and cover.

The panels surrounding the elevator trim drive chain and cable drum were cut away and the routing of these could be observed (Figures 28 and 29).

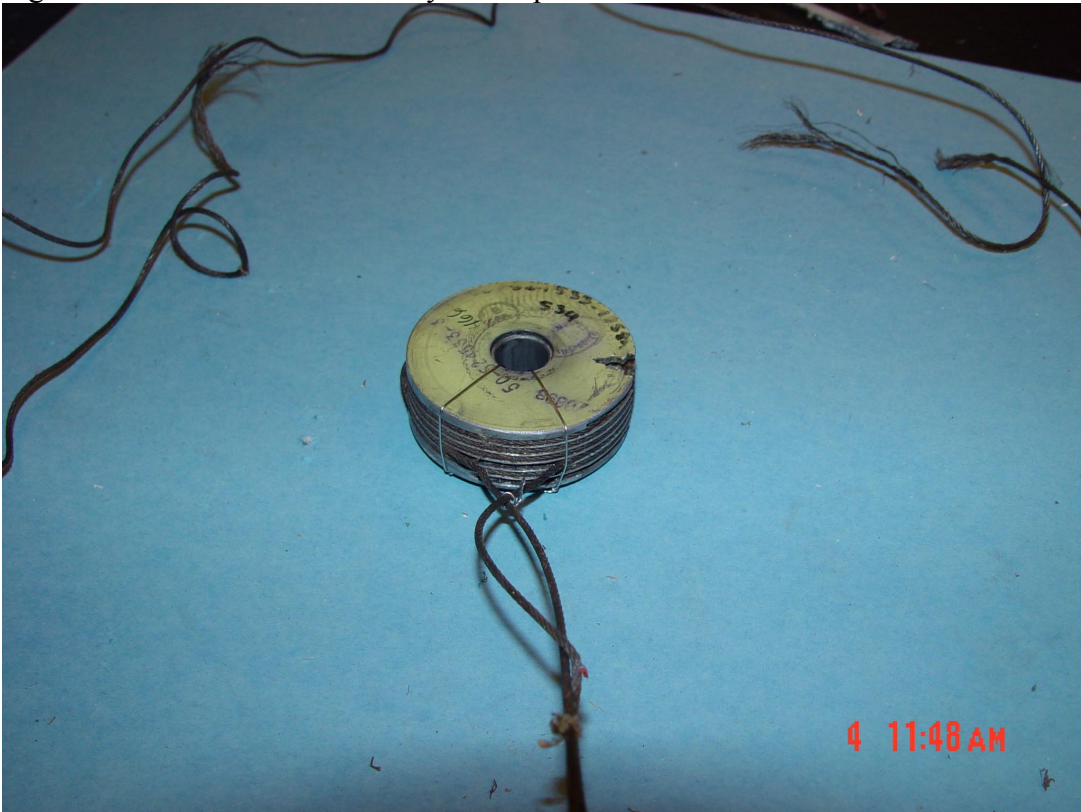
Figure 31. Cable drum with cables.

The cable drum and cable was removed from the housing and shaft (Figure 31)

The cable was removed from the cable drum. A permanent notch was evident where the cable lock pin (Fig. 15) was installed at the “Center” of the cable. The cable segment lengths were measured relative to the “Center”(Figure 32).

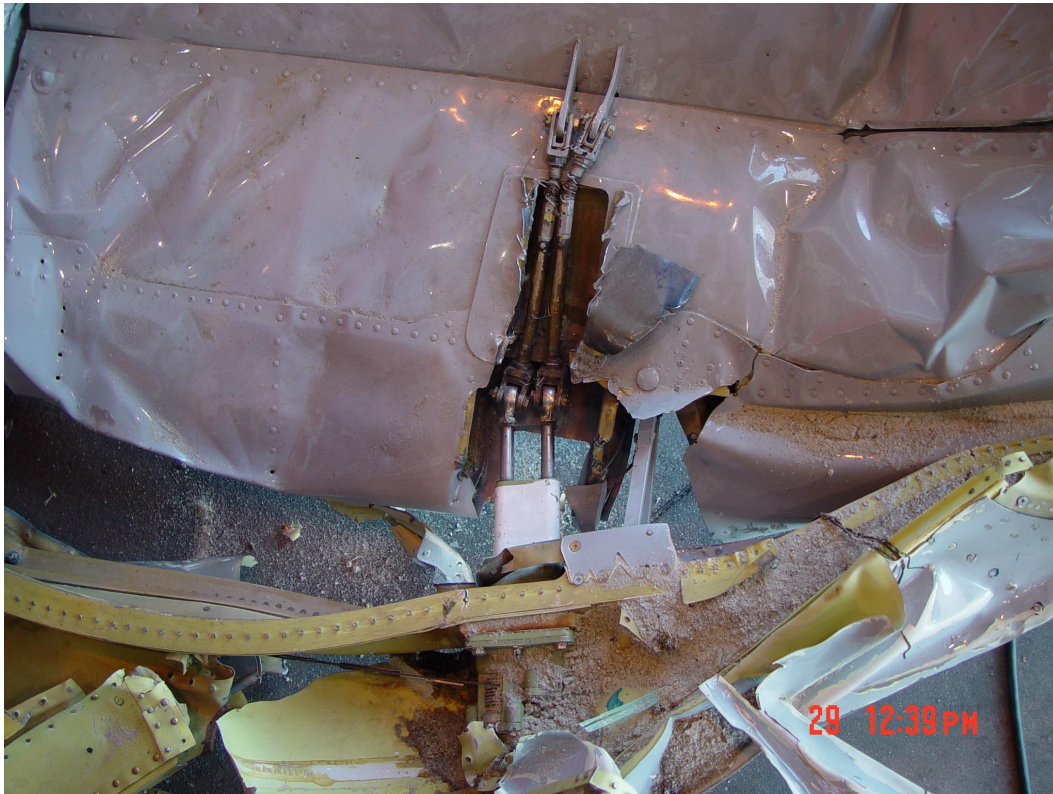
Figure 36. Right Elevator Trim Actuator.

The right trim actuator Figure 36, was identified as part number 129-526033-9, serial number 6-22-00-b. The distance between the actuator housing and the "Dogbone" was 2.14 inches.

The group checked the left side trim actuator by pulling on the top cable. The actuator extended, which would produce an airplane nose down effect. The right actuator was fractured and full of sand and could not be checked.

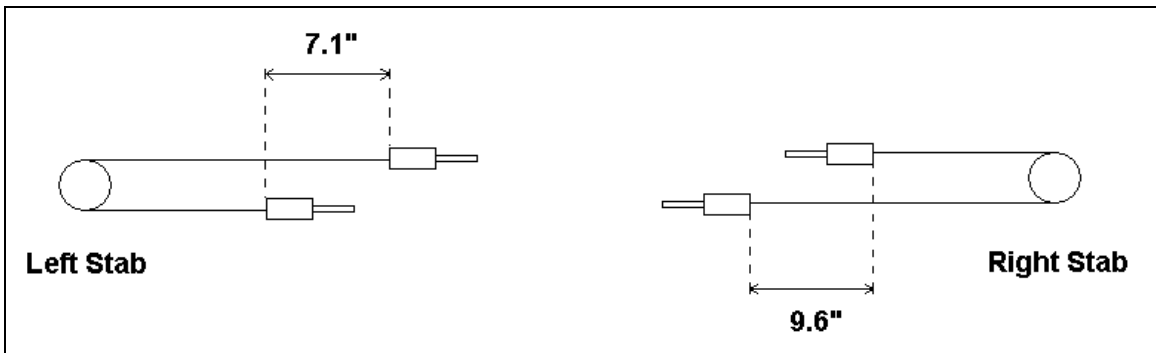
Figure 39. Position of turnbuckles at zero elevator tab deflection.

With the elevator tab at approximately zero degrees the following additional measurements were made (Figure 39)
