# **NATIONAL TRANSPORTATION SAFETY BOARD**

## **AIRWORTHINESS GROUP CHAIRMAN'S FACTUAL REPORT**

- A. ACCIDENT:** DCA08MA076
- LOCATIONS:** San Francisco International Airport, California
- DATE/TIME:** June 28, 2008, approximately 10:15 pm local time
- AIRCRAFT:** Boeing 767-281SF, N799AX

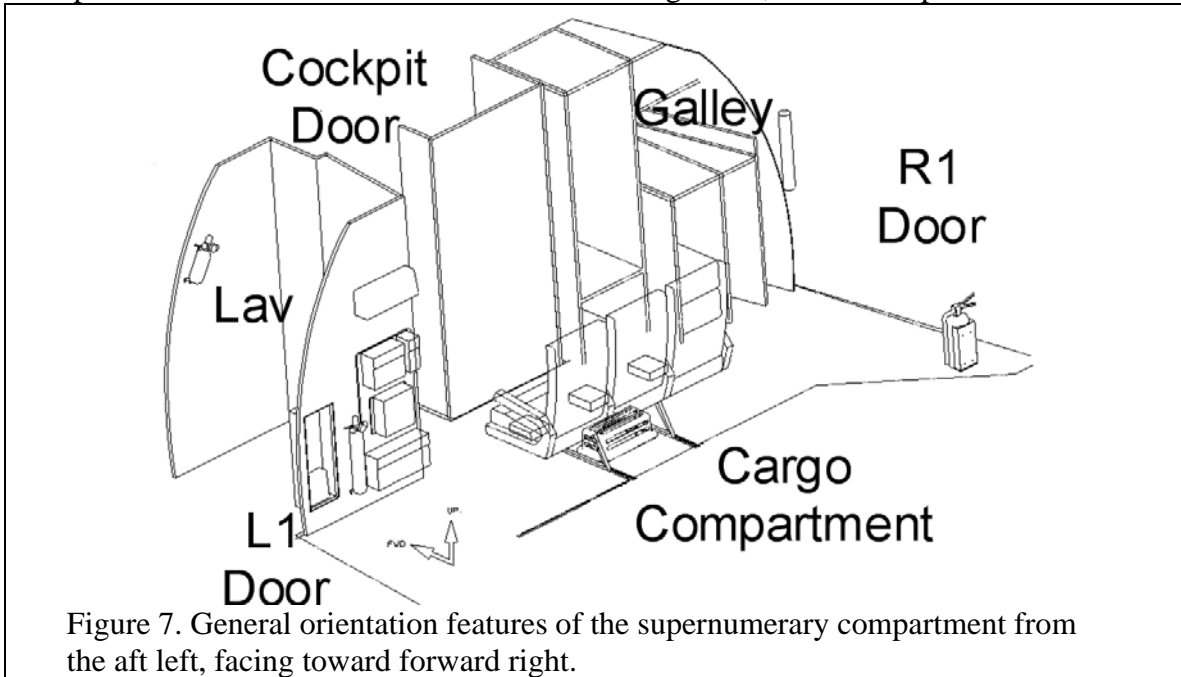
Figure 7. General orientation features of the supernumerary compartment from the aft left, facing toward forward right.

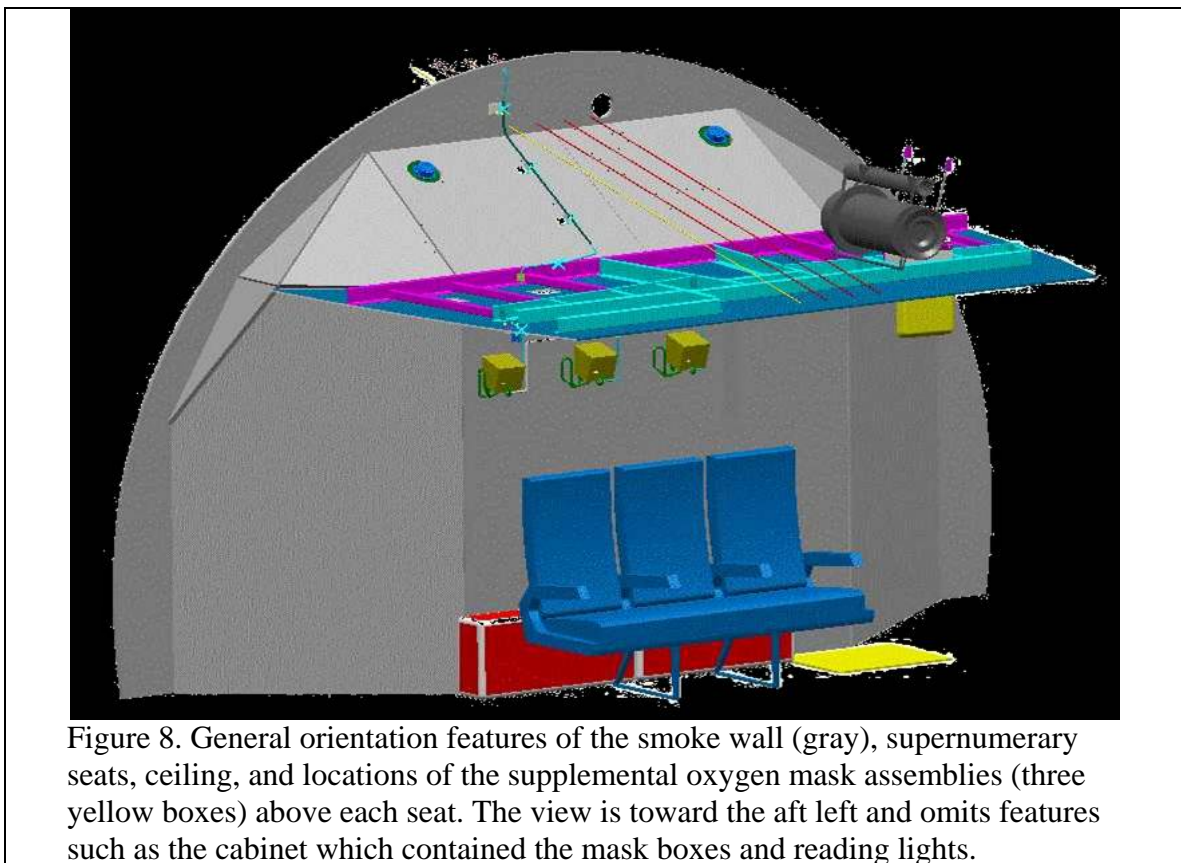
Figure 8. General orientation features of the smoke wall (gray), supernumerary seats, ceiling, and locations of the supplemental oxygen mask assemblies (three yellow boxes) above each seat. The view is toward the aft left and omits features such as the cabinet which contained the mask boxes and reading lights.

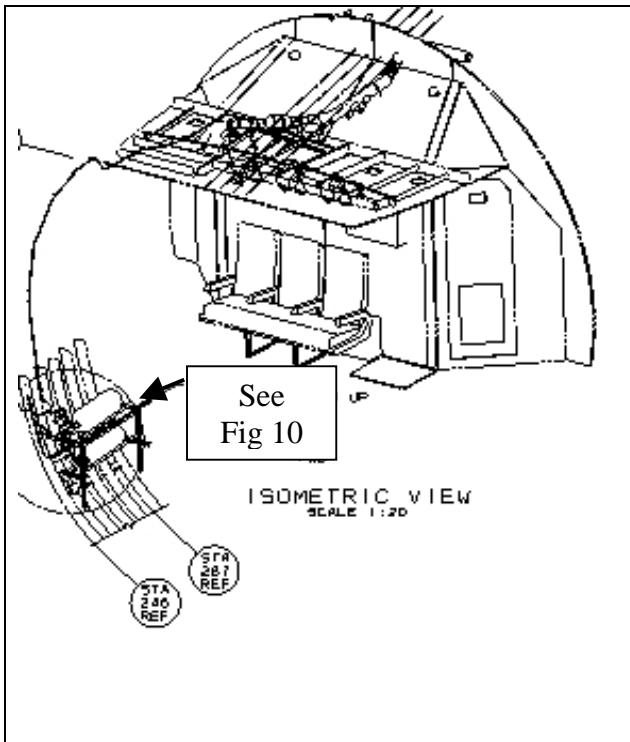
To supply oxygen to the supernumerary seats, rigid stainless steel metal tubing at a nominal 70 psi was routed from the pressure regulators near the cylinders, upward between the galley and aft right cockpit, then inboard above the main deck ceiling. The routing then was aft, slightly outboard of the supernumerary heating outlet and inboard of the forward R1 door track, then inboard to follow the forward station of the smoke wall. The metal line bent downward to a “T” fitting to service the right-most supernumerary installation, and branched to the center and left supernumerary installations. Directly above and slightly behind each of the supernumerary seats was a box-mounted, crew-type oxygen mask. The mask assemblies were generally similar to those provided for the pilots, although in the case of the supernumerary, the microphone wiring integral to the masks were not connected. (See Figures 9A, 10, and 11)

Figure 9. As viewed from the front left of the airplane, the drawing shows the routing of the supernumerary supplemental oxygen supply from the below-deck oxygen cylinders. The three supernumerary seats are shown.

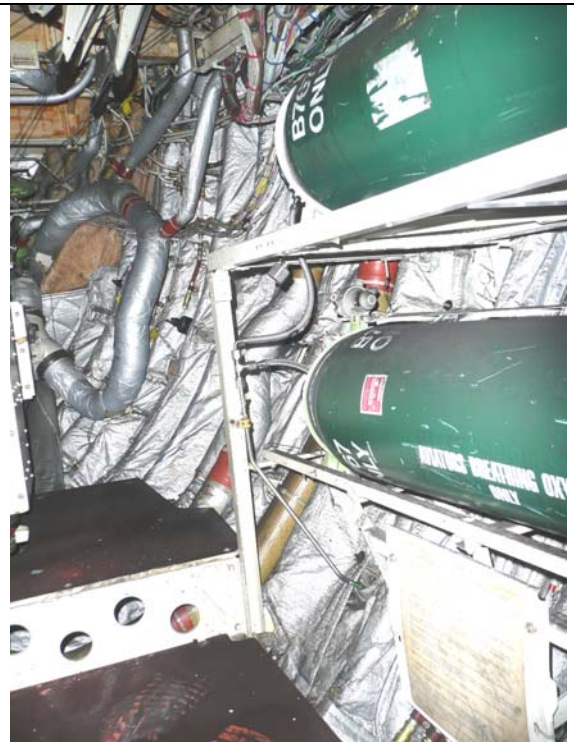
Figure 10. N799AX. The green oxygen bottles circled in Figure 9A are shown from the rear. The upper bottle supplied the supernumerary oxygen system. The top of this compartment is the cockpit floor and the nose landing gear compartment was to the left of this photo.

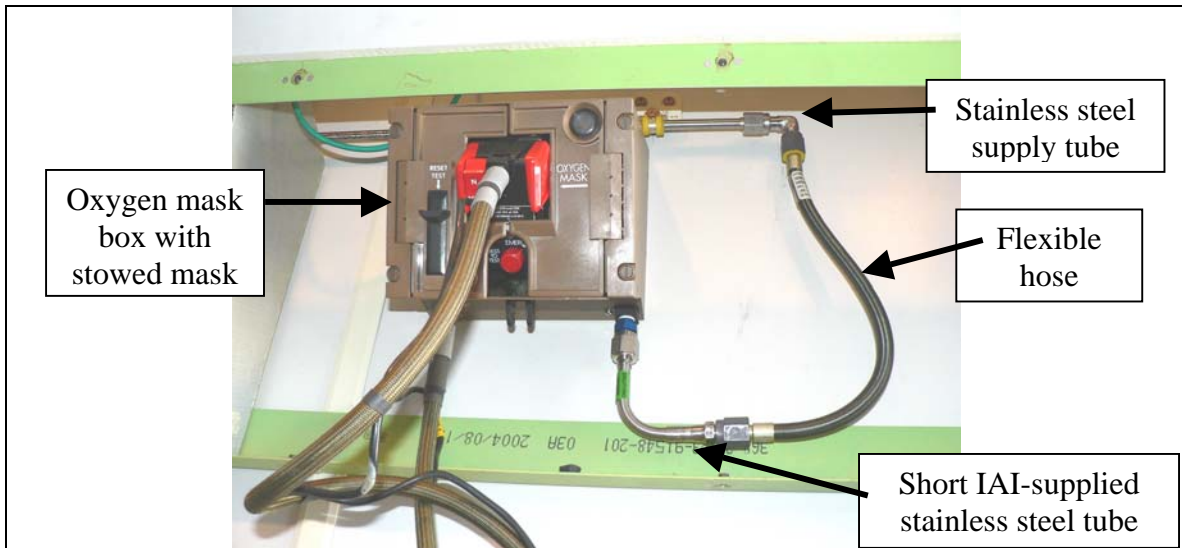
Figure 17. Exemplar airplane, showing the same supply tube and flexible hose visible in Figure 16. (Figure 16 was downward onto the components in this Figure.) This supernumerary mask assembly view was achieved by removing the front panel of the cabinet.

The nominal 70-psi supply to the mask arrives in the metal tube above the mask assembly box, then was routed to a Boeing part numbered flexible hose with stainless steel connectors. When the front of the enclosure was in place, the hose hanging at the bottom of the photo was laid in the box to not interfere with the person sitting in the supernumerary seat.

The short section of stainless steel tubing was a difference between the Boeing installations that investigators saw in the cockpit and the IAI-Bedek design in the supernumerary compartment. The Boeing installations found in the cockpit connected the flexible hose directly to the mask box. (See Figure 18)

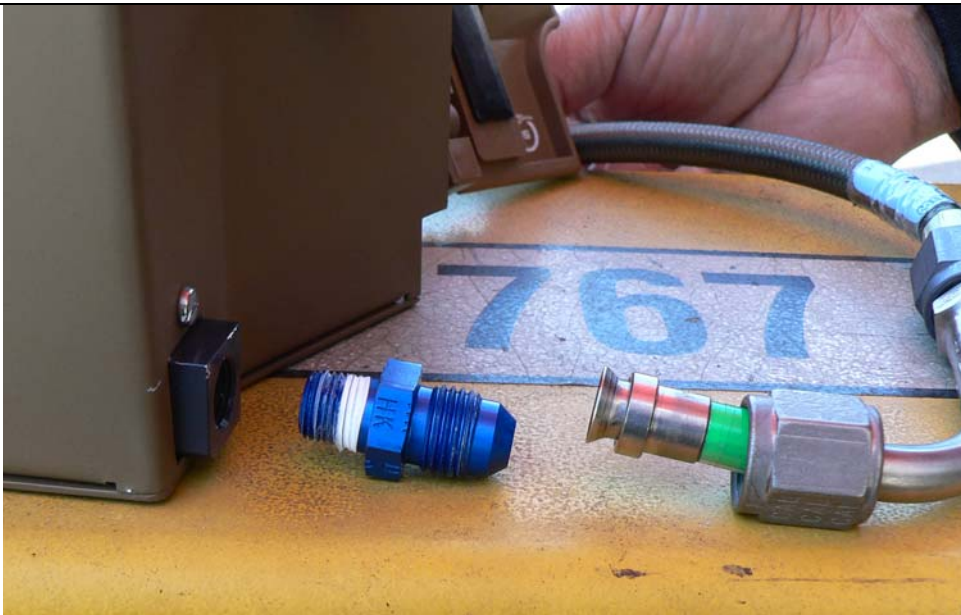
The supernumerary mask boxes (Part Number MXP-106-02) had been provided by Intertechnique-Eros.<sup>8</sup> The Captain's mask box had been manufactured under license from Intertechnique-Eros by Scott Aviation. The routing to the Scott-manufactured mask assembly box was less complex than those of the Eros assemblies. The flexible supply hose in the Scott-manufactured assembly attached directly to a fitting at the base of the mask box. In the Eros assembly, the stainless nut on the hose was routed to a stainless fitting on one end of the stainless elbow. The end of the elbow near the box had an aluminum nut to attach to a blue-anodized aluminum fitting. The fitting had an AN-flare at the end which attached to the elbow and a compression thread (also known as a pipe thread) at the end which attached to the box assembly. Rather than attaching directly to the hose assembly within the box, the Eros assembly used a square-shaped black-anodized fitting at the wall of the box and the hose assembly within the box connected to the black fitting. Teflon tape had been used on each of the three blue-anodized compression thread fittings. (See Figure 19)

Figure 19. N799AX: Parts required to connect the oxygen supply to the Eros mask box, as used in the supernumerary compartment.

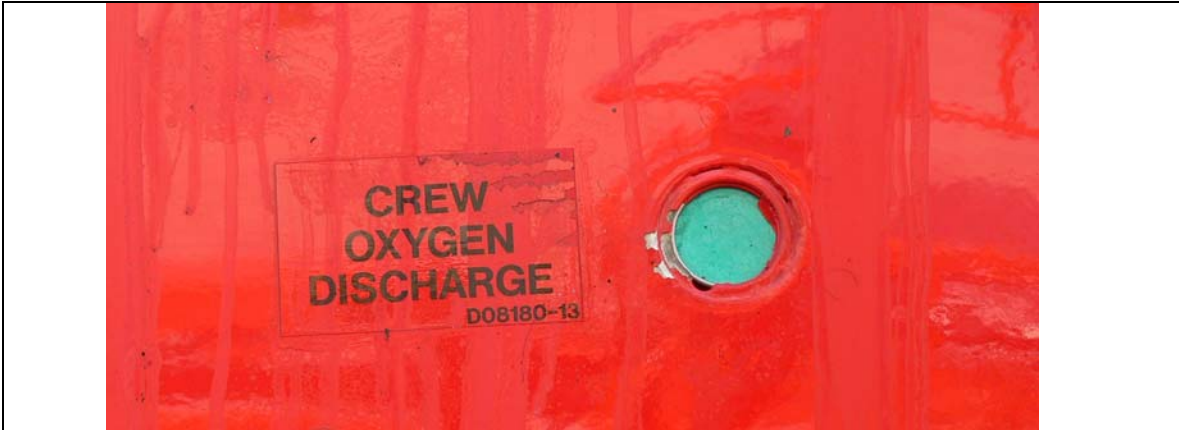
Electrical resistance between the supplemental oxygen system and the structure of the N799AX airplane was measured and the path of least resistance was found to be through a convolute high pressure oxygen hose (See Figure 22). No grounding straps were found between the supplemental oxygen system components and the airframe.

In the event of overpressure in the high pressure portion of the system, a green disc would open to vent the cylinder(s) overboard at 2850 psi. The vent had been located to the right of the nose landing gear and below the oxygen cylinders. The convolute hose in

the path to the housing of this green disc was Titeflex high pressure convolute oxygen hose p/n 96431-11, Boeing p/n 60B50060-11. (Ref. Figures 22, 26, 27)

Figure 26. N799AX: The exterior view of the overpressure disc, located to the right of the nose landing gear. The Titeflex convolute hose shown in Figure 22 was part of the routing to the interior of this port.

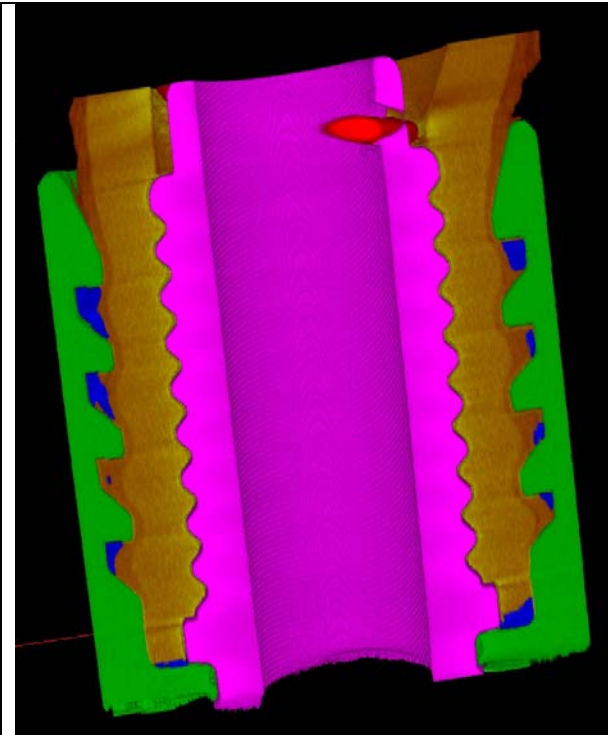
Figure 29. Exemplar airplane: Computerized tomography image of the sleeve on a typical hose end. This sleeve (green) is representative of all but one, in that it had serrations which were pressed into the pvc material (orange).

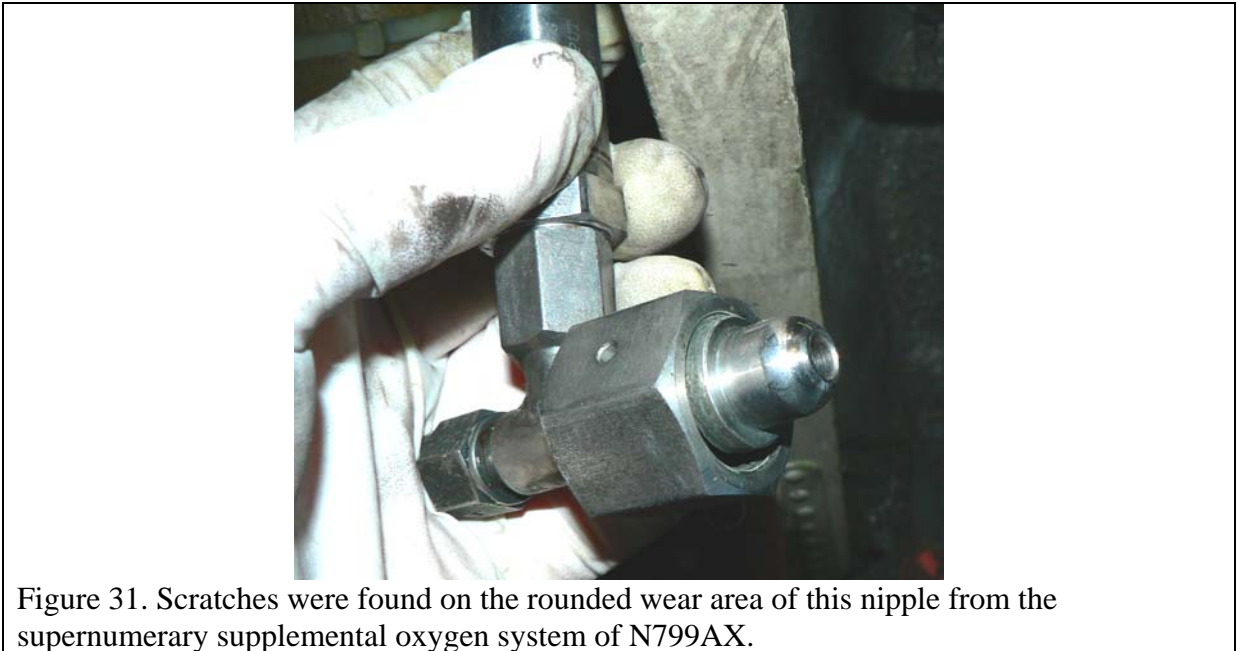
When at N799AX, investigators had attached the supernumerary nipple to the cockpit oxygen cylinder and the nipple had not leaked with cylinder pressure of about 1580 psig. (The test was performed outside of the airplane.) At AVOX, the supernumerary oxygen cylinder nipple was examined and found to have scratches which appeared minor, but which could be felt with a fingernail and seen. (See Figure 31)

During examination of the regulators at AVOX, the service history documentation for the sub-assemblies was reviewed. The supernumerary regulator had been overhauled in November 2007 after receipt from Delta Airlines, due to leakage at the nipple which had

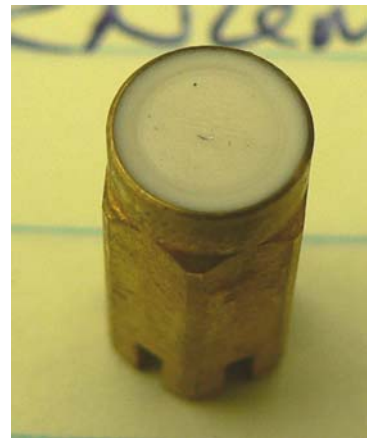
Figure 33. N799AX: The overpressure valve poppet from the supernumerary regulator

After disassembly, the interior area and components were clean and found to function freely against the spring assembly. The dark green/gray diaphragm had an ink-stamped manufacturing date of September 26, 2006, and the spring seat had a slip ring (plastic washer).

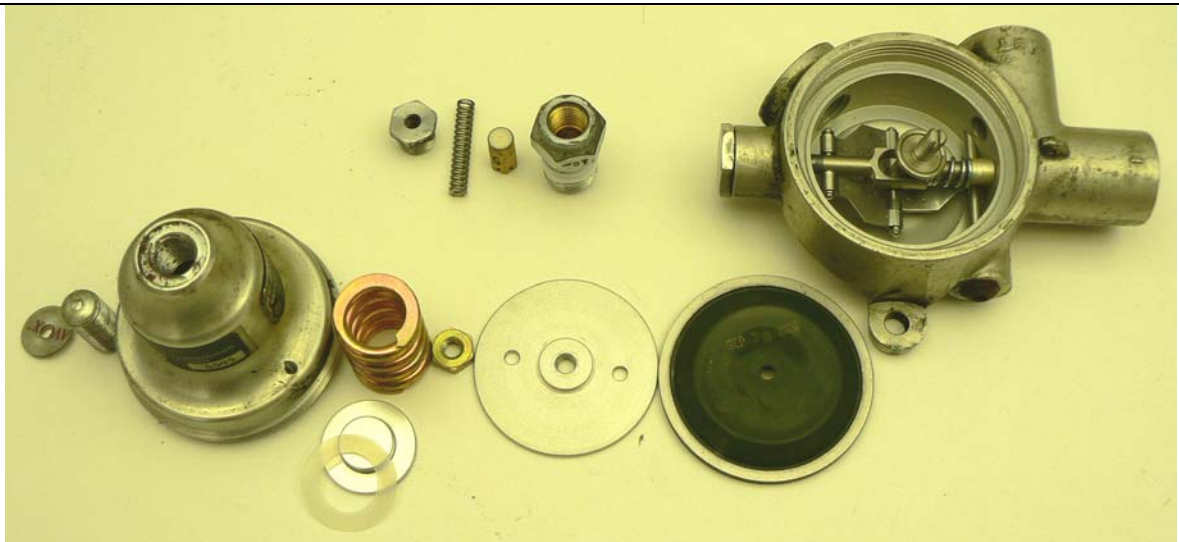
Engineering documents showed that the slip ring was added in October 1999 and the diaphragm material change from the previous light gray material was in June 2000. (Ref. Figure 34)

Figure 34. N799AX: Components of the regulator from the supernumerary supplemental oxygen system.

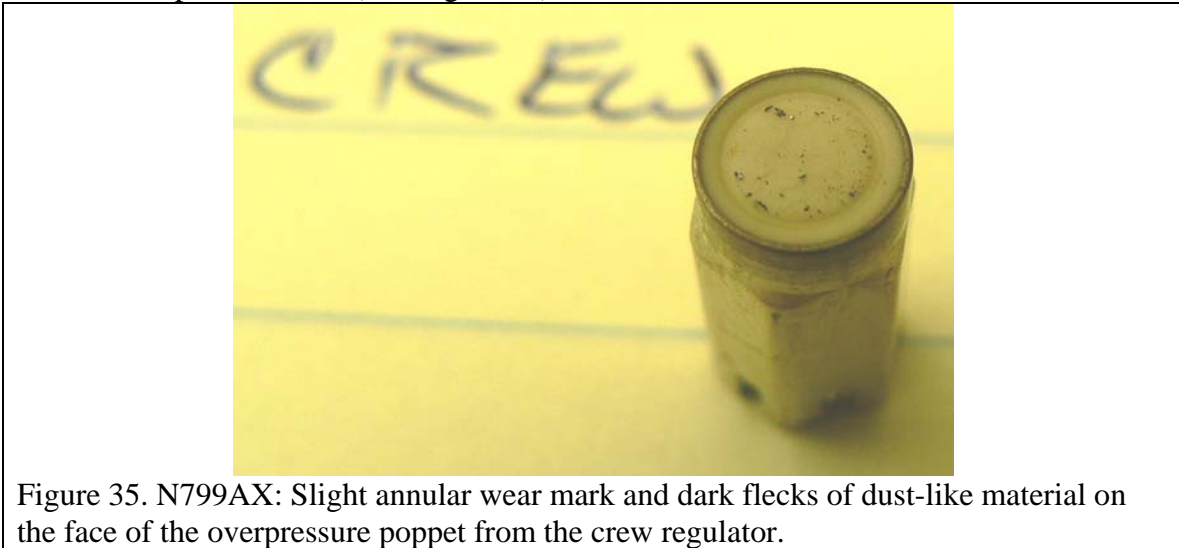
The overpressure valve began to release at about 100 psi, which was at/within the low specification limit, and re-seated at 90 psi. When disassembled, the plastic seat had a slight annular wear mark and several flecks of dark dust-like material which had not affected the performance. (See Figure 35)

After disassembly, the interior area and components were clean and functioned freely against the spring assembly. The diaphragm appeared to the AVOX personnel to be the light gray color which would have been used in 1985.

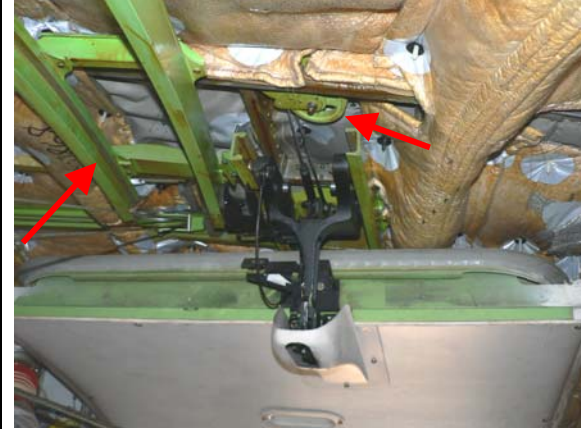
The L1 and R1 doors were several inches above the closed positions, with the L1 door higher than the R1. The exterior handles were ajar and not in the closed orientations. The tracks for the L1 and R1 doors were found twisted along the upper portions of the doors and melted away, higher than about 8-12 inches above each door. Two control rods for the L1 door mechanism had been consumed by fire. The counterbalance spring canisters had come apart and the canister for the L1 door was lying at the cockpit entrance. The pulleys for the doors that had been at the crown of the airplane were partially consumed and were in the fire debris near the floor, allowing the counterbalance cables to become slack. (See Figures 37 and 38)

Figure 37. Exemplar airplane: Photograph of the door when raised to the top of the tracks. The left arrow points to a track and the right arrow points to the counterbalance pulley.
