NATIONAL TRANSPORTATION SAFETY BOARD
Office of Aviation Safety
Washington, DC 20594

AIRWORTHINESS GROUP CHAIRMAN'S FACTUAL REPORT

A. **ACCIDENT**

Operator : SK Logistics d.b.a SK Jets
Aircraft : Bell Helicopter 206BIII [N5061M]
Location : Green Cove Springs, FL
Date : December 26, 2011
Time : 0554 EST
NTSB # : ERA12MA122

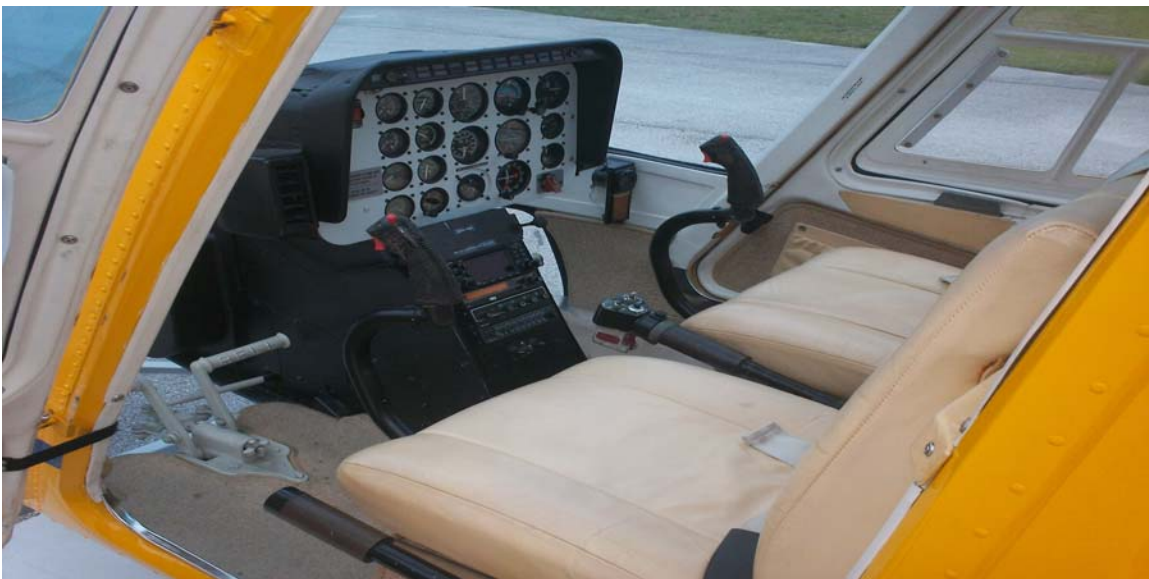
Photo 6: Instrument Panel

The majority of the airframe and the transmission was consumed by the postcrash fire. The center console and all instrument gauges were fire damaged. Fragments of windscreen, left and right chin bubble, and over head green house were located along the CDL. The forward and aft cabin seats and restraint systems were consumed by fire. Aft cabin doors were consumed by fire. Continuity of the flight controls could not be

The following instruments and navigation/communication, condition and position/reading are in Tables 1 and 2:

Tablet 1: Instruments		
Directional Gyro	Destroyed	-
Altimeter	Impact & Thermal Damaged	Baro Window at 30.22
Vertical Speed Indicator	Impact & Thermal Damaged	unreliable
Turn & Bank Indicator	Impact & Thermal Damaged	Left Turn
Attitude Indicator	Impact & Thermal Damaged	10 degrees nose above the horizon
Standby Compass	Impact & Thermal Damaged	unreadable
Main Rotor / Engine Speed RPM	Impact & Thermal Damaged	unreadable
Fuel Quantity Indicator	Impact & Thermal Damaged	unreliable
Engine Oil Pressure	Impact & Thermal Damaged	unreliable
Airspeed	Impact & Thermal	unreliable

Damaged	
Engine Temperature	Impact & Thermal Damaged	unreadable
% RPM Gas Producer	Impact & Thermal Damaged	14 percent
Turbine Out Temperature	Impact & Thermal Damaged	unreadable

Tablet 2: Navigation / Communication		
Intercom Control Unit	Impact & Thermal Damaged	Selector to Pilot ISO Position
Bendix/King, KMAA24H	Impact Damaged	Com 1 knob, HF Comm 1 & 2, Nav, & DME selected
King, KY 196 TSO, Radio Digital	Impact Damaged	Digital
Garmin GTX 328, Digital Transponder	Impact & Thermal Damaged	Digital
Garmin 430 GPS	Impact & Thermal Damaged	Digital
