# **NATIONAL TRANSPORTATION SAFETY BOARD**

## **AIRWORTHINESS GROUP CHAIRMAN'S FACTUAL ADDENDUM** **ENGINES AND THRUST REVERSERS**

**A. ACCIDENT:** DCA08MA098  
**LOCATIONS:** Columbia, South Carolina  
**DATE/TIME:** September 19, 2008  
**AIRCRAFT:** Learjet Model 60, N999LJ, S/N 60-314

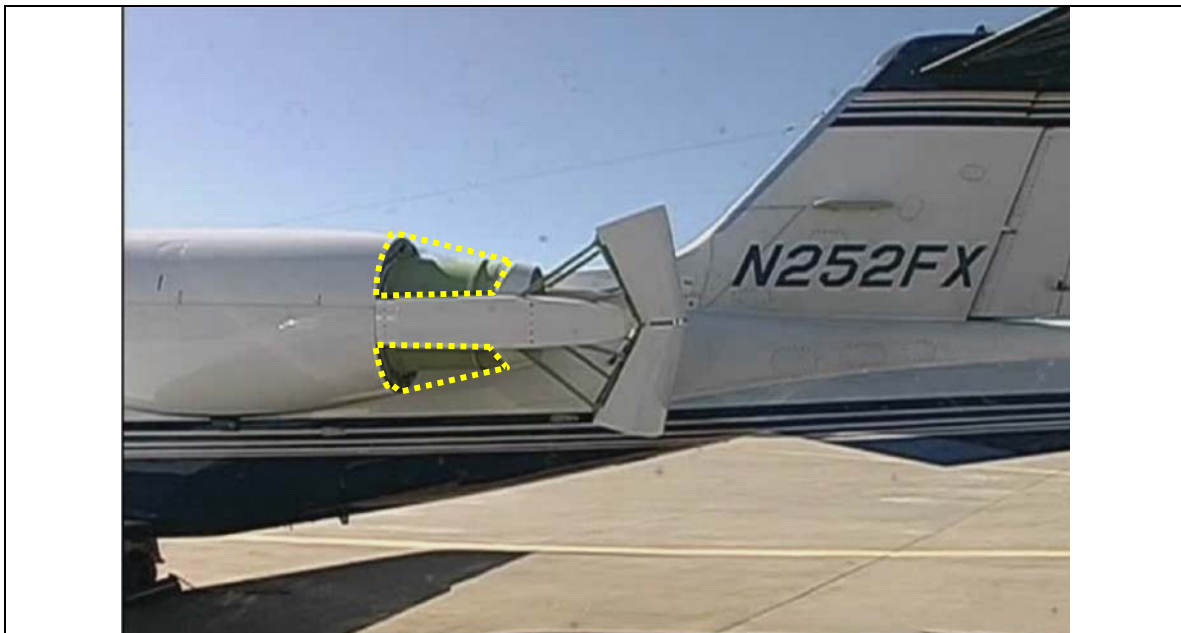
Figure 1. For reference and context of the following photographs, this shows the upper and lower thrust reverser doors in the deployed positions on a test airplane. The dotted lines show the stowed/closed positions for the doors, which can also be seen in Figure 2.

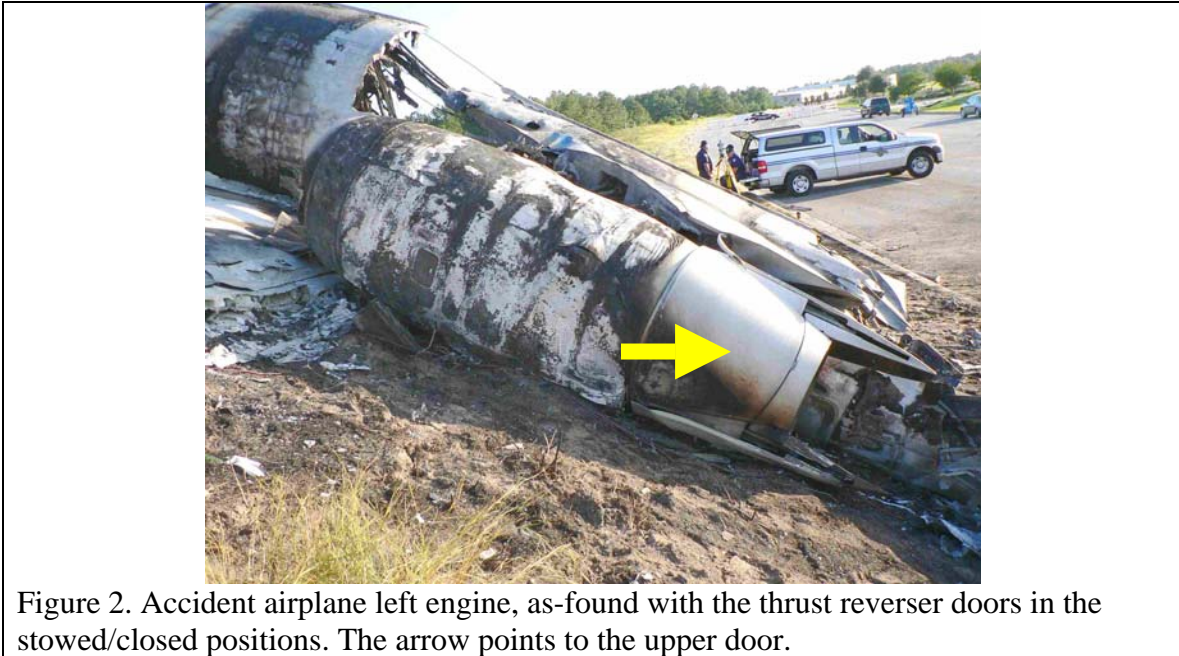
The engines were found loosely attached to the accident airplane and each had been fire damaged. The fire in the airplane center section had destroyed the integrity of the mounting structure and each engine was resting on the ground. The left engine T/R doors were found in the closed positions with external post-accident fire heat-damage. (See Figure 2) The doors had no dents, scuffs, or other damage consistent with impact damage in the open configurations.

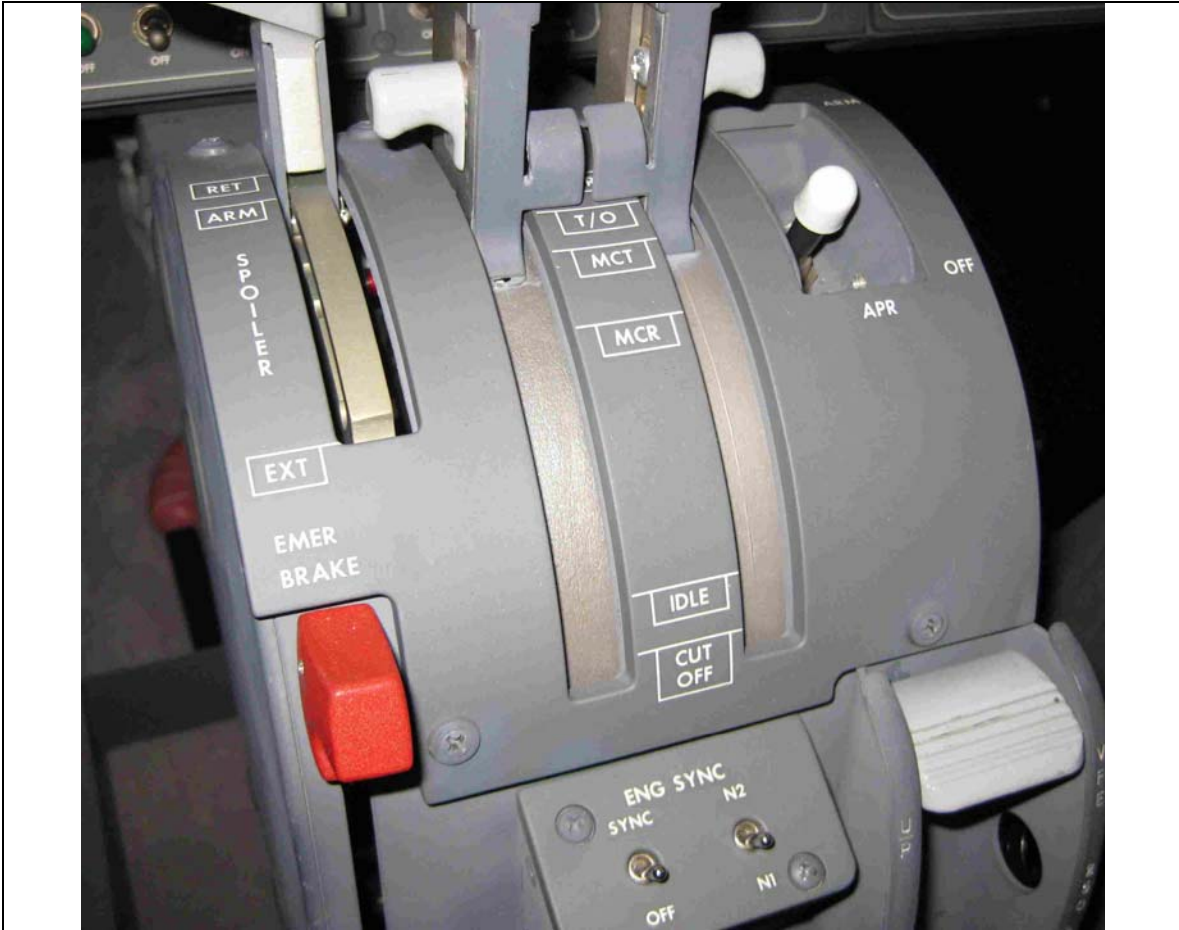
Figure 5. The throttle detent positions marked on the pedestal. The marked positions relate to the ranges shown in the next Figure. (Photo of airplane similar to N999LJ)

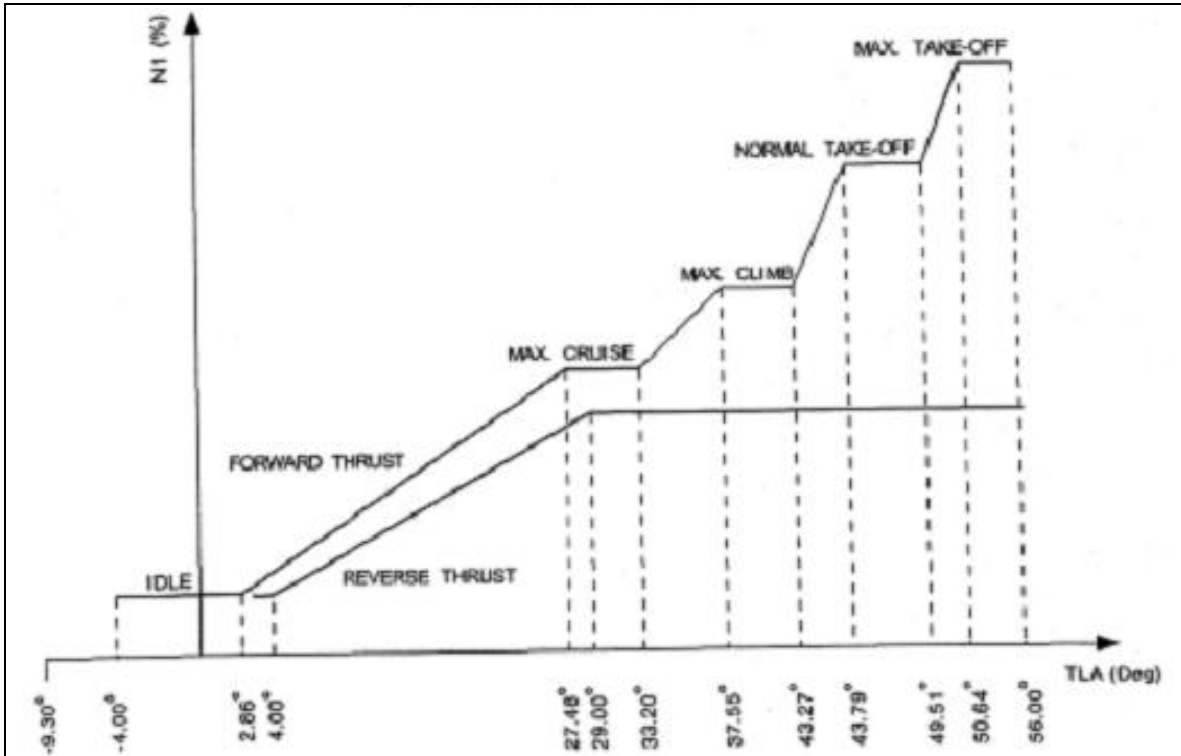
The Pratt & Whitney Canada PW305 Customer Training Manual (December 2000, page EEC 11.13) contained charts for the Lear 60 and Hawker 1000 to approximately depict the concept of forward fan (N<sub>1</sub>) speed (vertical axis) for both forward and reverse thrust lever angle (TLA) on the horizontal axis. (The Learjet 60 chart is shown as Figure 6.) The detented positions shown in Figure 5 relate to flat areas of the forward thrust schedule on the chart. These denote selections of cruise, maximum continuous thrust, takeoff power, and automatic power reserve (APR). Due to the lack of specific data on the vertical axis, this shows the relative relationships only, not actual specific data from an airplane. For example, at the reduced airspeeds consistent with take-off, the change in N<sub>1</sub> between the detents may be less than in the range leading to the first detent.

Figure 6. The PW305 Training Manual contained this chart that depicts forward fan (N1) speed (vertical axis) for both forward and reverse thrust lever angle (TLA) on the horizontal axis. The flat areas of the forward thrust schedule denote selections of cruise, maximum continuous thrust, takeoff power, and automatic power reserve (APR). Due to the lack of specific data on the vertical axis, this is not to scale and shows the relative relationships only, not actual specific data from an airplane.

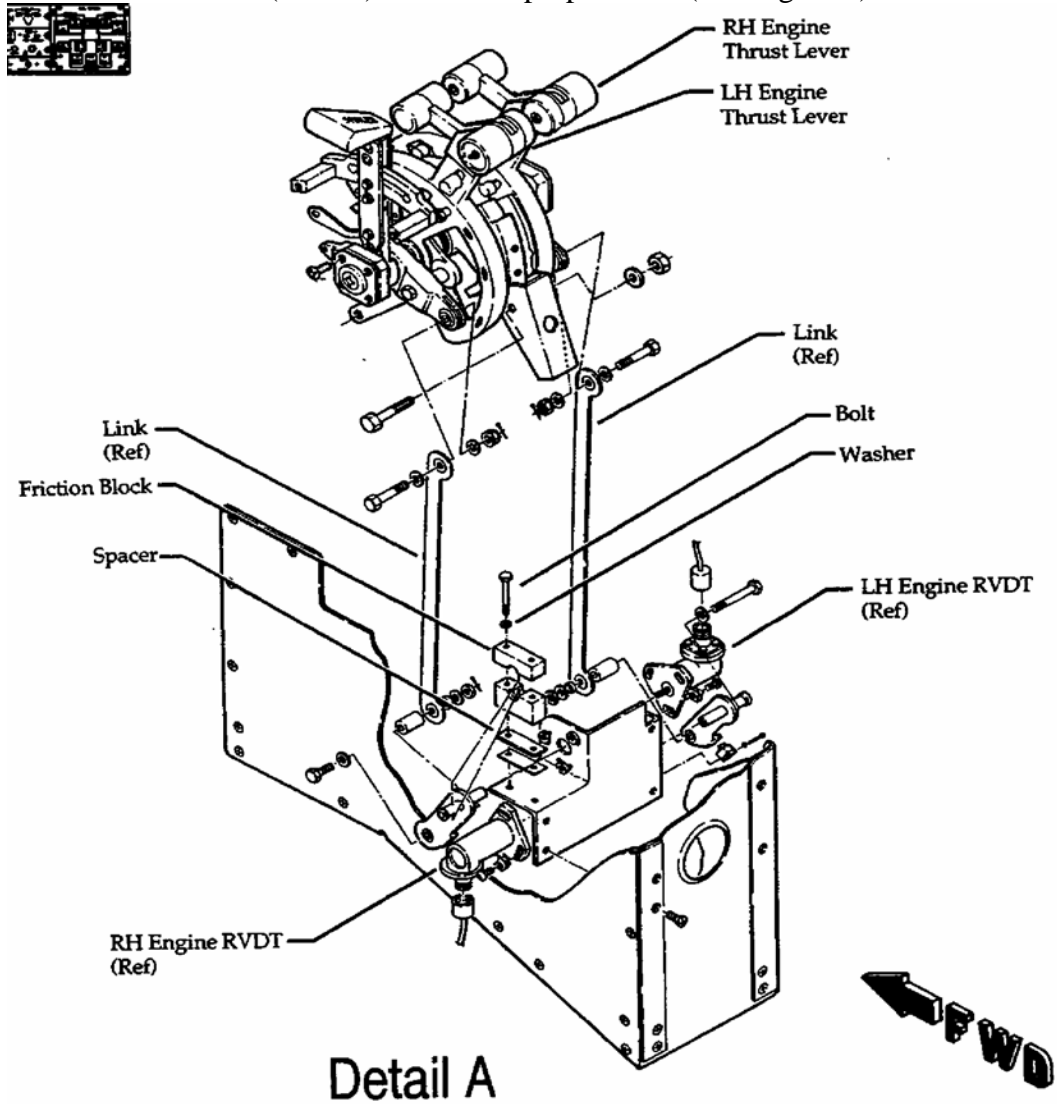
Figure 9. Cockpit thrust lever pedestal with RVDTs, per MM 76-10-00, page 204.

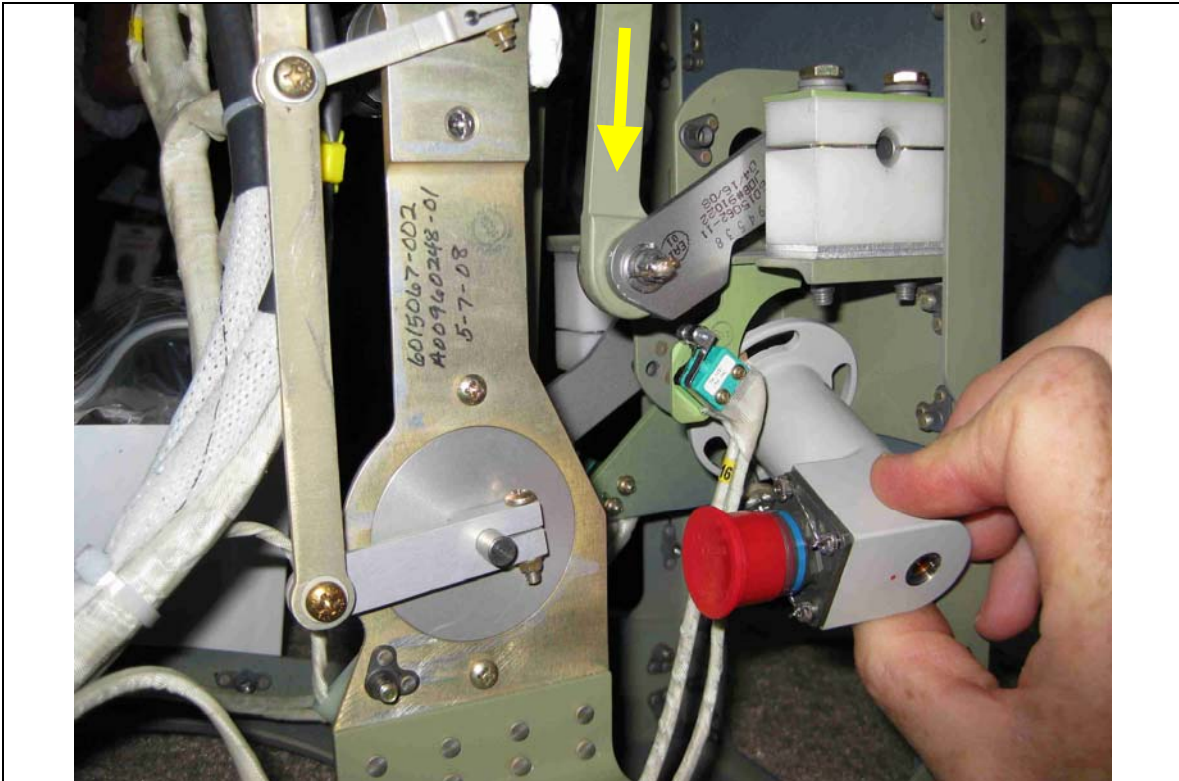
Each RVDT is actually a twin set of RVDT devices in a single housing, to separately provide input data to the EEC channels A and B. The EEC provides excitation at 6 volts and 3906 hertz, as well as interpretation of the RVDT positions, known as the thrust lever angle (TLA). (See Figure 10)

Figure 10. This photo is of a pedestal assembly in the factory. The hand is holding a dual RVDT beneath a dual (green) shut-down microswitch pack in a pedestal. This RVDT is labeled in the previous Figure as the RH Engine RVDT. The forward thrust and the T/R piggyback lever movements share the common vertical bar (yellow arrow) to rotate the input shaft on the far side of the RVDT. The RVDT output signals are the FADEC thrust commands.

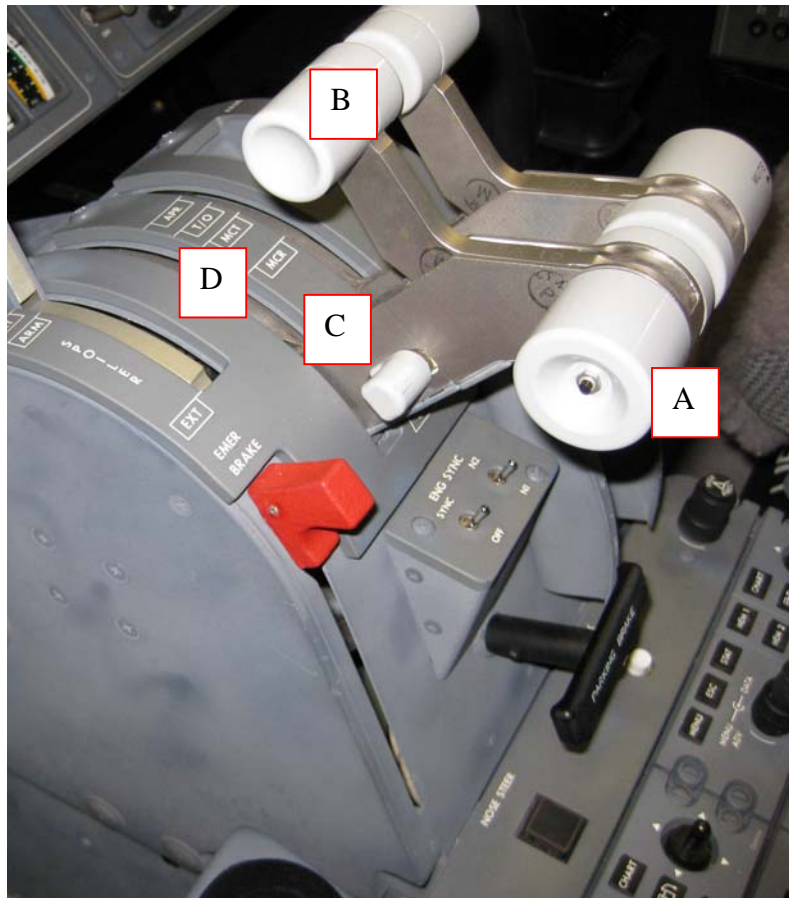
Figure 11. Captain's view of pedestal in an airplane similar to N999LJ. The view shows the thrust levers (A), thrust reverser (piggyback) levers (B), idle/cut-off latches (also known as toggles, shown as C), which must be lifted before the thrust lever can move aft from idle to cut-off, and location of thrust lever detents (D).

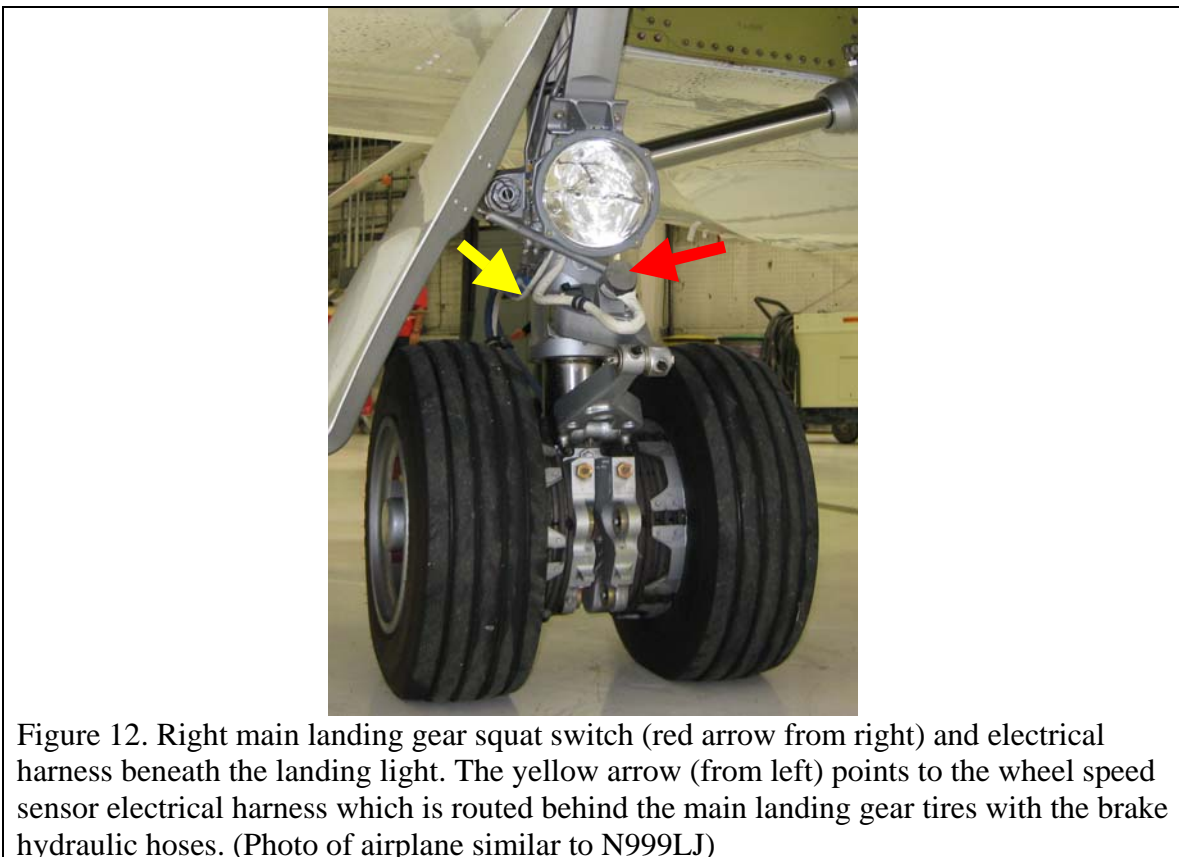
Figure 12. Right main landing gear squat switch (red arrow from right) and electrical harness beneath the landing light. The yellow arrow (from left) points to the wheel speed sensor electrical harness which is routed behind the main landing gear tires with the brake hydraulic hoses. (Photo of airplane similar to N999LJ)

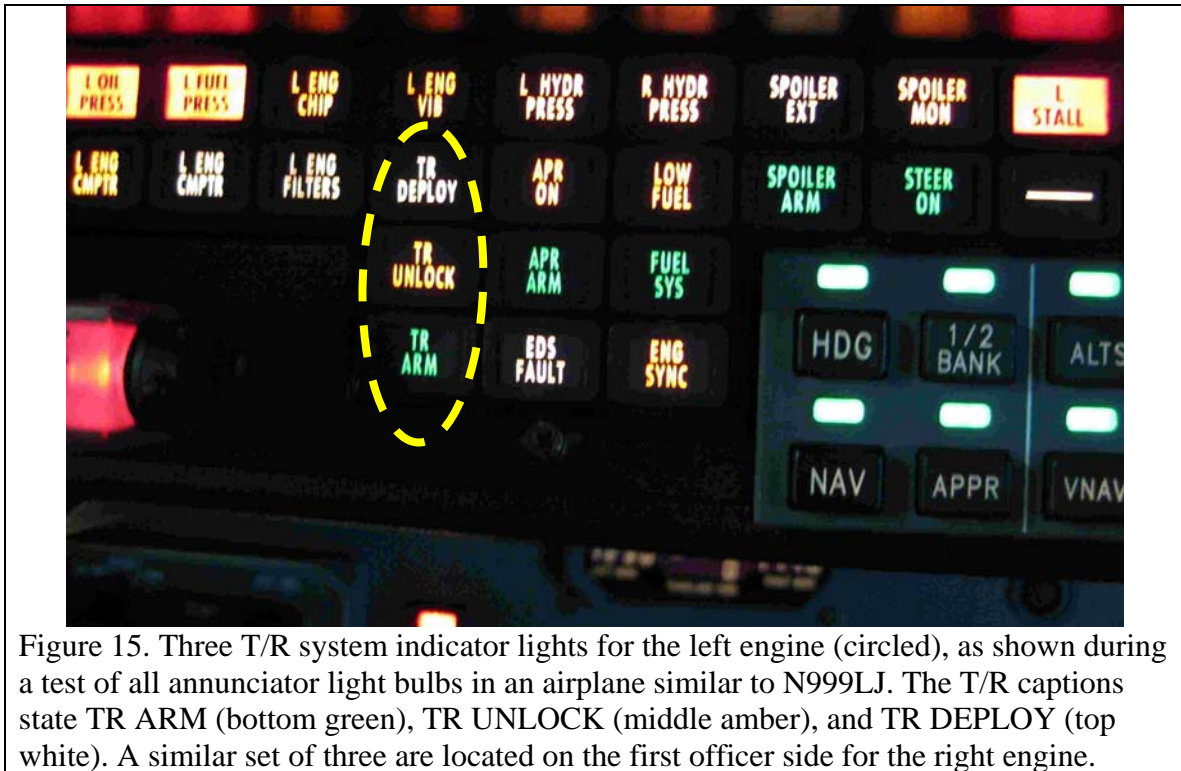
The thrust reverser system has three annunciator lights. From bottom to top, the three annunciator lights are T/R ARM in green, T/R UNLOCK in amber, and T/R DEPLOY in white. (See Figure 15) During testing of Model 60 airplanes, none of the T/R lights were illuminated (“black panel”) when the throttles were advanced in forward thrust from the idle stop. This lack of annunciations was the as-designed mode for forward thrust.

Figure 15. Three T/R system indicator lights for the left engine (circled), as shown during a test of all annunciator light bulbs in an airplane similar to N999LJ. The T/R captions state TR ARM (bottom green), TR UNLOCK (middle amber), and TR DEPLOY (top white). A similar set of three are located on the first officer side for the right engine.

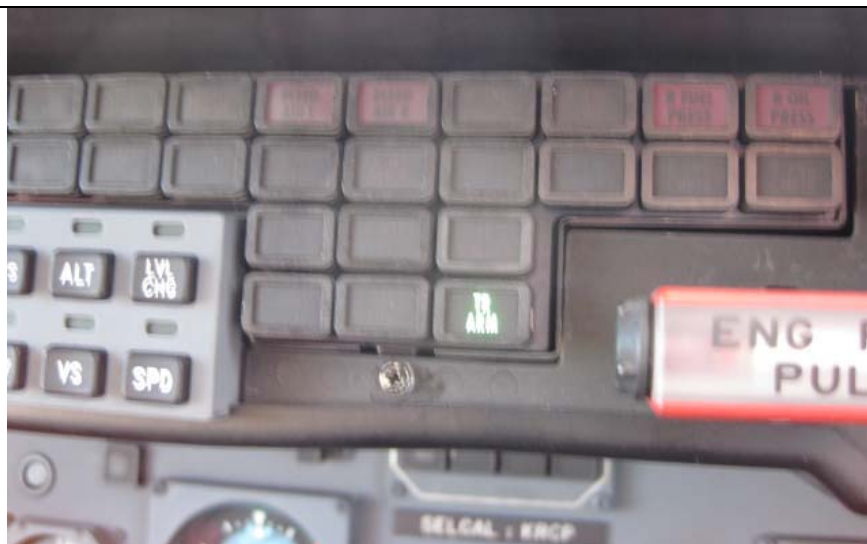
Figure 16. Illuminated right engine TR ARM green annunciation during ground test. (Photo of airplane similar to N999LJ)

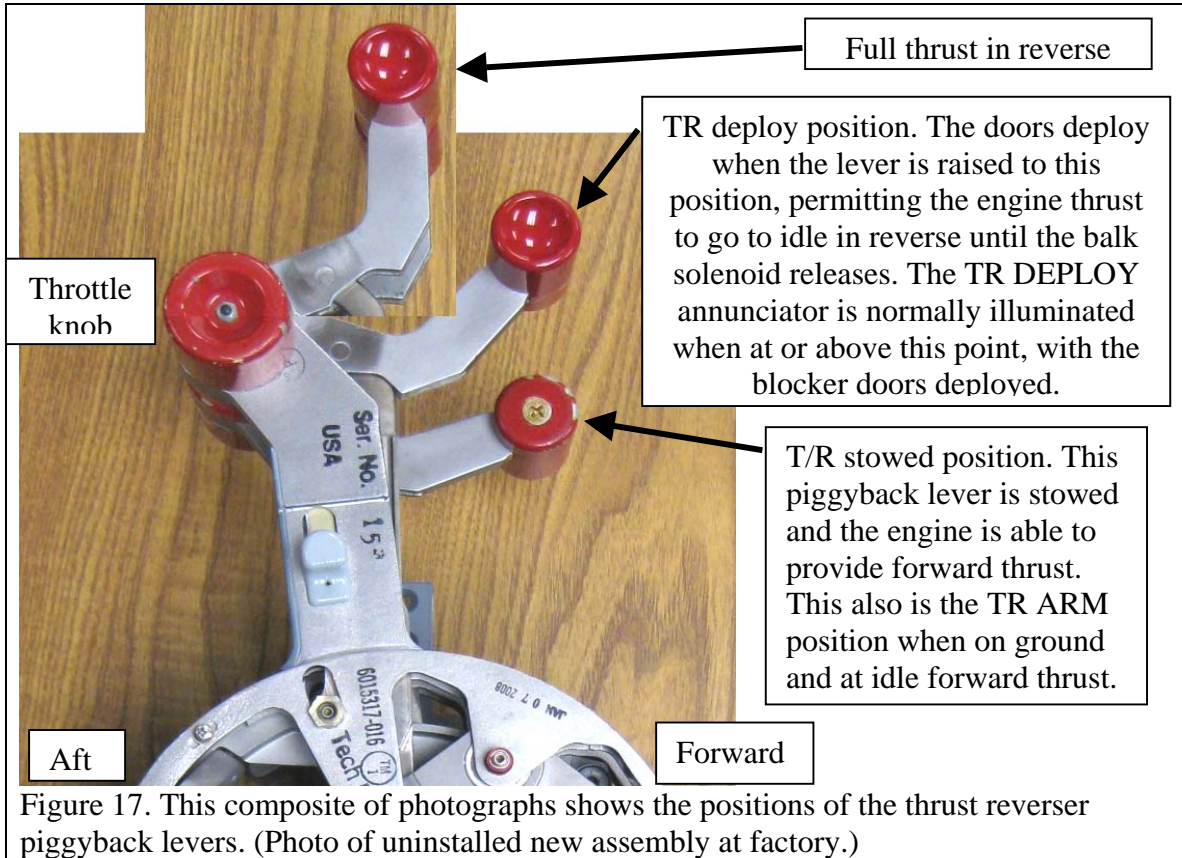
Figure 17. This composite of photographs shows the positions of the thrust reverser piggyback levers. (Photo of uninstalled new assembly at factory.)

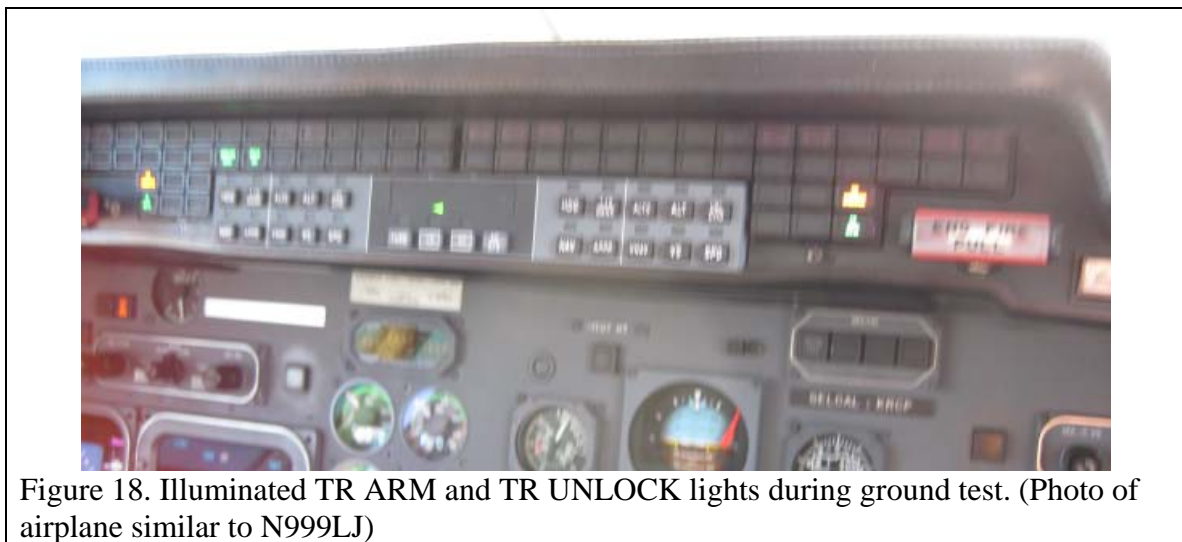
Figure 18. Illuminated TR ARM and TR UNLOCK lights during ground test. (Photo of airplane similar to N999LJ)

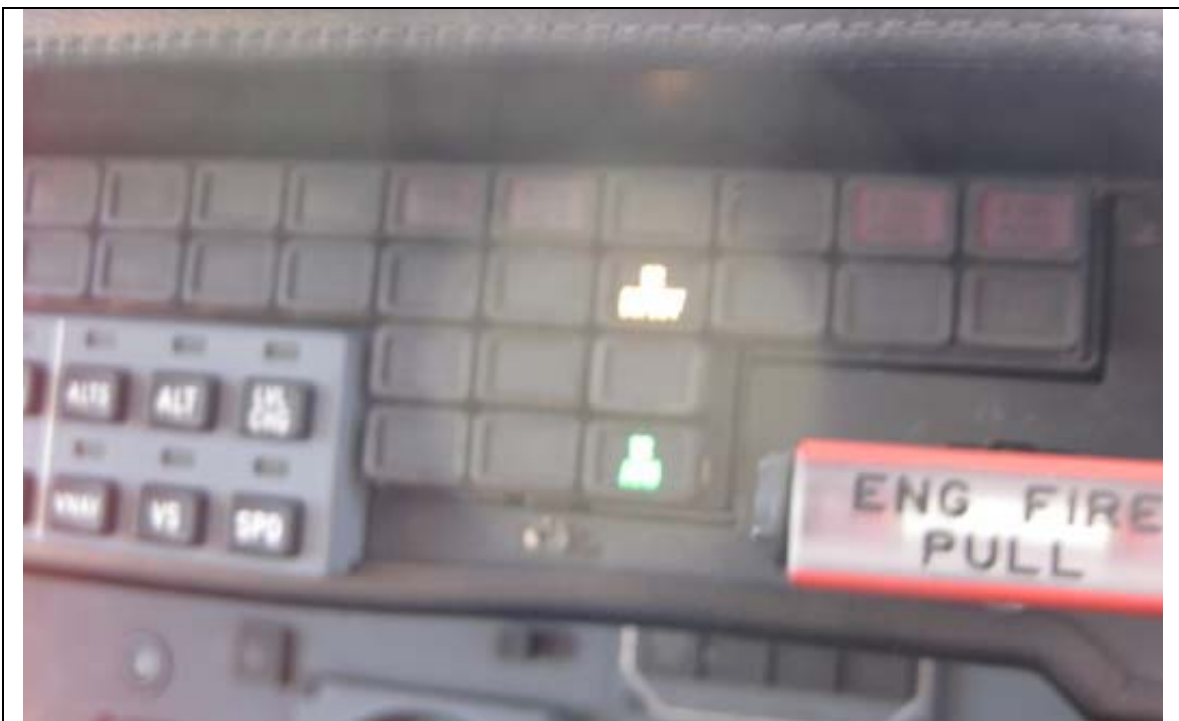
Figure 19. Illuminated engine TR DEPLOY light during ground test. (Arrow) (Photo of airplane similar to N999LJ)

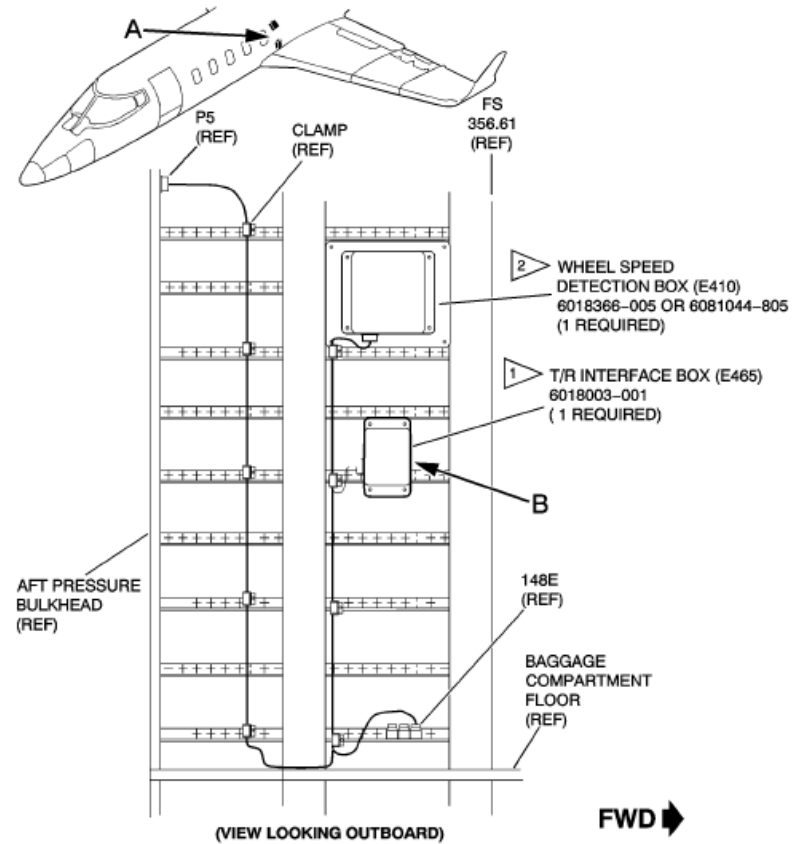
- Detail A**
- NOTES**
- 1 Electrically bond per Learjet Model 60 wiring manual.
  - 2 If correct part number wheel speed detect box (E410) is installed, it is not required to remove and replace unit.
- K60-607807-001-01
- Wiring Modification of Circuit Breaker Panel Connectors  
Figure 1 (Sheet 1 of 3)

- (8) Position the T/R Interface box on 6018004-803 and 6018004-804 brackets and clamp in place. (See Figure 1.)  
 (7) Mark T/R Interface box mounting hole pattern on the 6018004-803 and 6018004-804 brackets.

(d) Secure the 6018004-803 bracket to stringer 10L using MS20470AD4-3 rivets. (See Figure 1.)  
 (16) Install 6018004-804 bracket to stringer 11L as follows.

(c) Wipe remaining MPK from stringer 11L and bracket using lint-free cloth.  
 (d) Secure the 6018004-804 bracket to stringer 11L using MS20470AD4-3 rivets. (See Figure 1.)

(17) Install T/R Interface box to bracket with MS27039-0806 screws. (See Figure 1.)  
 (18) Modify aircraft wiring. (See Figure 2.)
