NATIONAL TRANSPORTATION SAFETY BOARD

**AIRWORTHINESS GROUP CHAIRMAN'S FACTUAL ADDENDUM FOR
TIRE, WHEEL, AND BRAKE DOCUMENTATION
WITH AIRCRAFT TIRE STUDY**

A. **ACCIDENT:** DCA08MA098

AIRCRAFT: Learjet Model 60, N999LJ, S/N 60-314

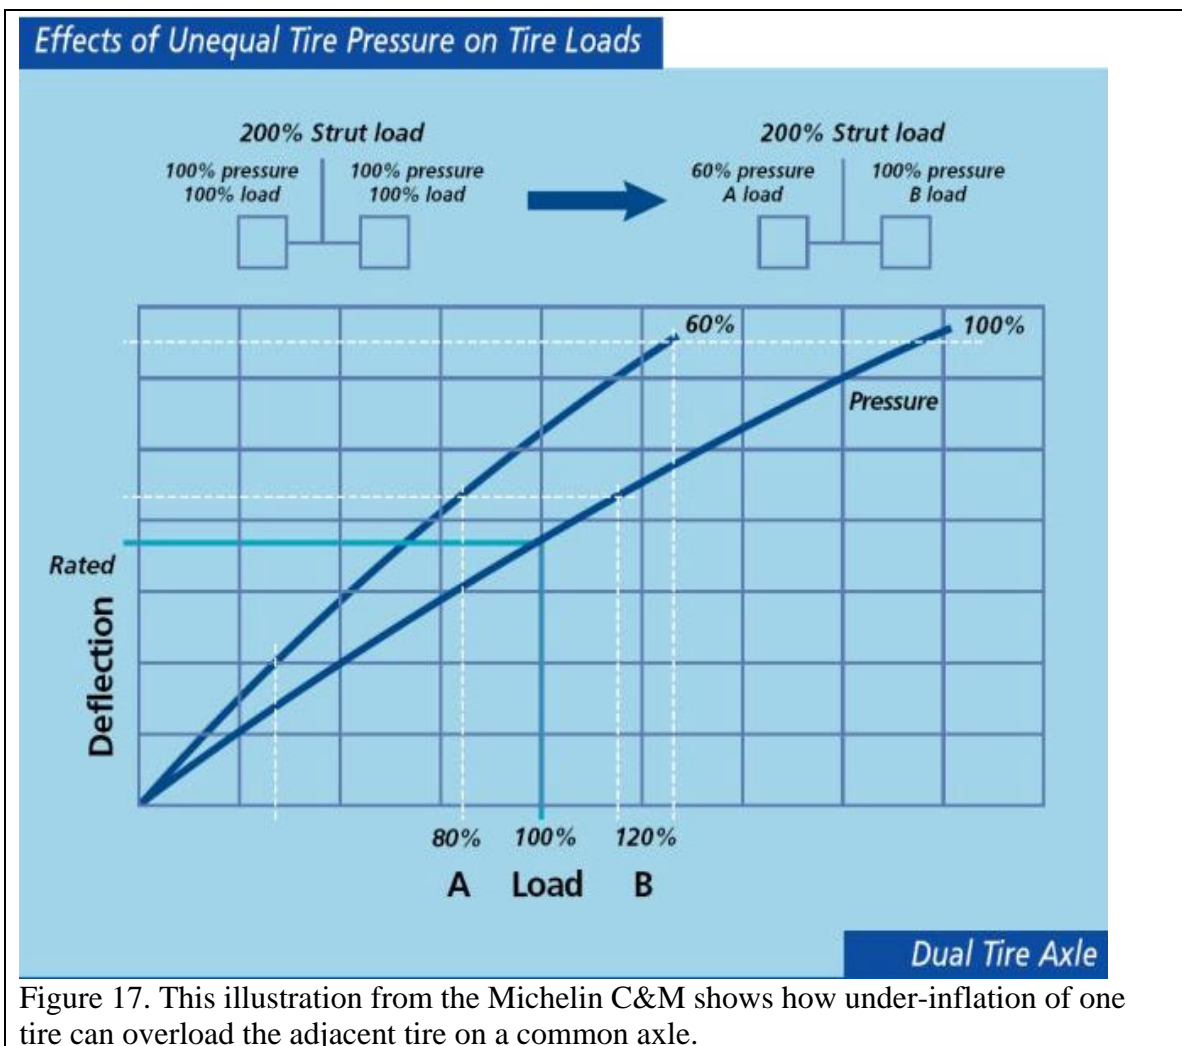
In dual-tire installations, the tire that is less under-inflated (i.e., overloaded) usually fails first from carrying relatively more load, causing it to heat faster. When a landing gear axle is fitted with more than one wheel and tire assembly, the load carried by each tire, when multiplied by 1.07, may not be greater than the rated load of the tire. (Ref. 14 CFR Part 25.733) This is to account for potential inequities of load-sharing in service (See Figure 17). This is not intended to account for improper/uneven inflation or a deflated tire.

Figure 17. This illustration from the Michelin C&M shows how under-inflation of one tire can overload the adjacent tire on a common axle.

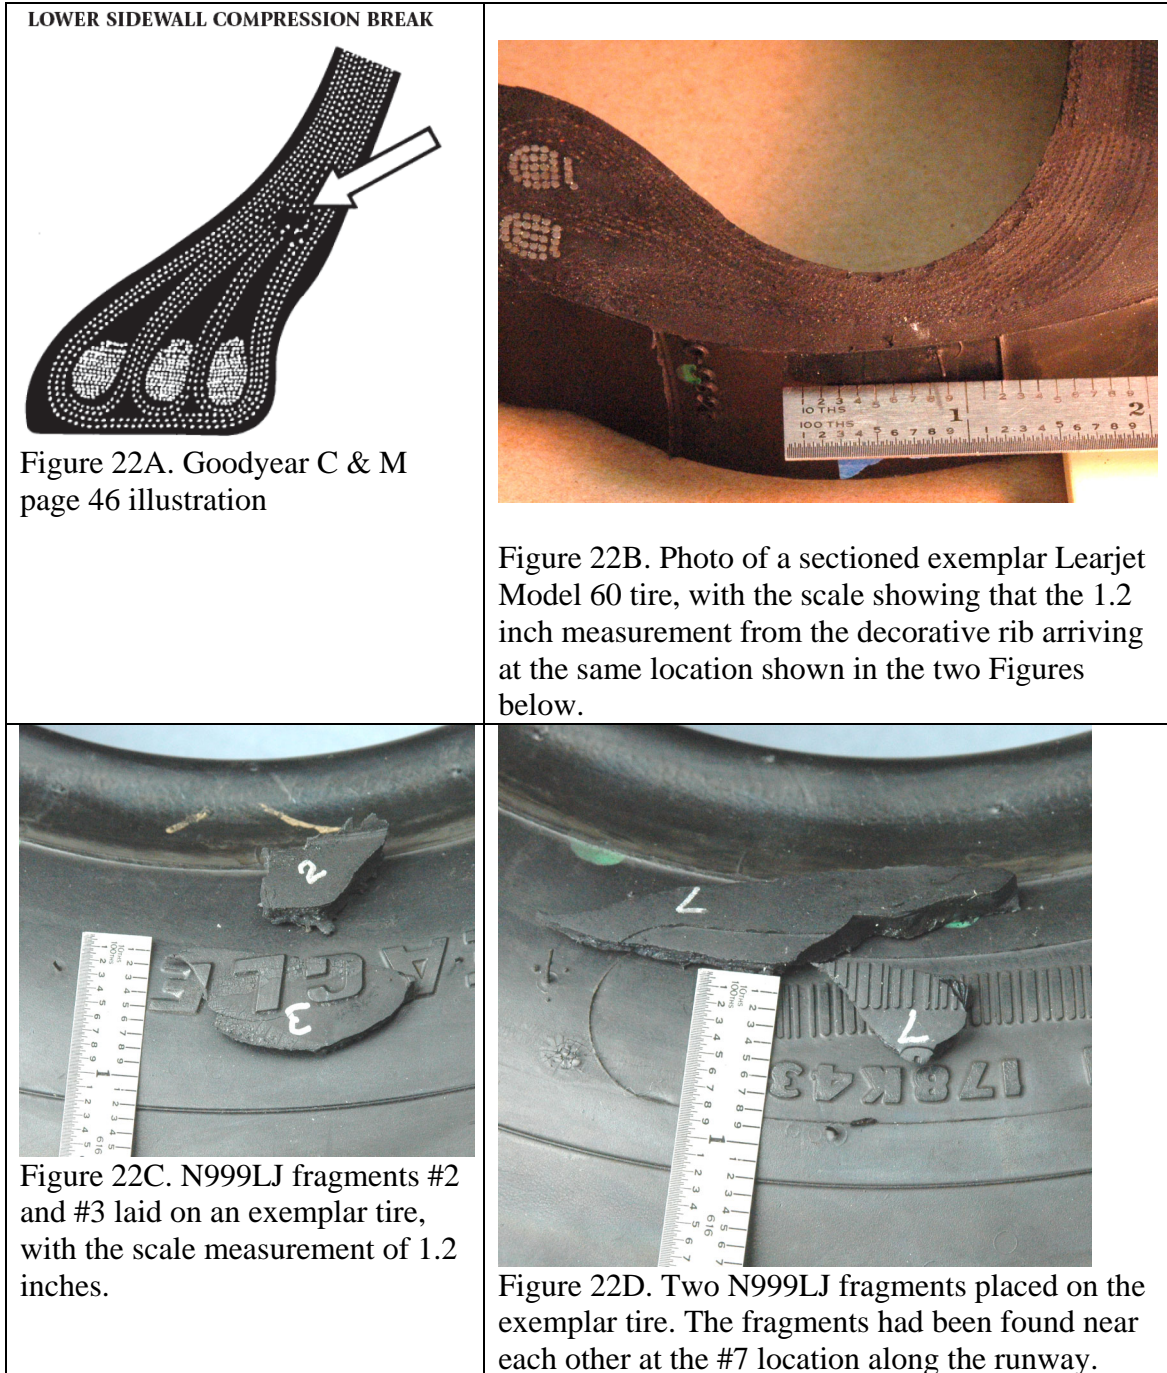
The location of the radius from the hub and where the plies were “turned up” around the beads wires matched the lower sidewall compression break shown on Goodyear C & M page 46. (See Figures 22A-22D) The illustration was captioned: “This is the start of the type of failure caused by under-inflation or overloading. The above photo shows carcass cords that are starting to fail due to flex fatigue.” The Bridgestone C&M publication contained a photograph of damage from a different view and captioned the photo “An example of Casing Break Up (CBU) in a bias tire at the lower sidewall caused by running the tire at pressures below those recommended.”

The location of these sidewall breaks was about 1.2 inches toward the hub from the decorative ribs, especially in both sidewalls of the outboard right tire, the outboard sidewall of the inboard right tire, and the right (inboard) sidewall of the left inboard tire. Extensively more shredding and tearing was found to the inboard sidewall of the right inboard tire (wheel position #3) and to the left outboard tire (wheel position #1).

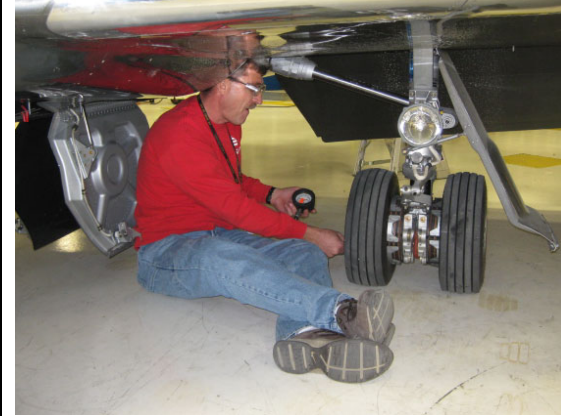
The person checking the tire pressures is required to get under the wing of the airplane. The outboard tires have a valve which may be concealed by the landing gear door, requiring the person to lay on the pavement. (See Figures 25 and 26)

Figure 25. Checking inboard tire pressure at the Learjet factory.

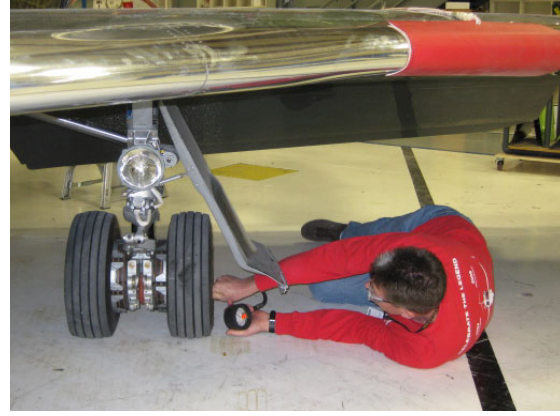
Figure 26. Checking outboard tire pressure at the Learjet factory.

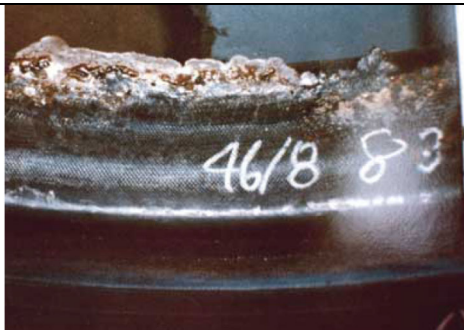
Fragments from bags 40, 42, 44, and 45 contained bead material that had been recovered from the earlier portion of the runway. Although not able to absolutely establish the original location of each, the runway location and remaining tire beads on the other three wheels indicated that these fragments were from the right outboard tire. The beads of all four tires had no evidence of extreme heat from the wheel brakes. (See Figures 28 and 29)

Figure 28. As copied from the Bridgestone Tire Care and Maintenance publication and as a comparison for the photo to the right. This photo shows how a tire bead with evidence of brake overheating could appear.

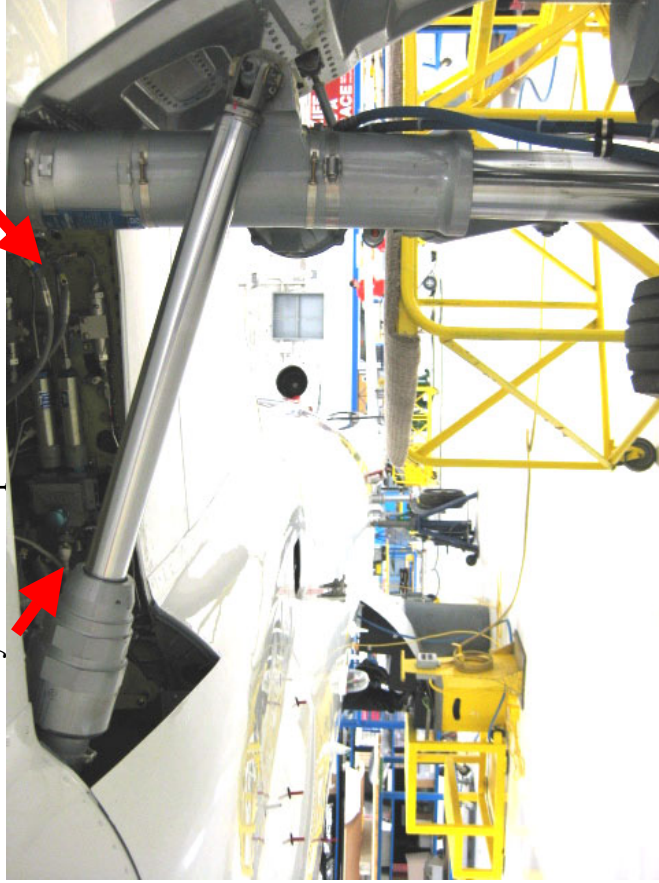
Figure 36B. Learjet Model 60 aft features of the right main landing gear, as viewed from behind. The hydraulic hoses and anti-skid wiring are in the plane of rotation for the outboard tire.

Note hydraulic components between red arrows.

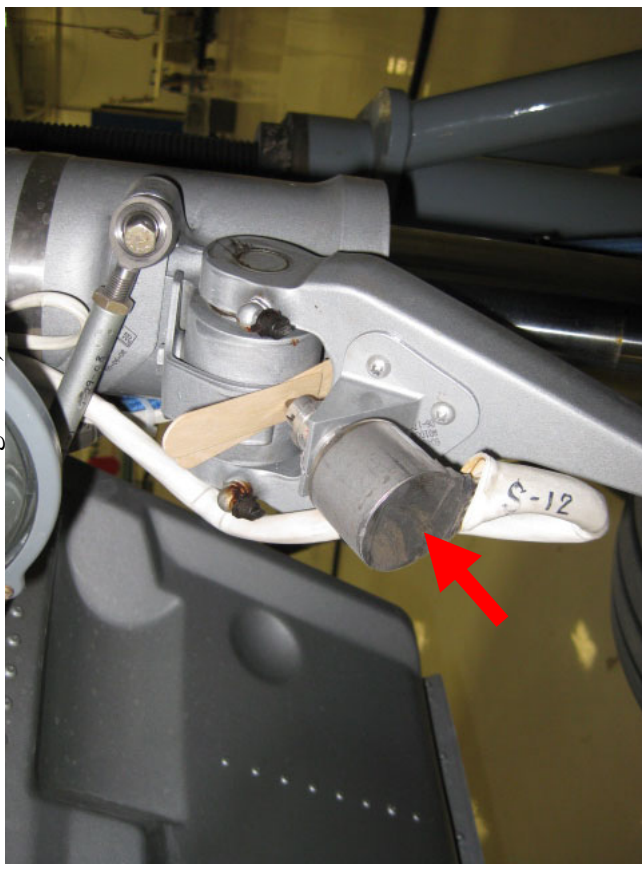
Squat switch comparison, as viewed from front

Figure 37B. Learjet Model 60 with an arrow indicating the single exposed squat switch on right main landing gear. (The photo includes a wooden stick that was installed to simulate air mode during tests.)

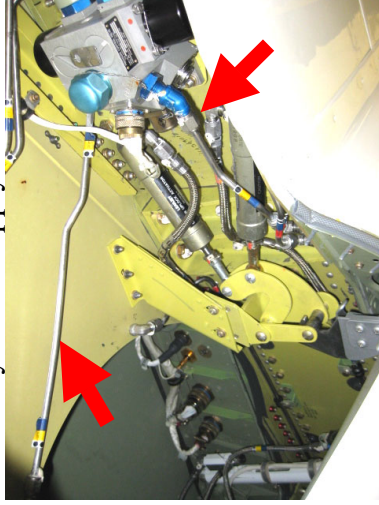
Figure 38B. Learjet Model 60. Hydraulic components mounted on wing spar that is above, and inboard of, the rotational plane of the right inboard tire. The upper-left arrow points to an unfused hydraulic return tube. The lower-right arrow points to an unfused hydraulic supply tube.

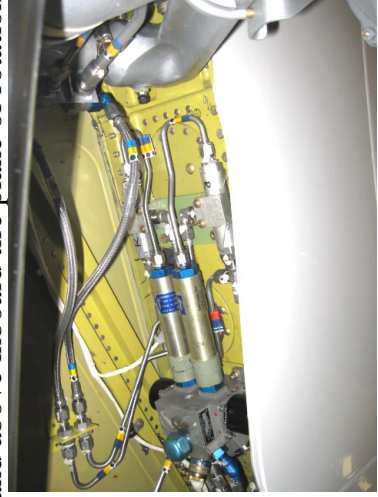
Figure 38D. Learjet Model 60 at top of right main landing gear strut, slightly oriented outboard of the photo above (Figure 38B) and above inboard tire plane of rotation.

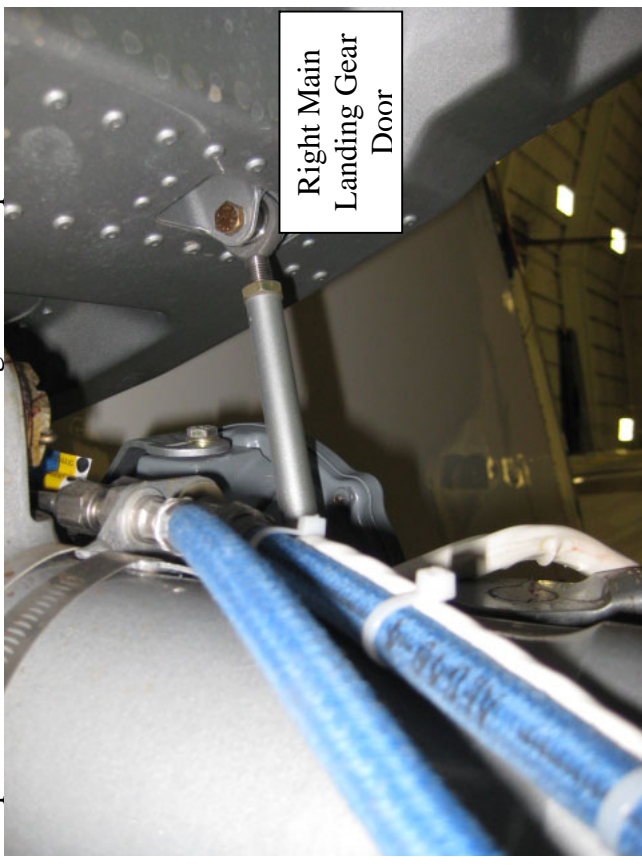
Figure 39B. Learjet Model 60. Right main landing gear, above outboard tire, showing wiring and hydraulic hoses above the tire plane of rotation. The white wiring is for the squat switch.

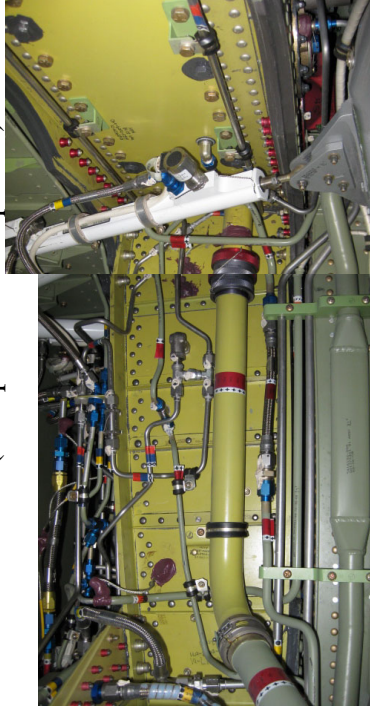
Figure40D. Learjet Model 60: View shows exposed hydraulic components on the front and inboard walls of right wheel bay inboard. (Composite of two photos)
