**NATIONAL TRANSPORTATION SAFETY BOARD**

**Airworthiness Group Chairman's Factual Report – Addendum 1**

**A. ACCIDENT                      DCA16MA204**

Location:                      Lockhart, Texas  
Date:                              July 30, 2016  
Time:                              0742 central daylight time (CDT)  
Aircraft:                      Heart of Texas Balloons Balony Kubicek BB85Z, registration  
   N2469L

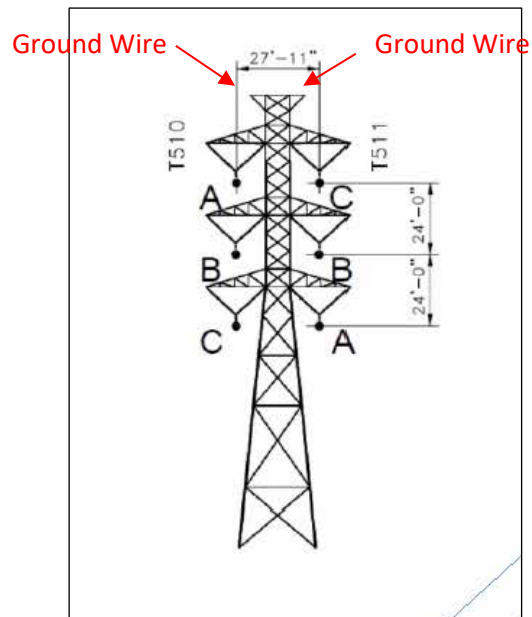
Each set of transmission lines consisted of three individually bundled conductor (of two conductors each) lines (named A, B, and C) along with a fourth ground wire, arranged vertically on one side of each tower. For T510, the wires were arranged Ground, A, B, and C from top to bottom, while T511 was arranged Ground C, B, A from top to bottom. (See Figure 2).

Figure 2 - Arrangement of Lines on Towers near Accident Site.

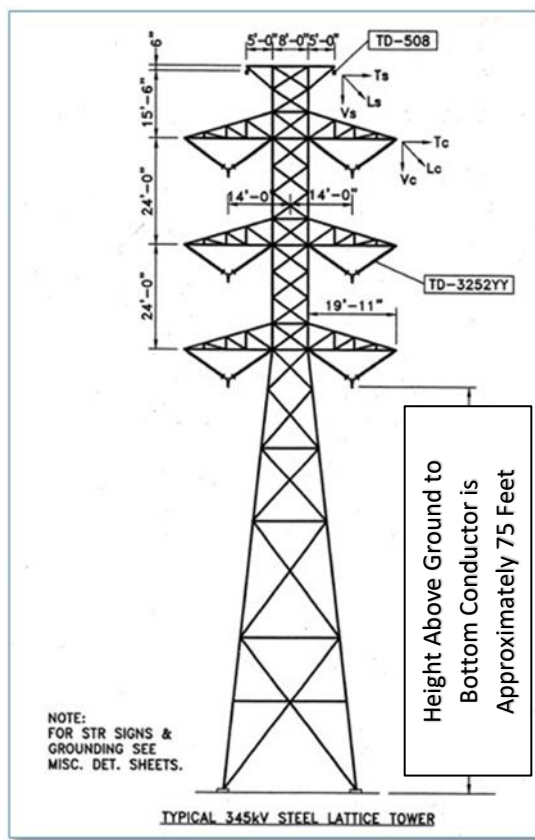
The lines were strung along towers that were a total of approximately 140-150 feet in height, depending on the tower. According to LCRA, at tower 127, the bottom conductor was approximately 75 feet off the ground, but, at the approximate point of balloon impact, the lowest conductor was approximately 58' above the ground, and the top (ground) line approximately 137' feet above the ground, due to conductor sag between towers. See Figure 3.

Figure 3 – Representative Dimensions of Towers near Accident Site
