NATIONAL TRANSPORTATION SAFETY BOARD

Group Chairman's Factual Report

ANC15MA041

**Promech Air Inc.
de Havilland DHC-3 Reg. N270PA
Ketchikan, Alaska
25 June 2015
PT6A-135A Engine
S/N 35056**

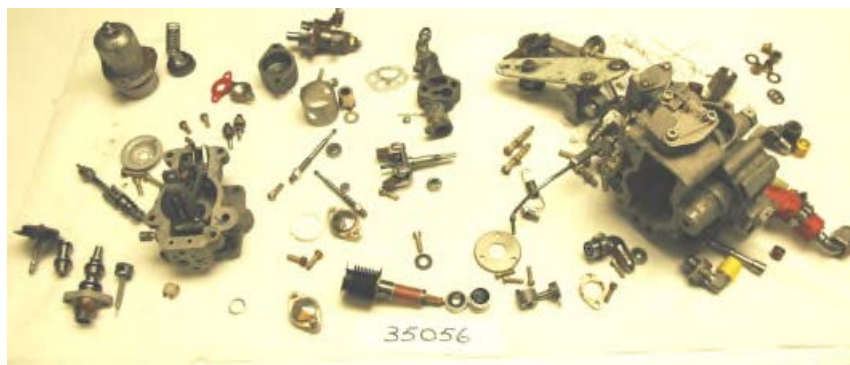
Photo No. 68

Fuel Control Unit: Impact damage included deformation of the input lever to the maximum flow position and deformation of the condition lever assembly. Functional testing was limited to operation at the fixed input lever position and showed no conditions limiting full power operation. Disassembly and inspection revealed no pre-impact conditions that would preclude normal operation. Please refer to photos No. 67 and 68.

Fuel control unit, as disassembled.

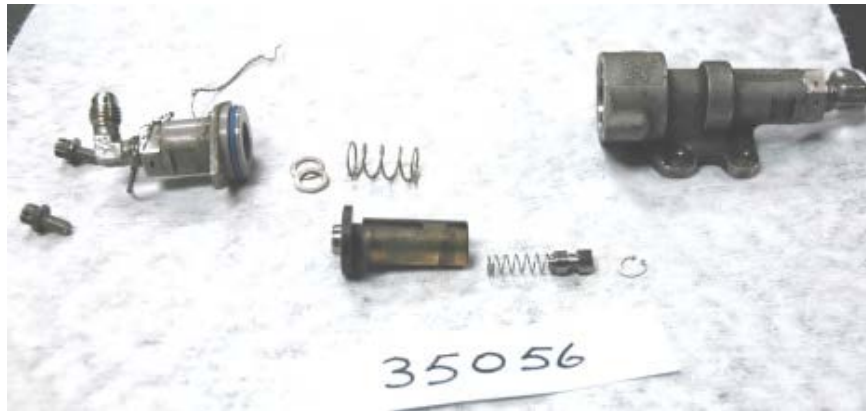
Photo No. 69

Flow Divider: Functional testing and disassembly inspection were satisfactory. Please refer to photo No. 69.

Flow divider, as disassembled.

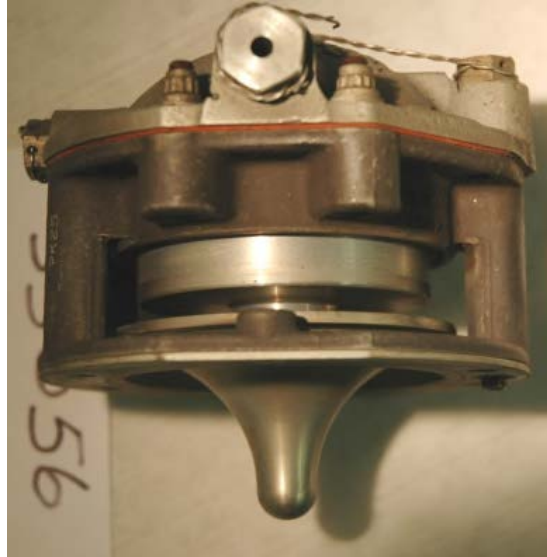
Compressor Bleed Valve: Functional testing was satisfactory. Please refer to photo No. 71.

Photo No. 71
Compressor bleed valve.
