NATIONAL TRANSPORTATION SAFETY BOARD

AIRWORTHINESS GROUP CHAIRMAN'S FACTUAL REPORT

A. ACCIDENT: ANC10MA068
LOCATION: Near Aleknagik, Alaska
DATE/TIME: August 9, 2010
AIRCRAFT: DeHavilland Canada DHC-3 "Turbine Otter", N455A

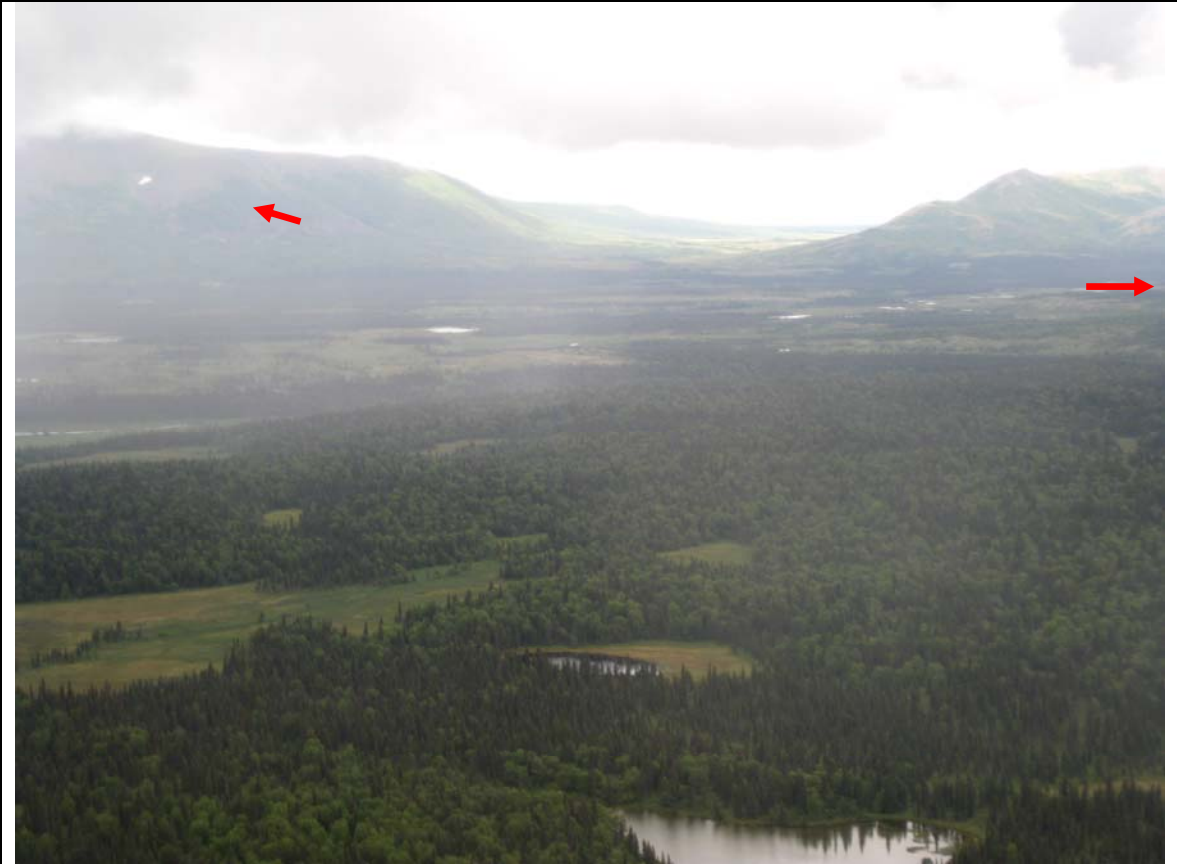
The site was to the left (east) of a pass between the Muklung Hills and an unnamed peak of 1,351 feet in height. A topographic map showed the floor of the pass to be slightly less than 400 feet msl. The tundra between Lake Nerka and the pass was about 100 feet msl. The altitude of the wreckage was 900-1000 feet msl, according to both a USGS topographic map and reference to a handheld GPS altimeter. Two Muklung Hill peaks in front of the airplane were shown on the topographic map to be 2,309 feet and 2,170 feet in elevation; an aviation sectional map showed the Muklung Hills peak to be 2550 feet msl. (See Figure 2)

Figure 2. View across tundra toward the accident site and the pass of more than a mile in width. The arrow in the upper left points to the approximate location of the accident site. The arrow at the right is placed on the Muklung River and points toward the user-created Muklung waypoint found in the Garmin GNS-530 GPS. The waypoint is beyond the edge of the photo, to the west of the hill shown. This view is on about a 100 degree magnetic heading, from about 5 miles SSE of Lake Nerka.

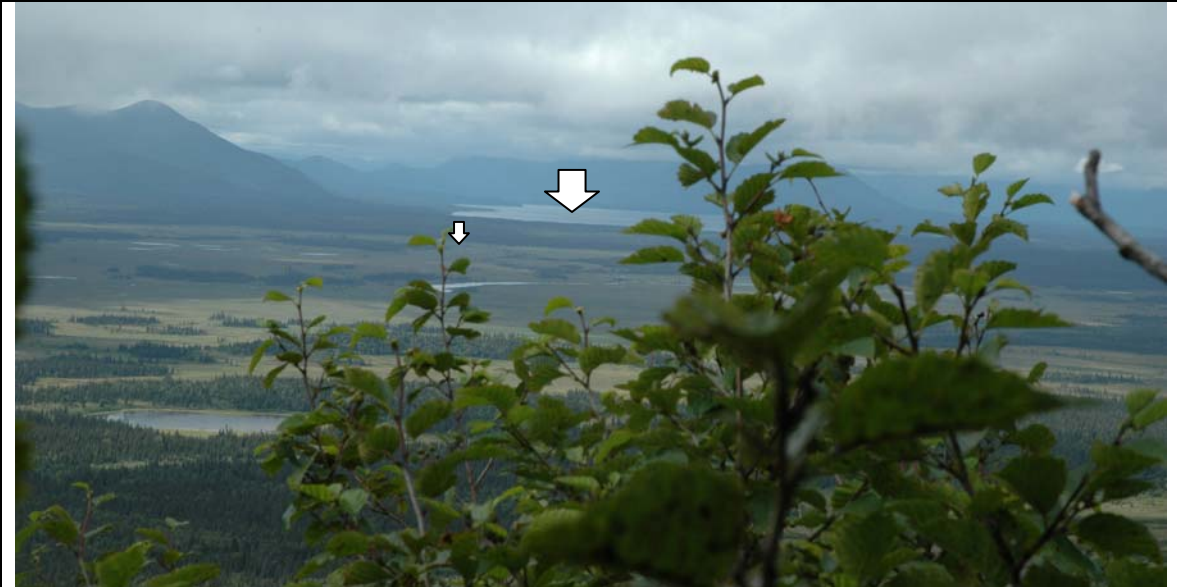
Figure 3. The large white arrow shows the body of water that the airplane came from, named Lake Nerka. The nearest end of the lake is slightly less than 9 miles away. The GCI Lodge would be off the left edge of the photo, and reachable by flying around the 2,487 foot tall mountain in the upper left. Photo 2 was taken from an airplane flying to the lake and near the small white arrow.

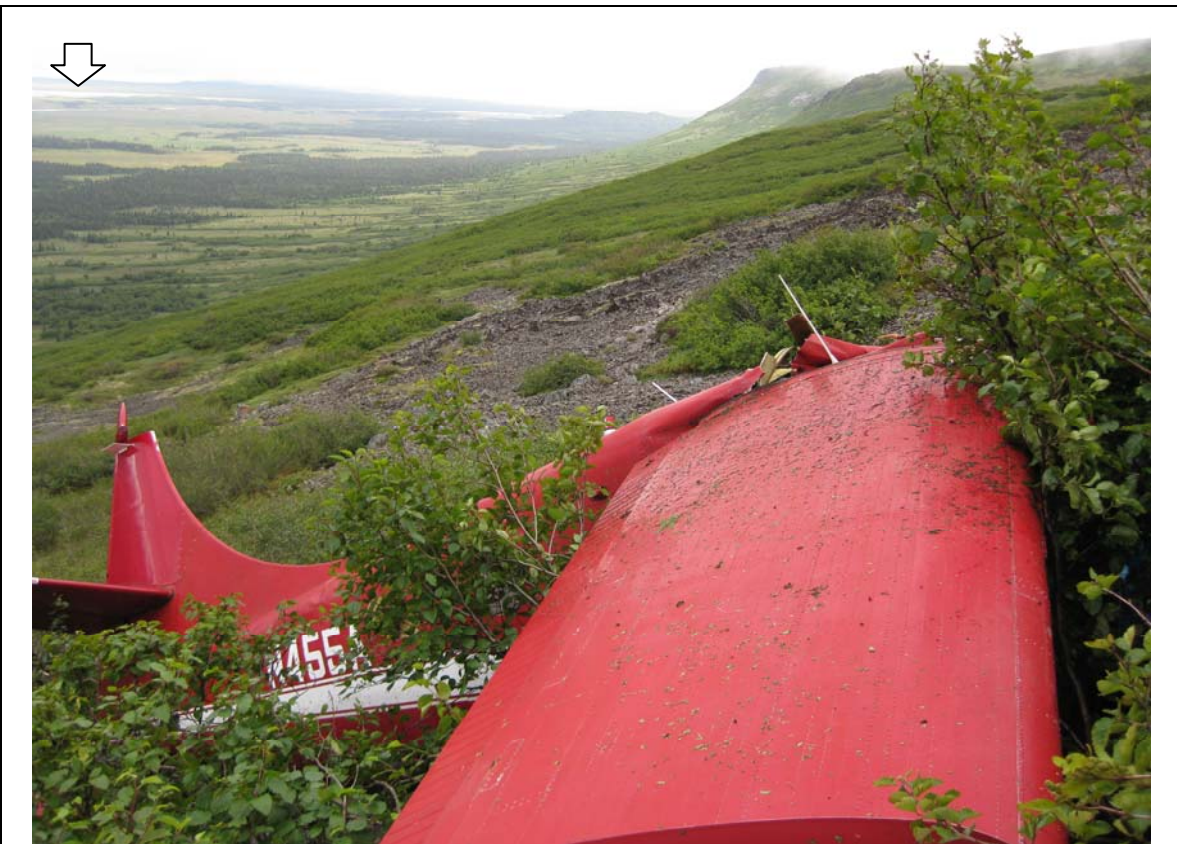
Figure 4. Airplane wreckage on hillside, with arrow at upper left pointing at Lake Nerka, to align with Figure 3.

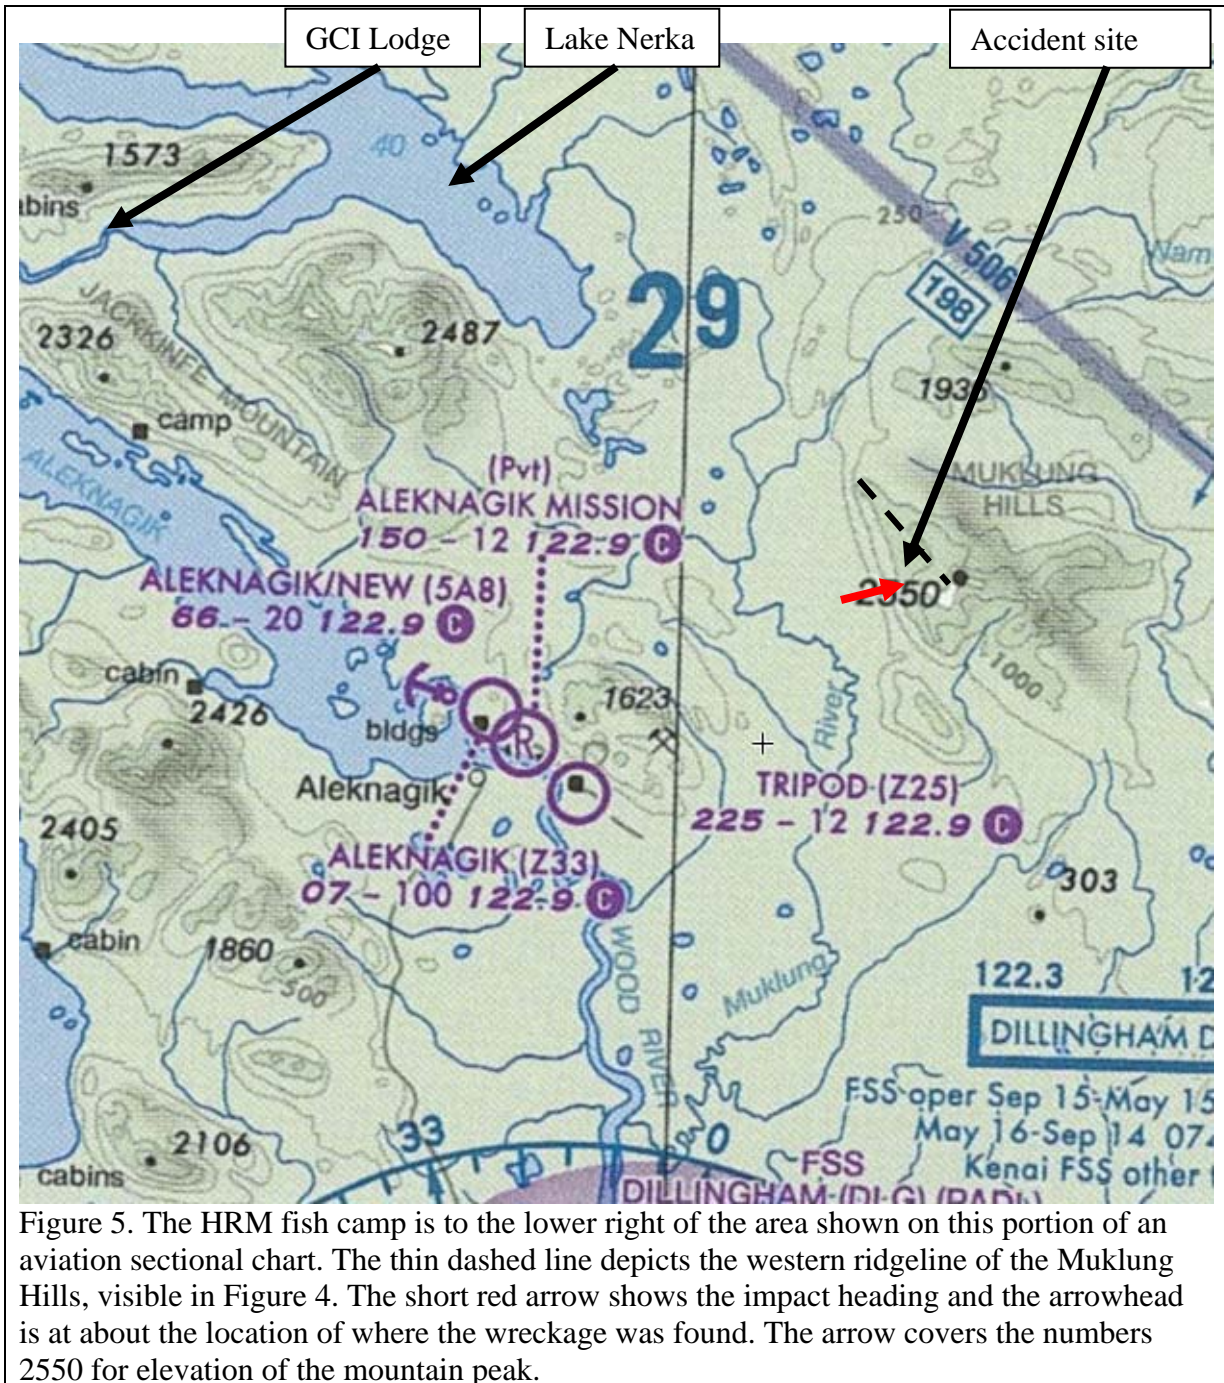
Using the compass in a helicopter to determine heading into the accident site, the airplane struck the side of the Muklung Hills on a heading of 070 degrees.³ (See Figure 5)

Figure 5. The HRM fish camp is to the lower right of the area shown on this portion of an aviation sectional chart. The thin dashed line depicts the western ridgeline of the Muklung Hills, visible in Figure 4. The short red arrow shows the impact heading and the arrowhead is at about the location of where the wreckage was found. The arrow covers the numbers 2550 for elevation of the mountain peak.

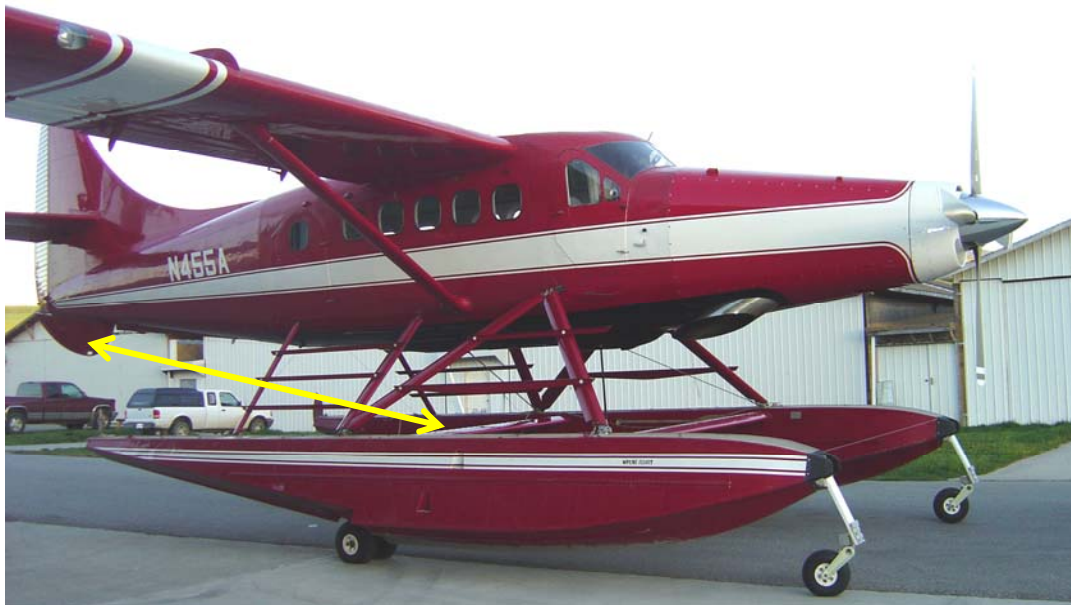
Figure 7. Pre-accident view of the N455A airplane to show the height of the ventral fin above the rear float spreader bar.

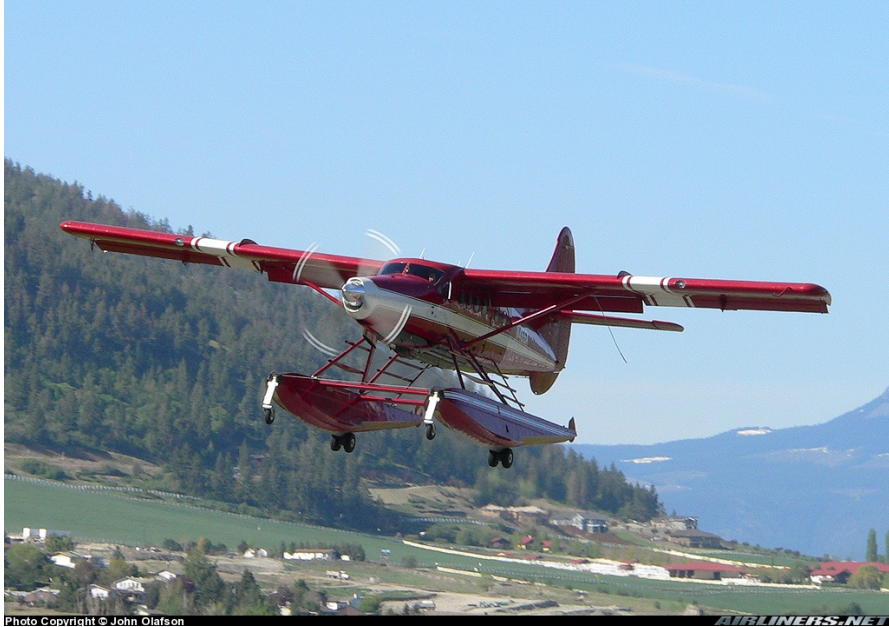
Figures 8. Pre-accident view of the N455A airplane to show the height of the ventral fin above the rear float spreader bar. Note the extended flaps and nose above cruise attitude.

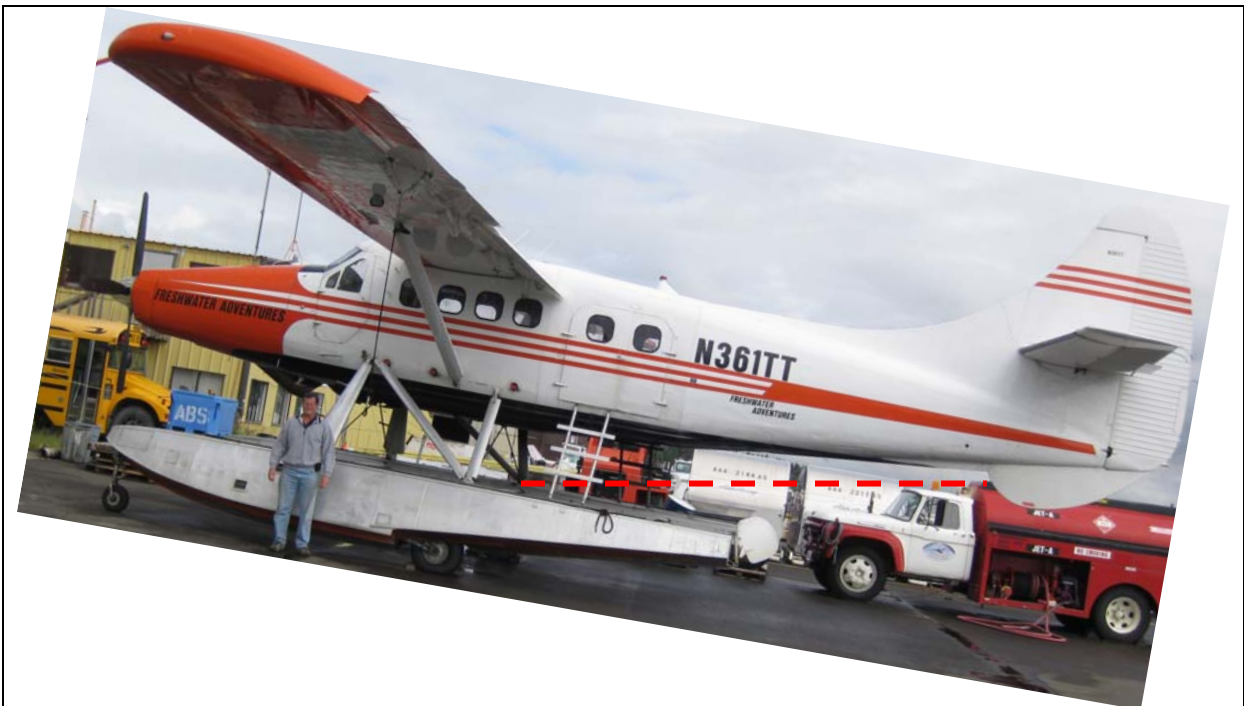
Using photographs of another Turbine Otter at the Dillingham airport as a reference, the access to the installed location of the ventral fin was determined. The fin would have been above and aft of the aft float spreader bar. The angle from the spreader bar to the impacts in the ventral fin was 10 degrees, and the ventral fin was 22 degrees above the tails of the floats. The crushed bottoms of the floats also matched a 30 degree reference line (See Figure 9)

Figure 9. This photograph does not convey impact attitude; it was used to find the minimum angle that exposed the ventral fin to potential impacts. The ventral fin is beneath the tail and a float spreader bar is between the rear set of struts that attach the fuselage to the floats. This side view had to be rotated 10 degrees to have the ventral fin lower than the level line drawn aft of the float spreader bar.

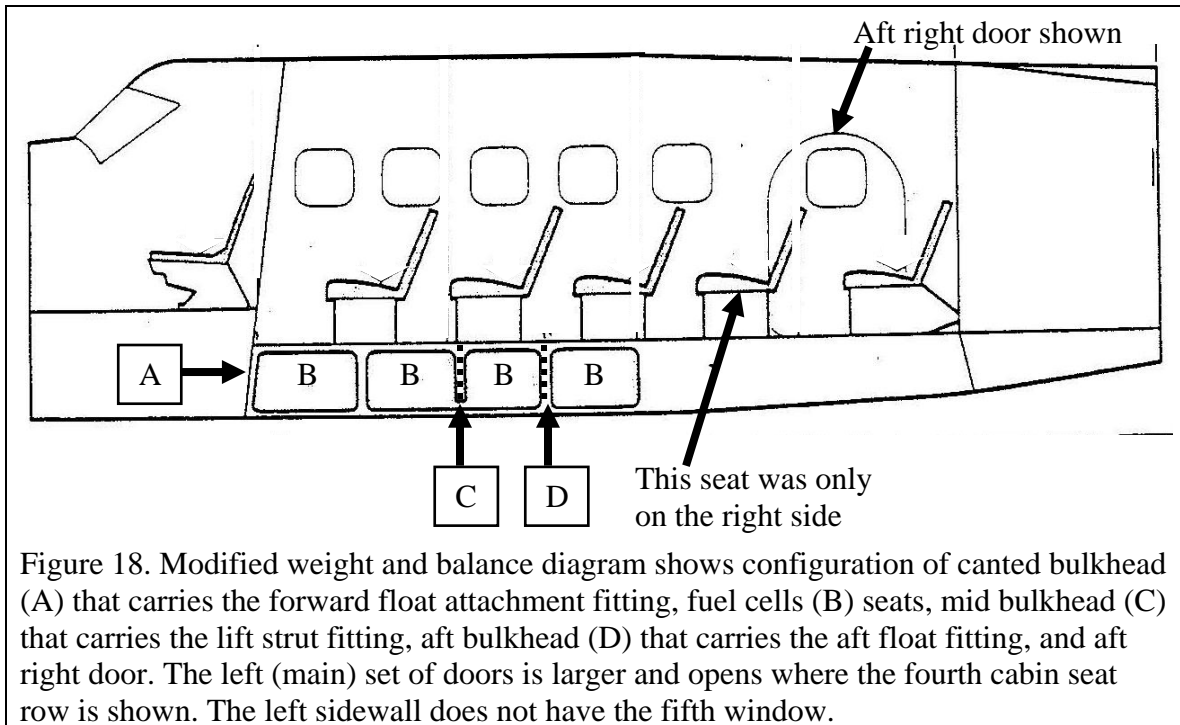
cabin windows on the right. Between the third and fourth rows of cabin windows was a third reinforced bulkhead that had attachment points for the aft float attachment fittings. Between each of the three bulkheads the design included the bladders for the forward, mid, and aft fuel tanks. An escape hatch was located on top of the fuselage and was between the same frames that partitioned the third set of cabin windows. (See Figure 18)

Figure 18. Modified weight and balance diagram shows configuration of canted bulkhead (A) that carries the forward float attachment fitting, fuel cells (B) seats, mid bulkhead (C) that carries the lift strut fitting, aft bulkhead (D) that carries the aft float fitting, and aft right door. The left (main) set of doors is larger and opens where the fourth cabin seat row is shown. The left sidewall does not have the fifth window.

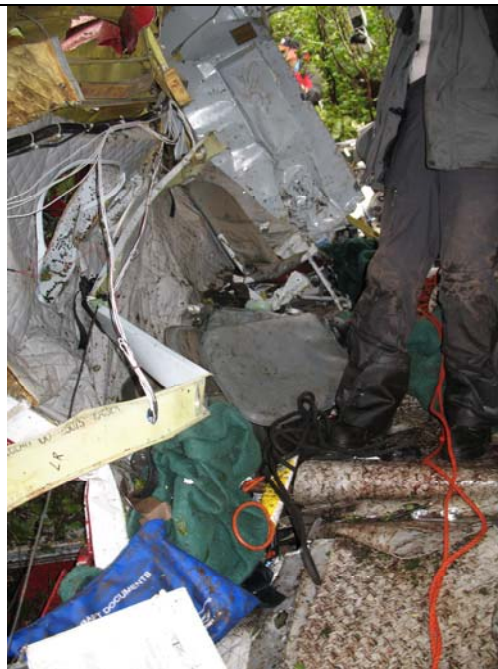
The mid and aft bulkheads were also torn apart and little structure remained beneath the cabin floor. The left cabin wall had buckled in multiple places (Figure 22) and the wing strut fitting was twisted aft. The right cabin wall bent inward through the area of the second cabin window and seat above where the lift strut fitting had been. Between the bulkhead locations were only shreds remaining of the fuel cell bladders.

Figure 23. View from aft of cabin to show disruptions to the left cabin side wall and floor prior to recovery. Figure 22 showing the same features from the other end of the cabin was photographed from the where green foliage can be seen at the top of this photo.

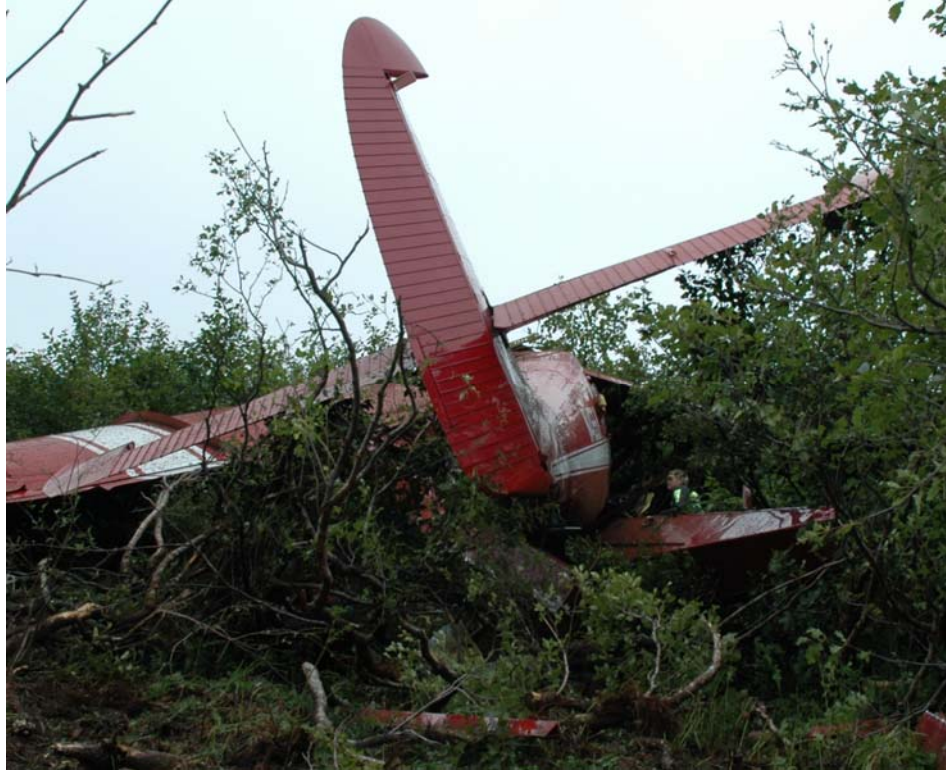
Figure 27A. Aft view of airplane, showing tail control surfaces, including trim. The right float is beneath the right side of the fuselage with the keel toward the camera.

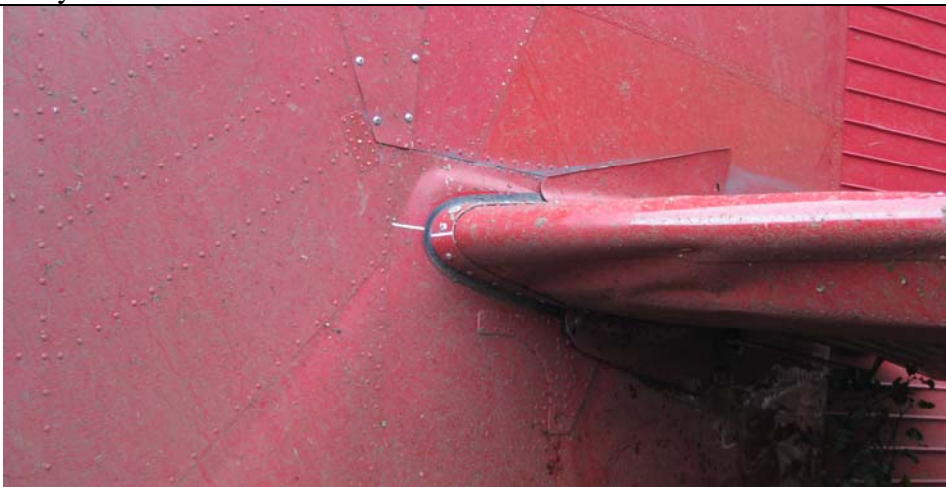
In the tail of the accident airplane, the horizontal stabilizer position was near the paint mark that indicated neutral trim. The interconnect trim tab moved in the correct direction when the cable drum was rotated within the tail structure. The servo tab functioned appropriately when the elevator was moved.

Figure 27B. Left side of horizontal stabilizer that is shown in Figure 27A, showing closeup of trim setting found.

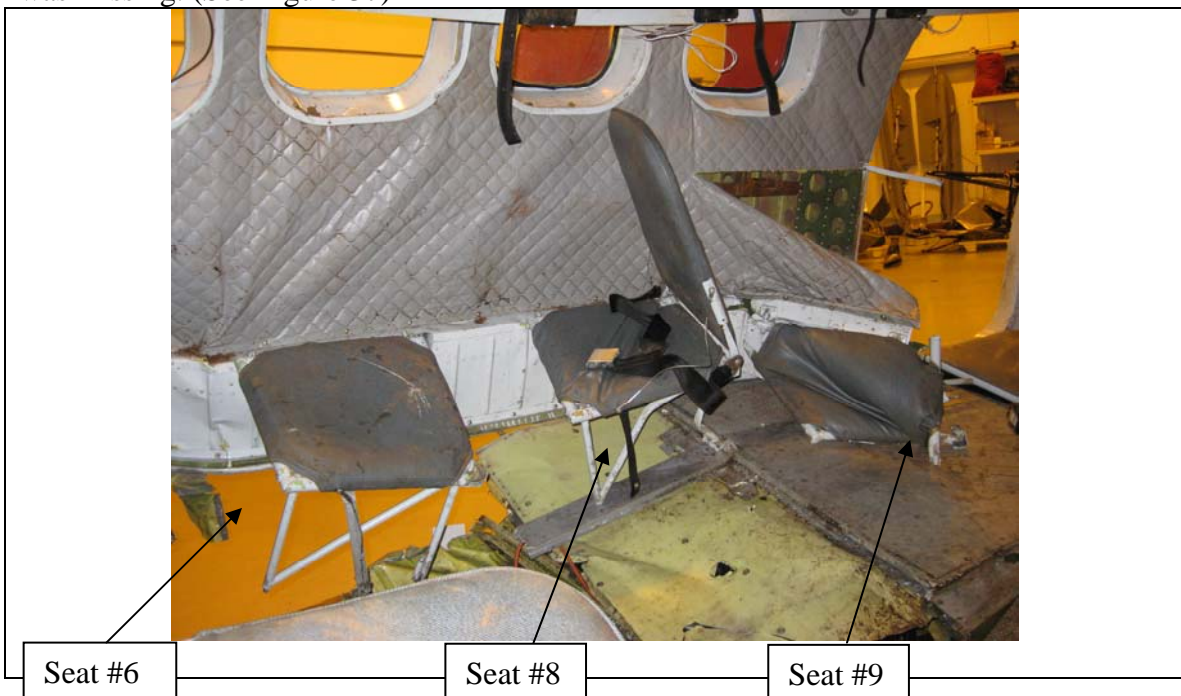
The seat back had separated from the bottom of the seat. The welded tube leg assembly remained without floor to attach to. The seatbelt and structure that the belt had attached to was missing. (See Figure 37)

Figure 37. Seats #6, #8, and #9 on right cabin side wall and lack of supporting structure.

The seat back had been ripped off. The right lap belt structure remained with the back portion of the seat. The structure that remained was still attached to the front leg of seat #8 (ref AD 88-15-08) (See Figures 37 and 39).

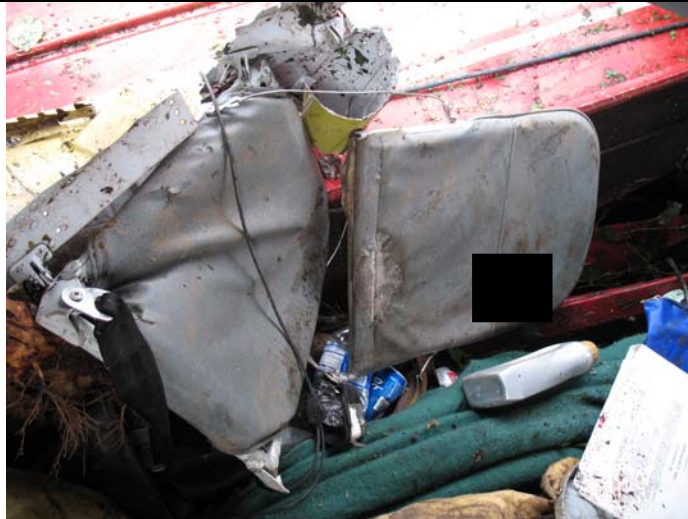
A branch penetrated upward through the floor and into the rear of seat. The seat remained attached to torn structure and was deformed, with the back separate. (See Figure 38)

Figure 38. Photo taken prior to recovery shows branch (lower left corner of photo) penetrating up from cabin floor and through area of aft outboard hinge for seat #7.

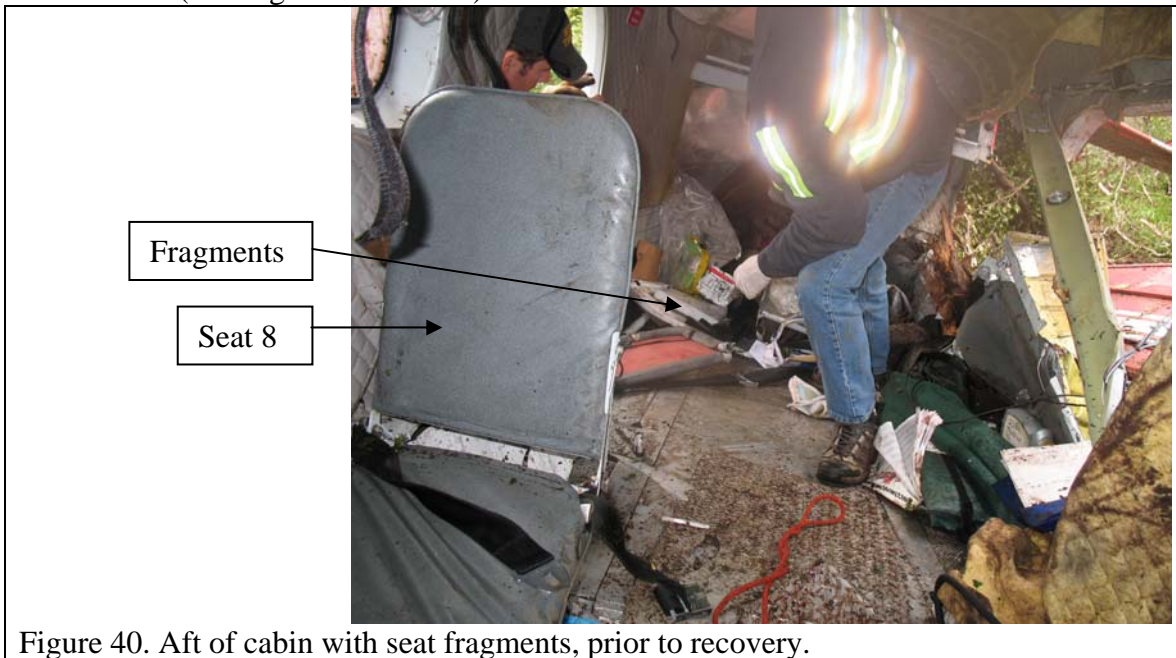
Both seats were collections of fractured tubing. The attachment points for the seatbelts had broken. (See Figures 40 and 41)

Figure 40. Aft of cabin with seat fragments, prior to recovery.

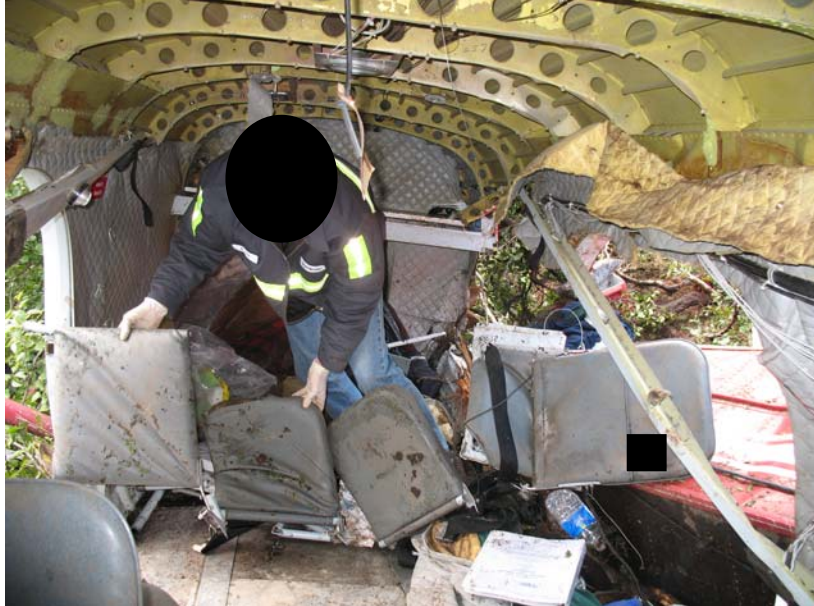
Figure 41. Aft of cabin, prior to recovery, showing enough seat fragments to account for seats 10 and 11, aft of the cabin doors.

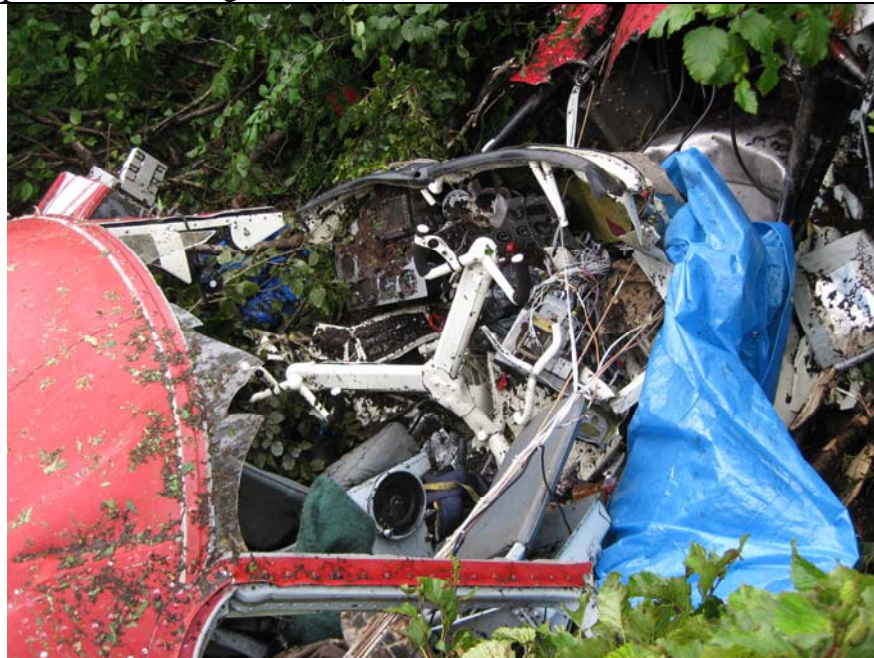
The control column was displaced to the left, with the right yoke partially crushing the engine control pedestal. The bottom of the control column had folded above the level of the floor. (See Figure 42A) The mud on the instrument panel had a flattened and evenly pressed appearance. (See Figure 42B)

Figure 42A. Cockpit, as viewed from above right wing root.

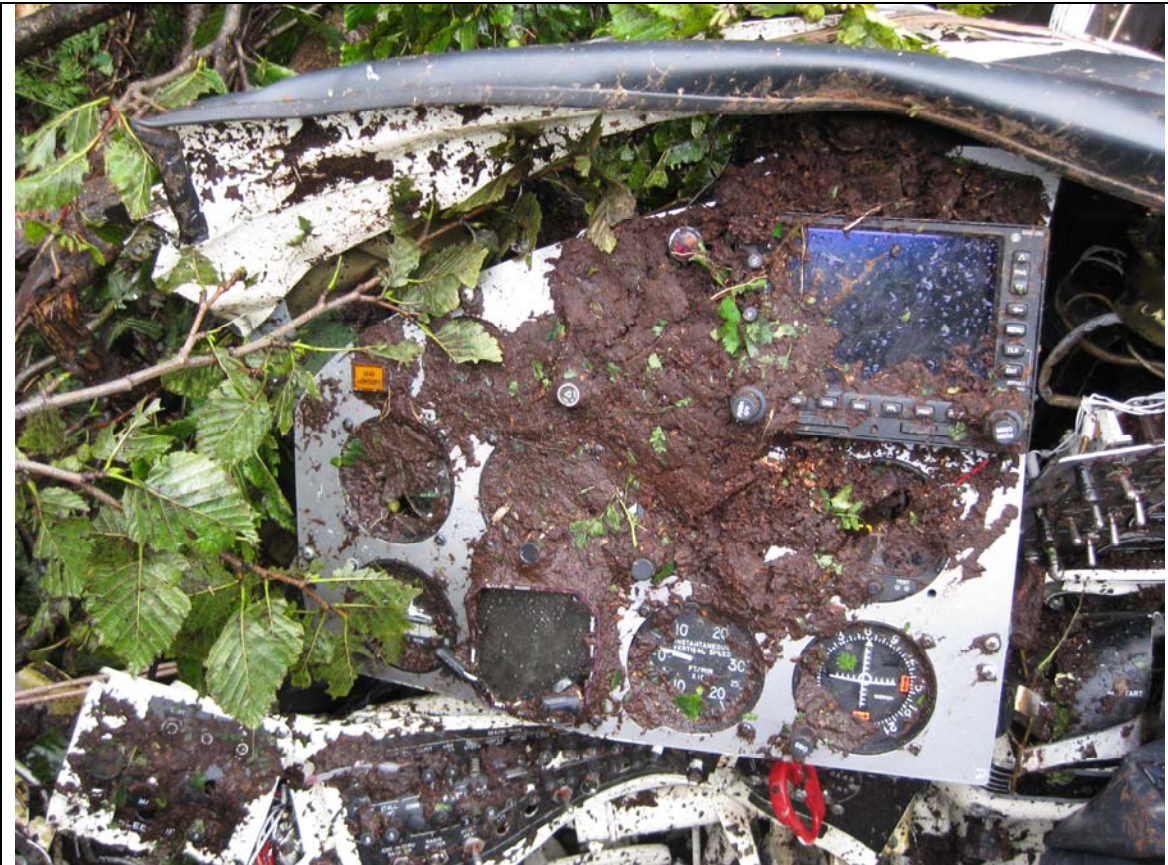
Figure 42B. Closer view of the instrument panel as initially found.

Above the Garmin GNS-530 was a Mid-Continent control panel with a TAWS inhibit pushbutton switch. When first found, the panel was covered with mud and the instrument panel had post-impact movement marks in the mud. (See Figure 42B) Nothing was visible to show the position of the pushbutton prior to impact. (See Figures 68 and 69)

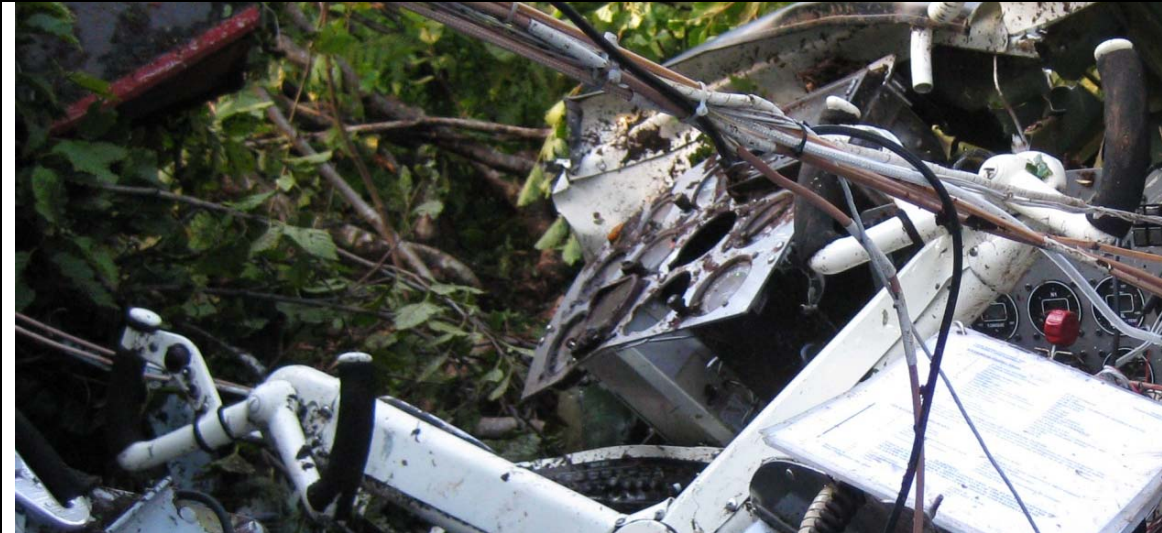
Closer examination of the control yokes shown in Figure 42A revealed more of both generalized and localized damage to the yoke on the captain's side. The left handle was found slightly more bent forward than the right handle, with the copilot's yoke otherwise generally intact. The large crossbeam that both control yokes were mounted upon had been bent forward at the captain's end. The lower portions of the welded steel captain's yoke had paint fractures, a switch bracket to the left handle was found bowed, and the foam covering on the right handle had split (not worn). Paint, bending, and twist evidence were extensive where the captain's yoke mounted to the cross beam. The same area of the copilot's mounting had significantly less localized damage.

Figure 42C. A cockpit photo that has been magnified and cropped to show the control yokes.

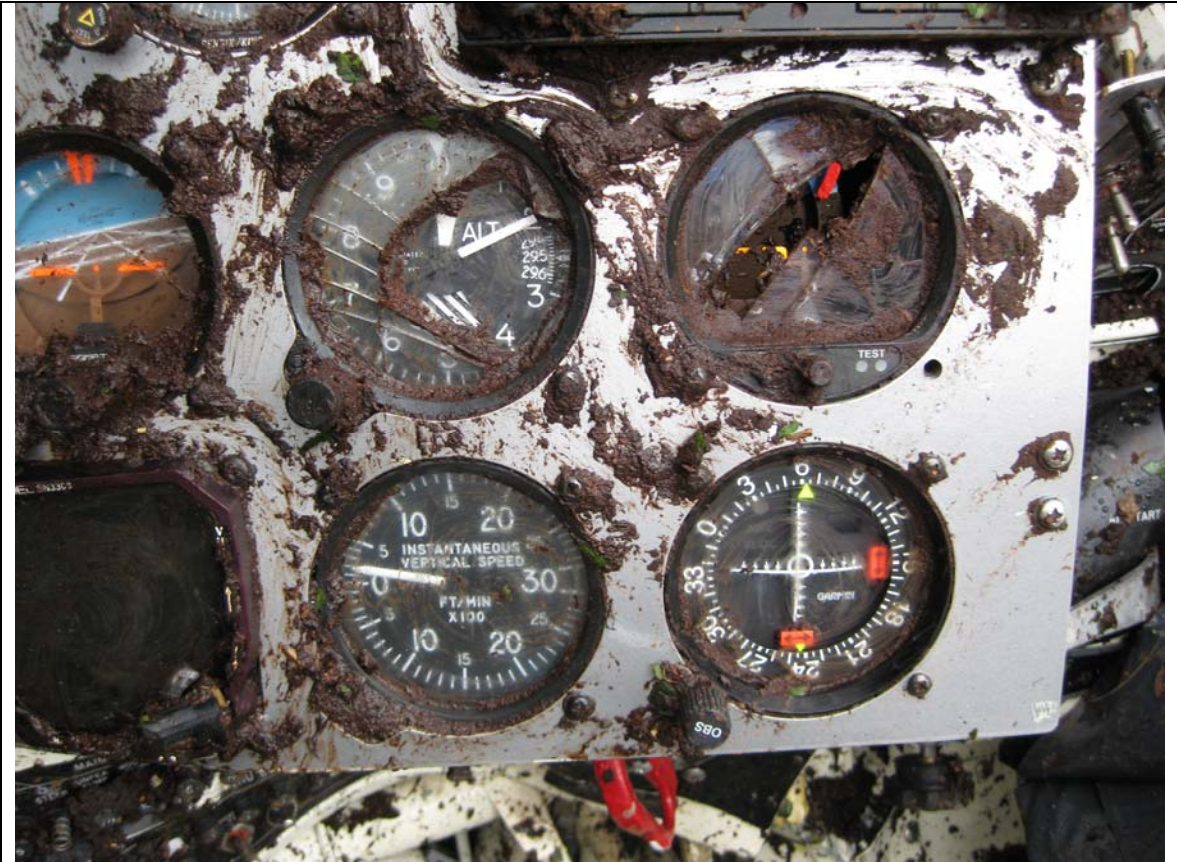
Figure 44. Primary flight instruments, after wiping away some of the mud that is visible in Figure 42B.

The altimeter setting was between 29.51 and 29.52 and the displayed altitude was slightly less than 200 feet. During and after removal, the display needle moved freely between 120 and about 190 feet. The altimeter had been manufactured by United Instruments of Wichita, KS.

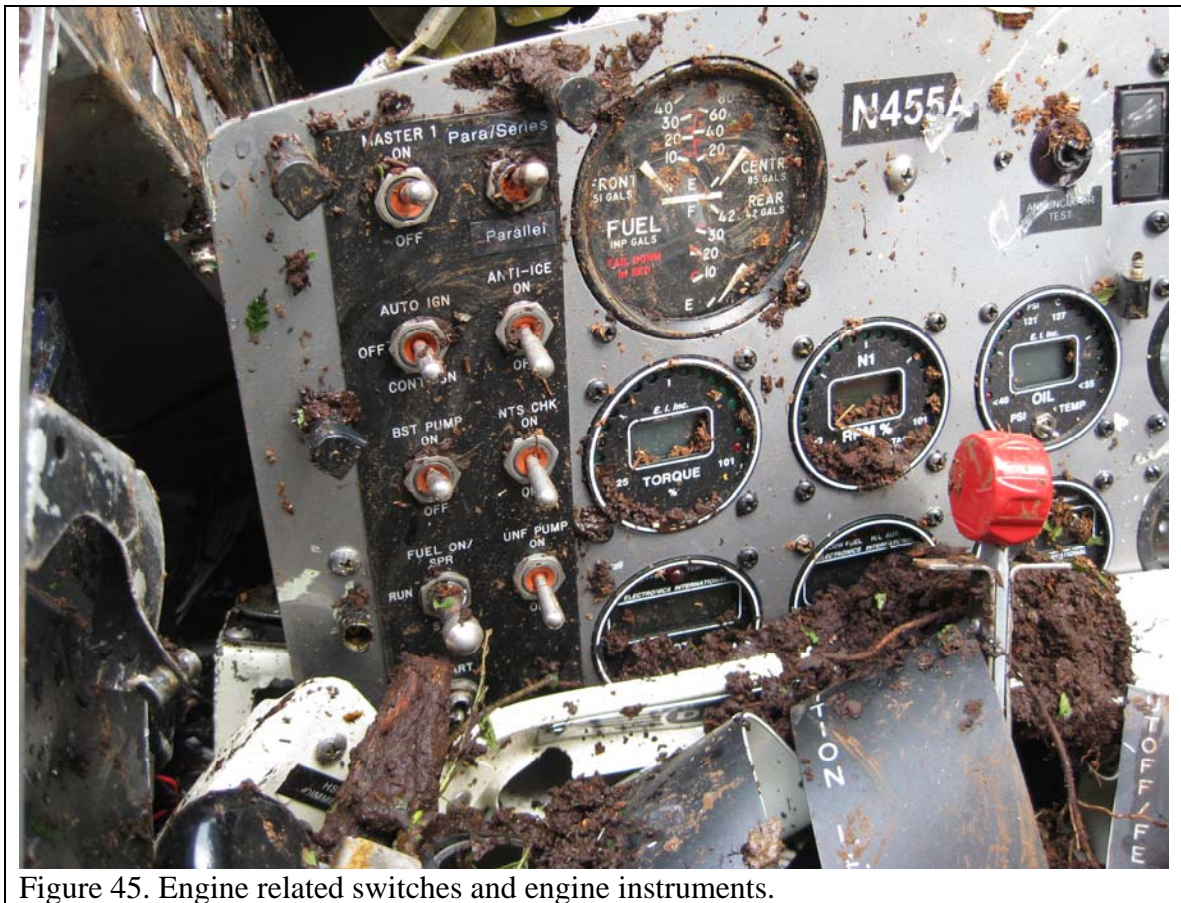
To the left of the engine indicating instruments were two columns of switches in the following positions: (See Figure 45)

Master 1	ON
Para/Serial	UP
Auto Ignition	OFF
Anti-Ice (engine inlet)	OFF
Boost Pump	ON
NTS Check	OFF
Fuel On toggle	RUN
Unfeather Pump	OFF

Figure 45. Engine related switches and engine instruments.

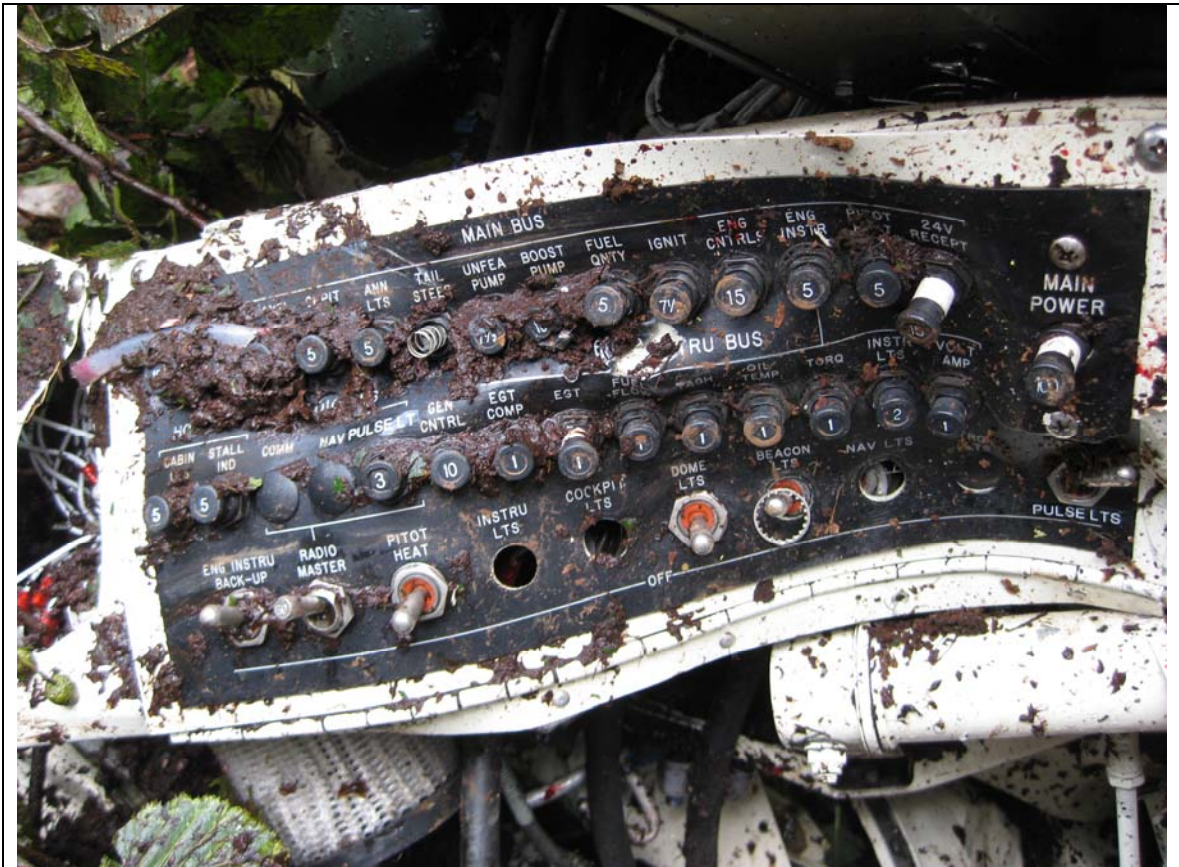
Open circuit breakers on the subpanel were marked MAIN POWER and 24V RECEPT. The fuel selector was between the REAR and the OFF positions. (See Figure 46)

Figure 46. Electrical subpanel.

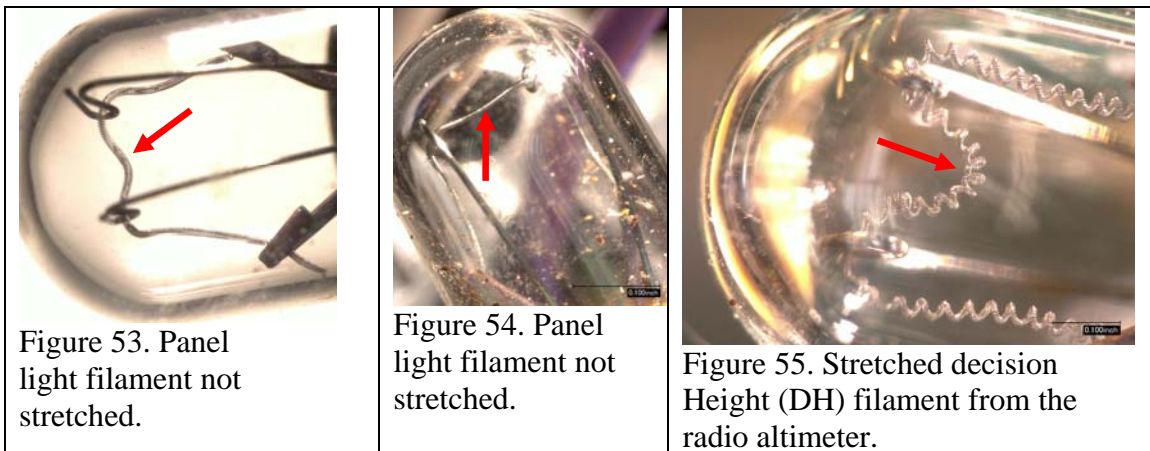
The remnants of the crushed instrument contained three light bulbs. Prior accident investigations and laboratory testing has found that tungsten filaments may stretch when hot and subjected to an impact load. Two bulbs existed for panel lighting and the third was the DH bulb. The filaments of the panel lights had not stretched and were visibly different than the stretched DH filament. (See Figures 53, 54, and 55)

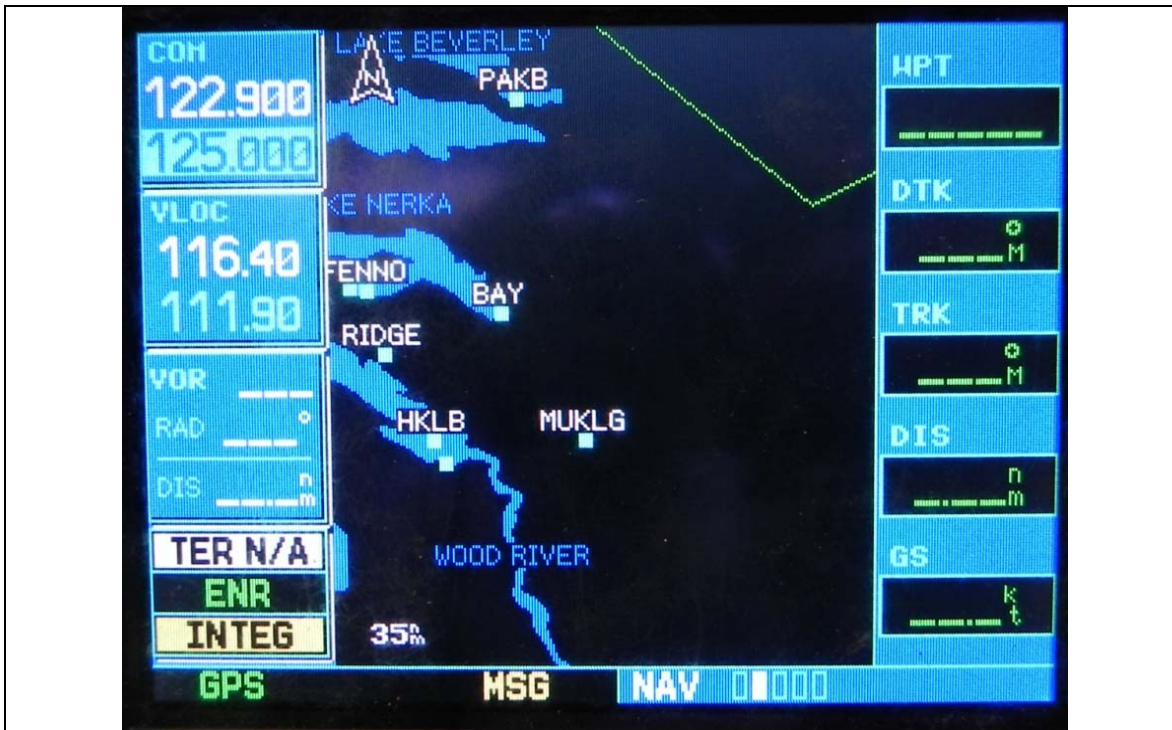
Following display of the information about the unit, this was the first map page displayed when power was first applied after the accident. The display was found on the 35 mile scale, centered near a white square icon labeled MUKLG. White square icons are user-defined waypoints.⁸

Figure 56. Map display when power was first applied. Note the display of 35 nautical mile range.

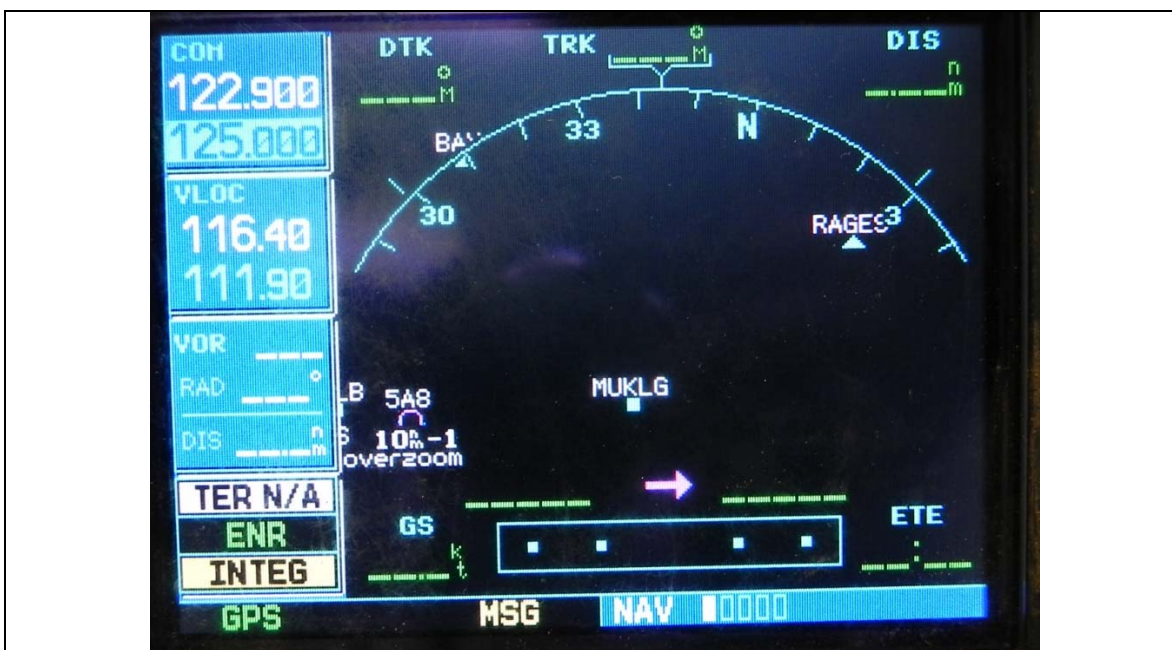
NAV Page #1 (See Figure 57) showed the 10 nm scale, centered just north of a white square icon labeled MUKLG. The DTK, TRK, GS, FROM/TO, ETE, and DIS all showed as blank lines (_ _ _).

Figure 57. The NAV page #1 display of position, after first application of power. The

display range is on the 10 nautical mile scale. The “BAY” waypoint in the upper left may be used to compare this scale with the scale shown in Figure 56. The “5A8” is the Aleknagik airport.

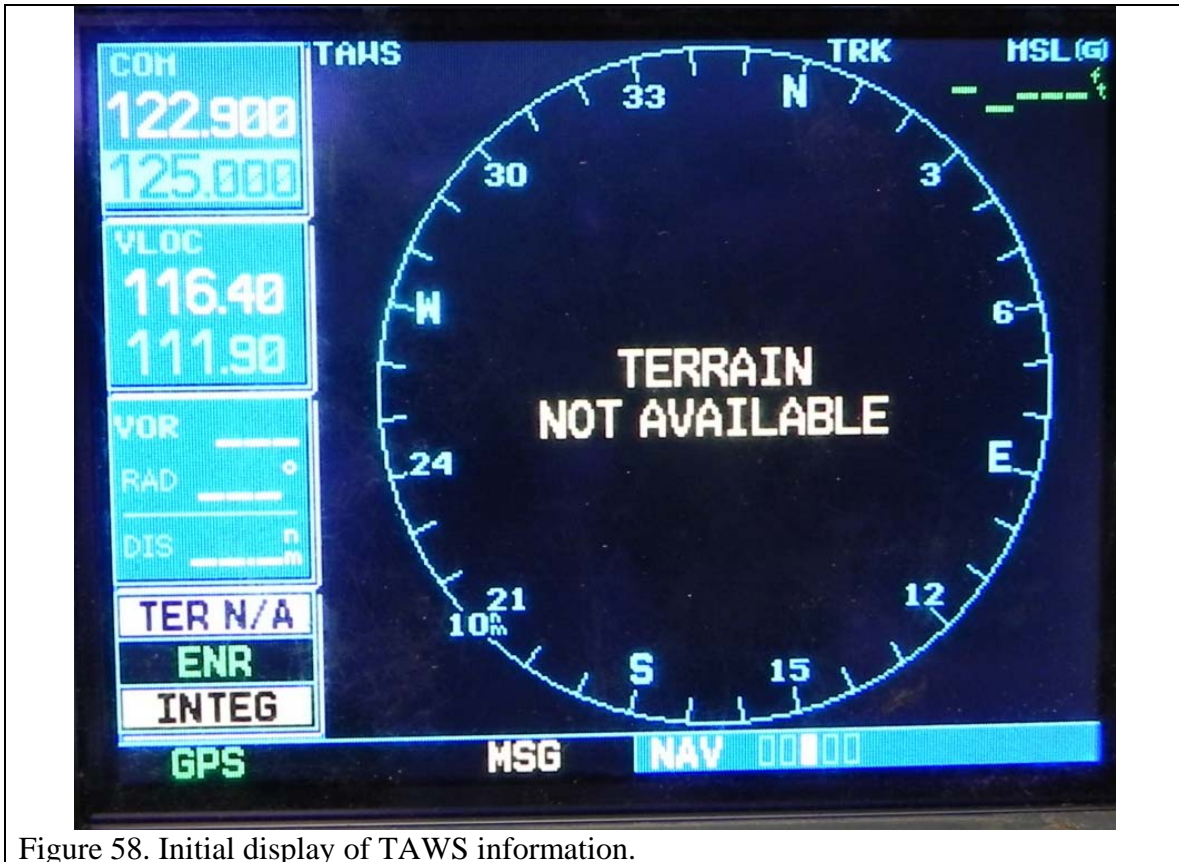
Note: The TAWS display requires satellite data for altitude, which was not available during this examination. Additional TAWS information was found on February 1, 2011, as described in a later section of this report.

Figure 58. Initial display of TAWS information.
