NATIONAL TRANSPORTATION SAFETY BOARD

AIRWORTHINESS GROUP CHAIRMAN'S FACTUAL REPORT

A. ACCIDENT: ANC10MA068
LOCATION: Near Aleknagik, Alaska
DATE/TIME: August 9, 2010
AIRCRAFT: DeHavilland Canada DHC-3 "Turbine Otter", N455A

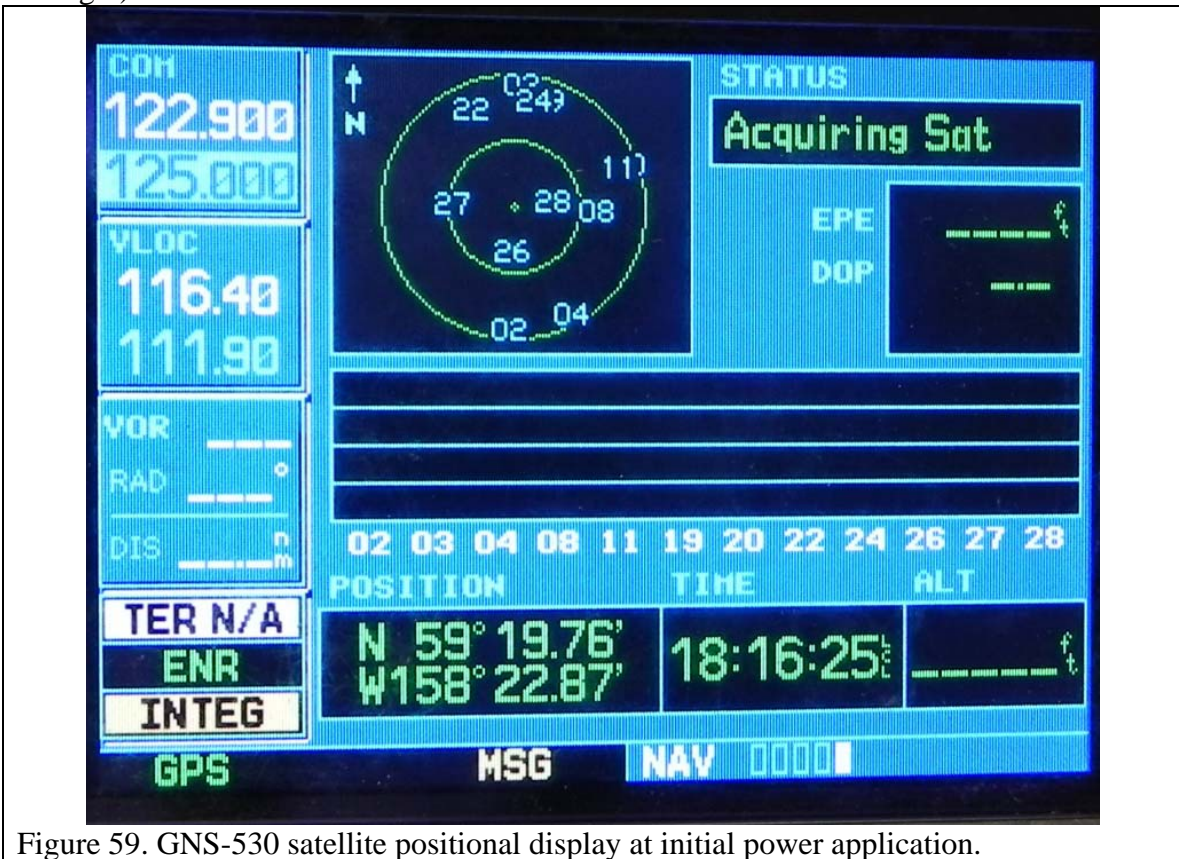
Figure 59. GNS-530 satellite positional display at initial power application.

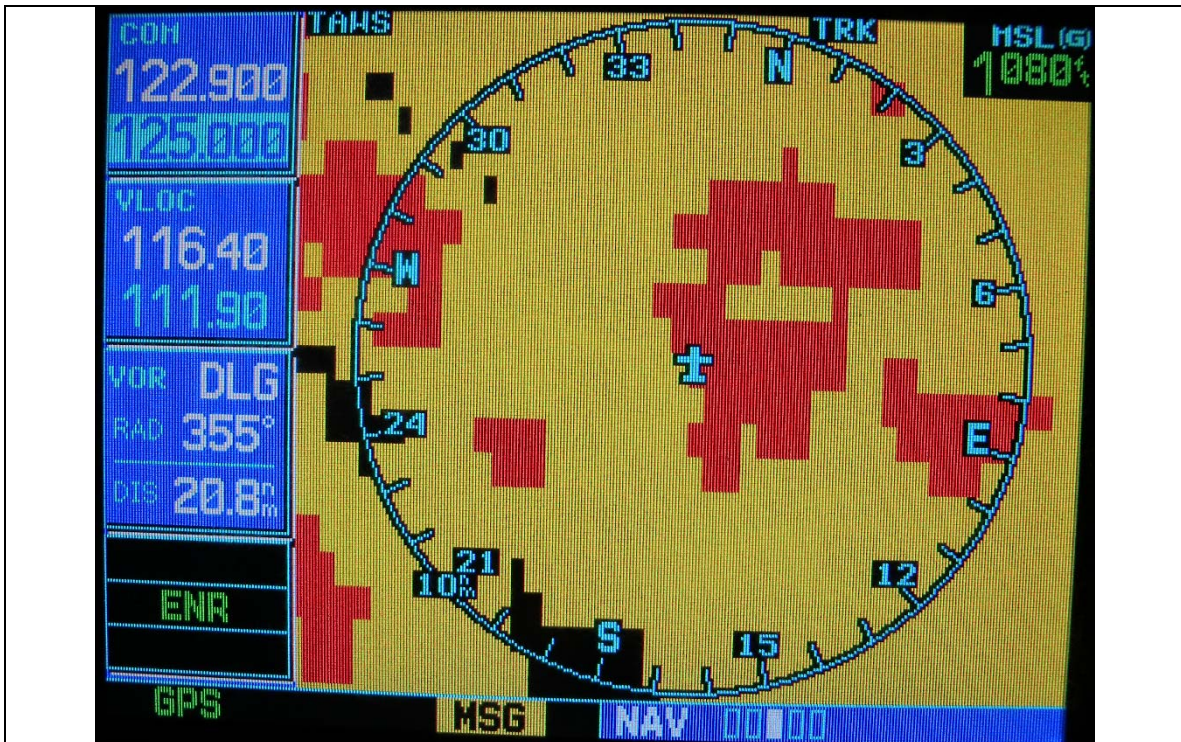
The docking station provided an altitude input for the TAWS computation. This only provided an altitude and did not change the position coordinates within the GNS-530. With an input altitude of 1080 feet above sea level, the display was almost entirely red and yellow. Further, both the large and small pass could be seen. (See Figures 66 and 67)

Figure 66. This was the TAWS display shown by the Garmin GNS-530 at a test input altitude of 1080 feet msl. Providing altitude was the only difference between this and the displays shown as Figures 57 and 58. The route to the fish camp would have been on a heading of roughly 125 degrees, to the lower right of this display. At this range, the smaller Muklung pass is not visible.

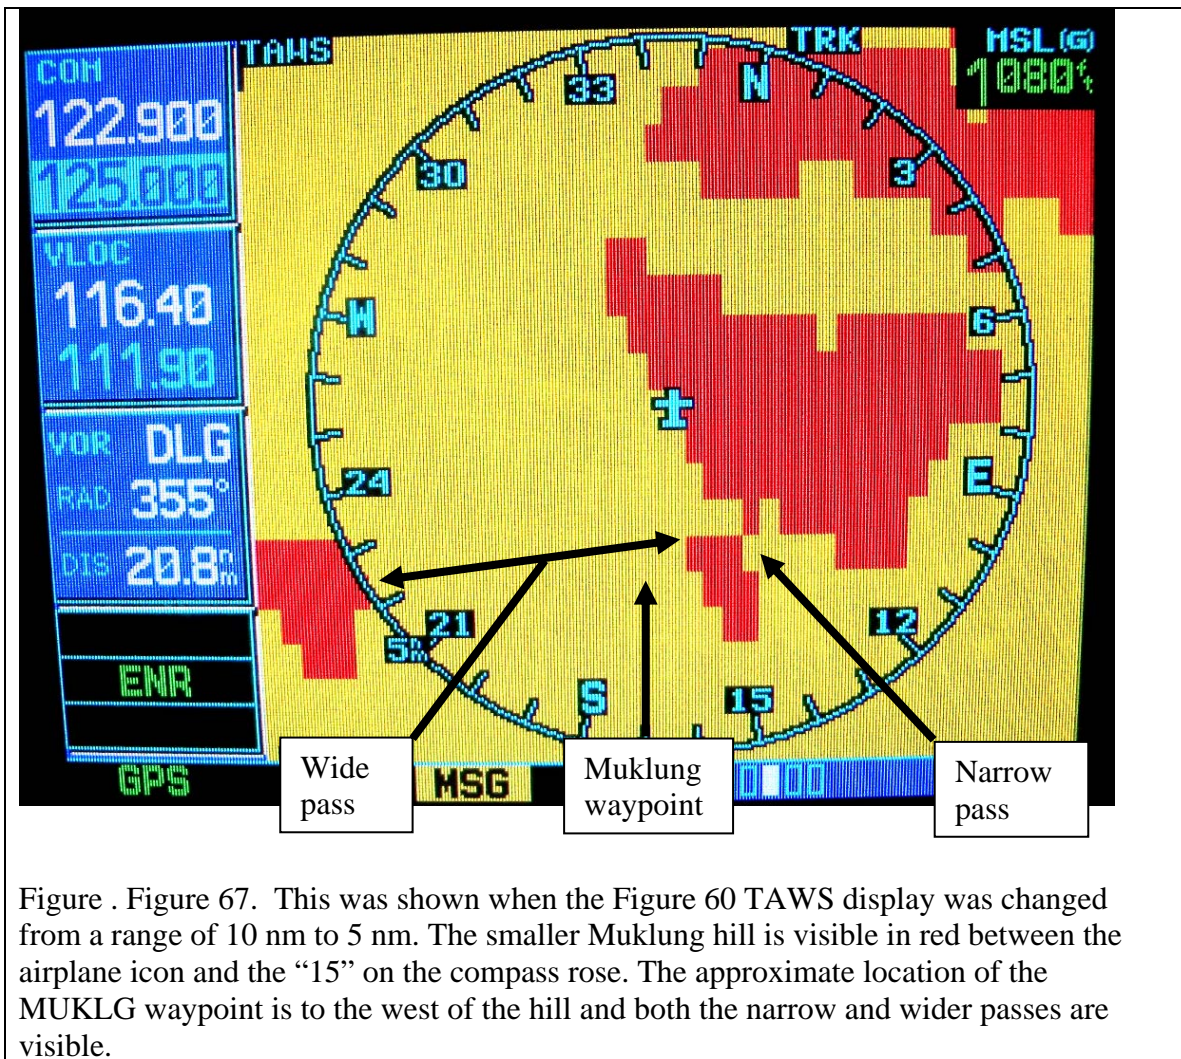
Figure . Figure 67. This was shown when the Figure 60 TAWS display was changed from a range of 10 nm to 5 nm. The smaller Muklung hill is visible in red between the airplane icon and the “15” on the compass rose. The approximate location of the MUKLNG waypoint is to the west of the hill and both the narrow and wider passes are visible.

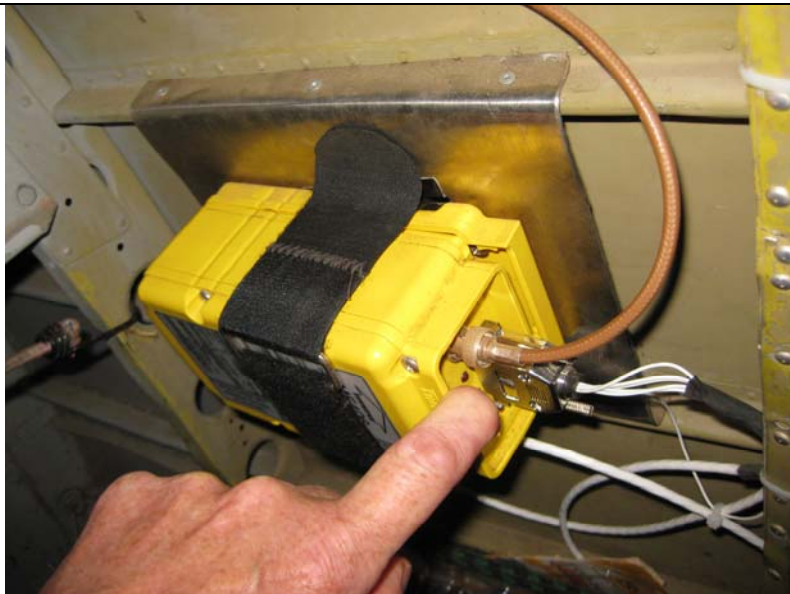
Examination of an identical plastic mount for the ELT on the left (opposite) wall of another DHC-3 Otter found that the electrical portion had contours that matched the mount and was attached by a hook and loop (Velcro) strap. However, the mating contours were shallow and if the installer did not make the strap extremely tight, finger tension could pull the ELT away from the mount. Once the leading edge of the ELT was above the height of the mount, the ELT could be thrown forward by impact, sliding out from beneath the mounting strap and breaking the antenna cable. (See Figure 71)

Figure 71. ELT in another Otter, showing gap between the ELT and mount that was created by finger tension. Forward is to the right.

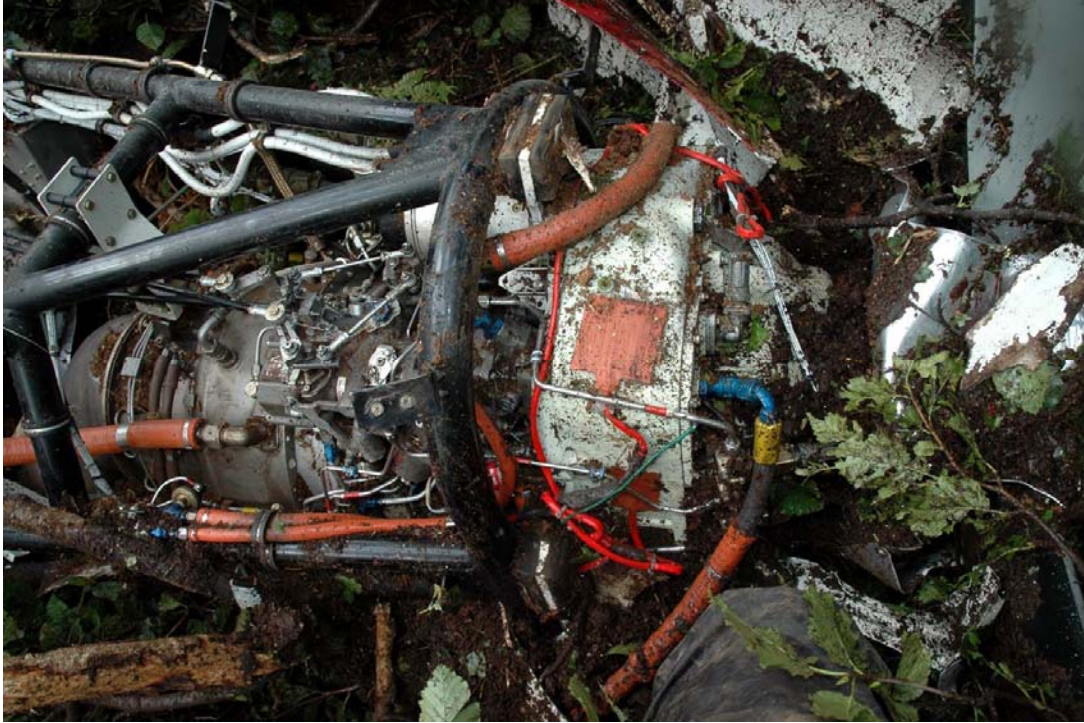
Upon removal of the right and top cowling panels, dirt was observed in the engine area. (See Figure 72) While removing a significant quantity of this dirt, care was taken to ensure that no linkage/control positions were disturbed. Removal of the dirt was required to see the details of the engine and controls.

Figure 72. Engine after the cowling was removed

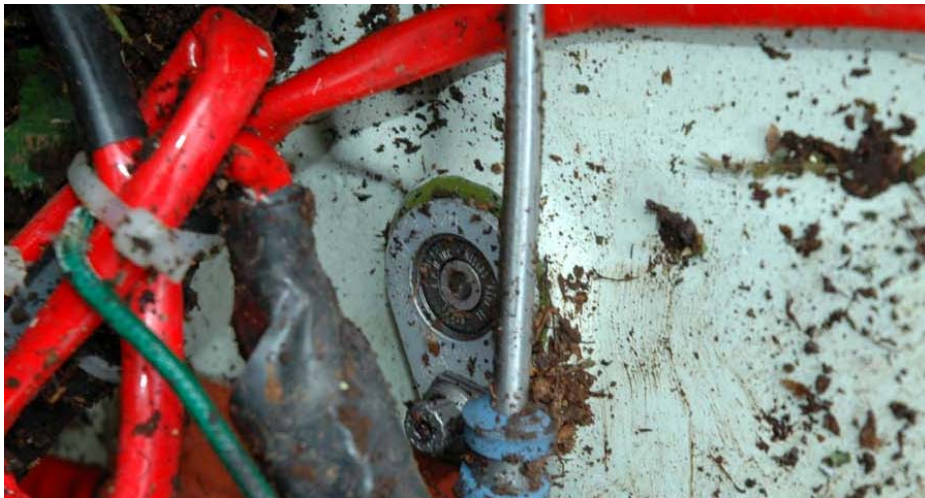
The oil filter bypass valve was found in the normal (not extended) position. (See Figure 73)

Figure 73. Oil Filter By Pass Valve

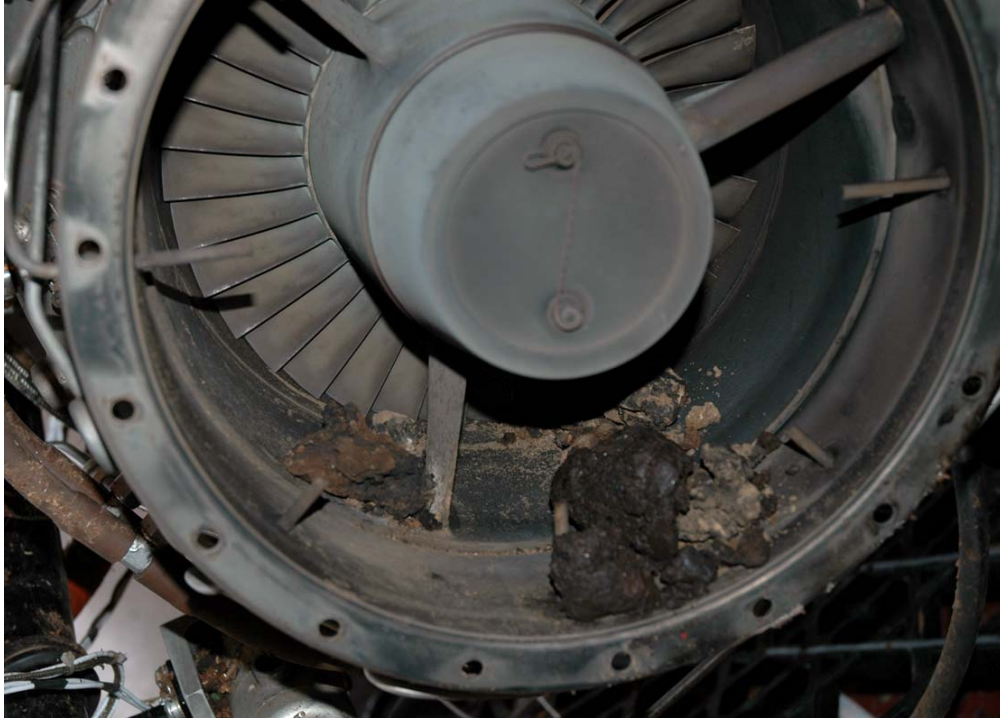
All aircraft to engine exhaust duct attachment nuts and bolts were removed to allow for the removal of the aircraft exhaust duct. Removal of this duct disclosed dirt in the engine exhaust duct area (See Figure 76). All third-stage turbine wheel blades were found to be present. Some trailing edge areas of numerous blades were observed to have small areas that were silver in appearance, consistent with the blades having come into contact with foreign material while still rotating.

Figure 76. Engine exhaust area and third-stage turbine wheel.

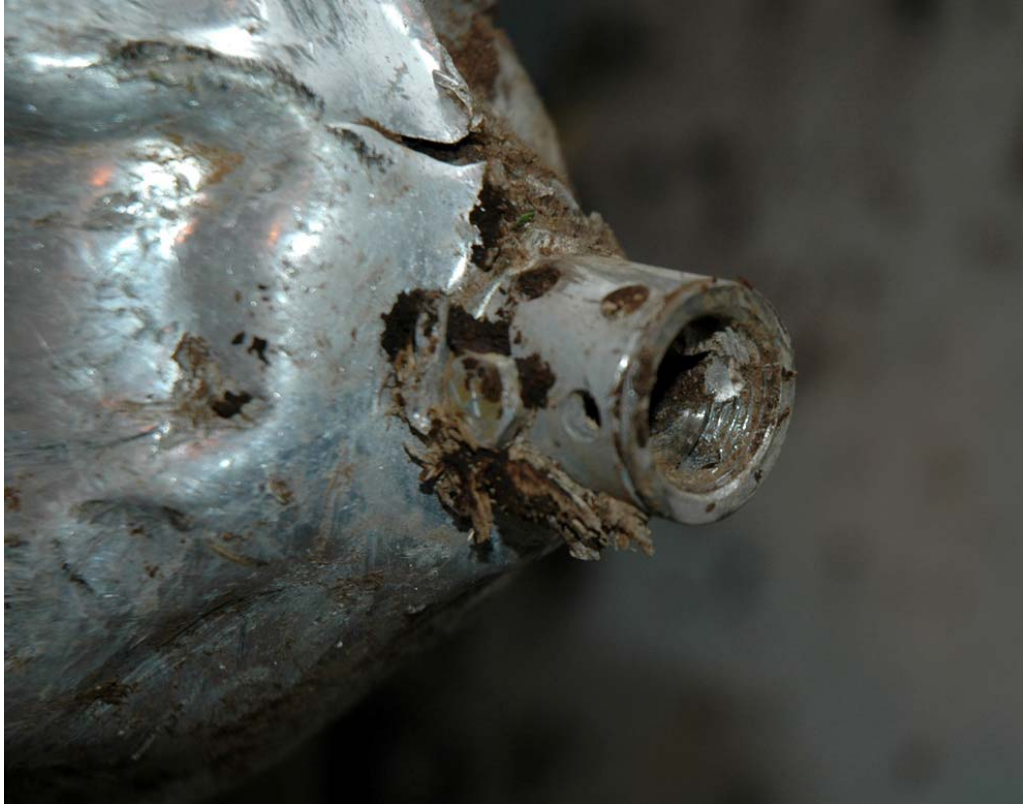
The Beta tube position in the propeller piston was photo documented prior to removal. (See Figure 77). An attempt was made to remove the Beta tube by unscrewing it from its receptacle, however, it reached a point where further rotation was not possible. As a result, the Beta tube was removed along with the propeller.

Figure 77. Propeller beta tube position
