NATIONAL TRANSPORTATION SAFETY BOARD
Office of Aviation Safety
Washington, D.C. 20594

Airworthiness Group Chairman's Factual Report of Investigation – Addendum 1

A. ACCIDENT **CEN13FA196**

Location: South Bend, Indiana
Date: March 17, 2013
Time: 1623 Eastern Daylight Time
Aircraft: Hawker Beechcraft Corporation Model 390 Premier 1A,
 N26DK

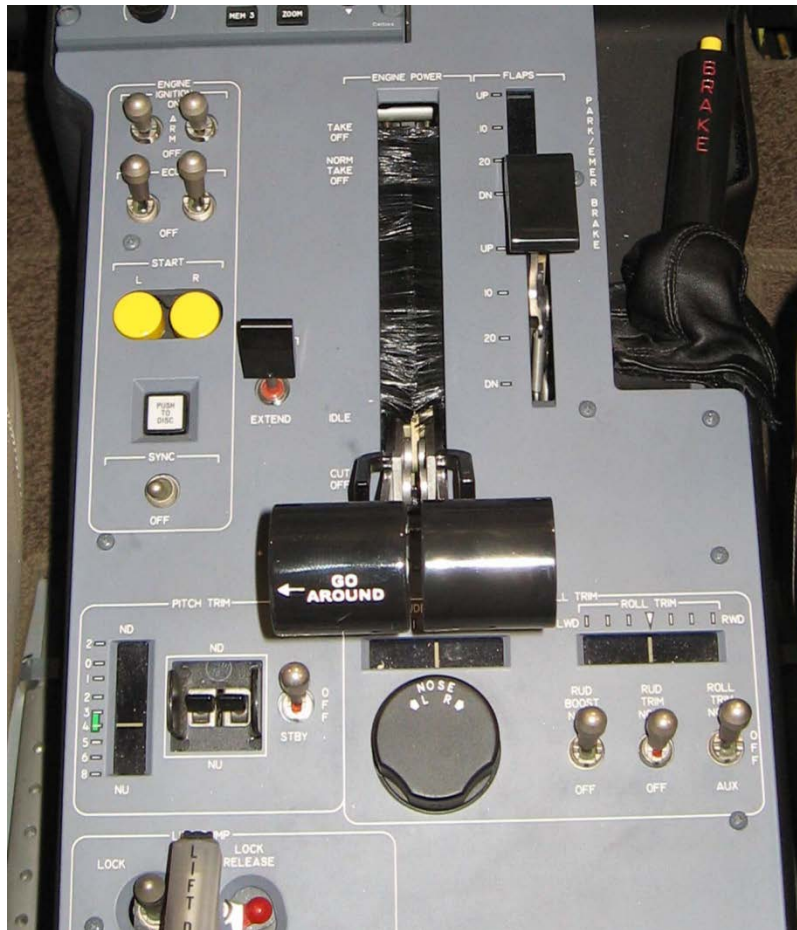
The center pedestal is labelled in four areas of the thrust levers – CUT OFF, IDLE, NORM TAKE OFF, and TAKE OFF. In addition, the thrust levers have four stop positions at each of these positions, as well as a single detent at the MCT position. To move the thrust levers forward from CUT OFF to IDLE or backward to CUT OFF, there are finger pull-up locks on the thrust levers. See Figure 6.

Figure 6 - Throttle Quadrant and Engine Controls, including IDLE and CUT OFF positions (picture taken in sister ship).
