# **NATIONAL TRANSPORTATION SAFETY BOARD**

## **AIRWORTHINESS GROUP CHAIRMAN FACTUAL REPORT**

**ACCIDENT:** CEN10FA443

**AIRCRAFT:** Hawker Beechcraft Model 390, N6JR

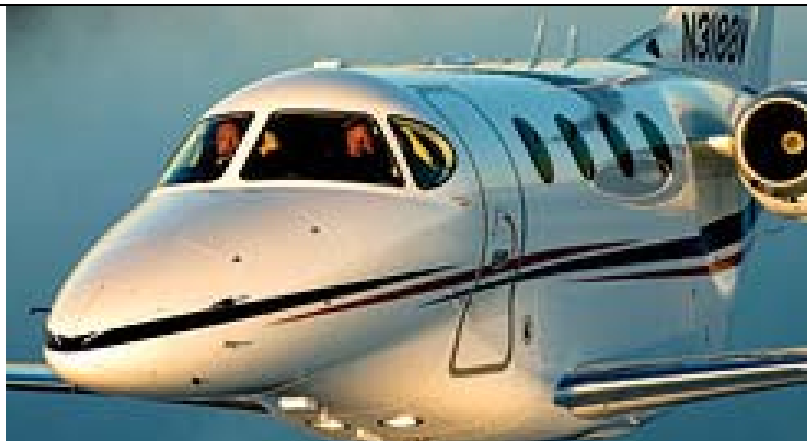
On the ground and in a level attitude, using the shoulder harnesses as a vertical reference, the position of an investigator's head placed the eye level vertically near the center of the windshield. At this vertical position, the view out of the side window placed the eye level near the top of the side window and the top of the head near the track for the window shade. A similar head position can be seen in a marketing photo of the airplane. (See Figure 13)

Figure 13. Cropped marketing photo that shows pilot head positions with respect to the side windows and window track components for orientation in the next two photos.

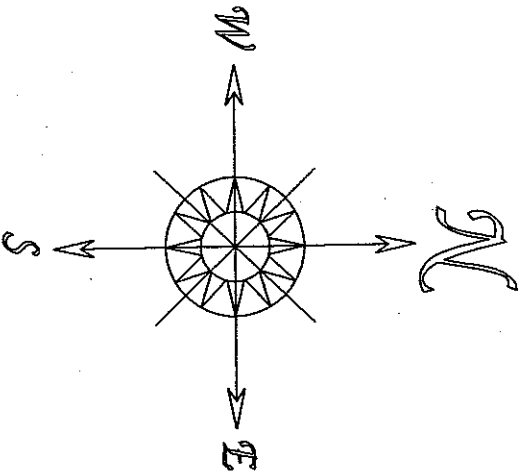
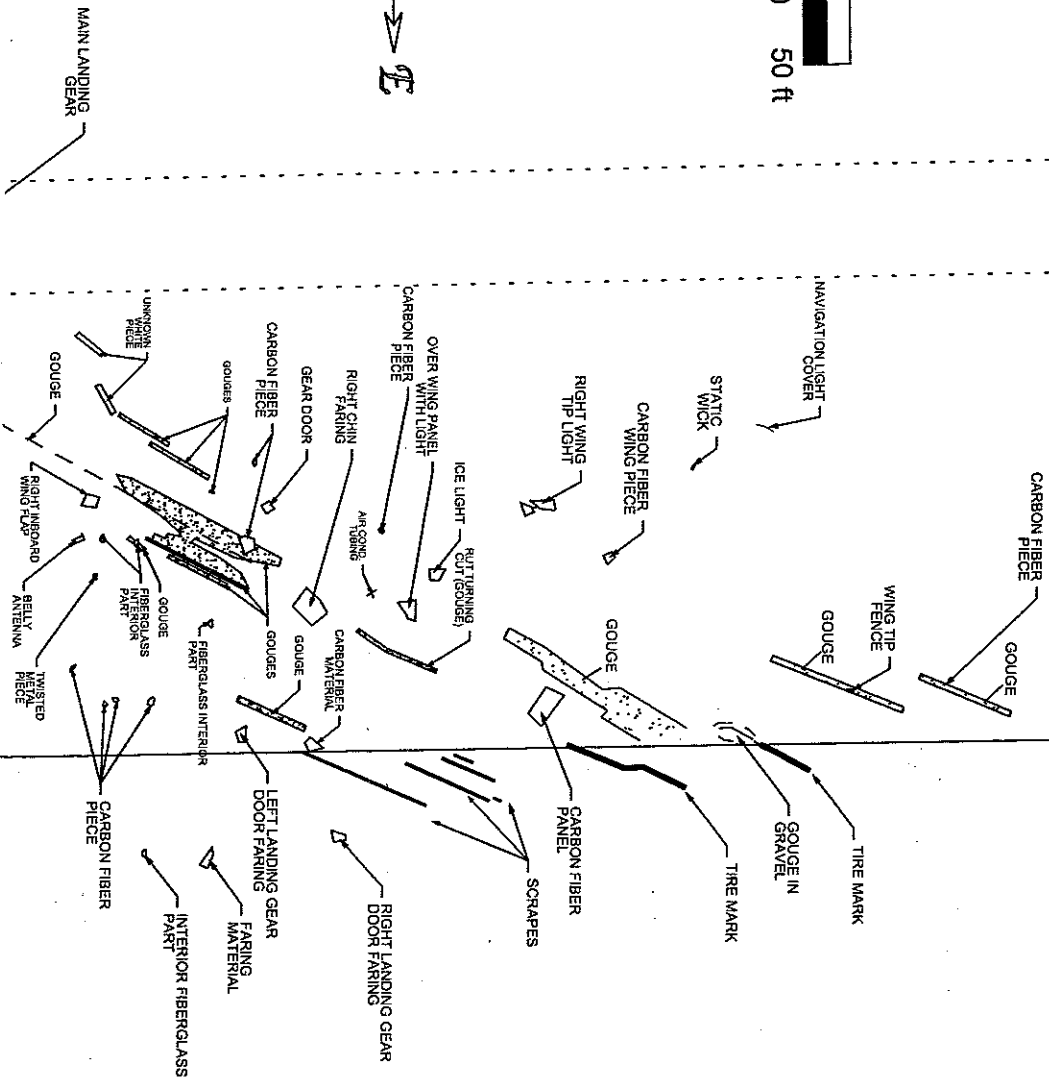
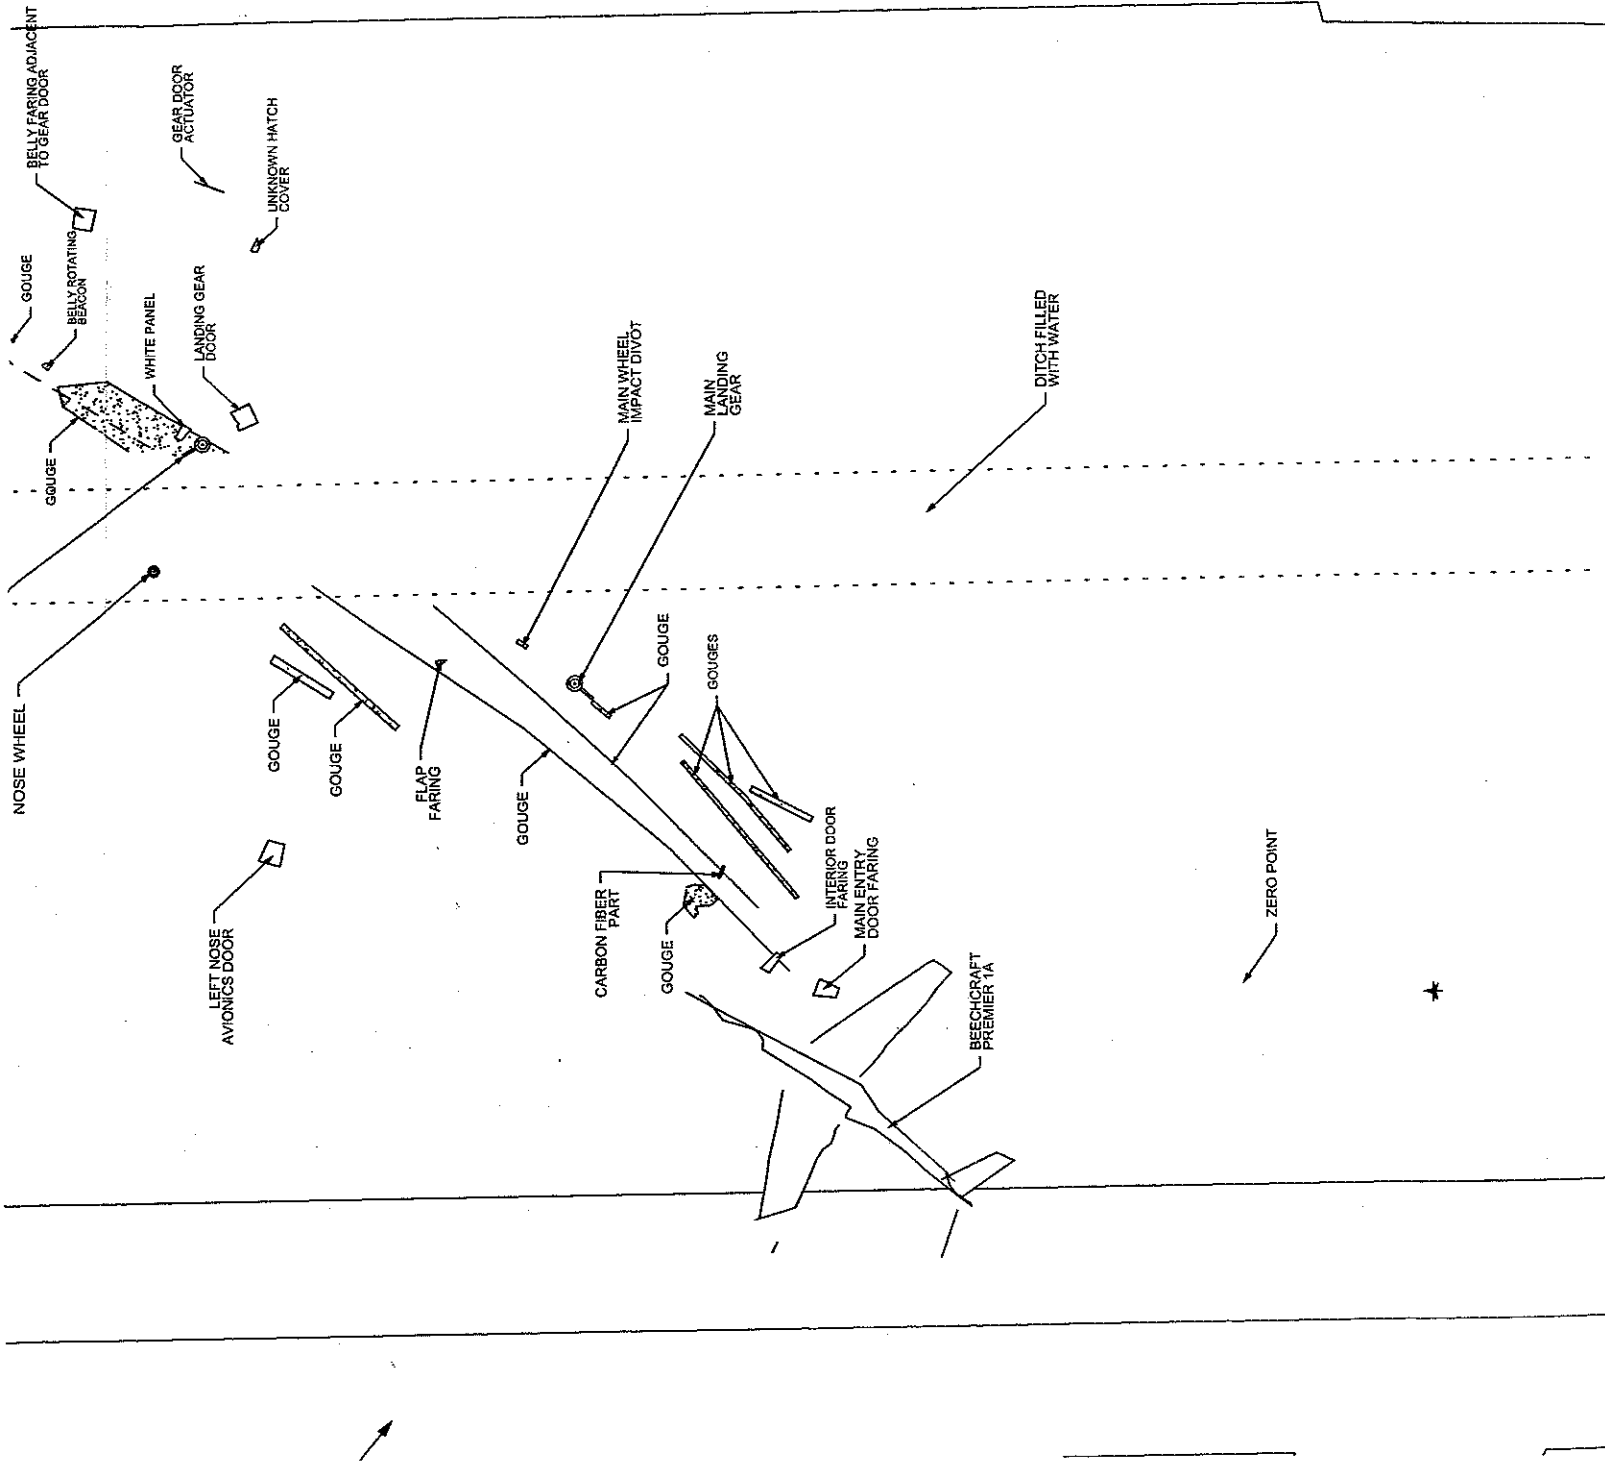
WINNEBAGO COUNTY SHERIFF'S OFFICE  
 07-27-10 10-2829 WITTMAN FIELD  
 OSHKOSH, WI BEECHCRAFT PREMIER 1A  
 MEASURED BY: LUKER W45 & PUTZER W20  
 (TOPCON TOTAL STATION GPT3107W)  
 TOPCON FC-120 DATA COLLECTOR)  
 DRAWN BY: D. PUTZER W20 (CRASHZONE 7.5.4)

A WAAS-enabled GPS and TotalStation® survey equipment used by the Winnebago County Sherriff's Department provided positional data about the debris trail.<sup>2</sup> The location of the first fragment and ground contact was about 4,300 feet from the southern end of the pavement for the main runway that the airplane had been traveling toward. (See Figure 2)

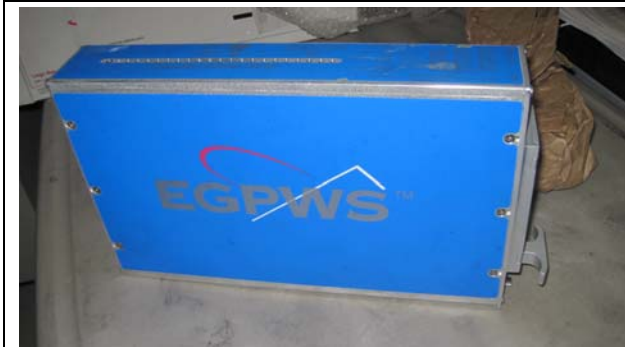
Photo 1: View of the EGPWS unit as received.

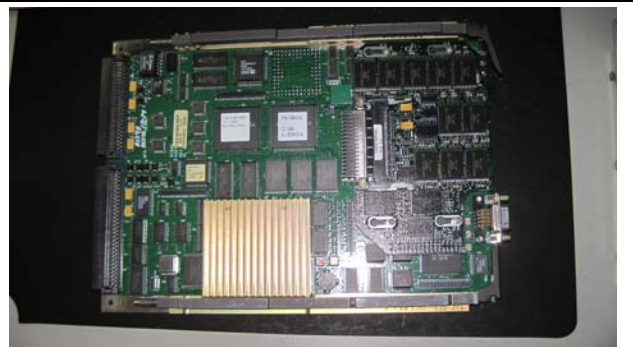
Photo 2: View of the internal PCB that contains the flash memory chips.
