----- AIRWORTHINESS GROUP CHAIRMAN'S FACTUAL REPORT -----

Location: Las Vegas, Nevada
Date: September 8th, 2015
Time: About 1627 PDT
Aircraft: Boeing 777-200
Serial Number: 29320
Registration: G-VIIO

3. SUMMARY

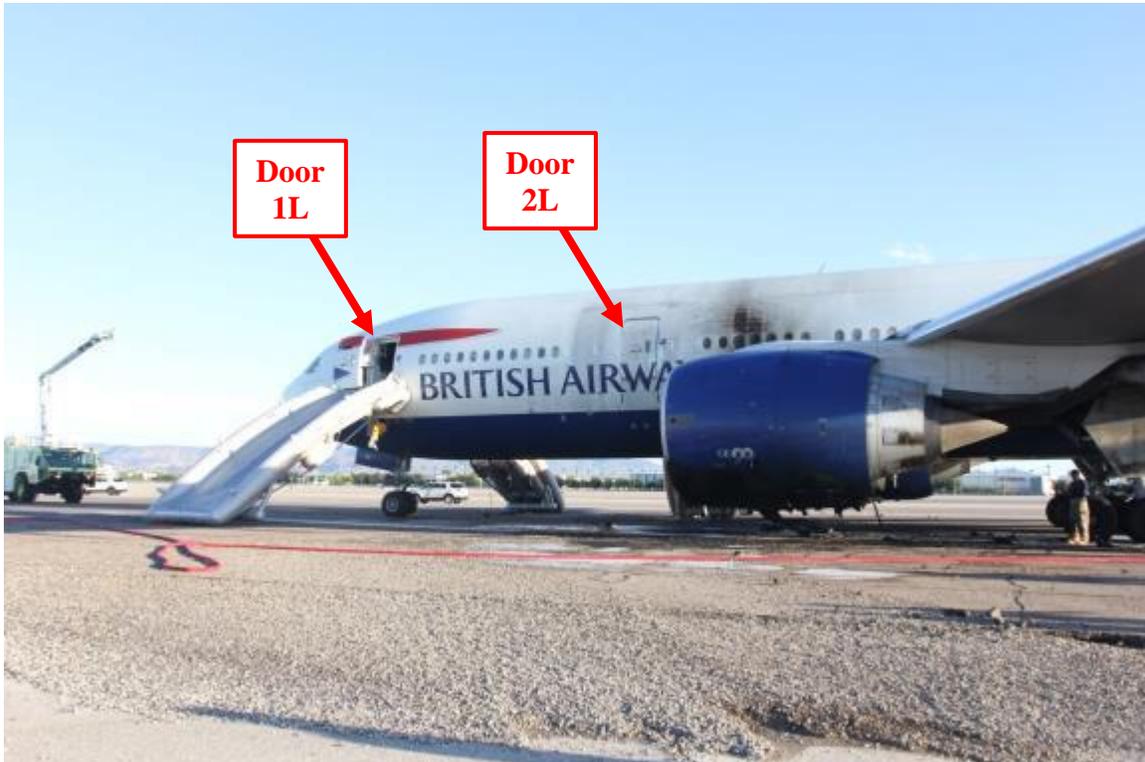
The aircraft came to rest on RWY 7L where the passengers and crew evacuated the aircraft. Five (1L, 4L, 1R, 3R, 4R) of the eight entry doors were opened during the evacuation with slides deployed. Door 2R was opened following the evacuation and the slide was deployed. Figure 1, Figure 2 and Figure 3 show the doors after the evacuation was complete and prior to the aircraft being relocated.

Figure 1 - View of FWD LHS of the aircraft on RWY 7L, doors 1L and 2L shown

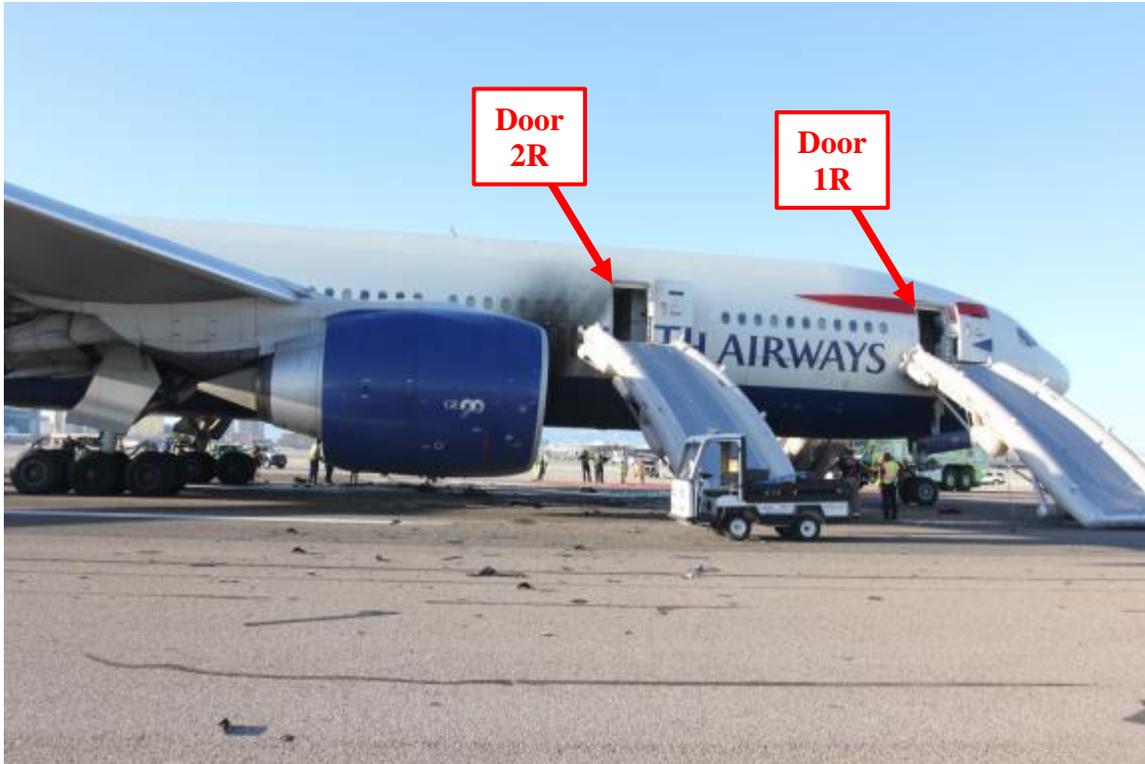
Figure 2 - View of FWD RHS of the aircraft on RWY 7L, doors 1R and 2R shown

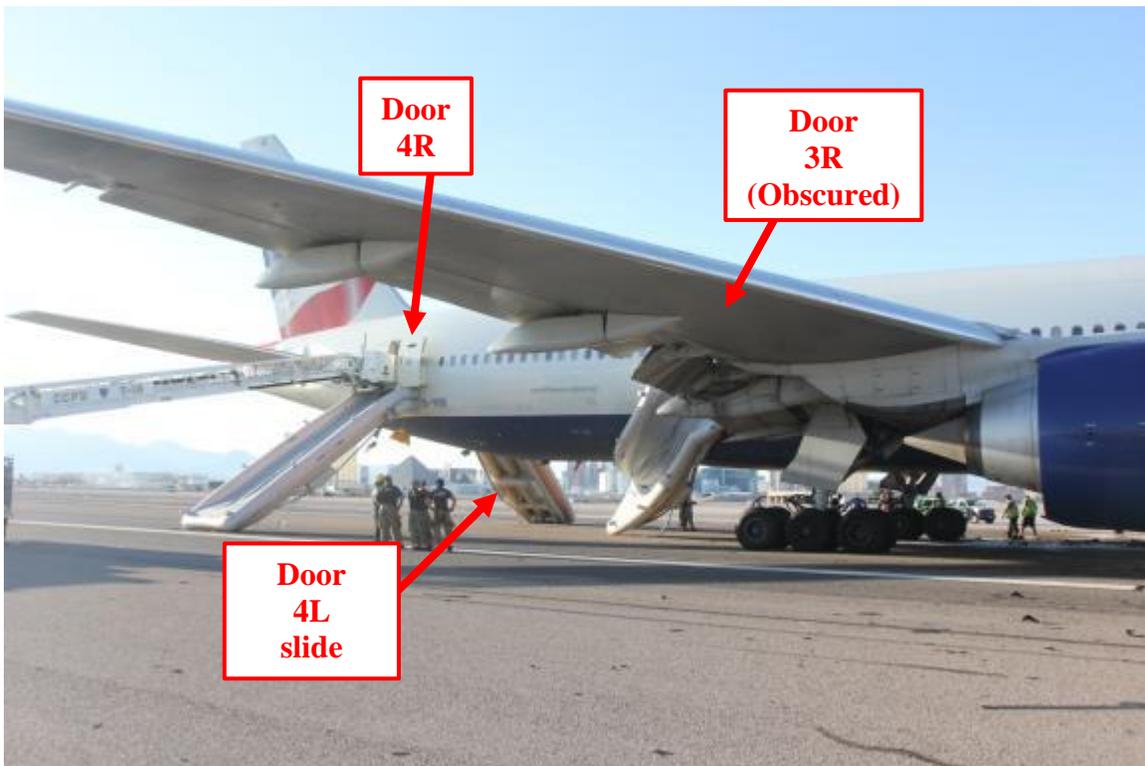
Figure 3 - View of aft RHS of the aircraft on RWY 7L, doors 3R and 4L obscured and 4R shown.

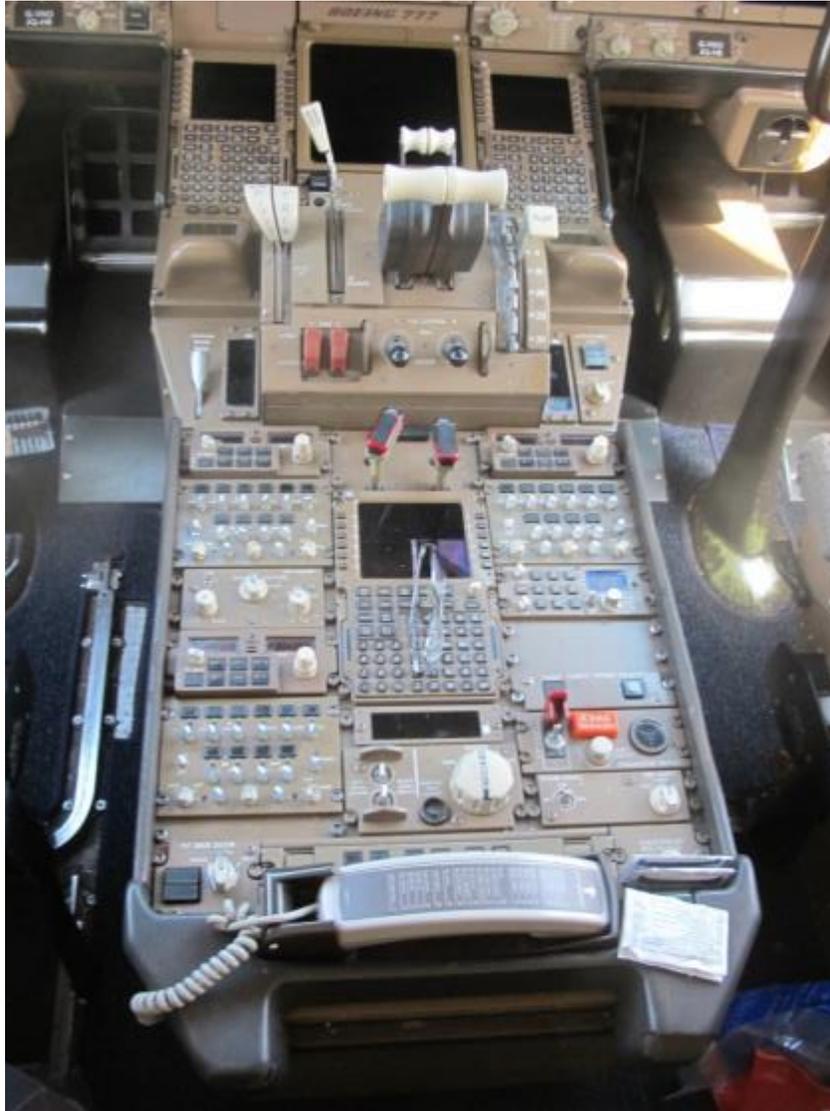
The following lists the condition of relevant handle and switch positions located on the center pedestal, see Figure 6:

- The parking brake was not set.
- The Flap handle was in the 5 position.
- L and R TLA's were in the idle position and the thrust reverser piggybacks stowed.
- L and R FUEL CONTROL switches were in the CUTOFF position.
- L ENG FIRE handle was in the pulled position and rotated towards the number 2 fire bottle position; Figure 7 and Figure 8.

Figure 6 - Center Pedestal

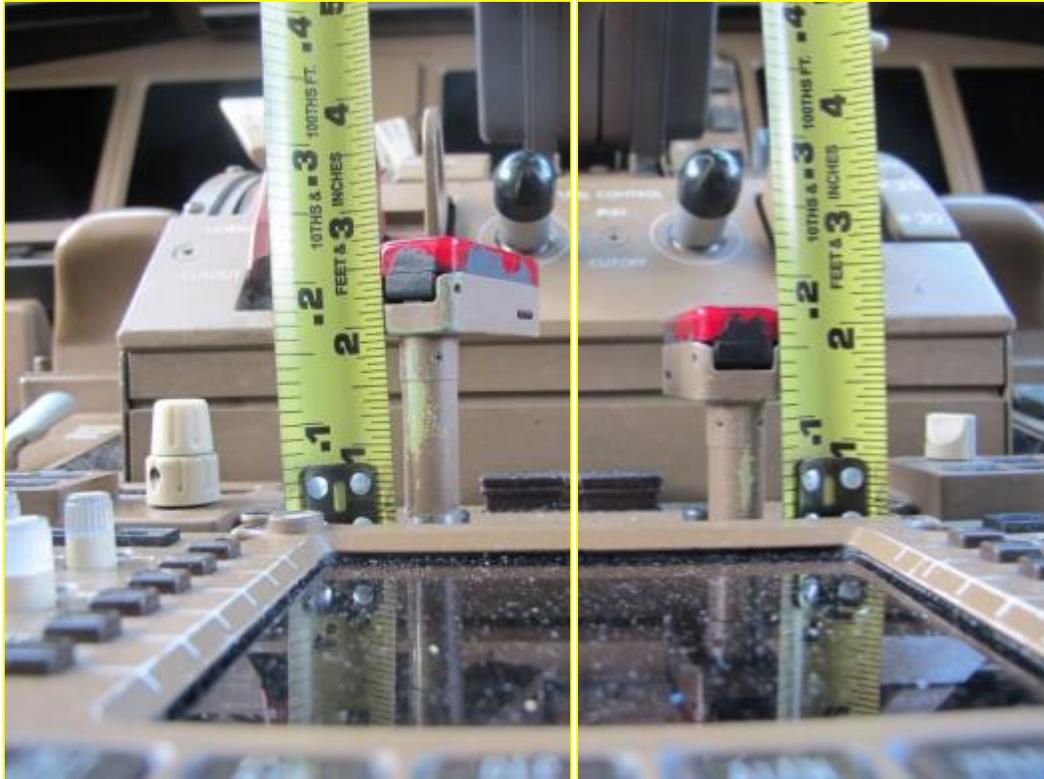
- R ENG FIRE handle was in the not pulled position and was not rotated towards either the number 1 or number 2 fire bottle positions; Figure 7 and Figure 8.
- The guard on the evacuation command switch was raised and the “Command” switch was in the ON position, Figure 9.

Figure 7 - Left and Right Fire Handles - Side View looking forward

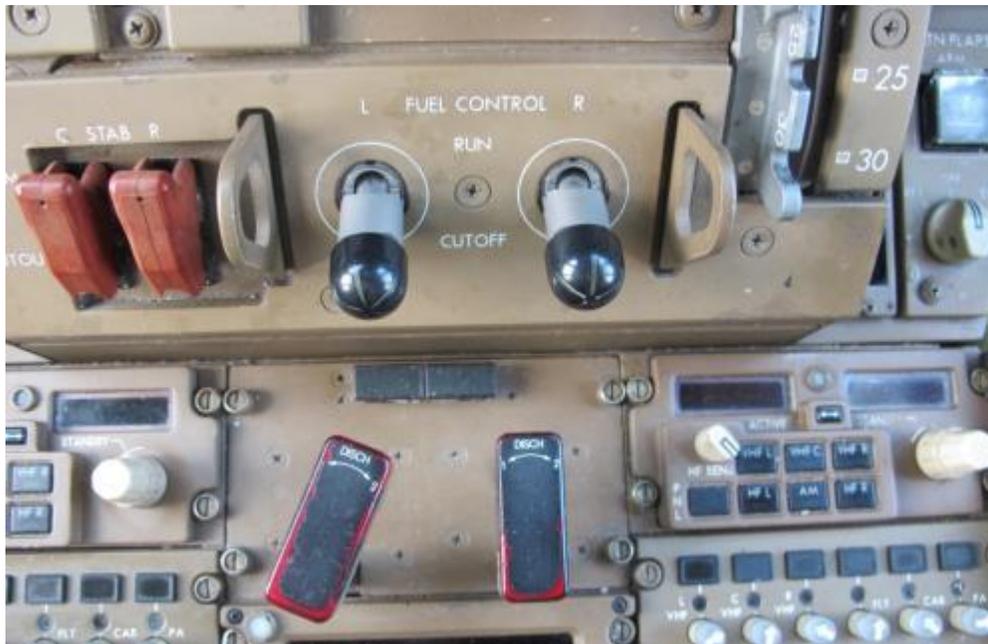
Figure 8 - Fuel control and fire handles – View looking down

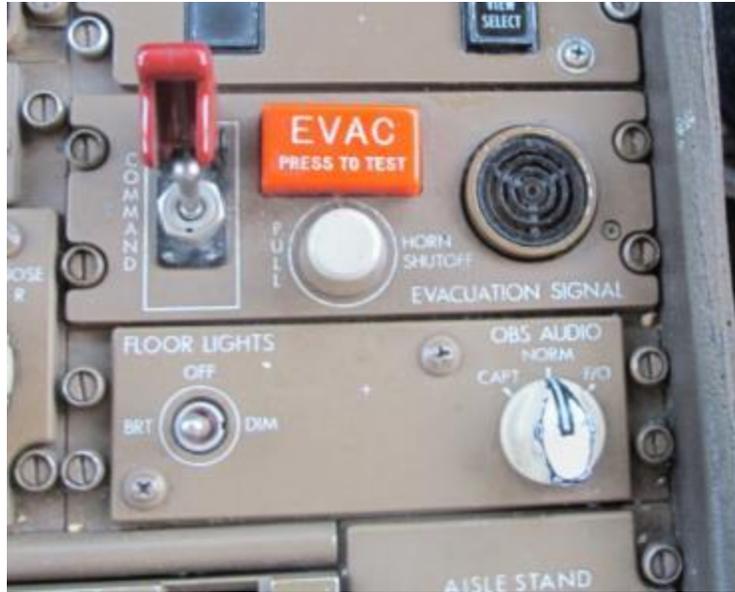
Figure 9 - Evacuation Panel

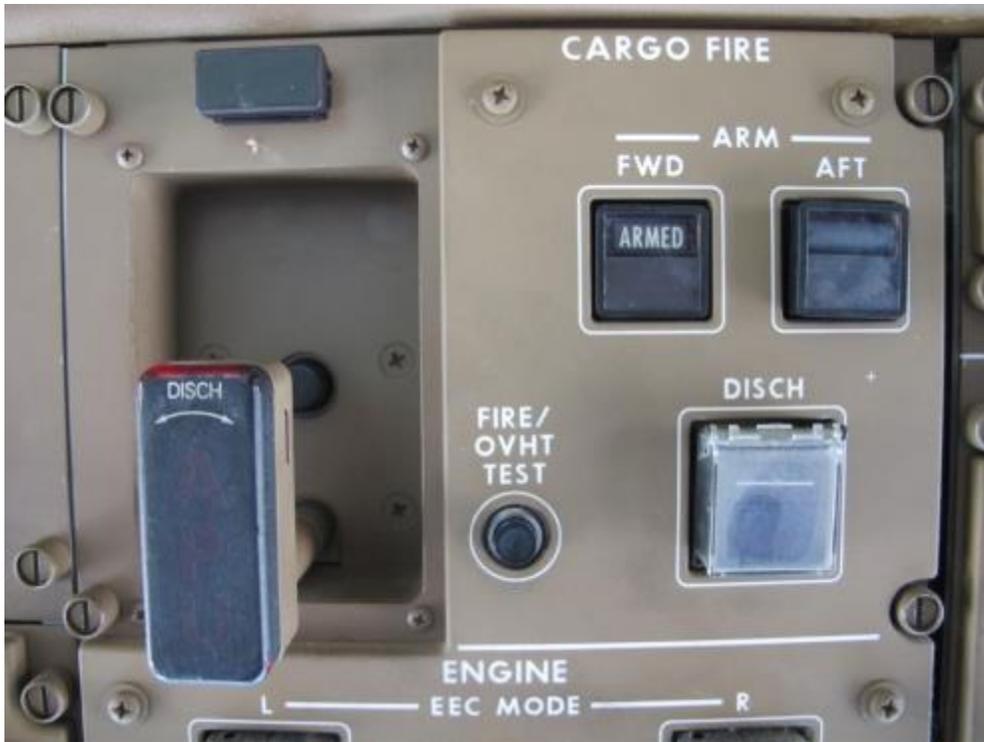
- APU/Cargo Panel - The FWD cargo bay arm switch was armed and depressed, Figure 10.
- APU/Cargo Panel - The AFT cargo bay arm switch was not armed and not depressed, Figure 10.
- APU/Cargo Panel - The APU fire handle was extended 2.75 inches and not rotated, Figure 10.
- Pressurization Panel - Both outflow valves (FWD and AFT) were in the MANUAL position, Figure 11.
- Fuel Panel - Both L and R center fuel pumps were ON, Figure 12.
- Fuel Panel - Both FWD and AFT, L and R fuel pumps were ON, Figure 12.

Figure 10 - APU and Cargo Fire Panel

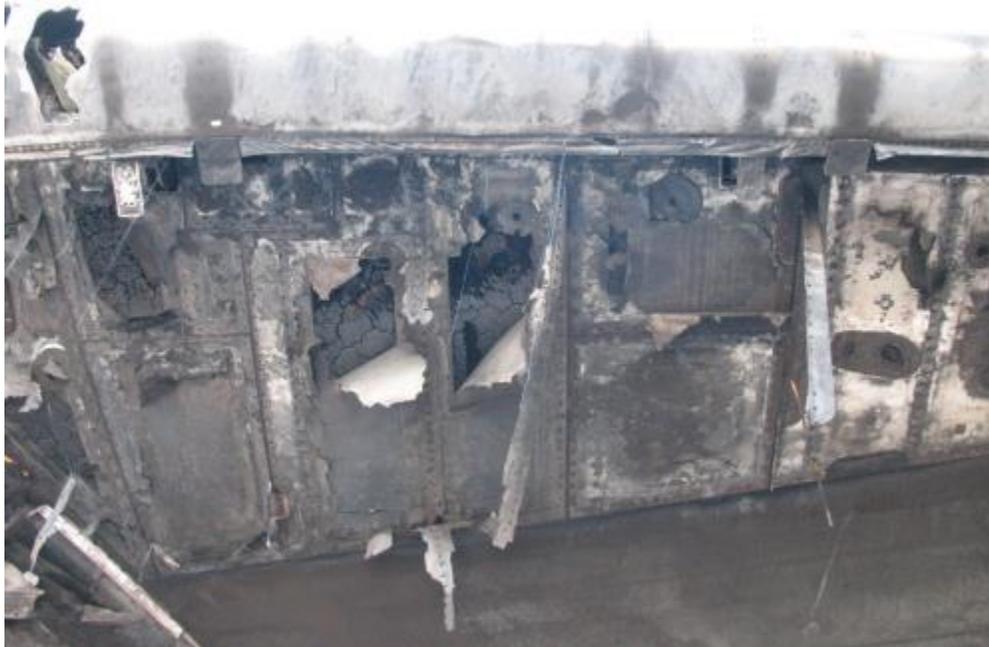
Figure 17 - View of bottom surface of left wing fixed leading edge.

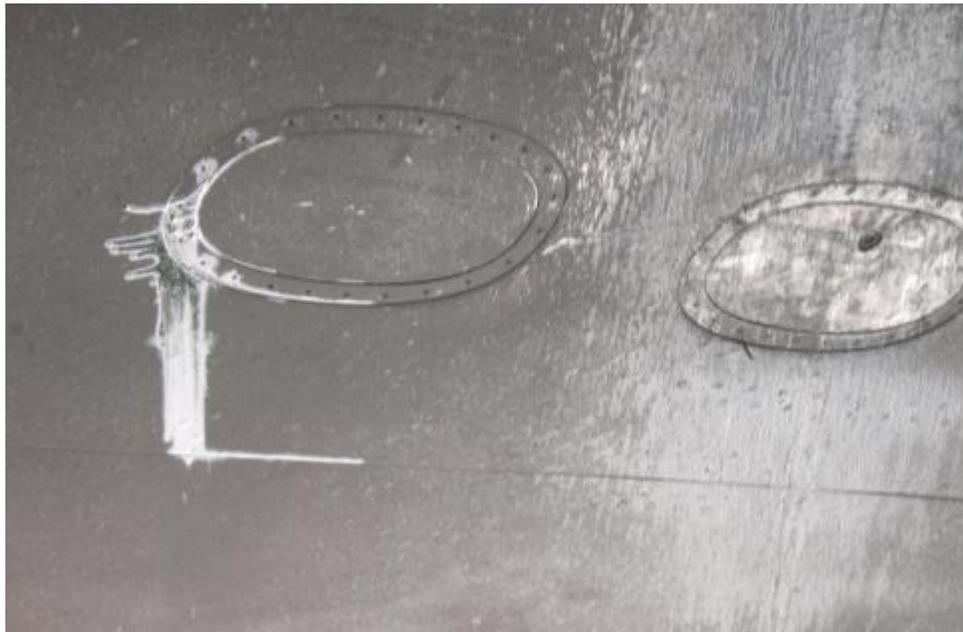
Figure 18 - Fuel tank access door on the inboard (of the engine) portion of the wing.

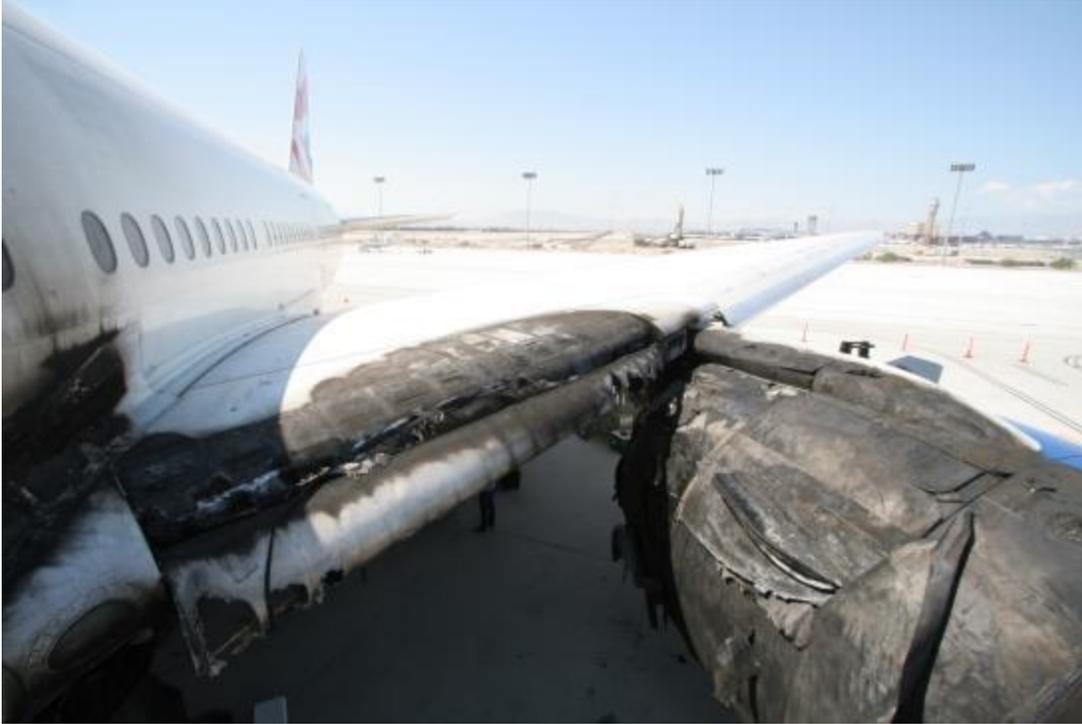
Figure 19 - Left wing upper surface of fixed leading edge.

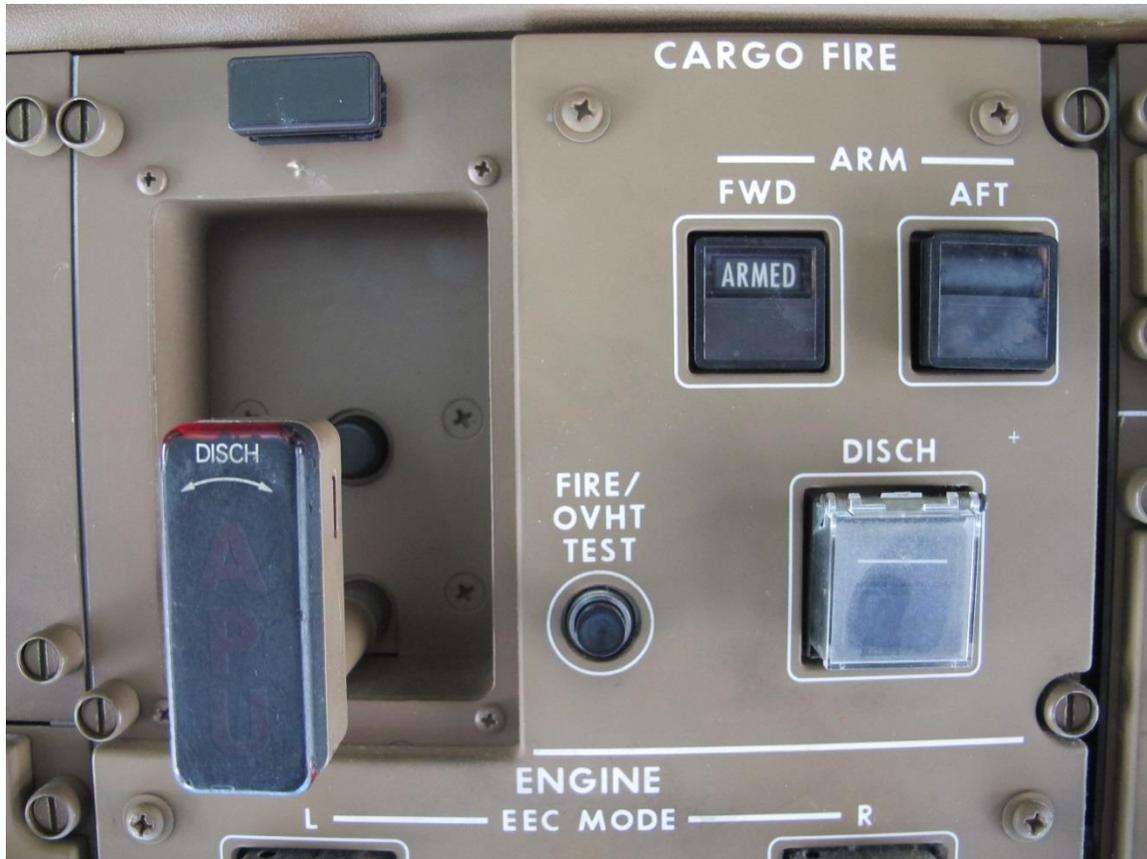
- The FWD cargo fire warning light on the overhead panel comes on, Figure 41

Figure 41 - Cargo Fire/Engine control panel from accident aircraft as found

The Cargo Fire/Engine control panel was documented by the group during the cockpit examination, see Figure 41. The forward cargo compartment arm pushbutton was found armed and depressed. The forward pushbutton displayed “ARMED”. The aft cargo compartment arm pushbutton was found not armed and not depressed. The “DISCH” pushbutton guard was in the guarded position.

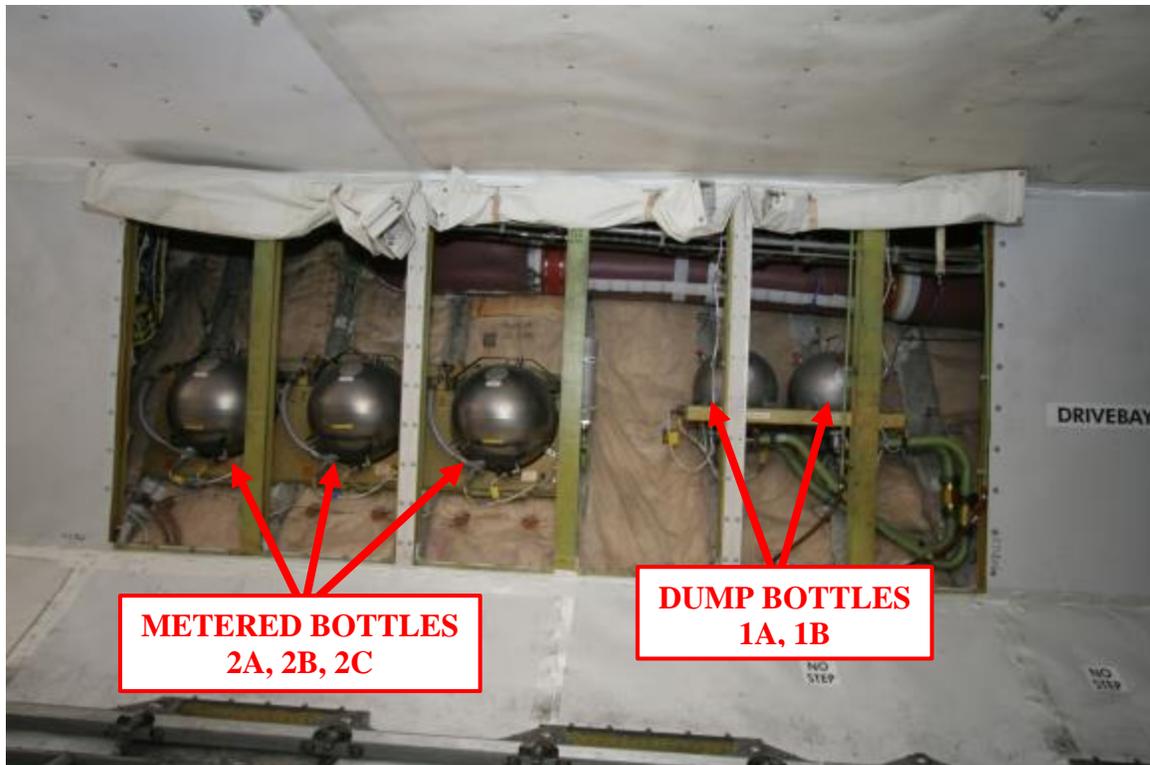
The two dump bottles (1A and 1B) and the three metered bottles (2A, 2B, and 2C) are mounted along the right hand side of the aircraft, below the main cabin floor, adjacent to the forward cargo compartment, see Figure 42.

Figure 42 - Cargo fire extinguishing system bottles

As stated previously in 4.5.2.5, the cargo compartment and liners looked normal, no soot or thermal damage was evident. The cargo liners on the right hand side of the aircraft were opened between frames 655 and 772 to reveal the cargo fire bottles, see Figure 42.

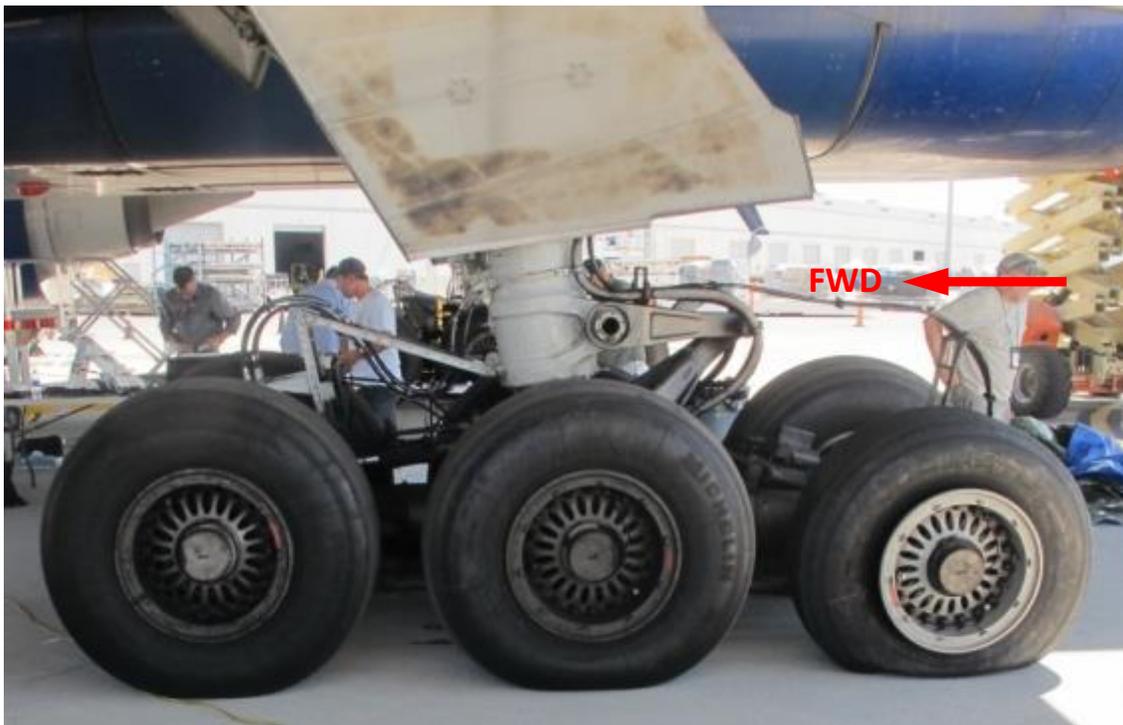
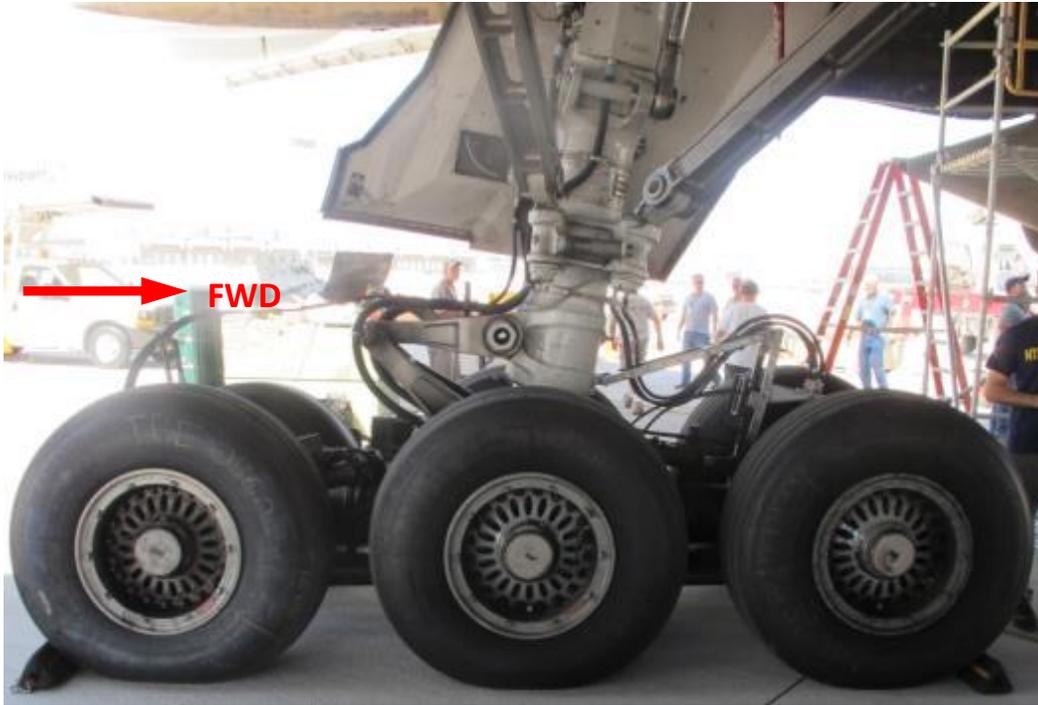
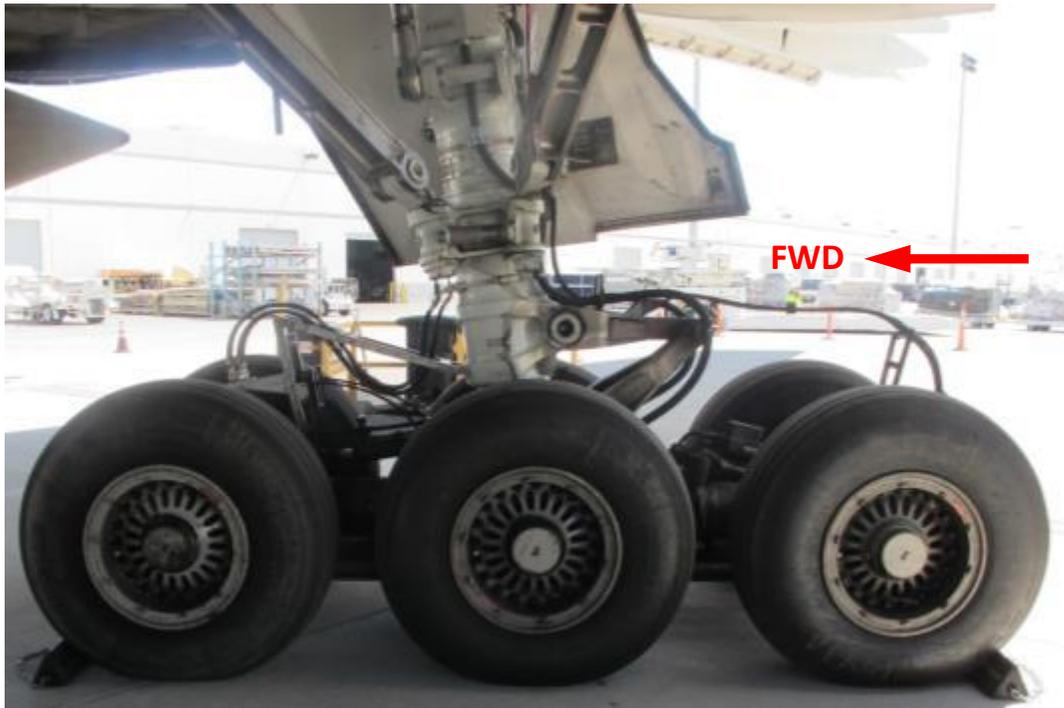
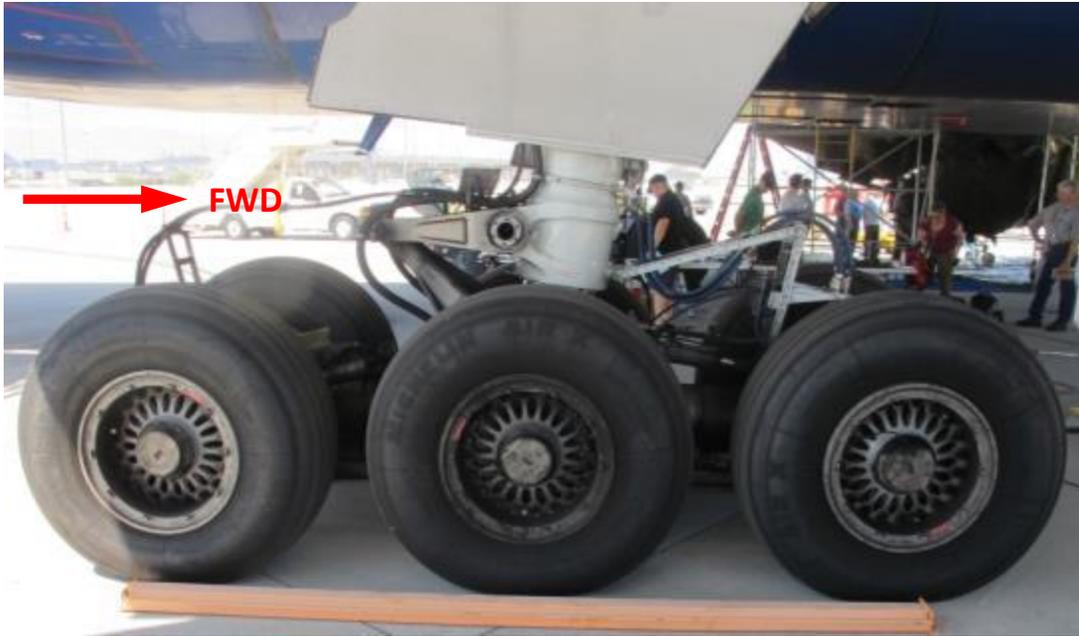
A visual inspection at the cargo ramp of the visible sections of all tires of the main landing gear showed no signs of flat spotting on the tread area of the tire.
