Rockwell Collins CRASH INVESTIGATION REPORT FOR THE FMC-3000

AIR-13-05

LOCATION: South Bend Regional Airport, Indiana

AIRCRAFT TYPE / TAIL: Beechcraft Premier 1A / N26DK SN: RB-226

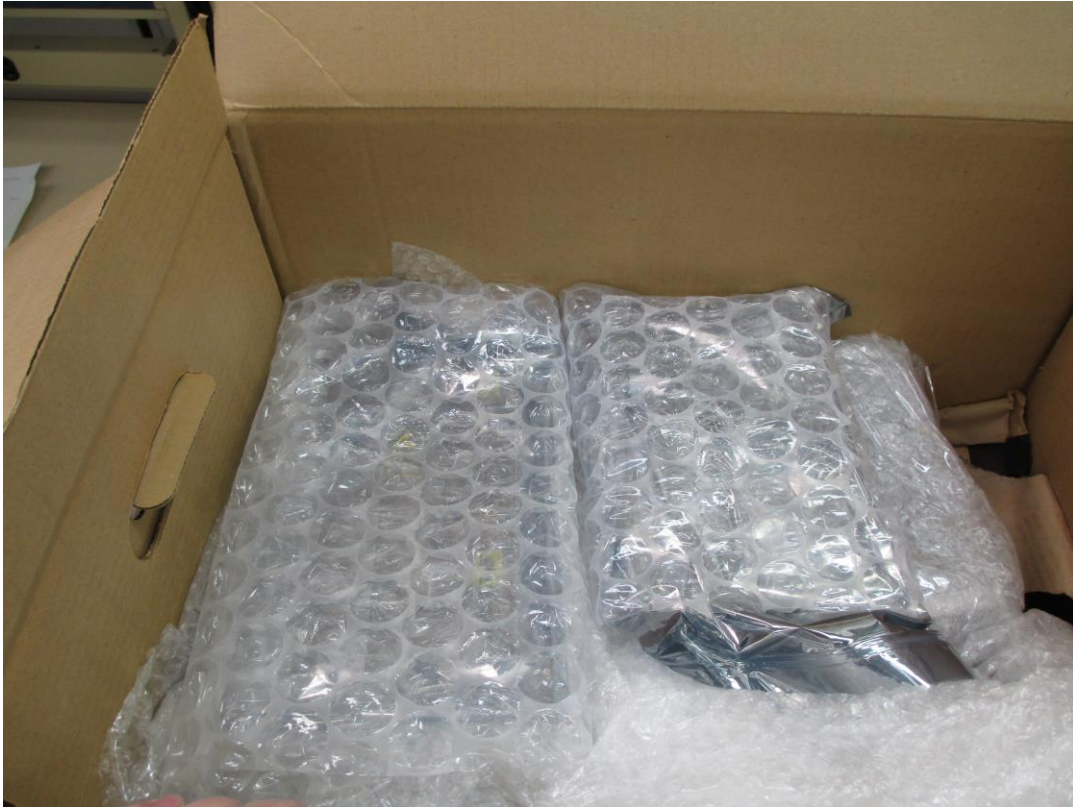
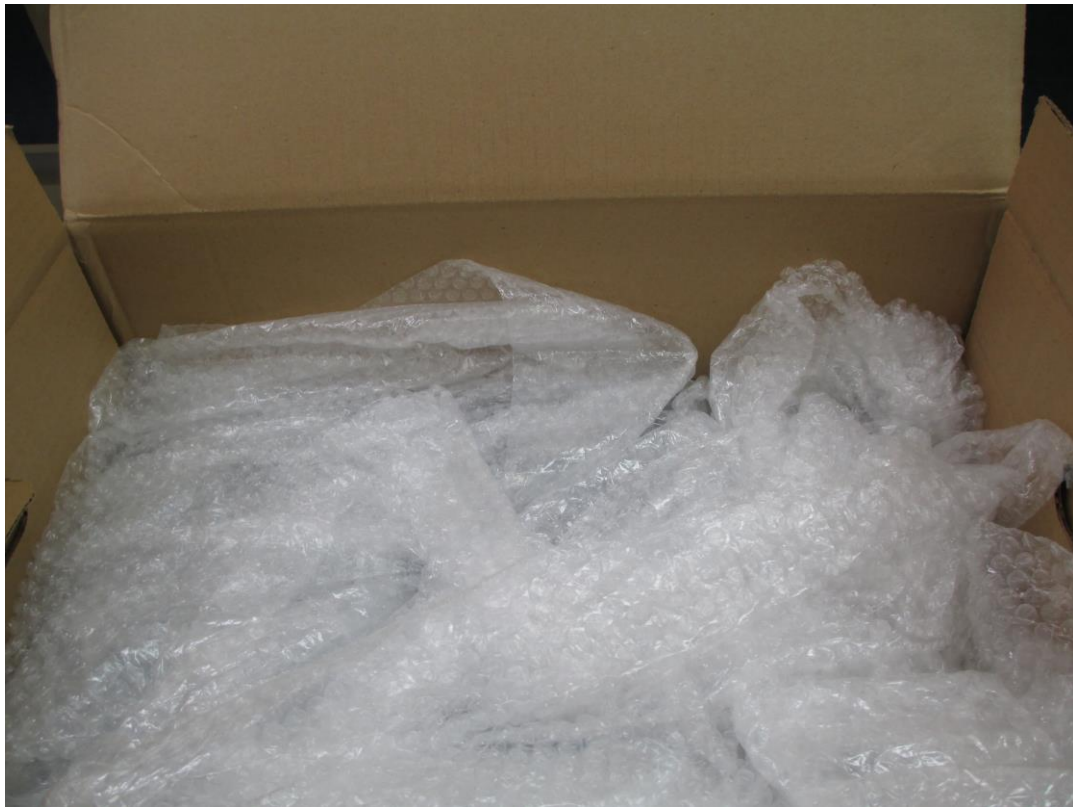
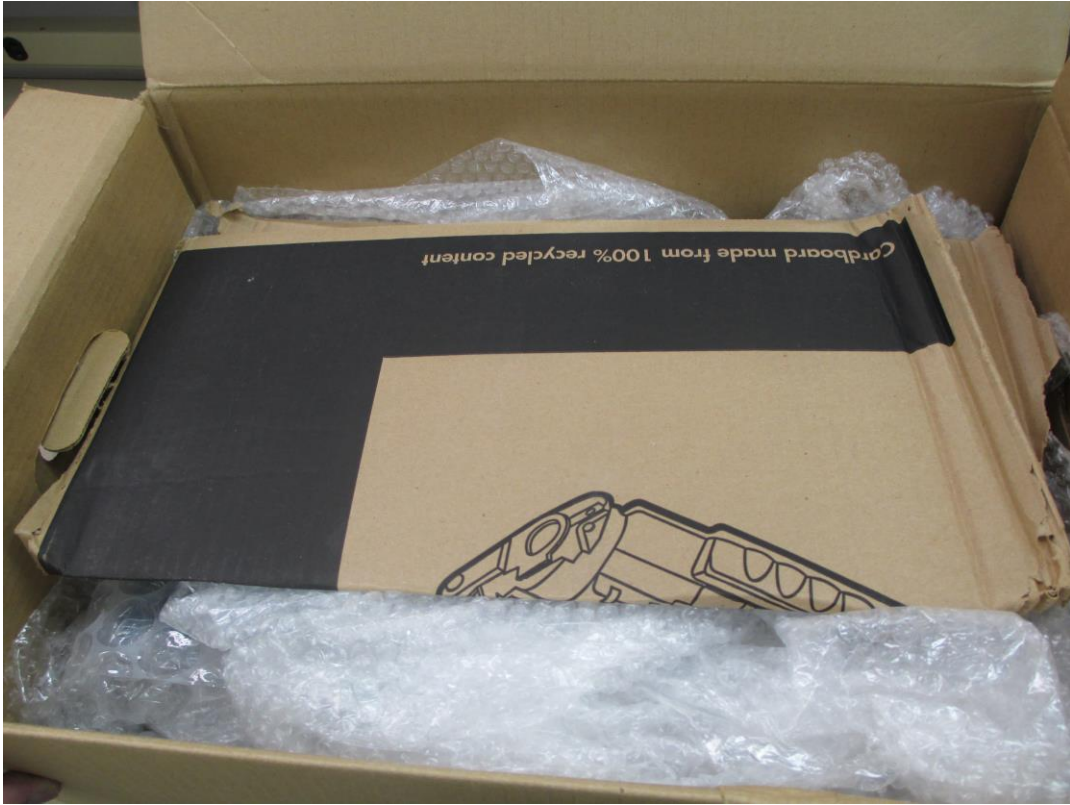
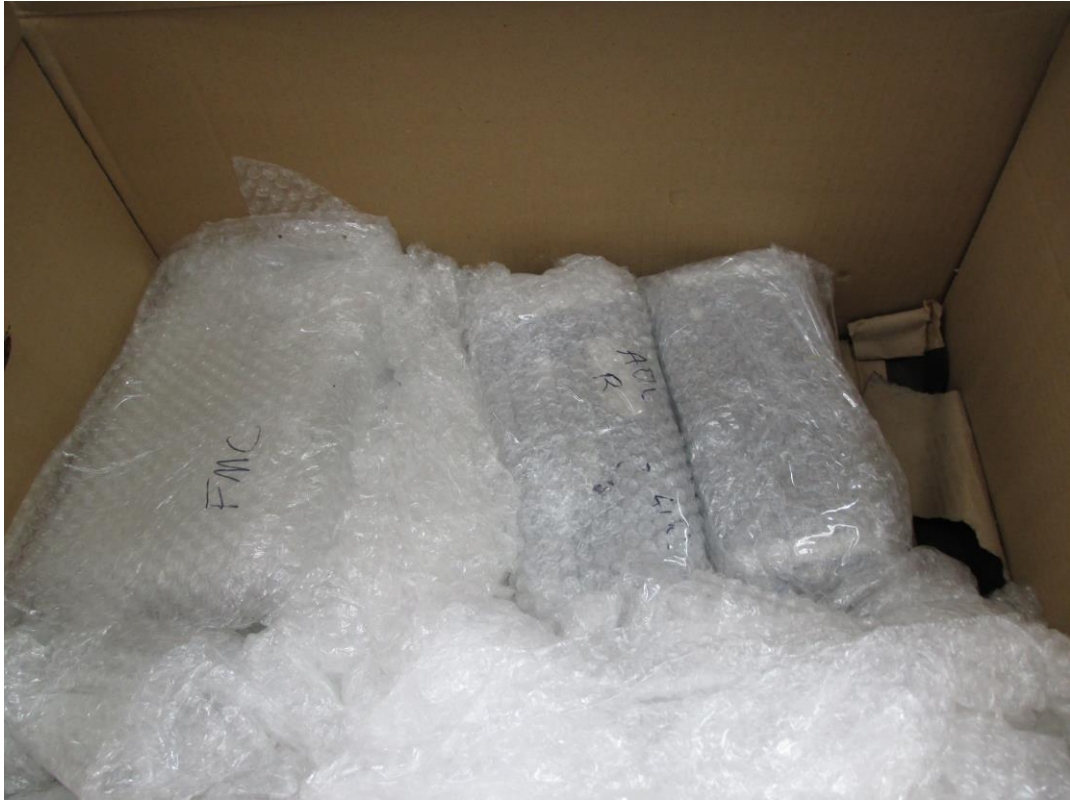
- a. Immediately examine for any trace of abnormal smell as soon as the container is opened and record the finding.
 - i. No abnormal smell noted.
- b. Take photos of the contents prior to removal from the shipping container.
 - i. See Figure 8 through Figure 11 in Appendix A.

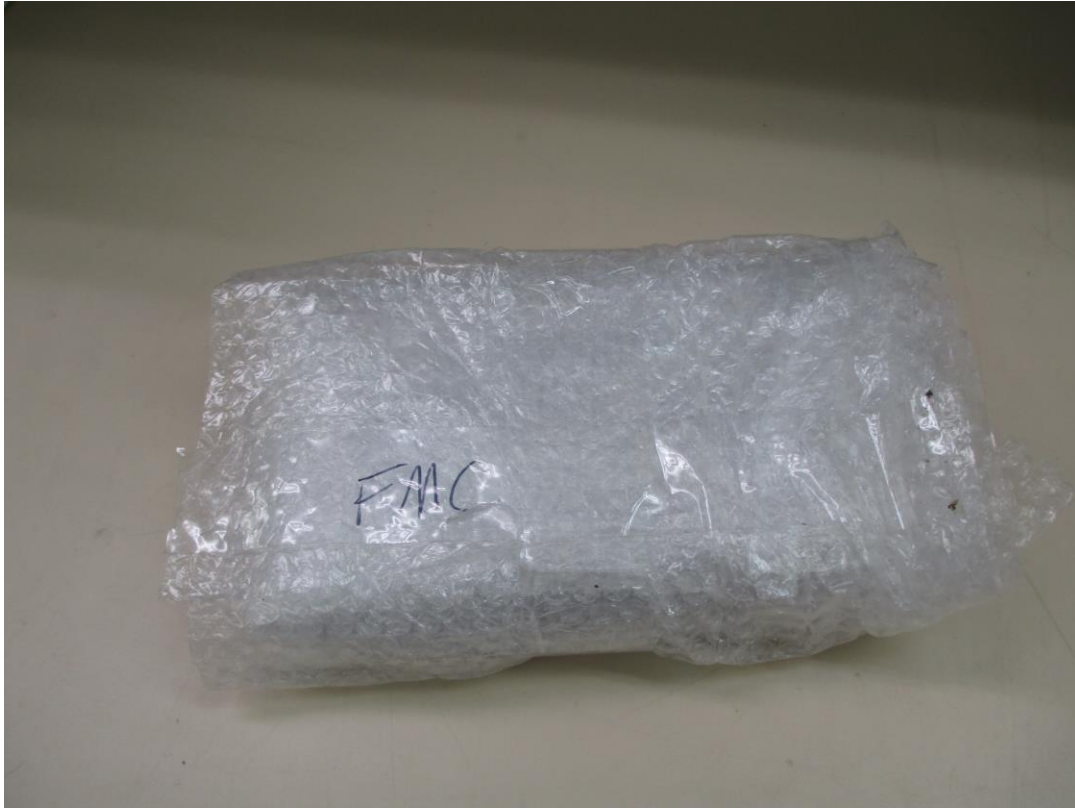
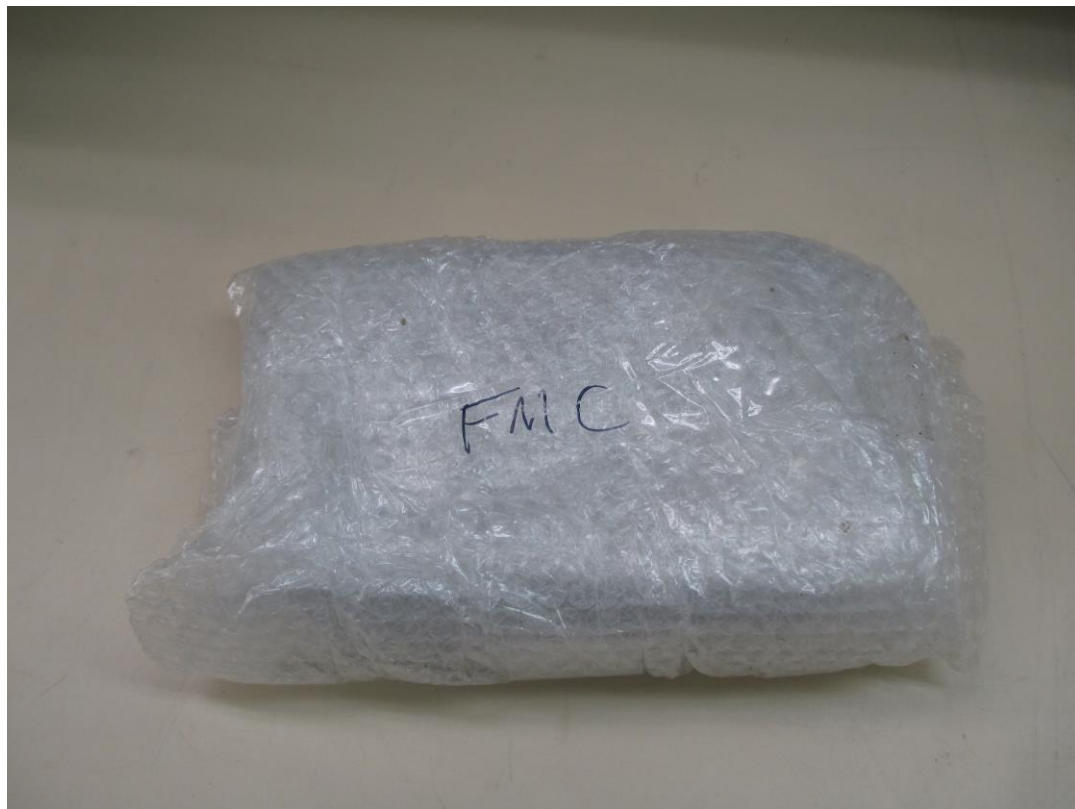
- a. Immediately examine for any trace of abnormal smell as soon as the FMC-3000 is removed from the container & packing material. Record the finding.
 - i. No abnormal smell noted.
- b. Take photos of the contents immediately after removal from the container.
 - i. See Figure 12 and Figure 13.
- c. Note any issue(s) with the packaging such as loose pieces or torn packaging walls, ESD compliance etc.
 - i. Units were wrapped in bubble wrap. No damage to the packaging observed.
- d. Record the contents of the container. Compare the documents to paperwork received (such as Incident Report). Note any discrepancies.
 - i. FMC-3000, SN's: 28DPH and 192TC.

SN 28DPH was removed from its shipping box. Initial visual inspection showed extensive damage to the exterior covers and some foreign material was inside the unit. The top and bottom covers were able to be removed from the unit without removing the cover screws. The cover screws on one of the covers were pulled through and were not holding the cover onto the CCA assembly. Applying a little pressure to the second cover allowed for the cover screw to detach from the cover.
