# ALERT SERVICE BULLETIN

NO. 206L-09-163

**MODEL AFFECTED:** 206L Series

**SUBJECT:** MAIN ROTOR BLADES P/N 206-015-001-115, /-117, /-119 & /-121 SPAR SPACER, ONE TIME INSPECTION OF.

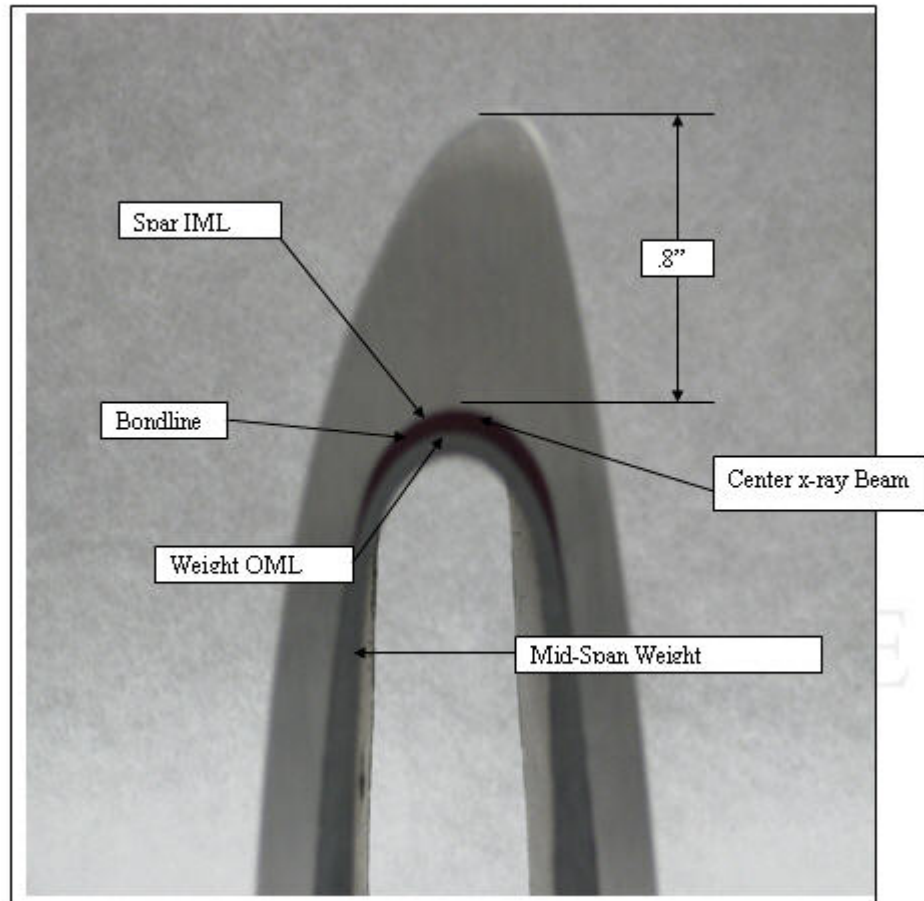
Figure 4. Cross Section of Main Rotor Blade.

- e. Align the X-Ray beam perpendicular to the blade lower surface and center the beam 0.8 inch from the leading edge, (Refer to Figures 3 and 4).
    - f. Process the films and return them to Bell Helicopter for review.
