Appendix B:

Tank Car Group Examination Observations, March 3, 2015

Mount Carbon, West Virginia

NTSB # DCA15FR005

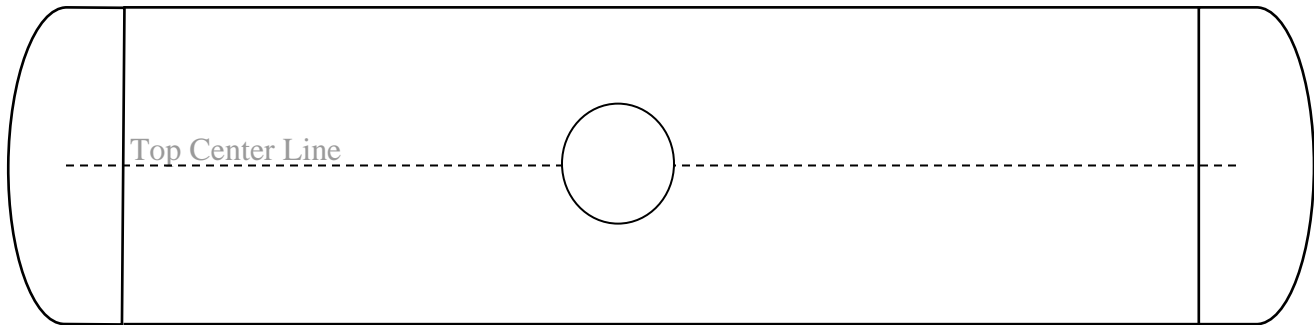
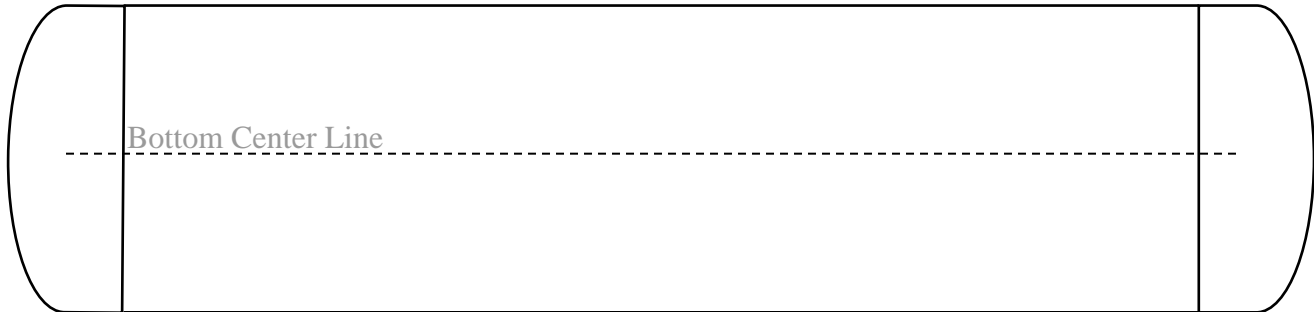
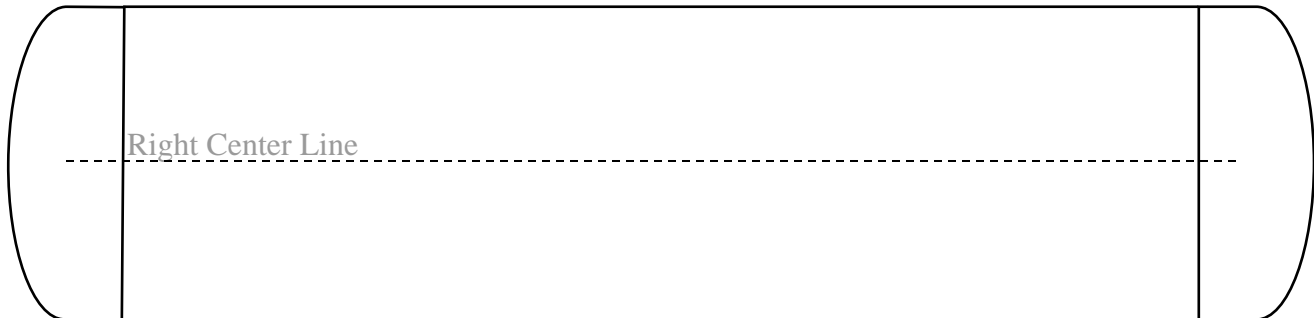
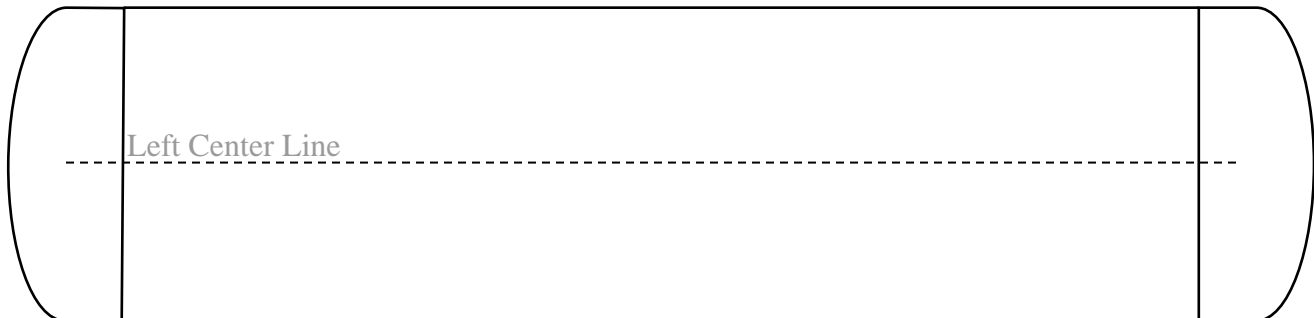
CBTX 742201 (02) Damage Assessment Notes

No derailment damage except for mechanical and safety appliances.

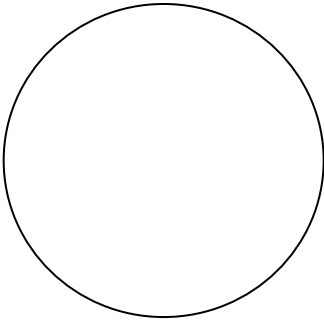
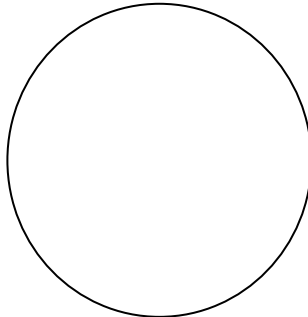
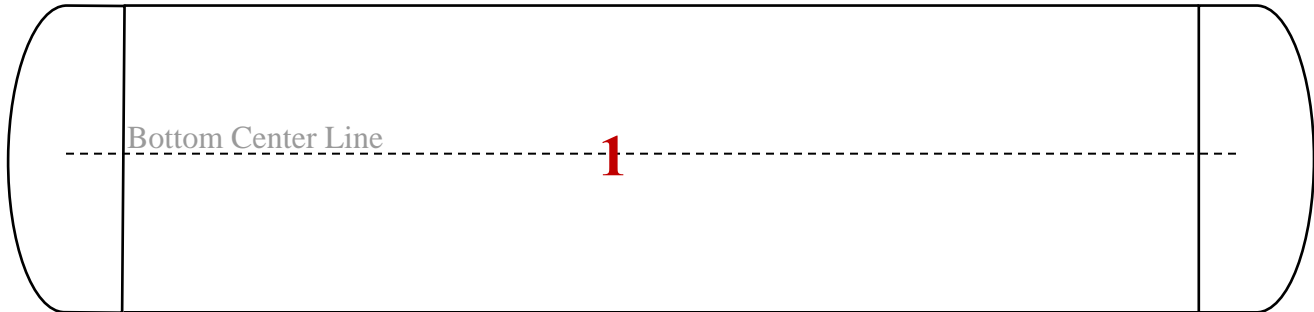
CBTX 742792 (04) Damage Assessment Notes

1. Bottom outlet nozzle was sheared off. Bottom outlet valve itself was not damaged.

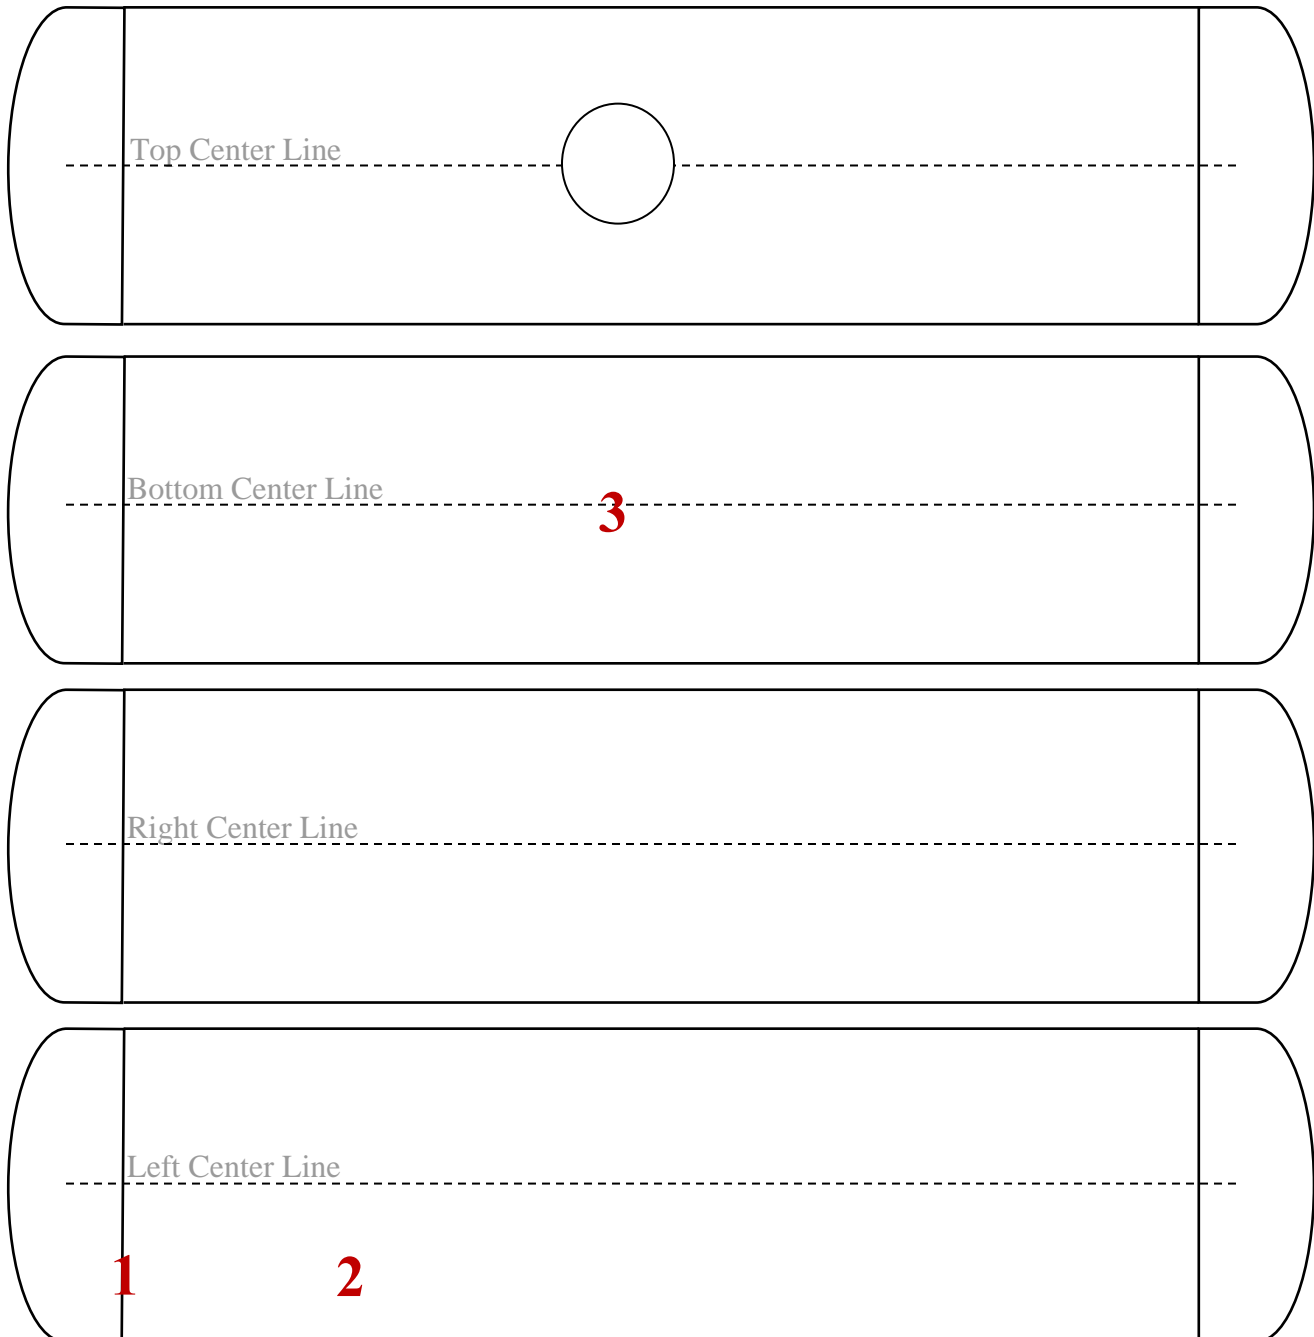
GATX 286285 (06) Damage Assessment Notes

1. Dent 2 ft. by 2 ft., 1.5 inches deep.
2. Dent 22 ft. longitudinal by 2 ft. transverse, 5 inches deep.
3. Bottom outlet nozzle sheared off, bottom outlet valve in good condition.

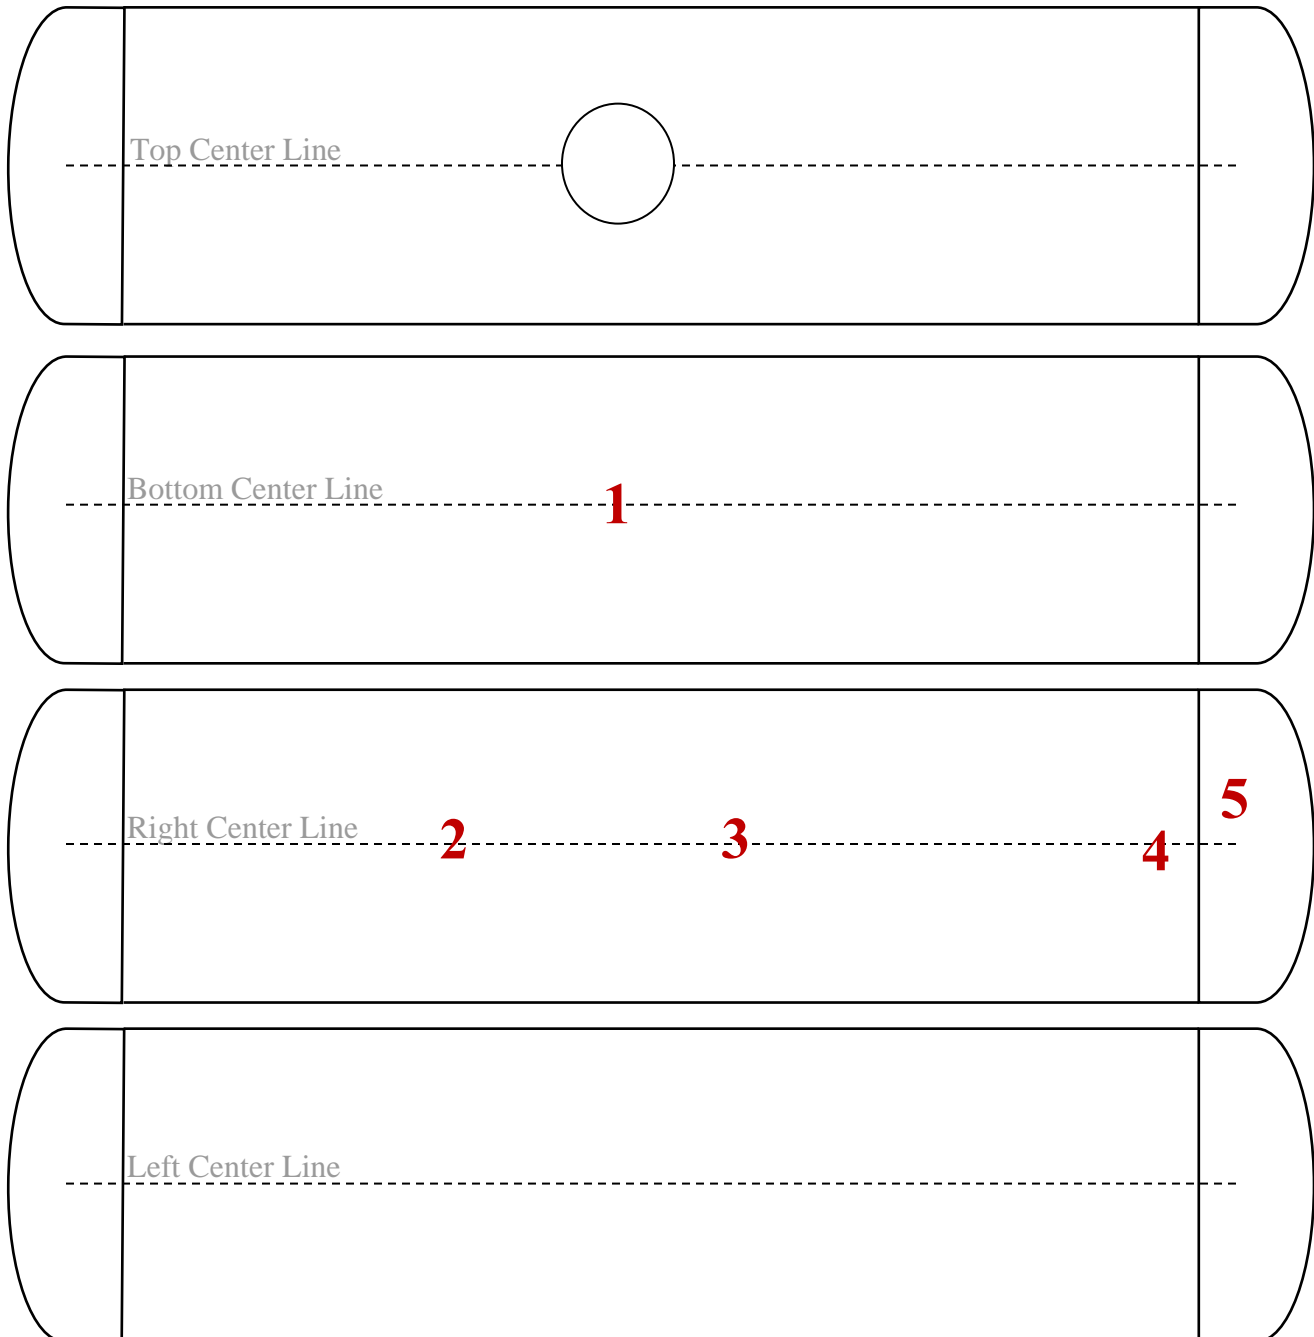
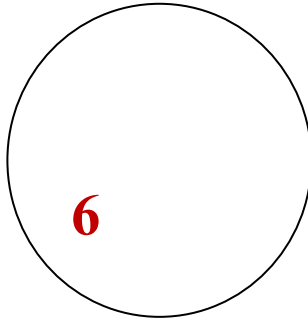
GATX 286241 (07) Damage Assessment Notes

1. Bottom outlet nozzle sheared off and bottom outlet valve was 1/8 opened at derailment site. Operating handle was broken away.
2. Dent 11 ft. longitudinal, 7 ft. transverse, 8-inches deep.
3. Flattened area 14 ft. longitudinal, 3 ft. transverse.
4. Dent 18 inches by 18 inches, 1 inch deep.
5. Dent 2 ft. longitudinal, 1 ft. transverse, 2 inches deep.
6. Dent to head shield and tank – 24 inches by 18 inches, 2 inches deep into tank head.

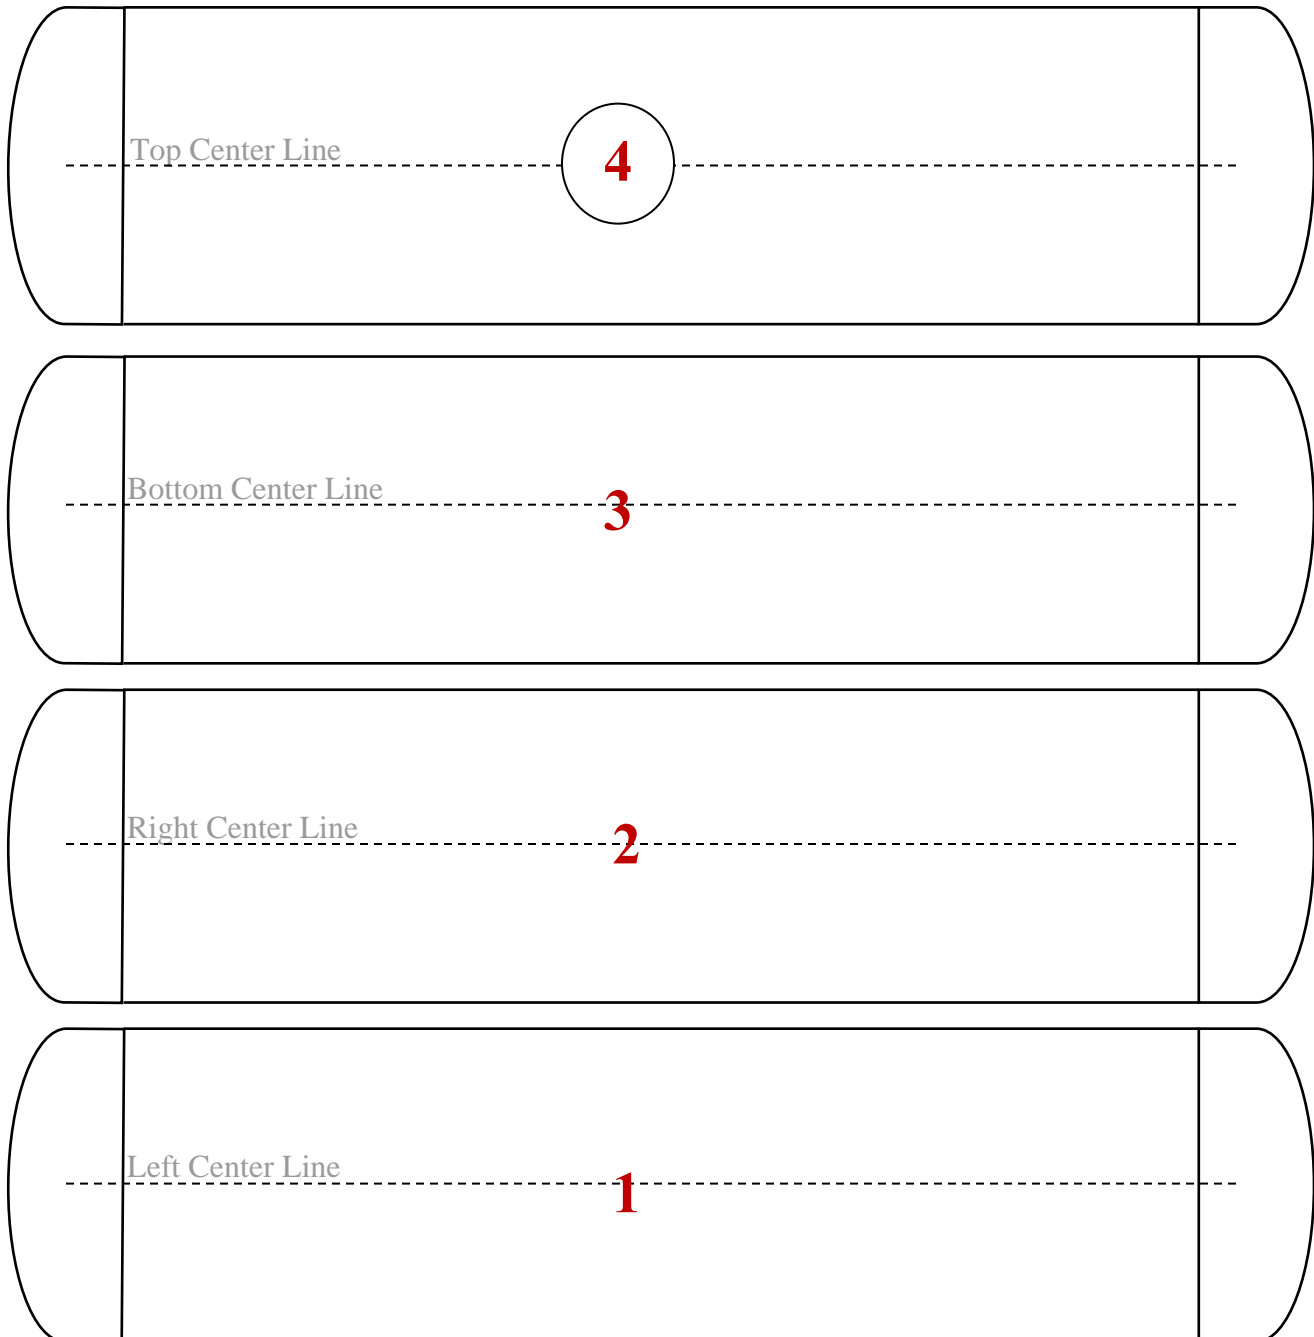
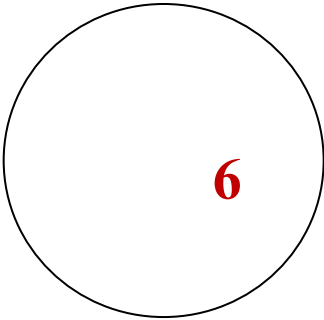
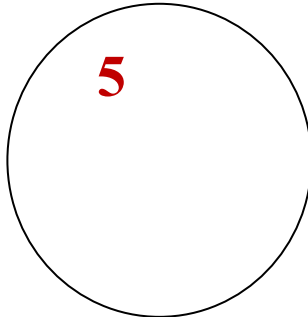
GATX 286214 (09) Damage Assessment Notes

1. Thermal tear 8 ft. longitudinal, 1.5 ft. transverse. Shell thinning measured to 0.311 inches near the center of the breach.
2. Entire right side of car was wrinkled.
3. Bottom outlet nozzle and operating handle sheared off. The BOV remained closed.
4. Top fittings and pressure relief device were heavily fire damaged.
5. Dent to head above head shield, 2.5 ft. wide, 2 ft. high, 2.5 inches deep.
6. Right half of B-end head shield pulled forward with 90 degree bend.

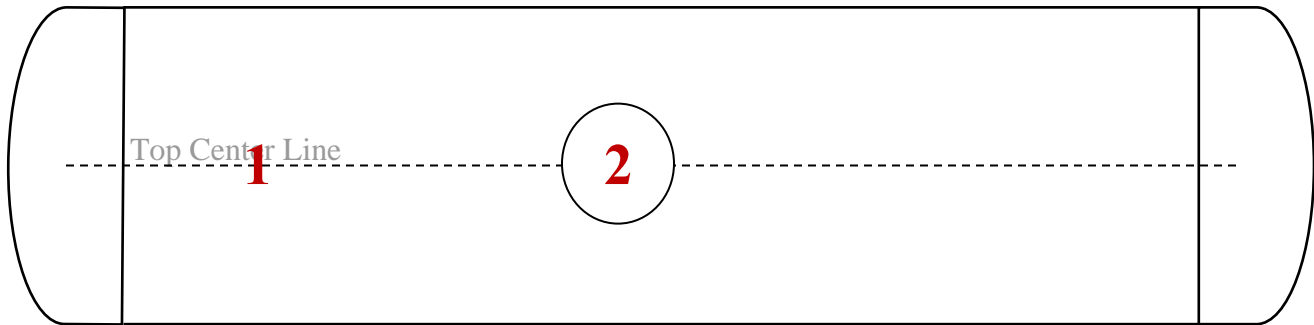
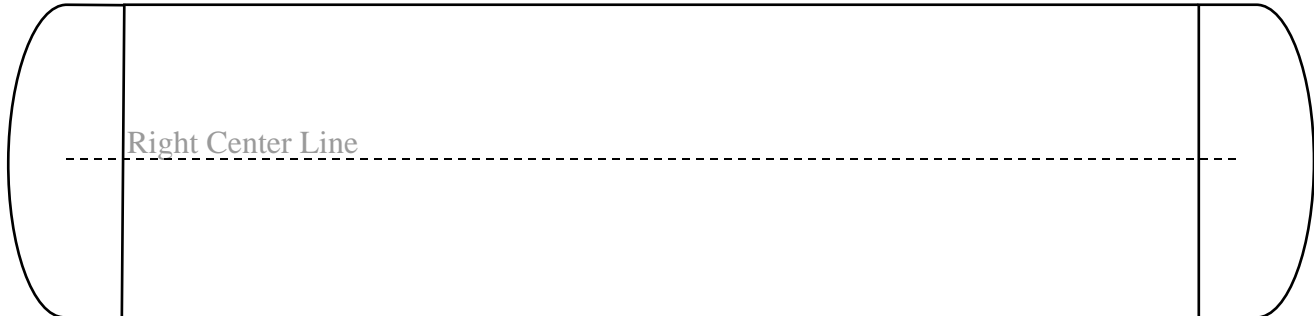
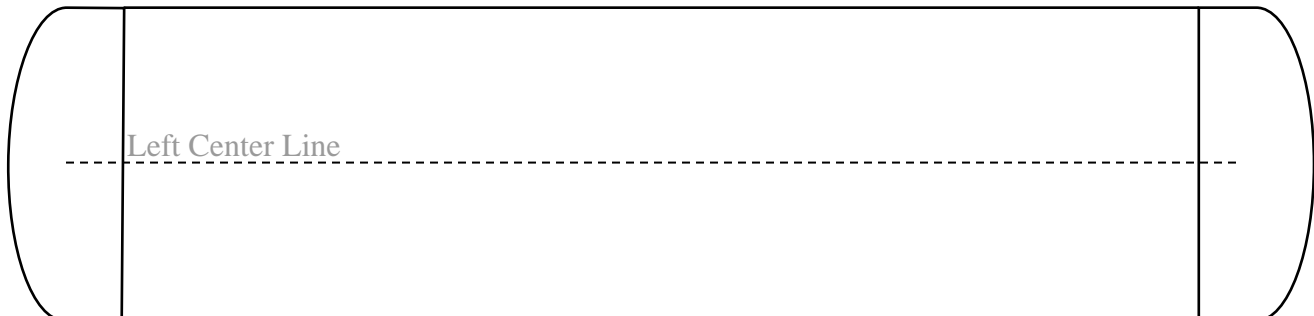
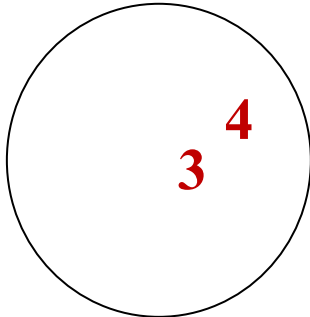
GATX 286292 (10) Damage Assessment Notes

1. Thermal tear, irregular fracture 8.5 ft. longitudinal, 1.5 ft. transverse. Shell thinning measured to 0.292 inches at the center of the tear.
2. Top fittings fire damage within protective housing.
3. Hand rail punctured by impact with an object having the shape of a nut.
4. Head shield bolts missing from bracket.

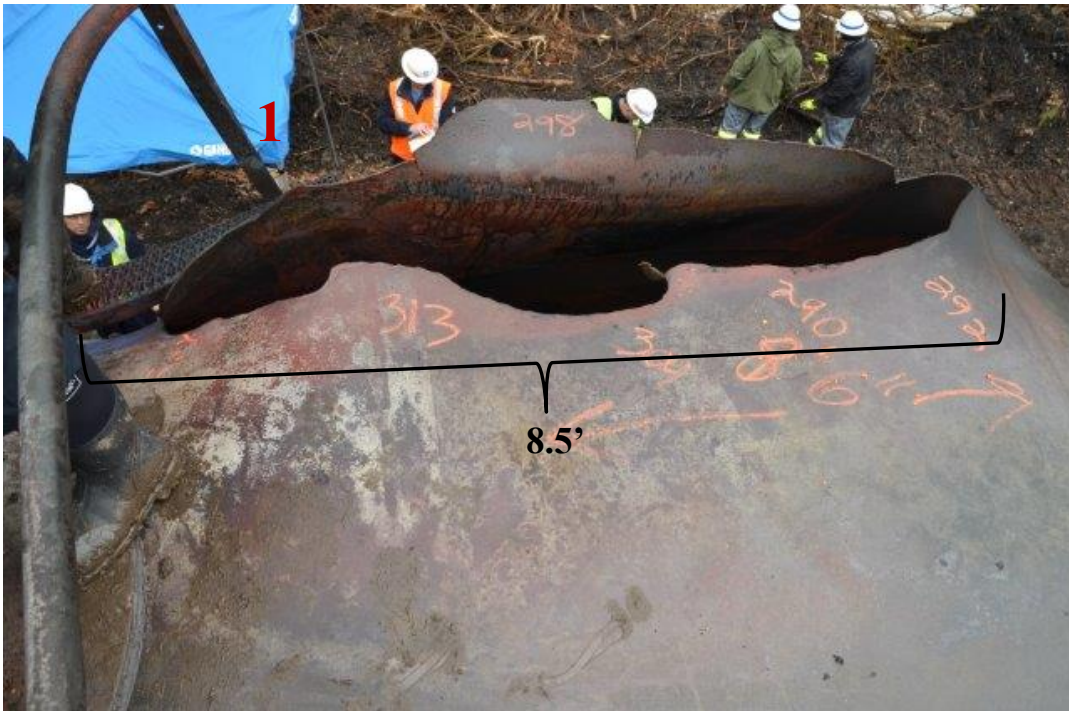
Figure 16: GATX 286292 thermal tear with steel thickness measurements.

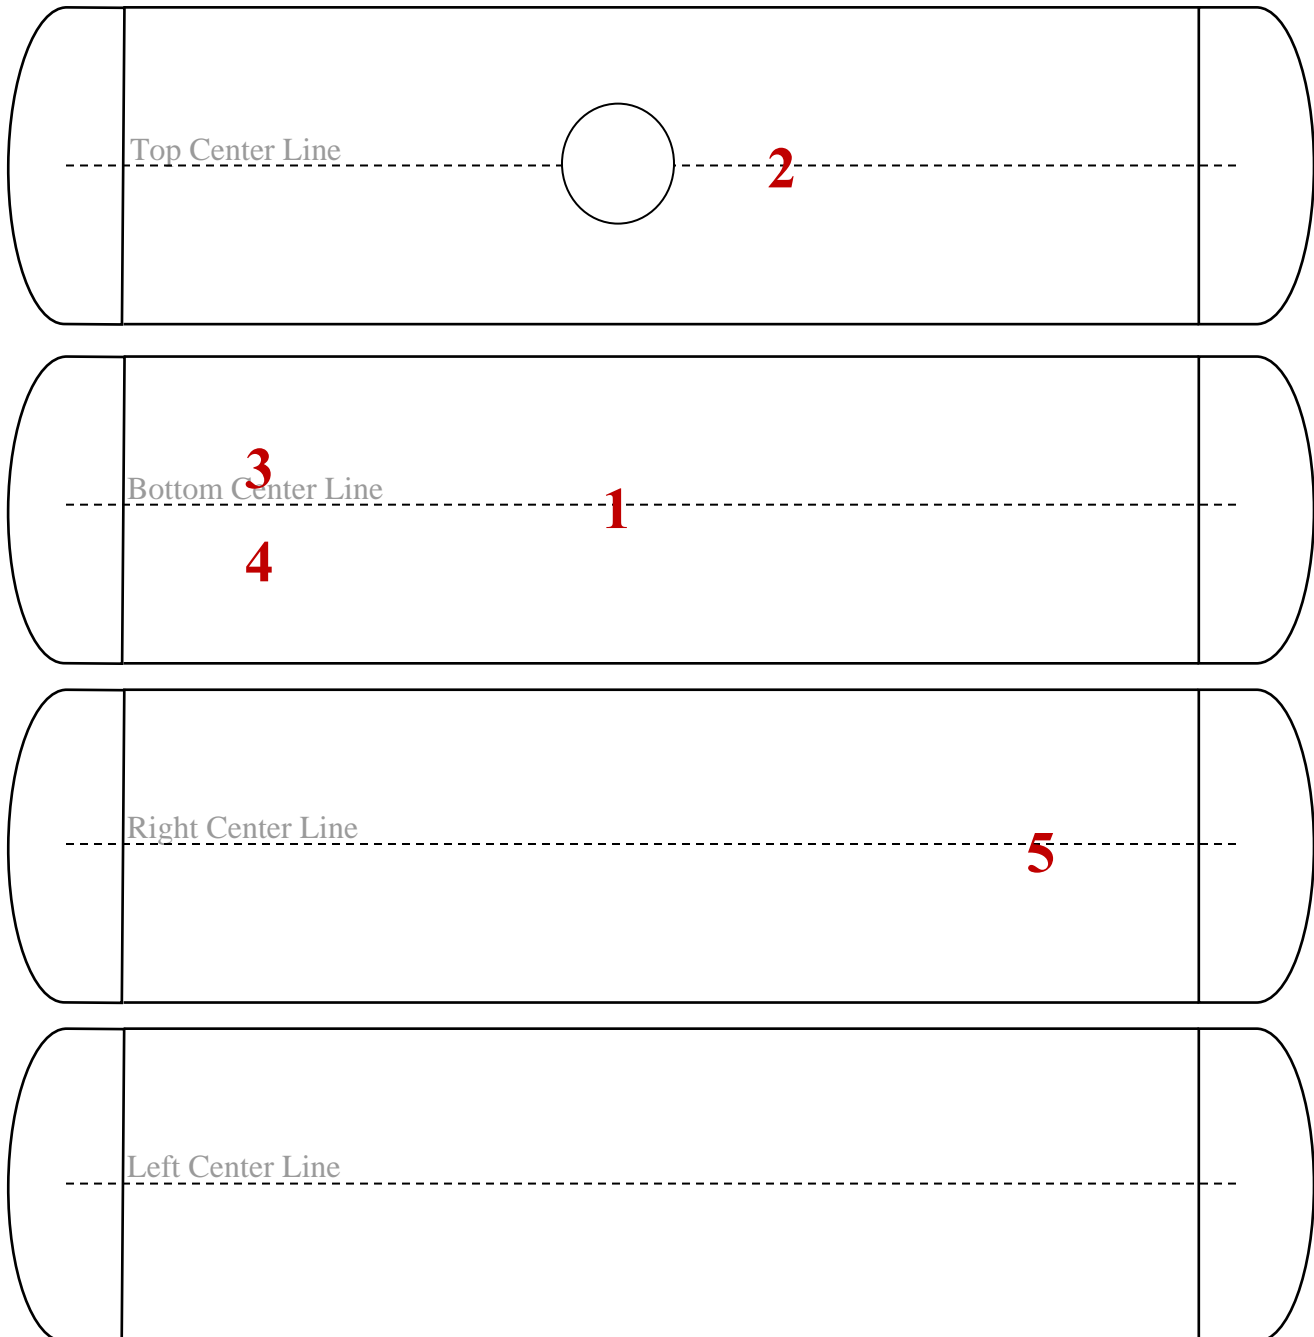
GATX 286274 (11) Damage Assessment Notes

1. Bottom outlet nozzle sheared away and ball valve leaked. Responders inserted wooden plug into opening to stop leakage.
2. Bulge with material thinning, 16 inches longitudinal, 30 inches transverse.
3. Dent, 5 ft. longitudinal, 1 ft. transverse, 3 inches deep.
4. Dent, 3 ft. by 3 ft., 1 inch deep.
5. Dent, 6 ft. by 6 ft., 5 inches deep.

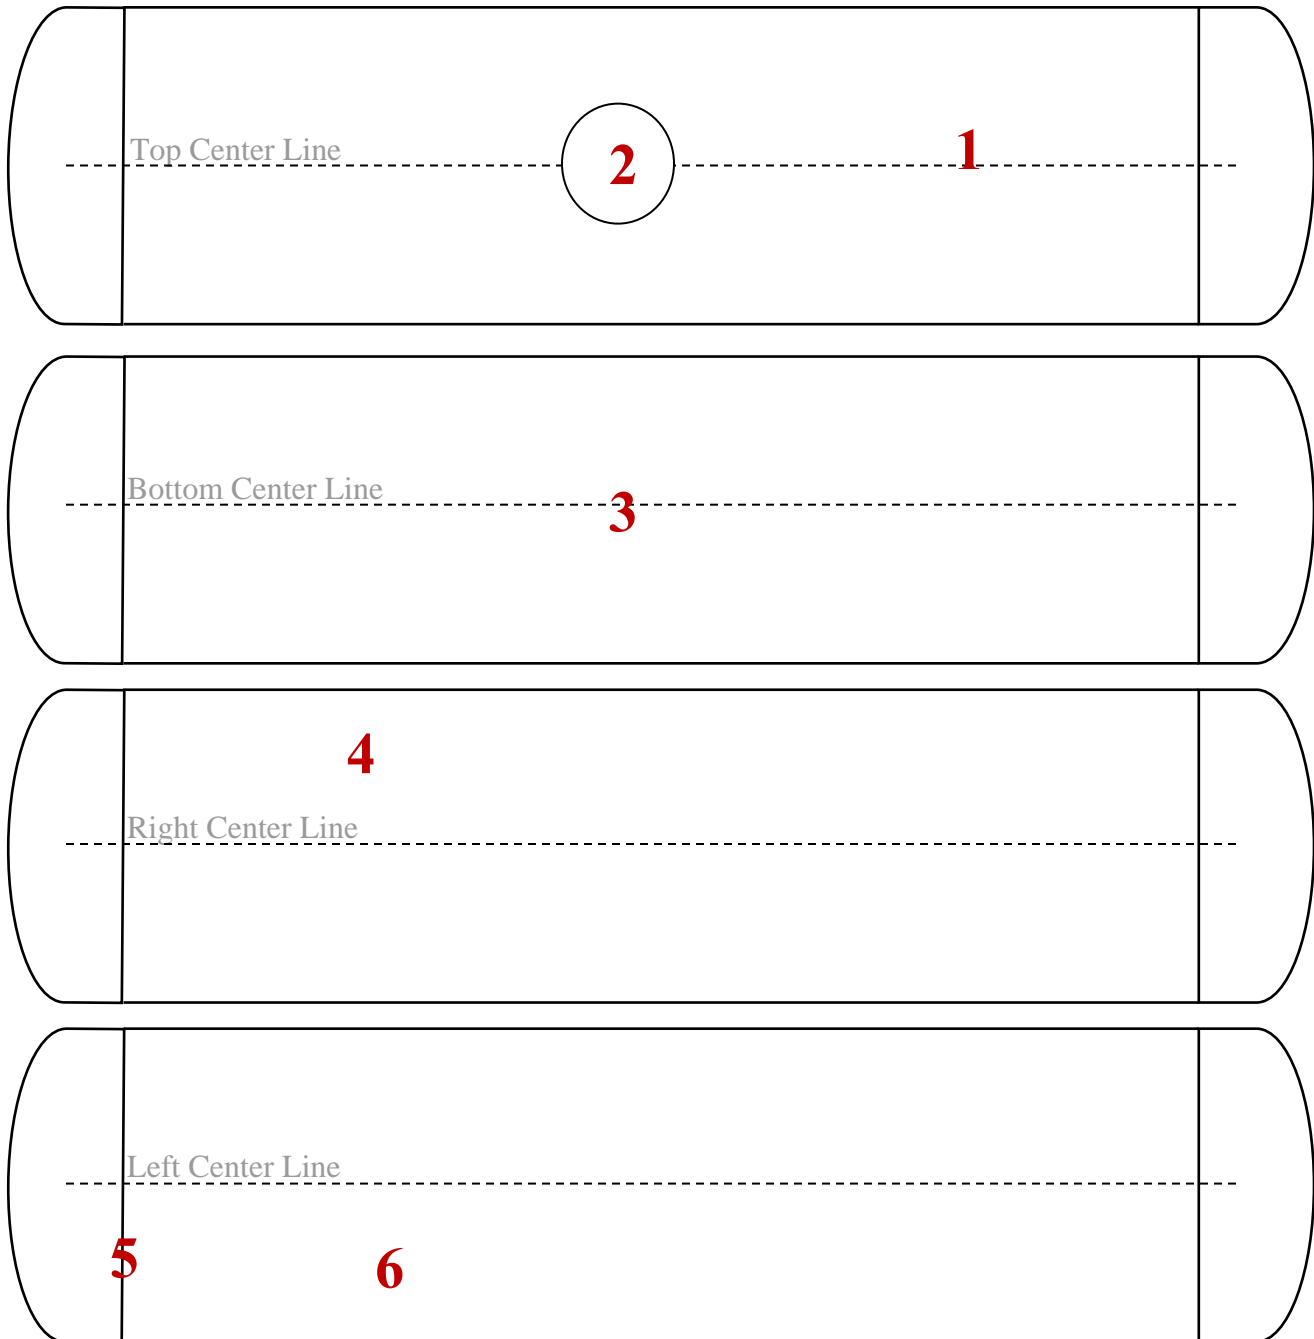
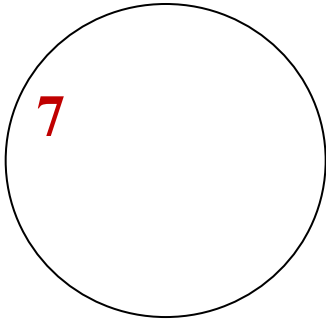
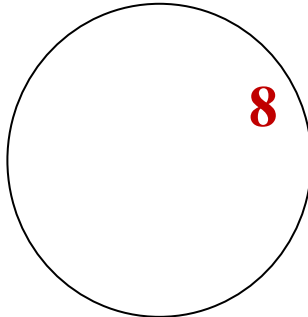
CBTX 741926 (13) Damage Assessment Notes

1. Thermal tear, 3 feet angular and longitudinal, 1 inch transverse. Shell thinning to 0.220 inch.
2. Liquid line siphon pipe pushed upward about 10 inches, dislodging liquid line fitting from plate.
3. BOV nozzle sheared off, valve not damaged, handle remained secured.
4. Shell wrinkled, 22 feet longitudinal, 10 feet transverse.
5. Dent, 16 inches longitudinal, 14 inches transverse, 1.5 inches deep.
6. Dent, 23 feet longitudinal, 8 feet transverse.
7. Dent, 2 feet by 2 feet, 2 inches deep.
8. Dent, rectangular at 2 o'clock position of head and across knuckle radius, 4 feet horizontal, 3 feet vertical, 12 inches deep.

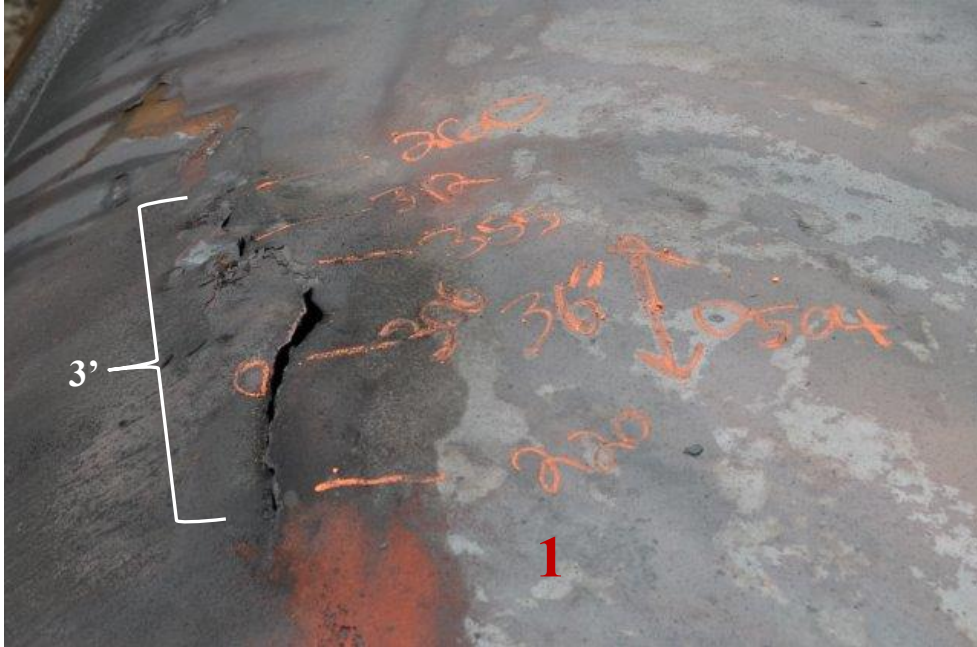
Figure 23: Thermal tear CBTX 741926 showing shell thickness measurements.

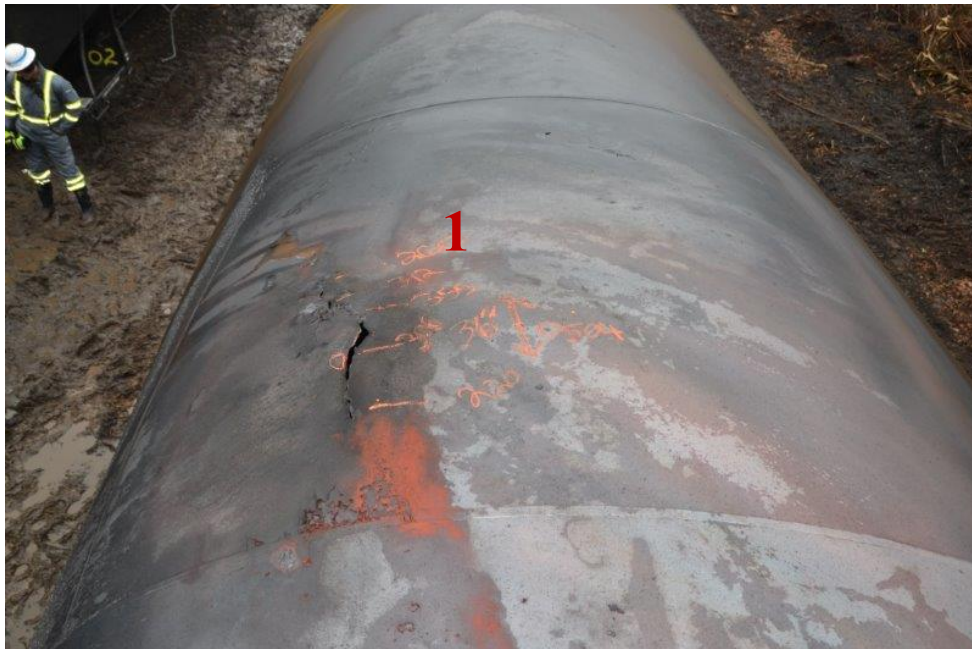
Figure 24: Thermal tear as seen from top of car looking toward B end.

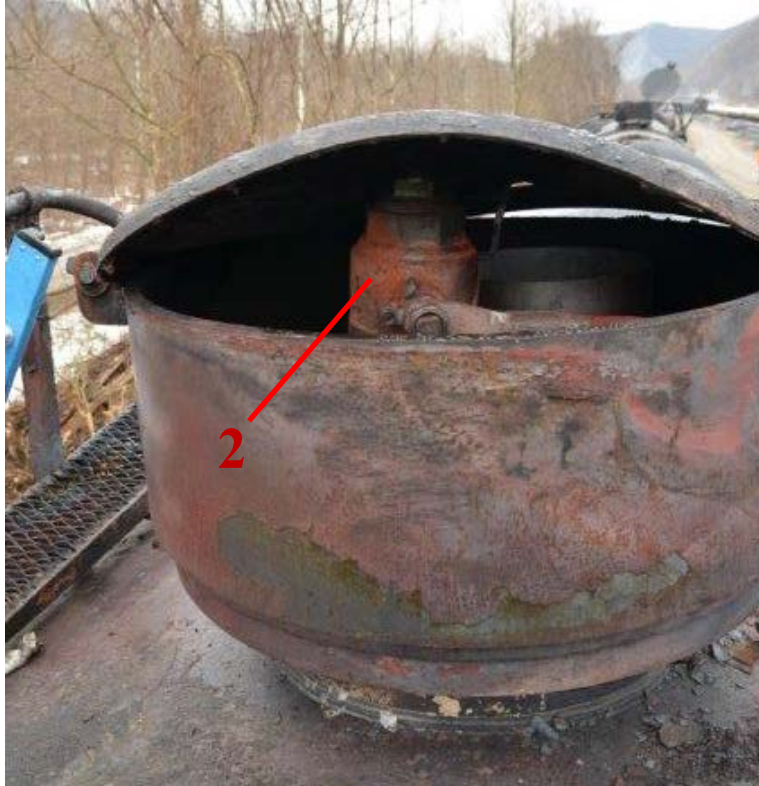
Figure 25: Liquid line upward displacement and impingement against protective housing cover.

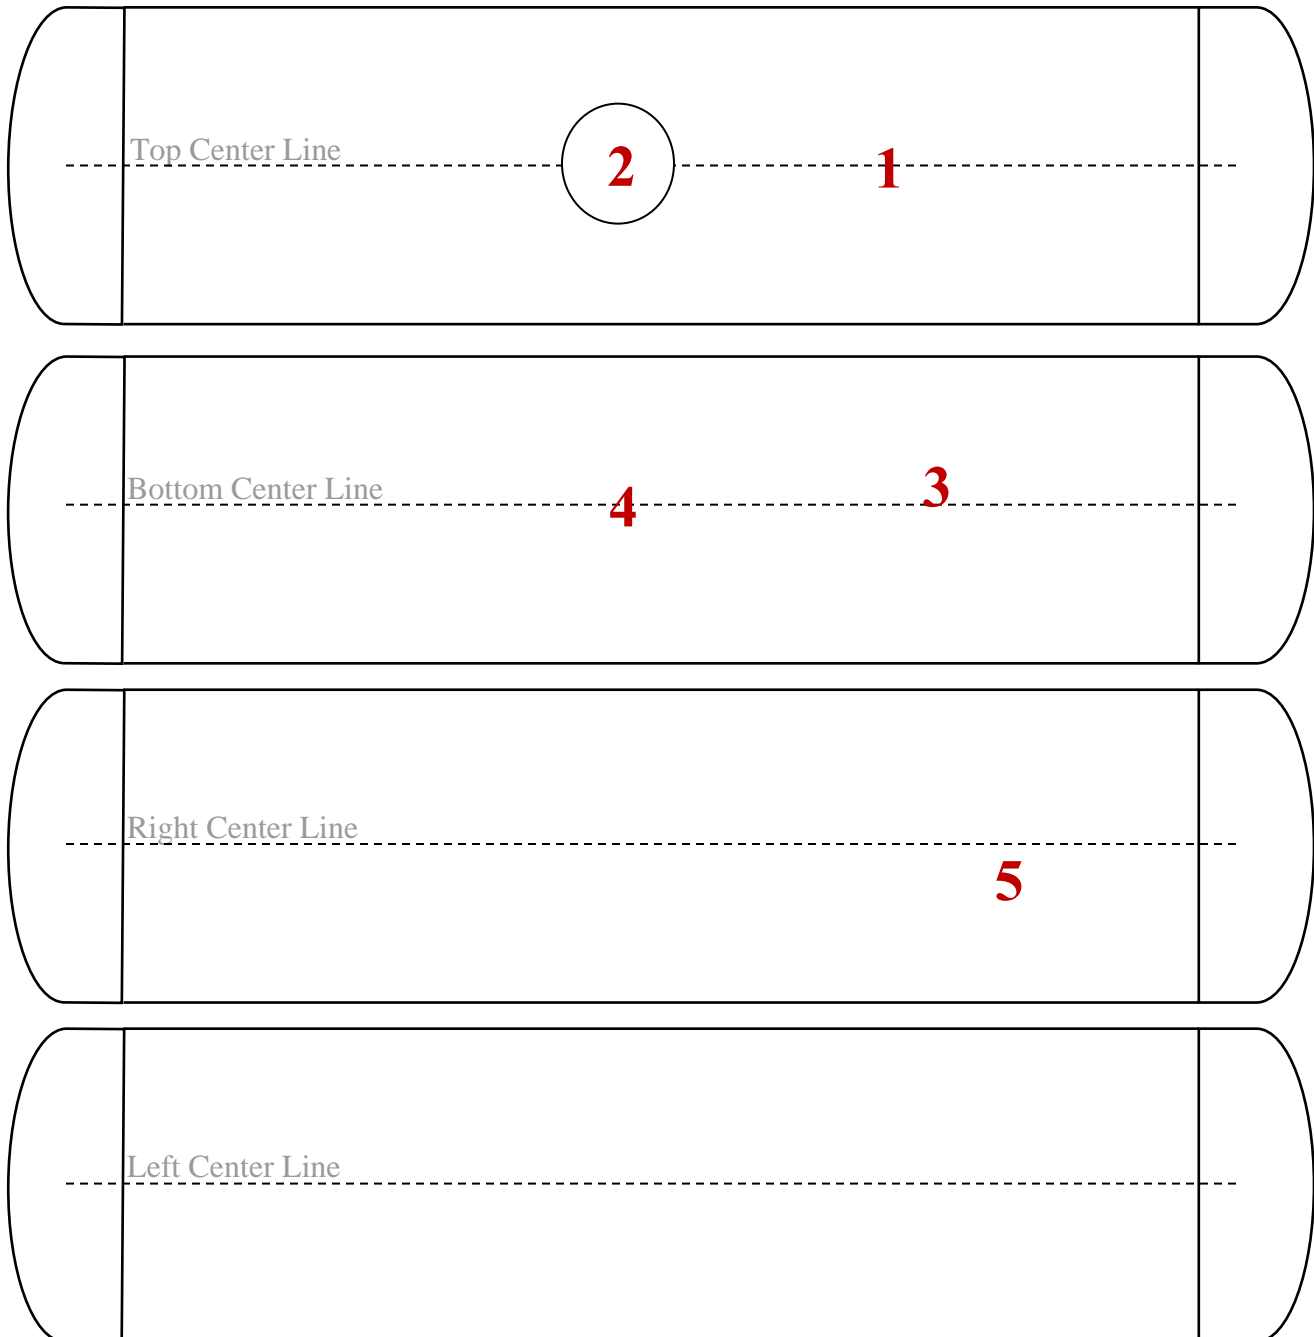
CBTX 742035 (14) Damage Assessment Notes

1. Thermal tear, 36 inches longitudinal, 2 inches transverse. Tear was within a bulge 10 feet longitudinal, 6 feet transverse. Severe thermal damage to surrounding shell material.
2. Protective housing cover burn-through.
3. Dent, 18 inches by 18 inches, 2 inches deep.
4. BOV nozzle sheared off, valve was closed.
5. Dent, 4 feet longitudinal, 3 feet transverse, 3 inches deep.

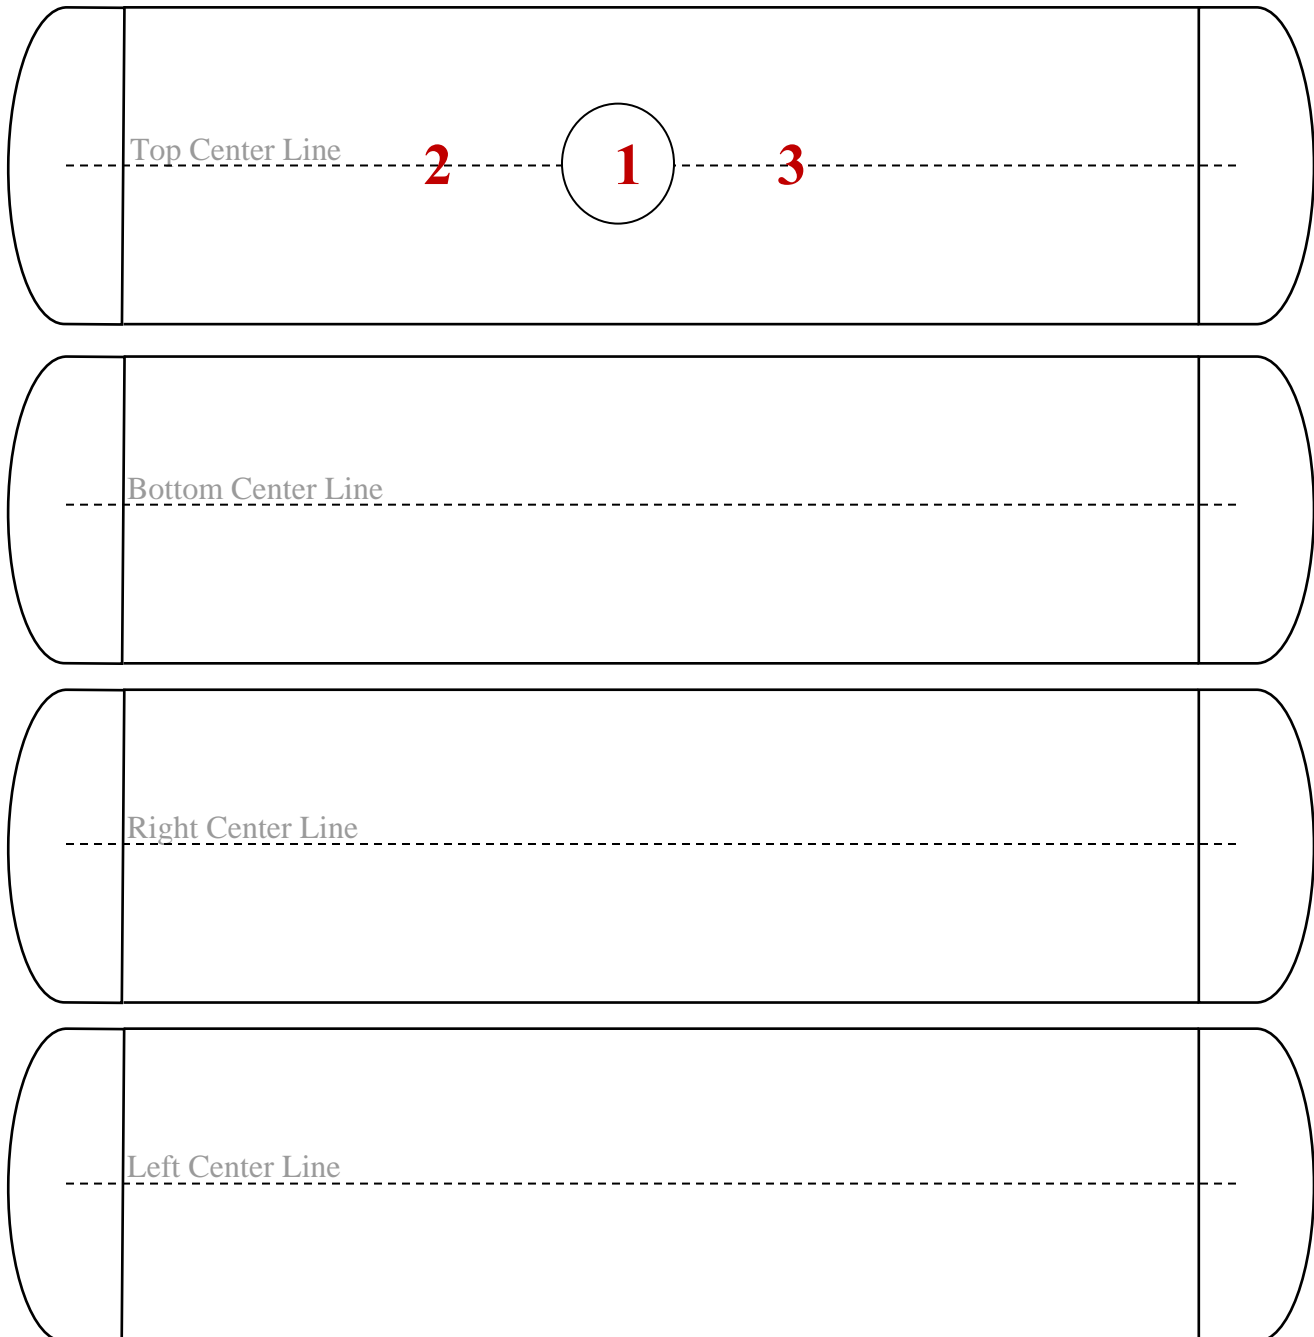
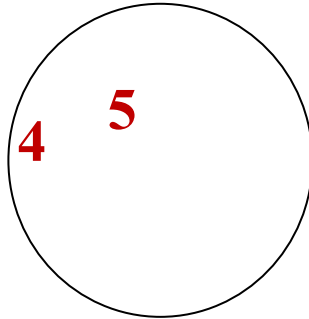
CBTX 741702 (15) Damage Assessment Notes

1. Liquid line eduction pipe displaced upward about 5 inches. Valves within top fittings protective housing were significantly fire damaged.
2. Shell flattening, A-end top of car.
3. Shell rippling, B-end top of car.
4. Dent, 3.5 feet high, 3 feet wide, 4 inches deep.
5. Dent, 4.5 feet by 4.5 feet, 3 inches deep.

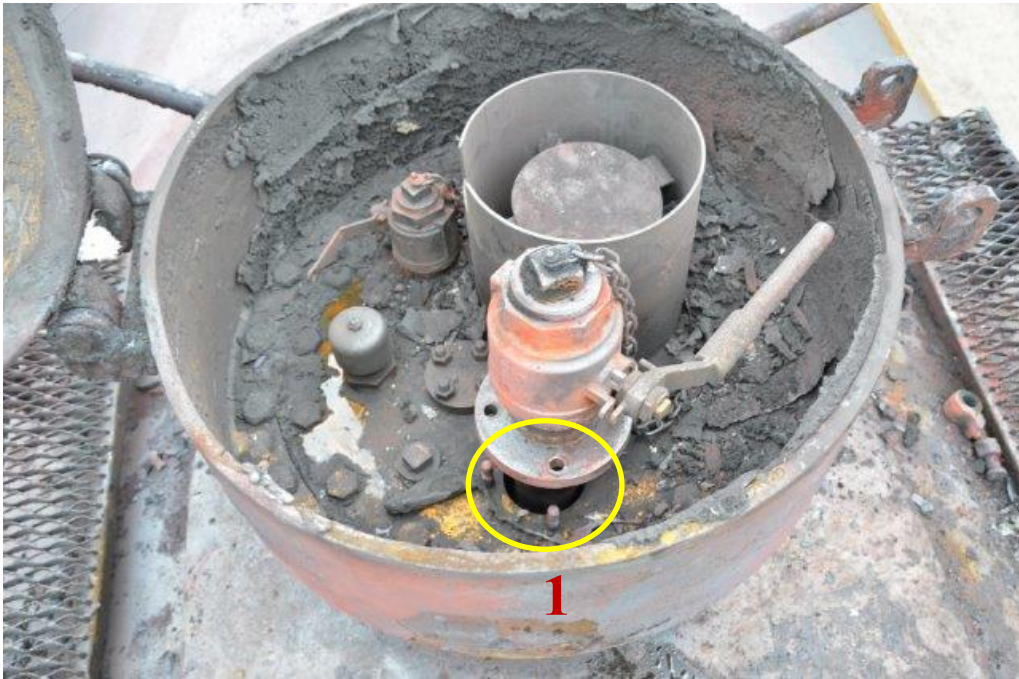
Figure 32: Liquid valve displacement upward about 5 inches, open annular space between eduction pipe and plate.

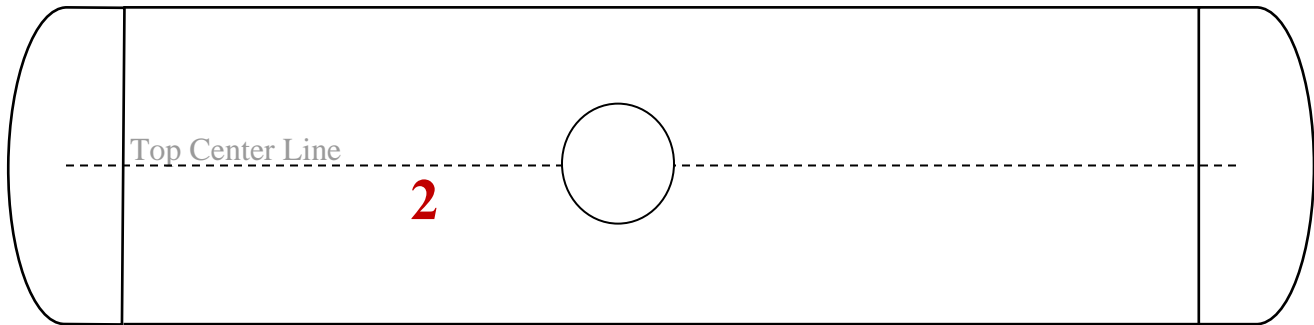
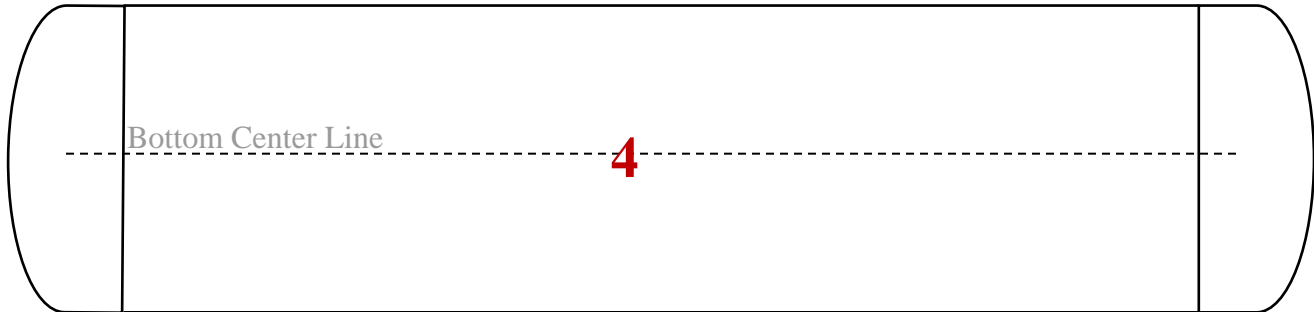
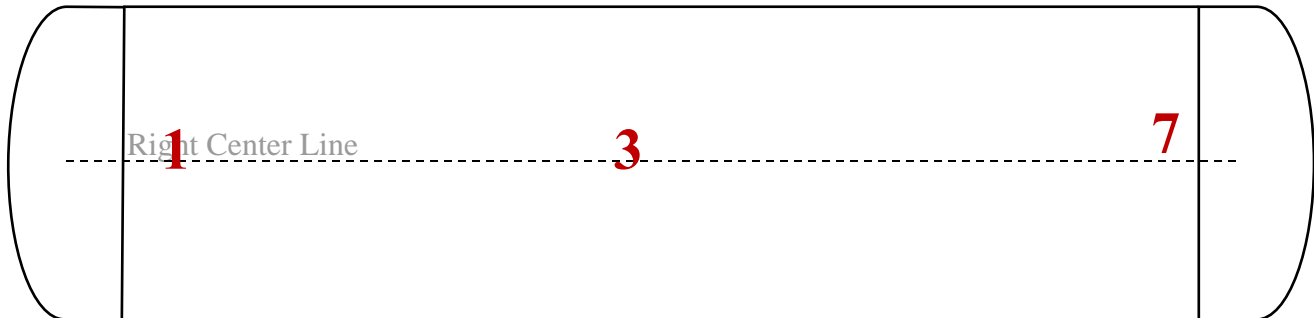
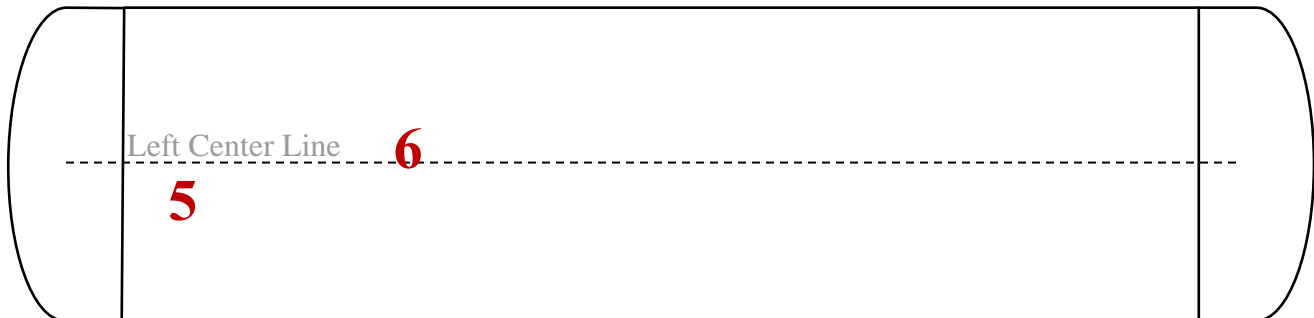
CTCX 743030 (16) Damage Assessment Notes

1. Shell puncture, coupler impact, breach in shell 5 feet longitudinal, 4 feet transverse.
2. Flattening of the top of the tank shell from impact damage.
3. Entire right side wrinkled and crumpled.
4. BOV cap sheared off, valve and operating handle were not damaged.
5. Bolster torn from mounting pad.
6. Dent, half the length of the tank was deeply crushed.
7. Bolster web structure torn away leaving robust top structure as a hook-like protuberance.
