Appendix B:

Tank Car Group Examination Observations, March 3, 2015

Mount Carbon, West Virginia

NTSB # DCA15FR005

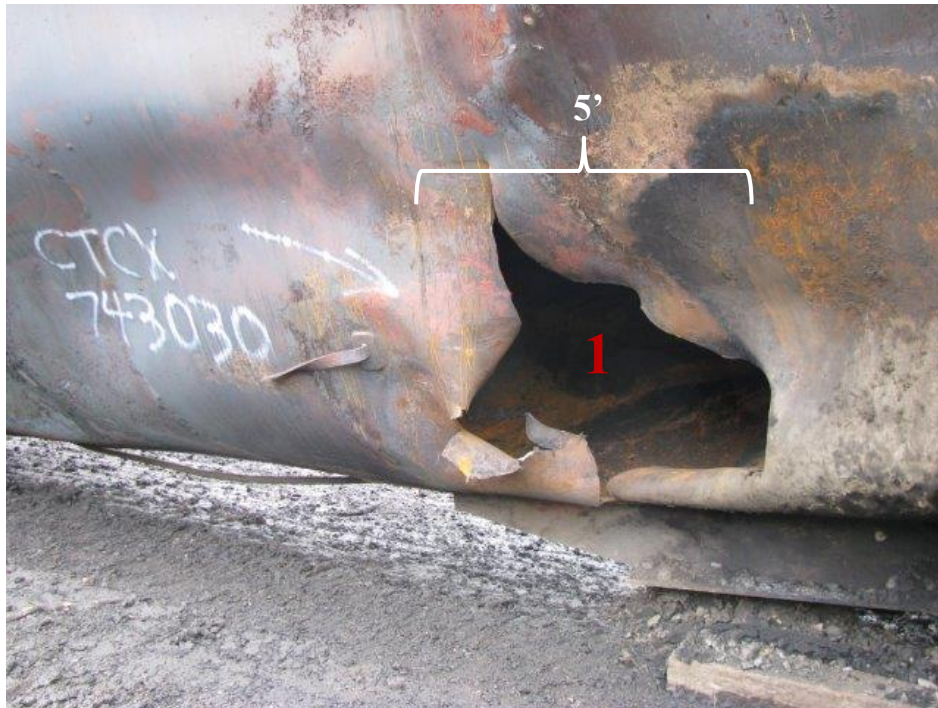
Figure 35: Puncture in right side near A-end from the coupler of an adjacent tank car.

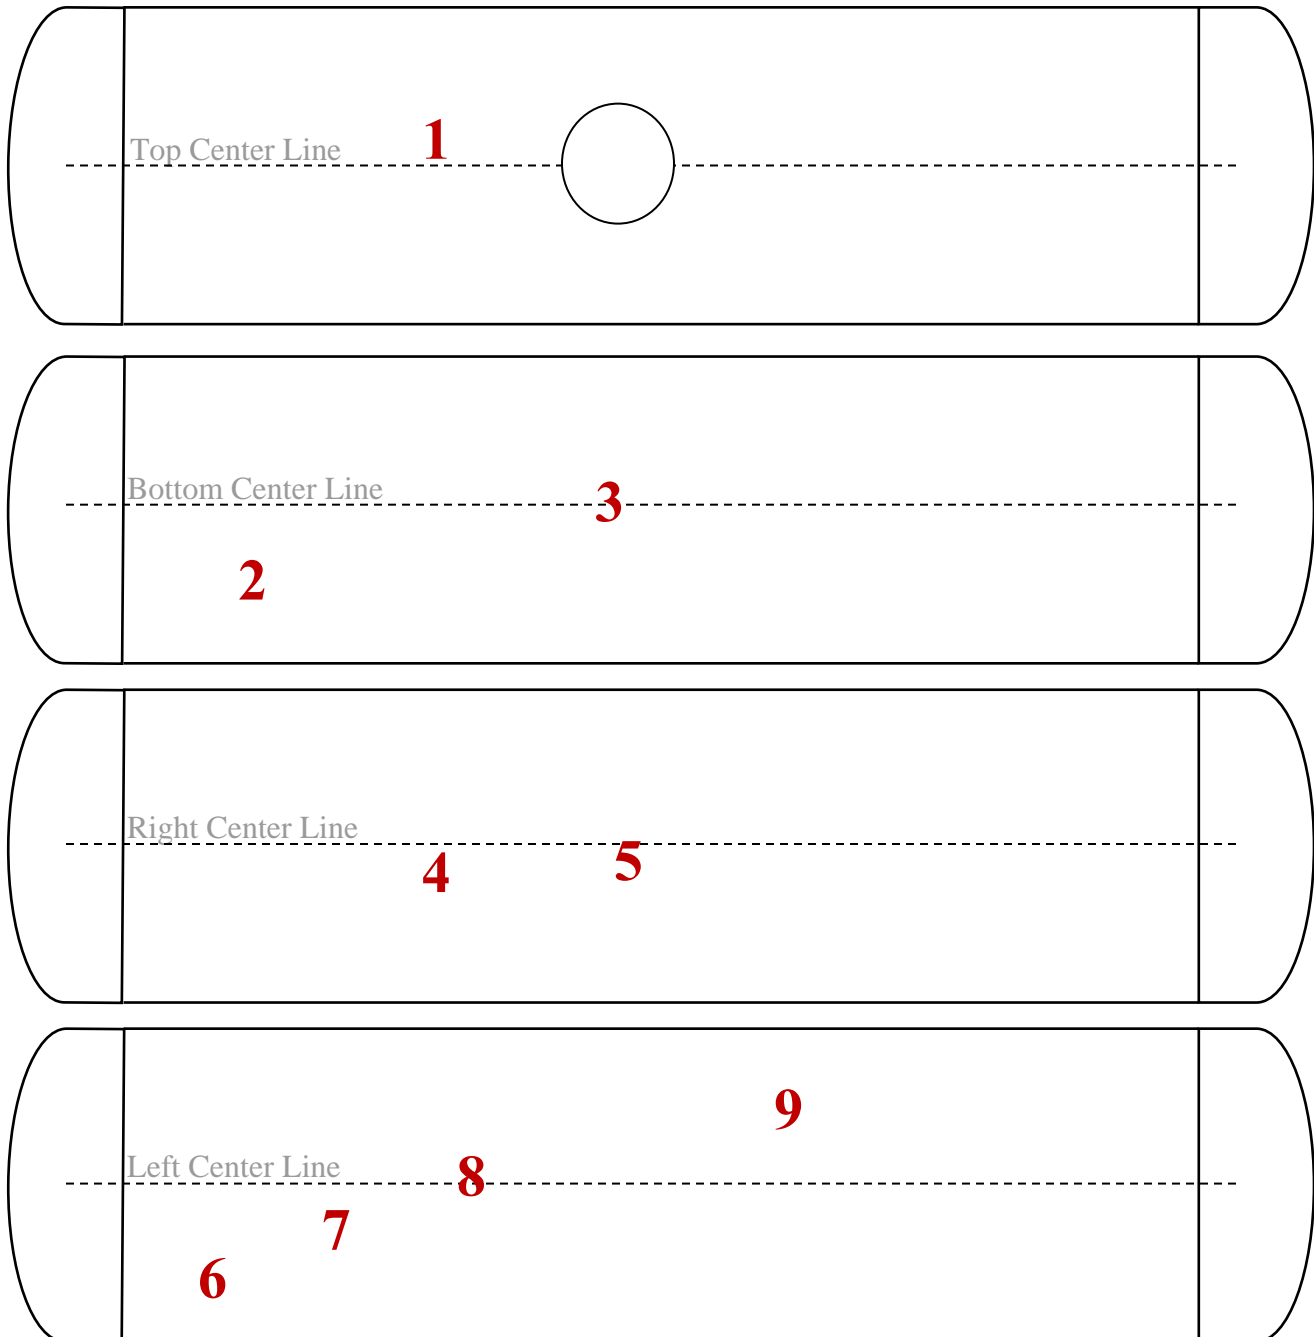
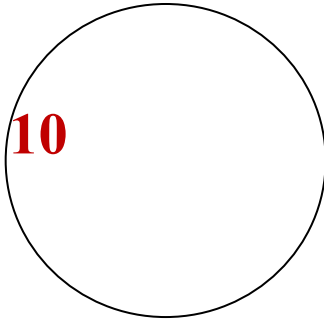
1. Thermal tear, 20 inches, two angular longitudinal segments, surrounded by a bulge 9 feet longitudinal, 7 feet transverse. Material thinning to 0.426 inch. Cracking of adjacent transverse barrel weld. Paint scorching at A-end shows car was tilted downhill toward B-end about 20 degrees.

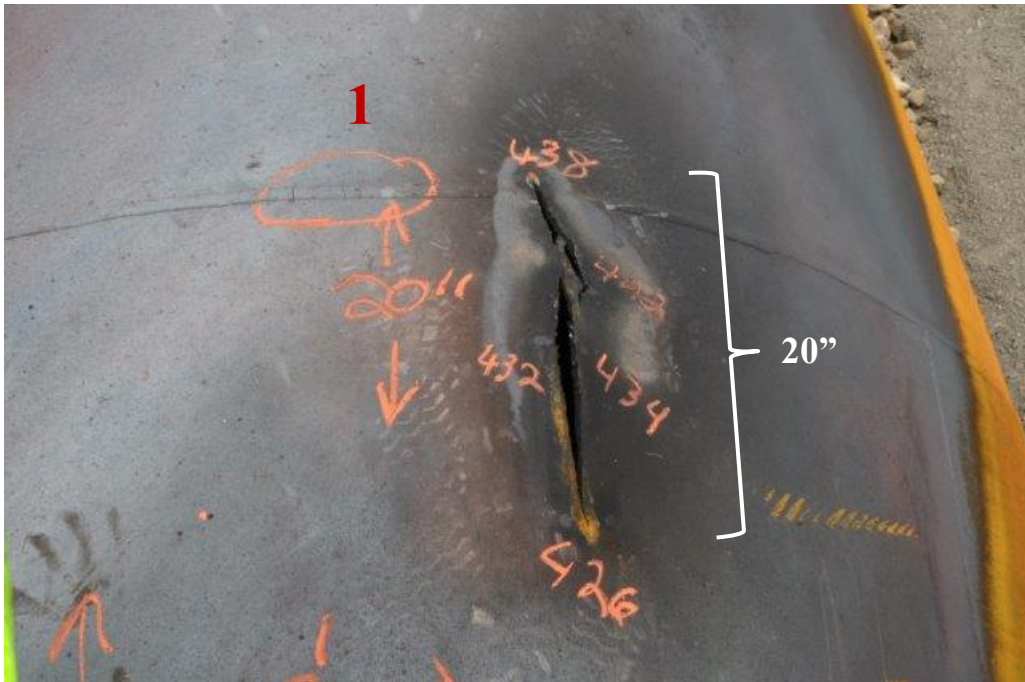
Figure 41: Thermal tear with annotated shell thickness measurements.

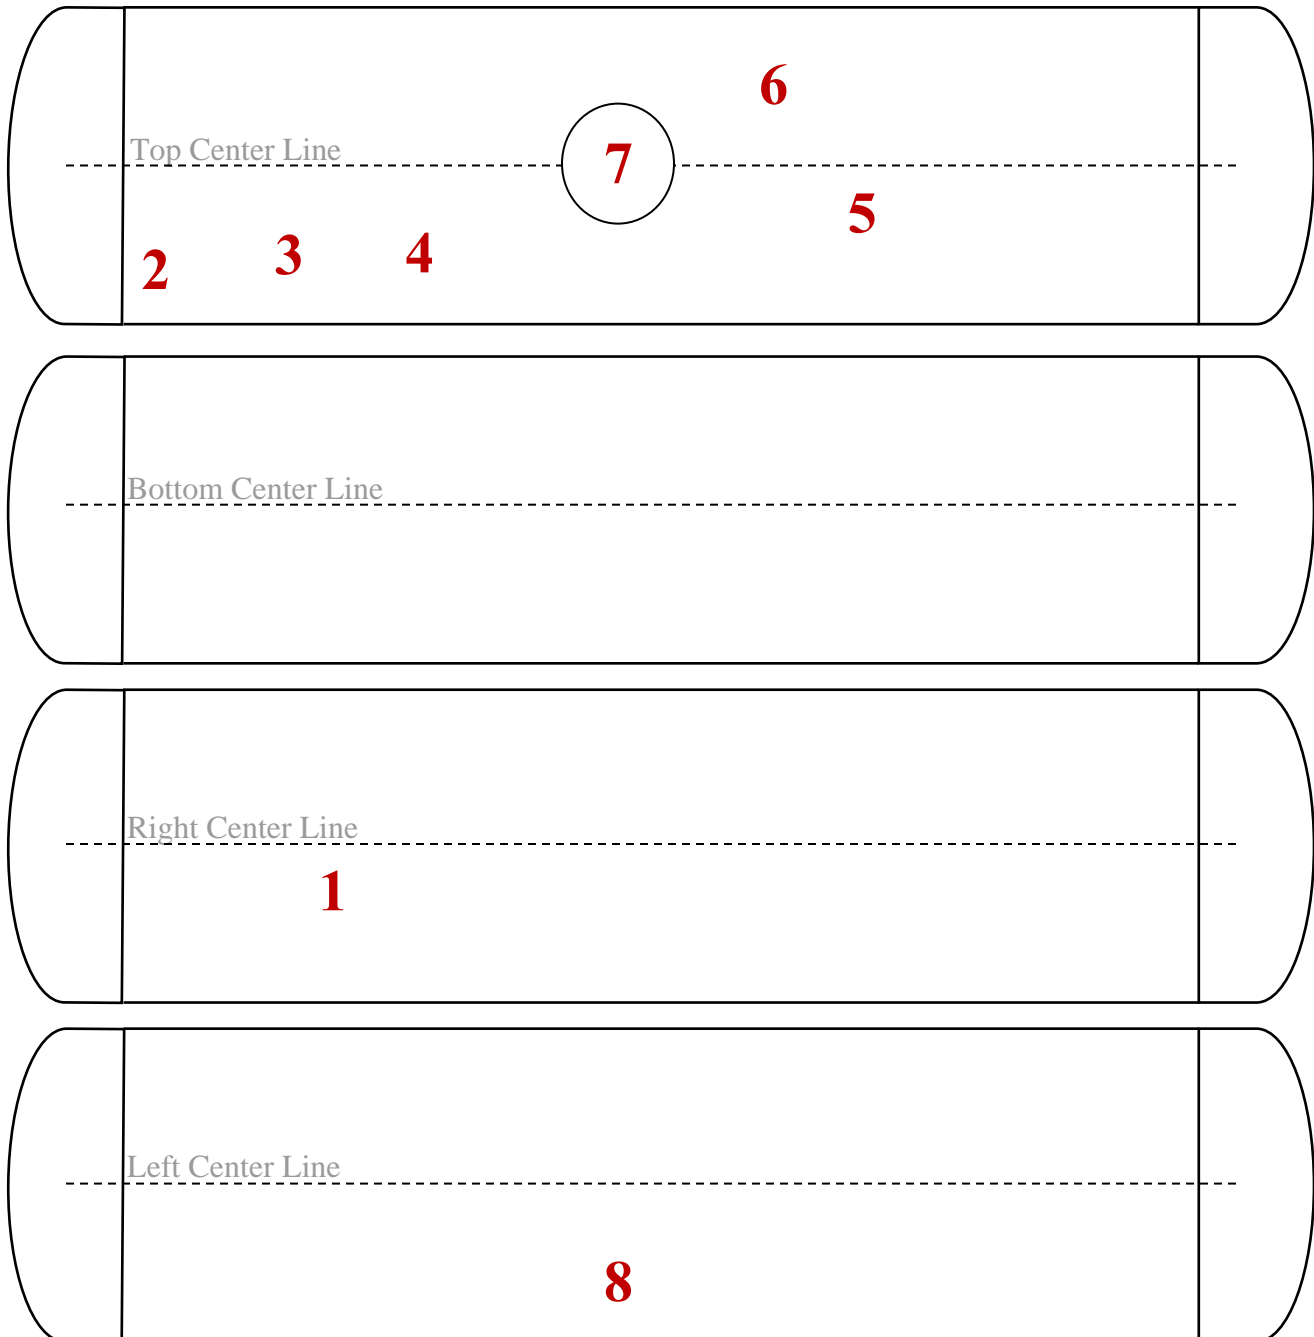
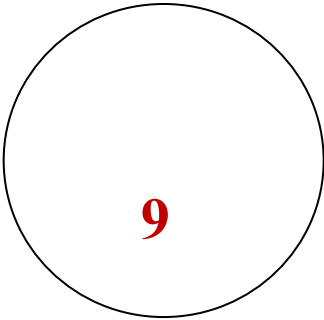
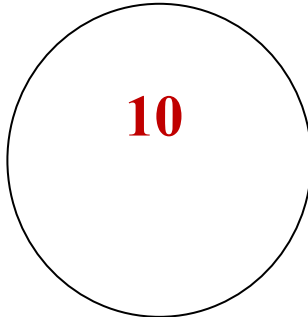
CBTX 741431 (18) Damage Assessment Notes

1. Thermal tear, 11 feet longitudinal, 8 feet transverse with flap of steel protruding outward from the tank. Shell thinning to 0.220 inch.
2. Body bolster (A-L) bent toward A-end.
3. Dent, 12 inches longitudinal, 2 inches transverse, 1.5 inches deep.
4. Dent, 3 feet by 3 feet, 3 inches deep.
5. Shell wrinkled, 13.3 feet longitudinal, 10.8 feet transverse.
6. Shell wrinkled, 10 feet longitudinal, 8 feet transverse.
7. Top fittings protective housing cover bent upward and PRD flapper cover extended. Heavy fire damage to valves and manway cover, thermal oxidation over surrounding shell material.
8. Dent, 4 feet longitudinal, 3 feet transverse, 2.5 inches deep.
9. Dent, B-end head below head shield (head shield missing) 4 feet by 4 feet, 7 inches deep.
10. Dents above head shield (head shield missing) 4 feet high by 3 feet wide, 2 inches deep. 20 inches high by 12 inches wide 1 inch deep.

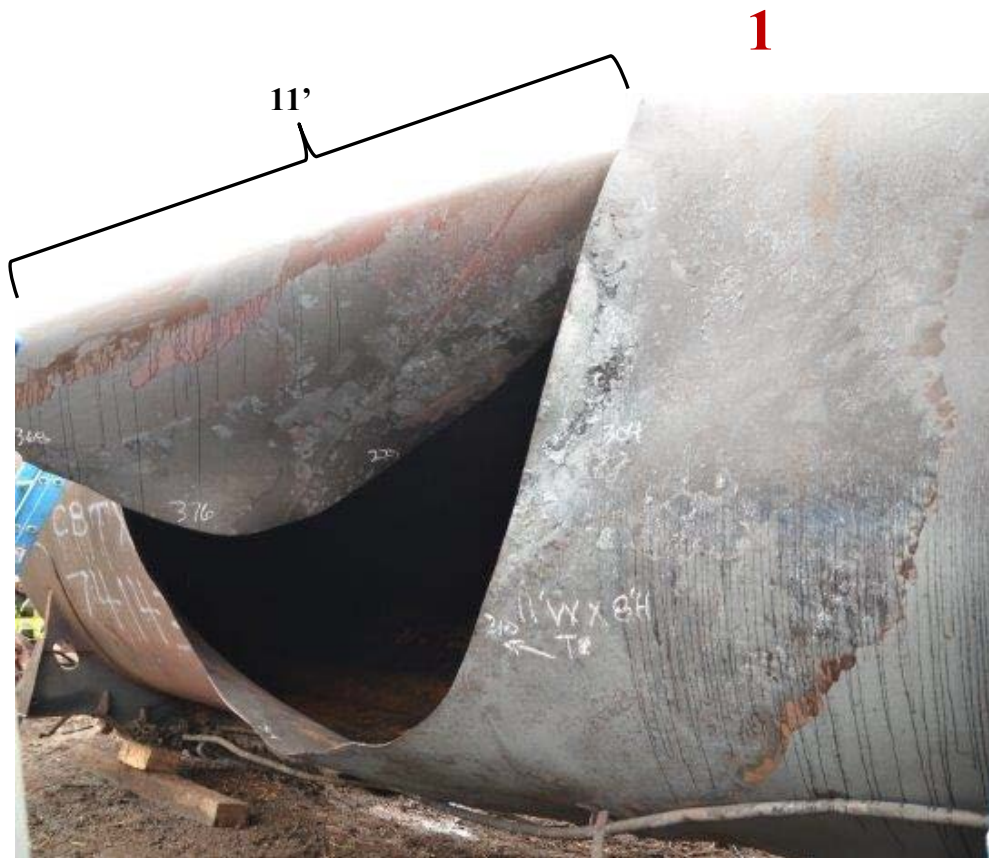
Figure 46: Thermal tear right side of tank car CBTX 741431.

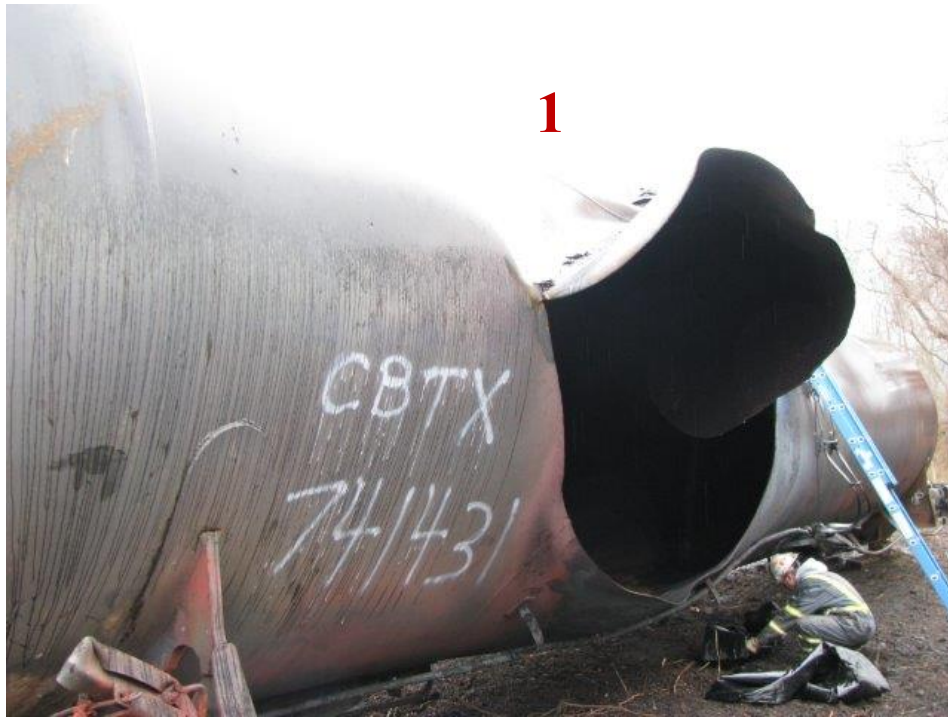
Figure 47: Thermal tear as viewed toward A-end.

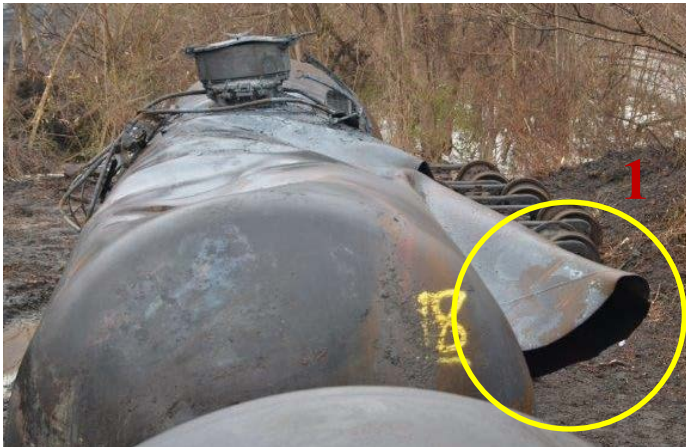
Figure 48: Flap of steel protruding from thermal tear (circled)

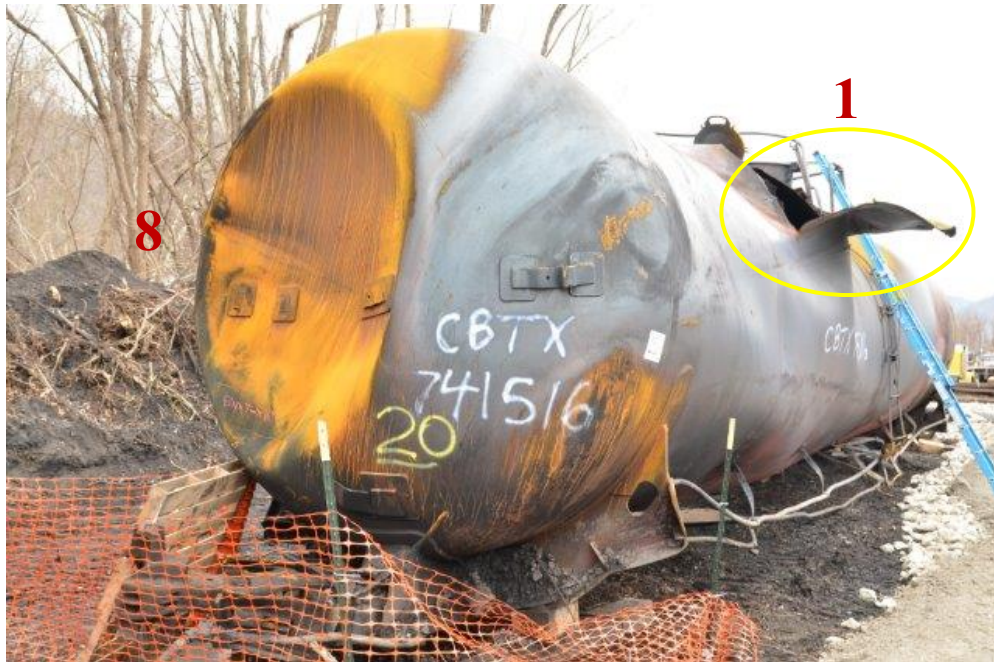
Figure 57: CBTX 741516 A-end head and thermal tear (circled).

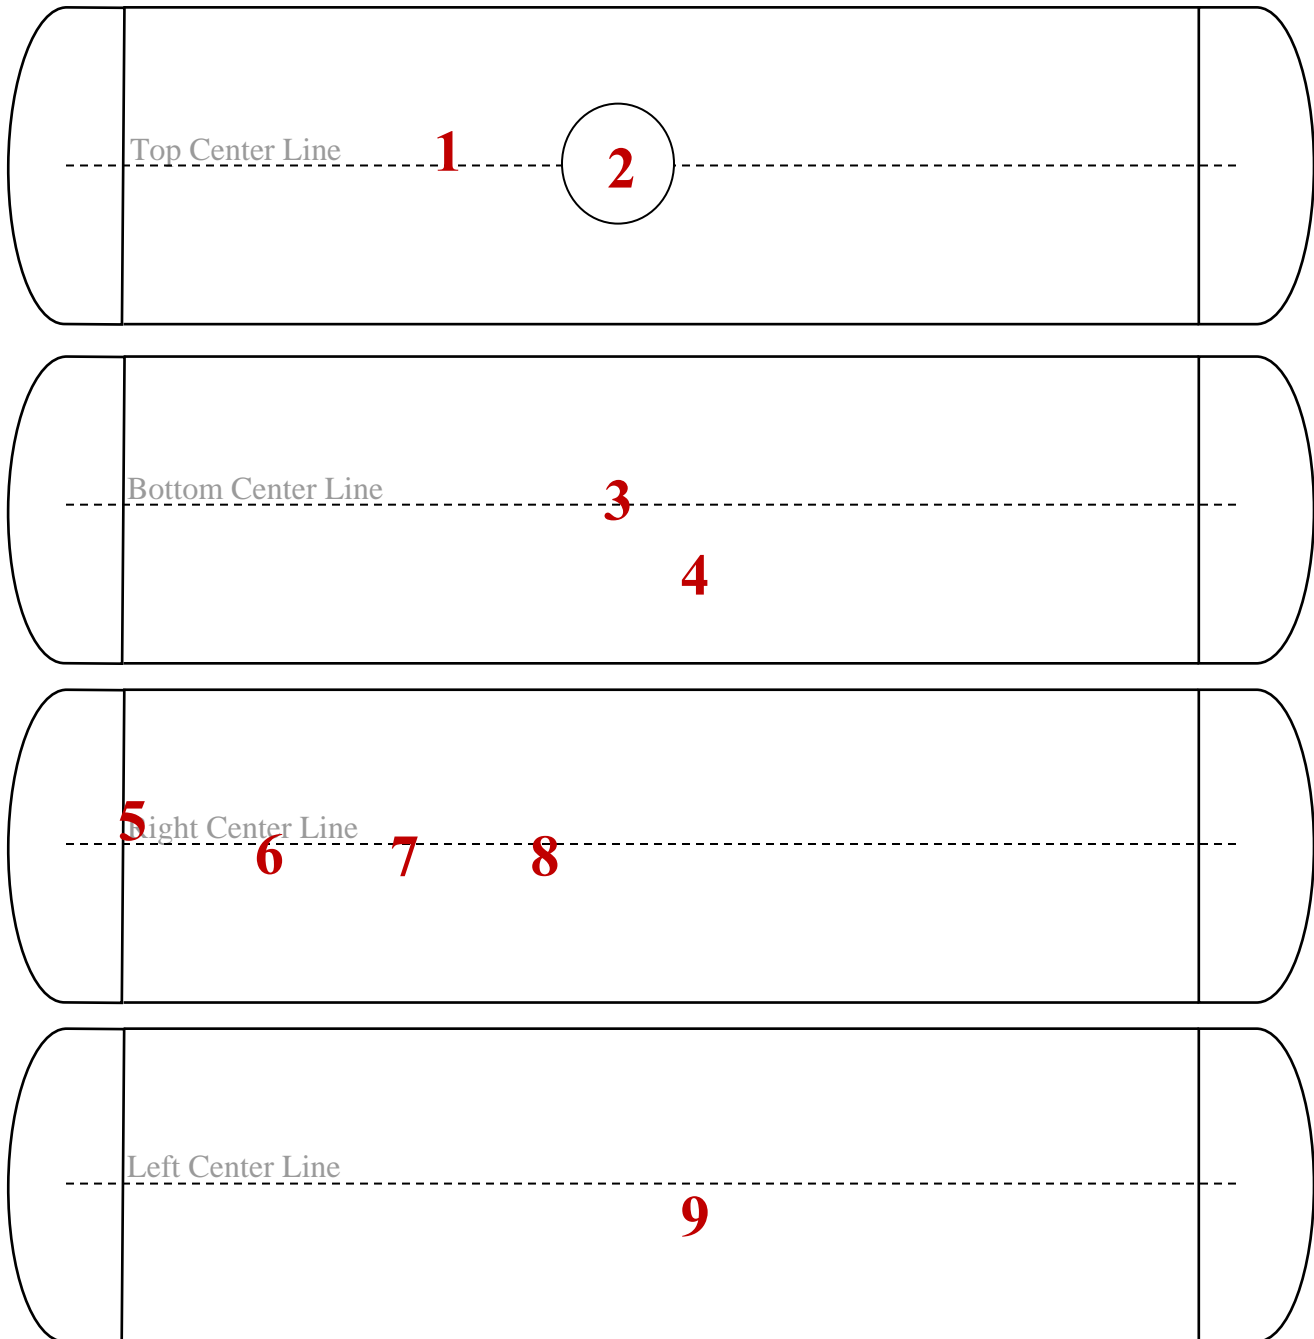
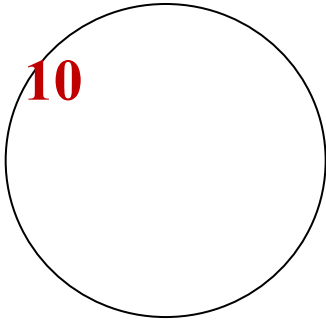
CBTX 741651 (21) Damage Assessment Notes

1. Thermal tear, 44 inches longitudinal, 12 inches transverse, tank thinning to 0.362 inch. Tear was located within a bulge in the tank 11 feet longitudinal, 5 feet transverse.
2. Valves and PRD were fire damaged, but intact.
3. BOV nozzle was sheared off, operating handle was secured and valve was closed.
4. Dent, 2 feet longitudinal, 2.5 feet transverse, 2 inches deep.
5. Dent, 2 feet by 2 feet, 2 inches deep.
6. Dent, 5 feet longitudinal, 4 feet transverse, 1 inch deep.
7. Dent, 3.5 feet longitudinal, 5 feet transverse, 3 inches deep.
8. Dent, 6 feet longitudinal, 4 feet transverse, 3 inches deep.
9. Dent, 19 feet longitudinal, 12 feet transverse, 6 inches deep.
10. Dent, above head shield at 10 o'clock edge, 3 feet wide, 2 feet high, 4 inches deep.

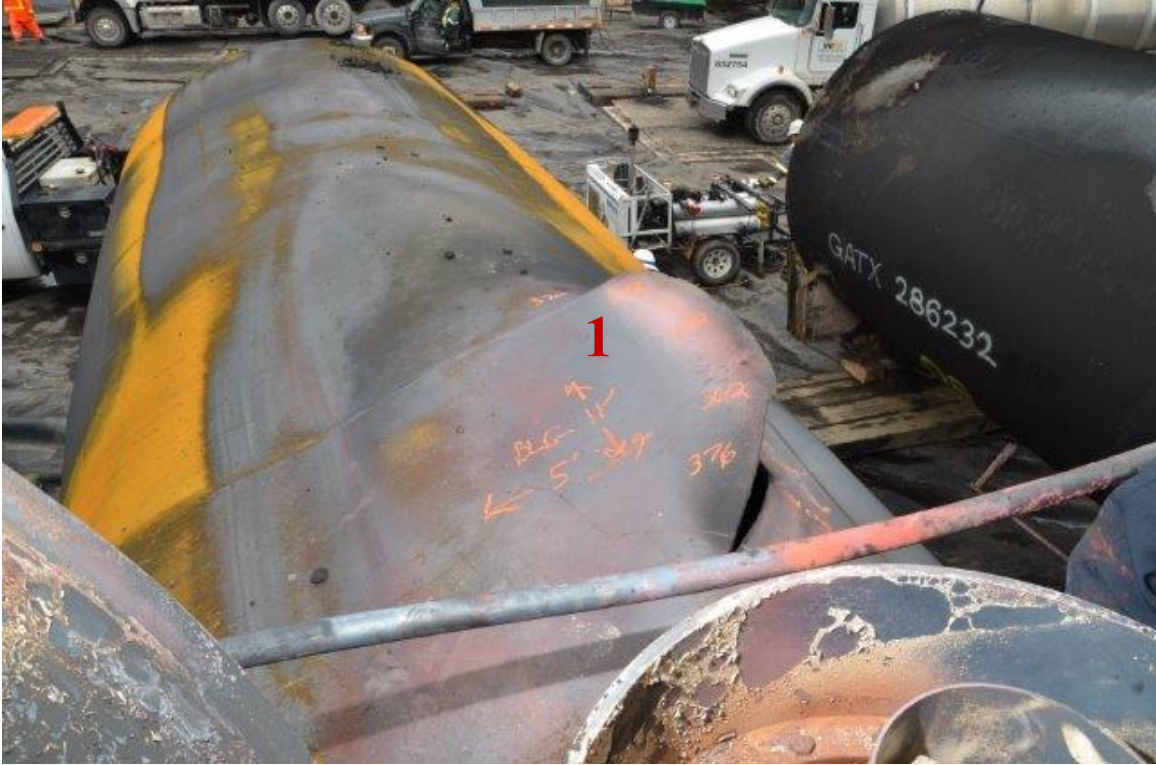
Figure 60: Thermal tear on top of tank car CBTX 741651.

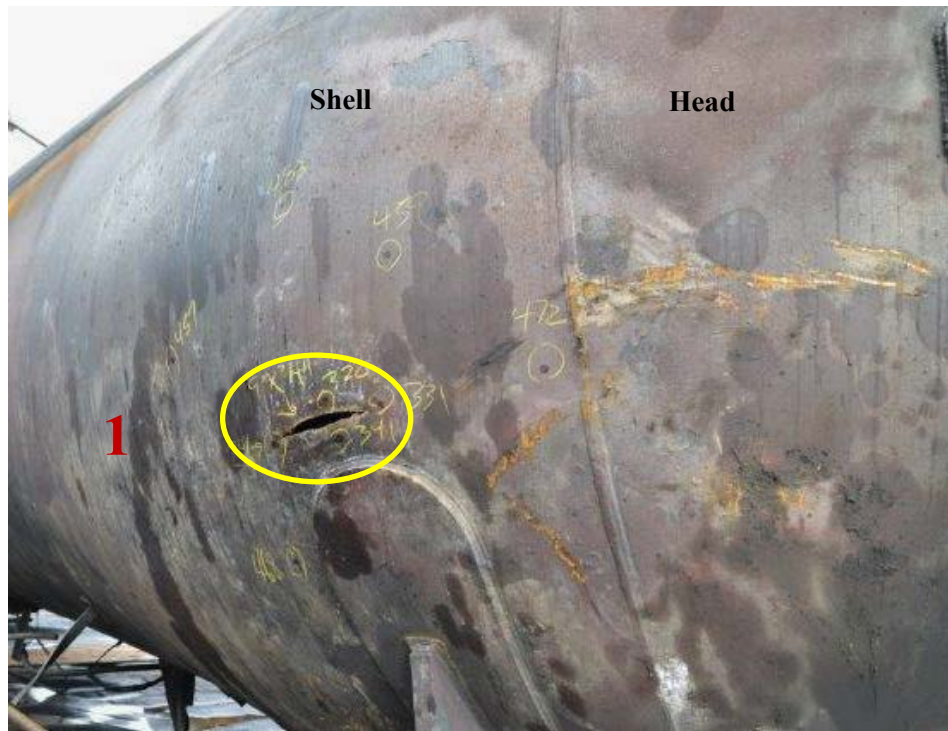
Figure 63: CBTX 742087 thermal tear above bolster pad (circled).

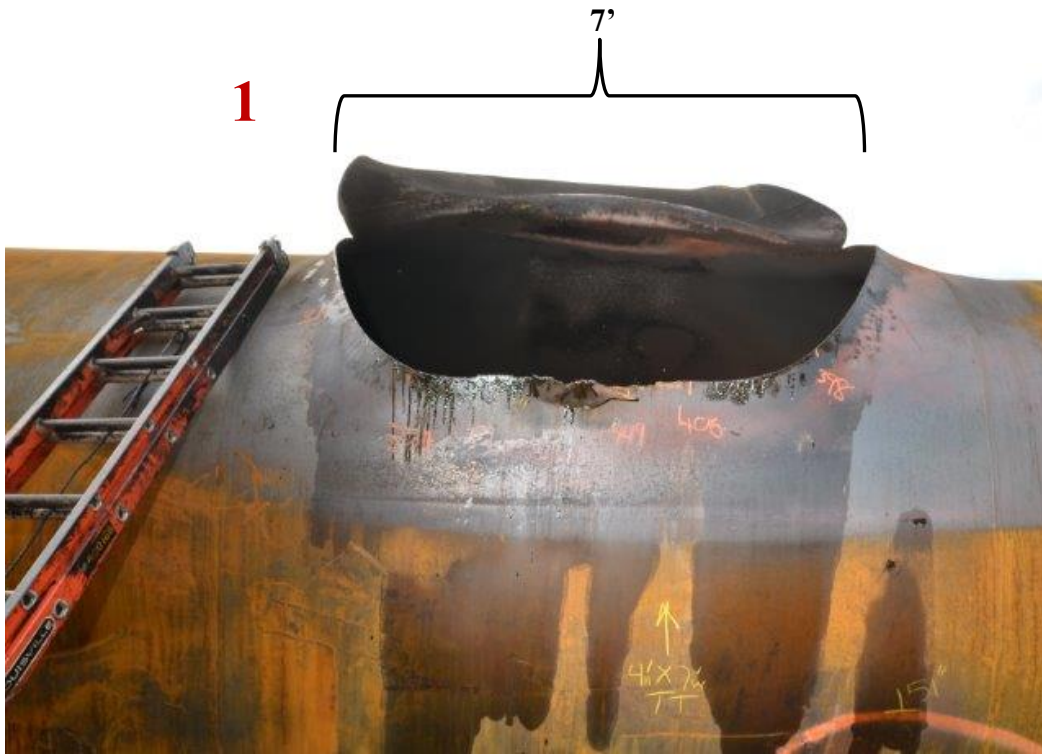
Figure 66: CBTX 741946 thermal tear with bulging and thinning shell material, B-R side.

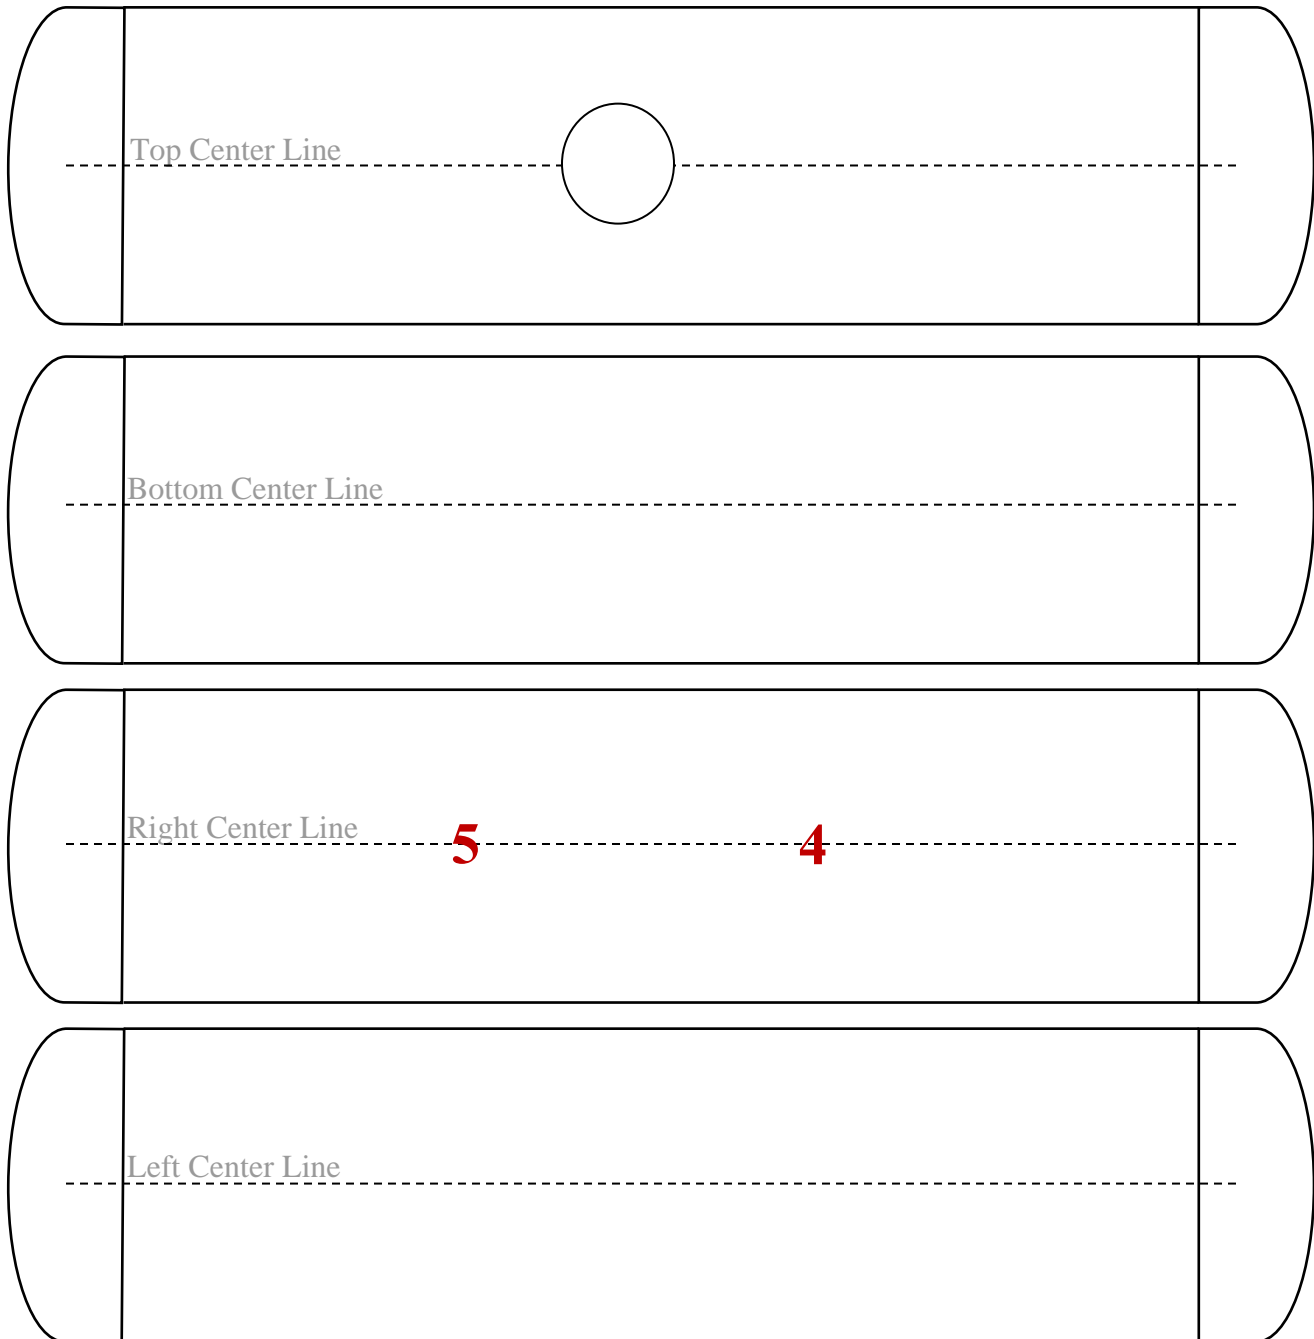
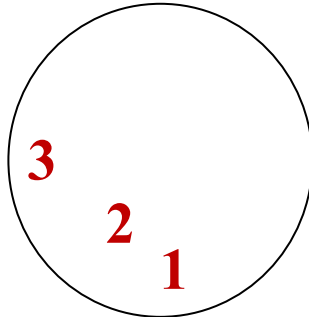
CBTX 741956 (24) Damage Assessment Notes

1. Gouge and fracture to head shield, with dent to the tank head beneath the impact area. A-L and A-center head shield mounting bolts were broken away from bracket.
2. Dent to head shield, 4 feet by 4 feet, 2 inches deep.
3. Dent to tank head above the head shield at 9 o'clock, 2 feet wide, 1.5 feet high, 2 inches deep.
4. Dent, 9 feet longitudinal, 5 feet transverse, 3 inches deep.
5. Oily residue streamers on right side center of tank shell suggest leakage from top fittings.

Investigators were not able to find breaching damage to account for released product. Oily residue streamers were found on the right side of the car.

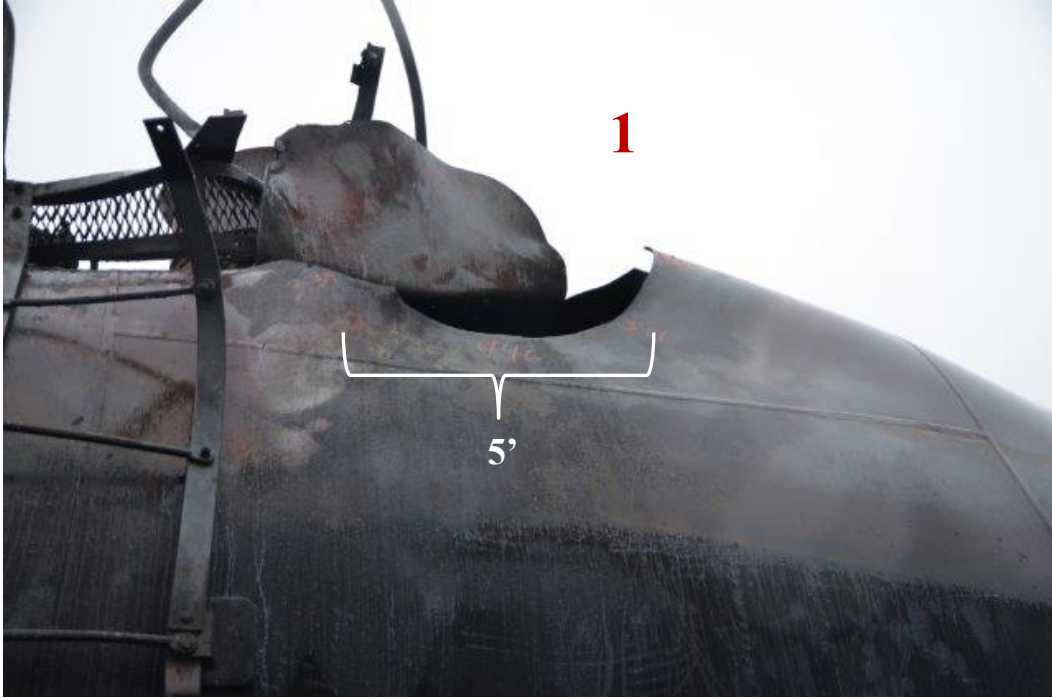
Figure 72: CBTX 743002 thermal tear near A-end center of tank car.

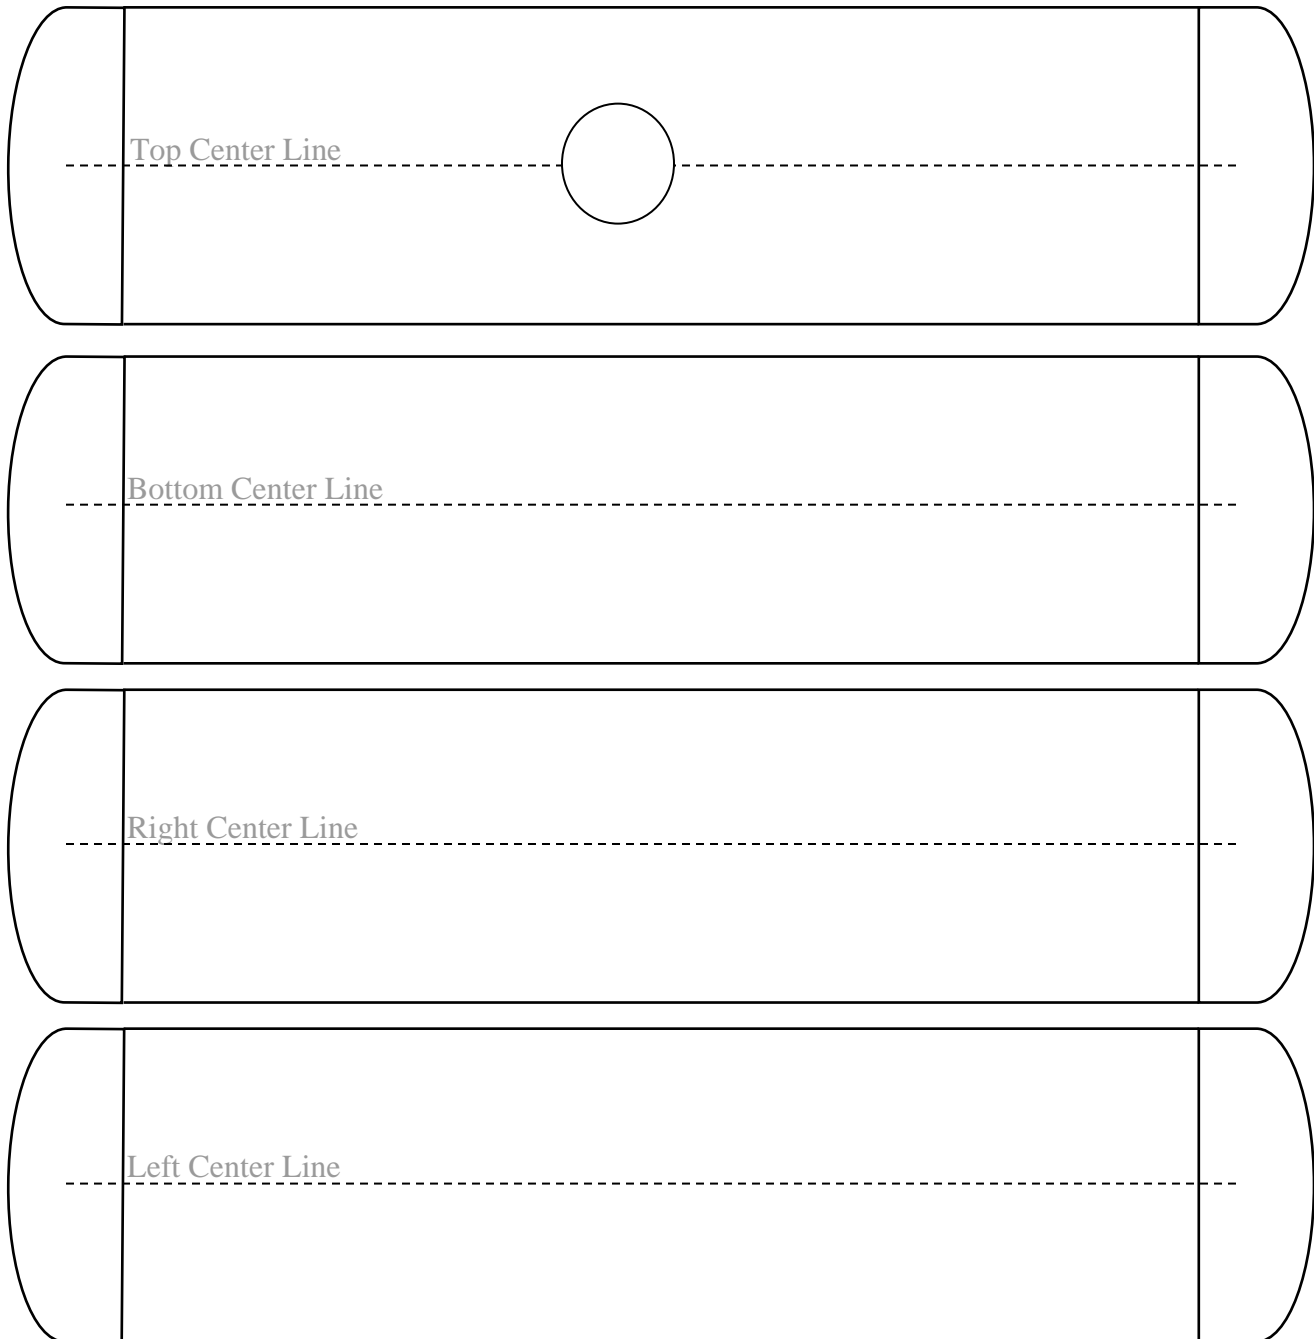
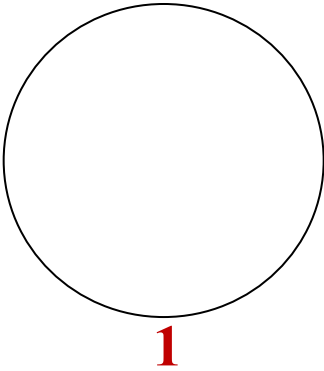
CBTX 741697 (27) Damage Assessment Notes

1. Striker plate and top plate of B-end draft sill fractured and bent upward.

No derailment damage to tank.
