CEN17FA168

Pilatus PC-12/45, S/N 105; Honeywell Examination

Re: NTSB ID: CEN17FA168, N933DC, Pilatus PC-12/45, S/N 105; Honeywell examination

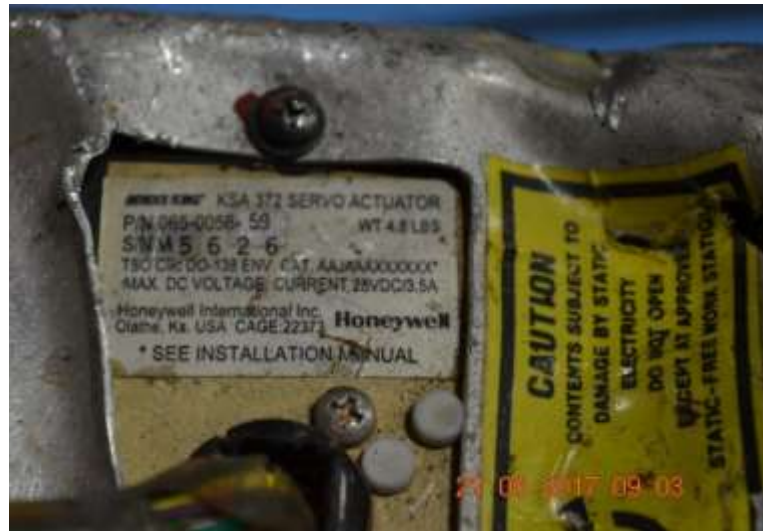
KSA 372 SN M5626 Data Plate

The wiring harness is damaged.

Crush damage at rear of the dust cover.  
Tear in dust cover.

Impact damaged wiring harness.

Broken diode (CR403) on the rear plate.

Under the supervision of the NTSB Investigator: The servo was visually confirmed to be in the disengaged state when received. The servo was connected to a test panel and power was applied. There was no clutch engagement or motor drive. Severed wires, related to impact damage, were found in the wiring harness. The severed wires were repaired and power was reapplied. The motor ran briefly followed by a resistor smoking. Power was removed. Power was reapplied and clutch engagement was tested. The clutch would not engage.

Circuit board (200-06444-0012) was lifted to visually examine the components. A blue wire was found contacting a screw due to the circuit board pressing up against it (impact related) resulting in a shorting condition. The blue wire had damaged insulation. The blue wire was moved away from screw.

As a precaution, the accident servo motor drive transistors Q 201, Q 202, Q 203, and Q 204 were replaced with exemplar drive transistors. The original drive transistors were retained with the accident servo.

An exemplar test aid diode was installed for the broken CR403.

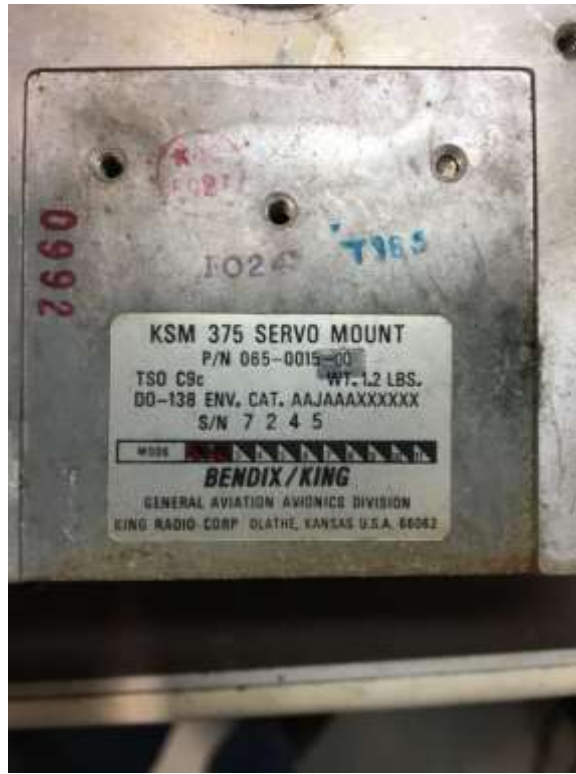
KSM 375 SN 7245 Data Plate

Mounting plate appears to in good condition. Dried clay/dirt observed on the mounting plate, the capstan, and the capstan / clutch cover.

Observed impact damage to the Capstan and Capstan cover.

The KSM 375 Pitch Servo Mount functioned correctly; however, the clutch slipped at approximately 50 in/lbs (CW) and 50 in/lbs (CCW) against a limit of 40 +/- 5 in/lbs. The out of tolerance condition would not have an adverse impact on operation. The Aircraft Flight Manual provides preflight instructions to confirm proper operation and ability to overpower the autopilot clutches.

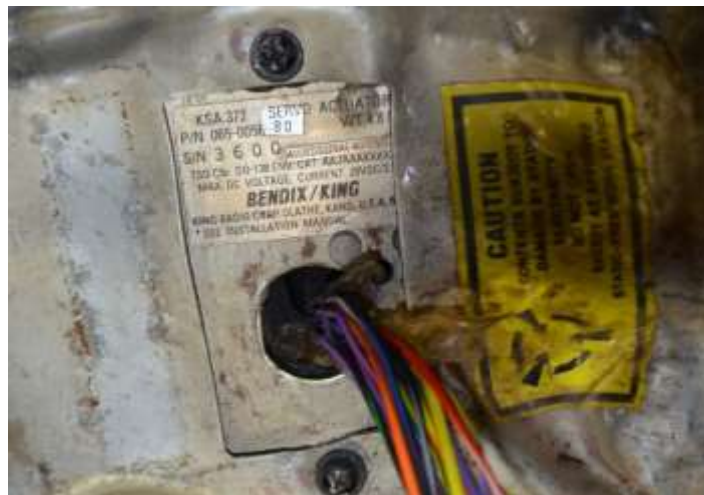
KSA 372 SN 3600 Data Plate

- The servo was visually confirmed to be in the disengaged state when received.
- The dust cover was crushed.
- The servo circuit cards were found detached from the main servo housing.
- The gear train appeared to be out of alignment.
- The servo housing was cracked
- A mounting boss was found broken.
- Connector back shell found broken.
- Wires found severed in the wiring harness.

The back plate was found bent / crushed.

The circuit cards were found crushed and broken.

The access panel was removed from the servo housing and the clutch was found Not Engaged.

No witness marks were observed on the clutch gear teeth crowns. Due to extensive damage, testing of the complete servo was not possible. No adverse operation observed during standalone testing of the clutch solenoid and drive motor.

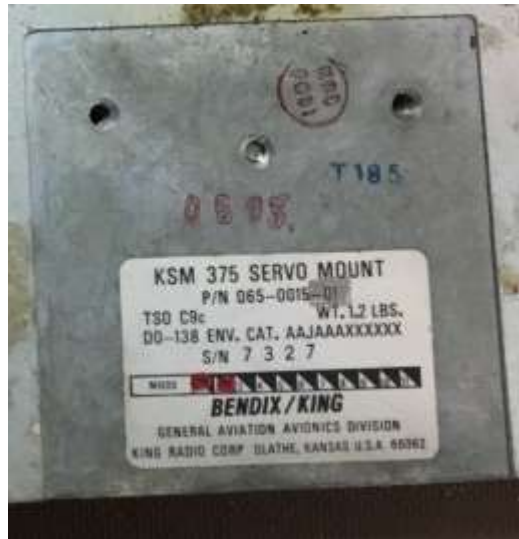
KSM 375 SN 7327 Data Plate

Mounting plate appeared to be in good condition. Dried clay/dirt observed on the mounting plate.

The clutch assembly was removed from the Servo Mount and inspected. The last service date noted on clutch assembly was in 1994. Month and day were not discernible. The clutch appears to be original for the airframe. The Clutch assembly appeared to be in good condition.

The KSM 375 Yaw Servo Mount functioned correctly; however, the clutch slipped at approximately 50 in/lbs (CW) and 50 in/lbs (CCW) against a limit of 85 +/- 5 in/lbs. The out of tolerance condition would not have an adverse impact on operation. The Aircraft Flight Manual provides preflight instructions to confirm proper operation and ability to overpower the autopilot clutches.

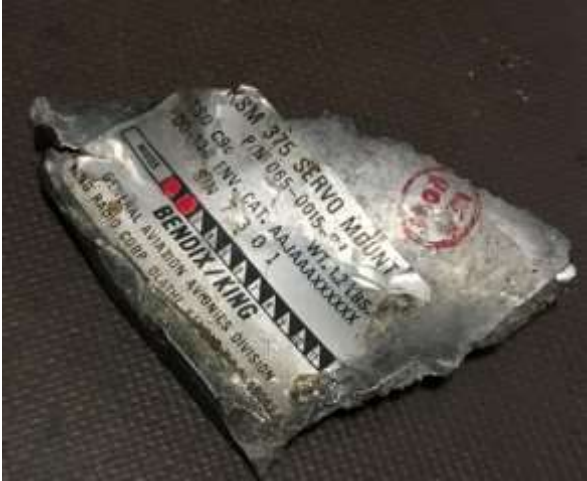
KSM 375 SN 7301 Data Plate

Servo Mount Inspection:  
The only portions of the servo mount recovered were a portion containing the ID plate, a portion behind the capstan, and a portion attached to a piece of the airframe.

KSM 375 SN 7301 Impact damage to clutch

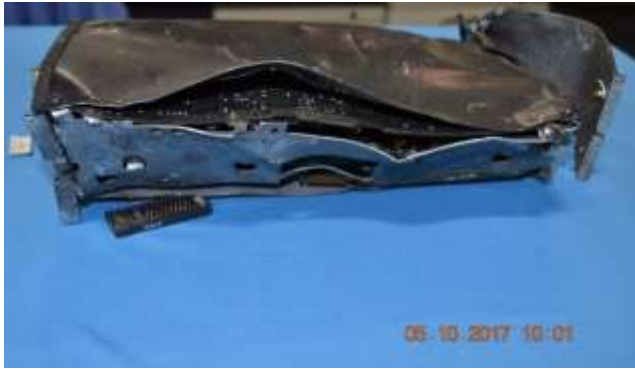
KCP 220 SN 1898 Exterior View 1

KCP 220 SN 1898 End view showing unit twisting.
