**Download and Analysis of Four
Actuator IO Process (AIOP) Modules
from
Houma, LA
Agusta AW139 Accident Aircraft
Registration N385RH**

NTSB Identification: CEN13LA025
Accident occurred October 22, 2103 near Houma, LA
Aircraft: Agusta AW139, Registration: N385RH

Actuator IO Processor (AIOP) Investigation

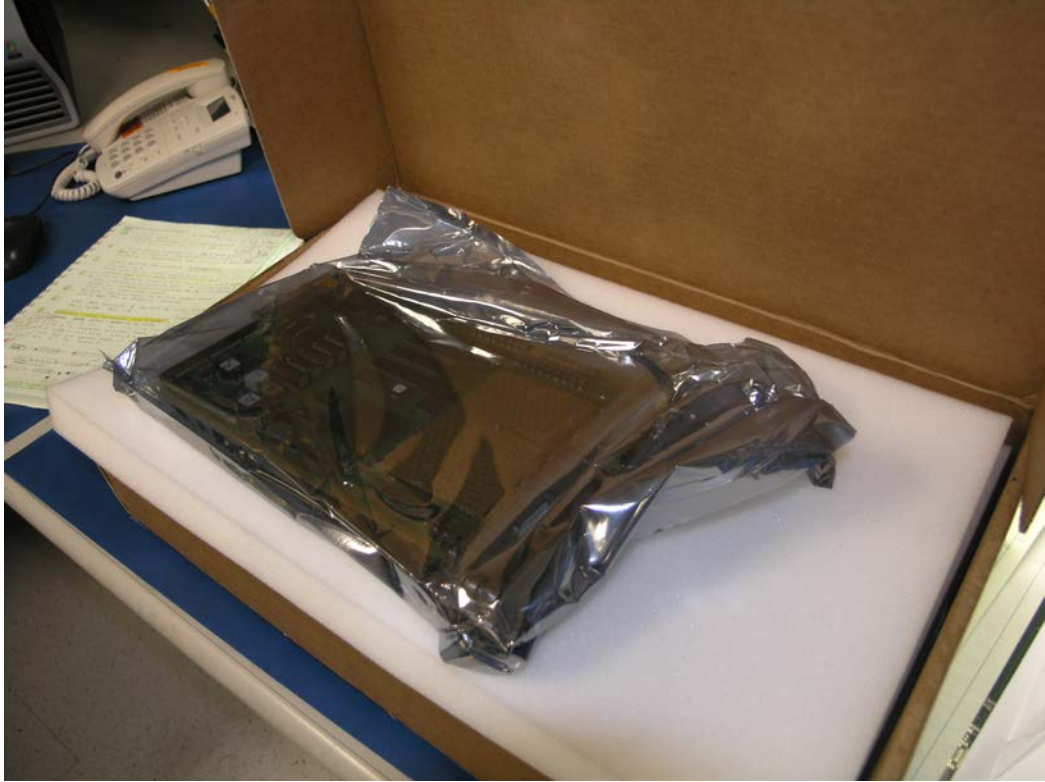
Figure 8. S/N 06080596 Shipping Box as Received

- The units were packaged in standard EPIC module shipping boxes. ([Figure 1](#) through [Figure 8](#))
- The shipping boxes appeared to be unopened and undamaged.
- After opening the shipping boxes, the AIOPs were found packaged within a standard Electro Static Discharge (ESD) safe bag. ([Figure 9](#) through [Figure 12](#))
- The AIOP modules appeared to be undamaged. ([Figure 13](#) through [Figure 20](#))
- One of the AIOP data plates identified the following information: ([Figure 21](#) and [Figure 22](#))
 - P/N: 7029194-1901
 - S/N: 07010735
 - Mod Status: A through L
- Another of the AIOP data plates identified the following information: ([Figure 23](#) and [Figure 24](#))
 - P/N: 7029194-1901
 - S/N: 05100394

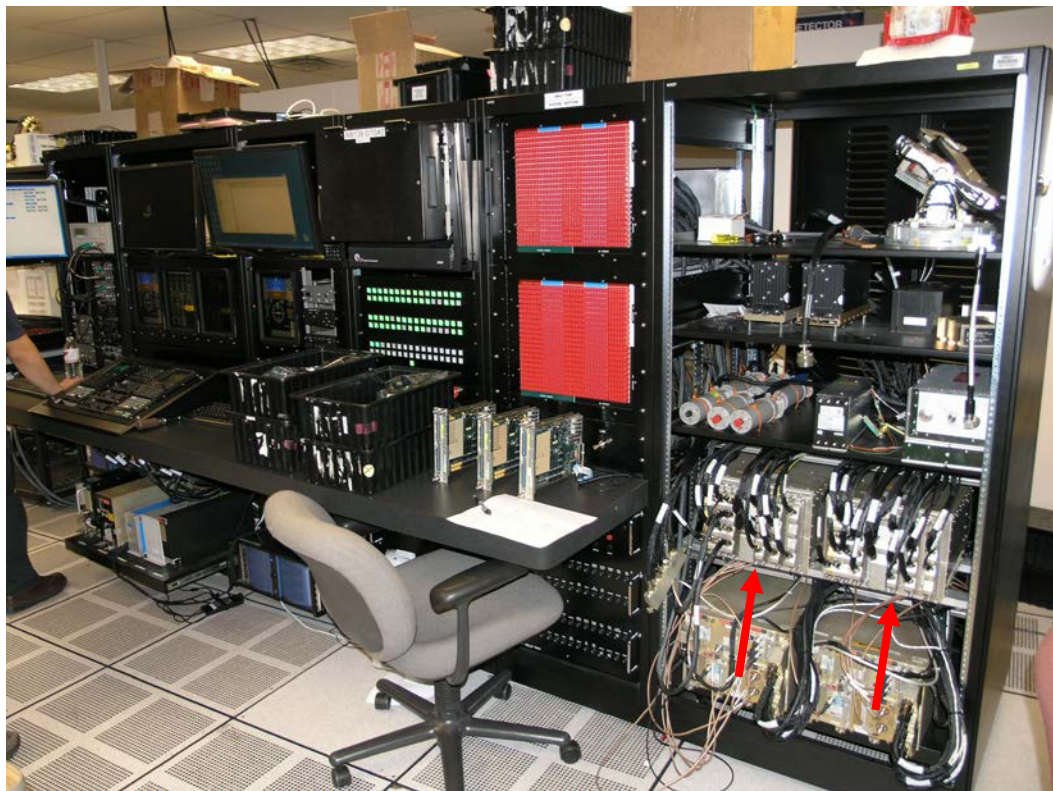
Figure 29. Installation on AFCS Engineering Bench

- Mod Status: A through L
- Each unit was connected to the AFCS engineering test bench (Figure 29). Communication was established with the test bench interface and the functional software, boot software, and fault history were successfully downloaded from each unit.
