FROM: John Purvis
Boeing Air Safety Investigation
Phone - [REDACTED]
Fax - [REDACTED]

SUBJECT: Upset During Approach

REFERENCE: Feb 95

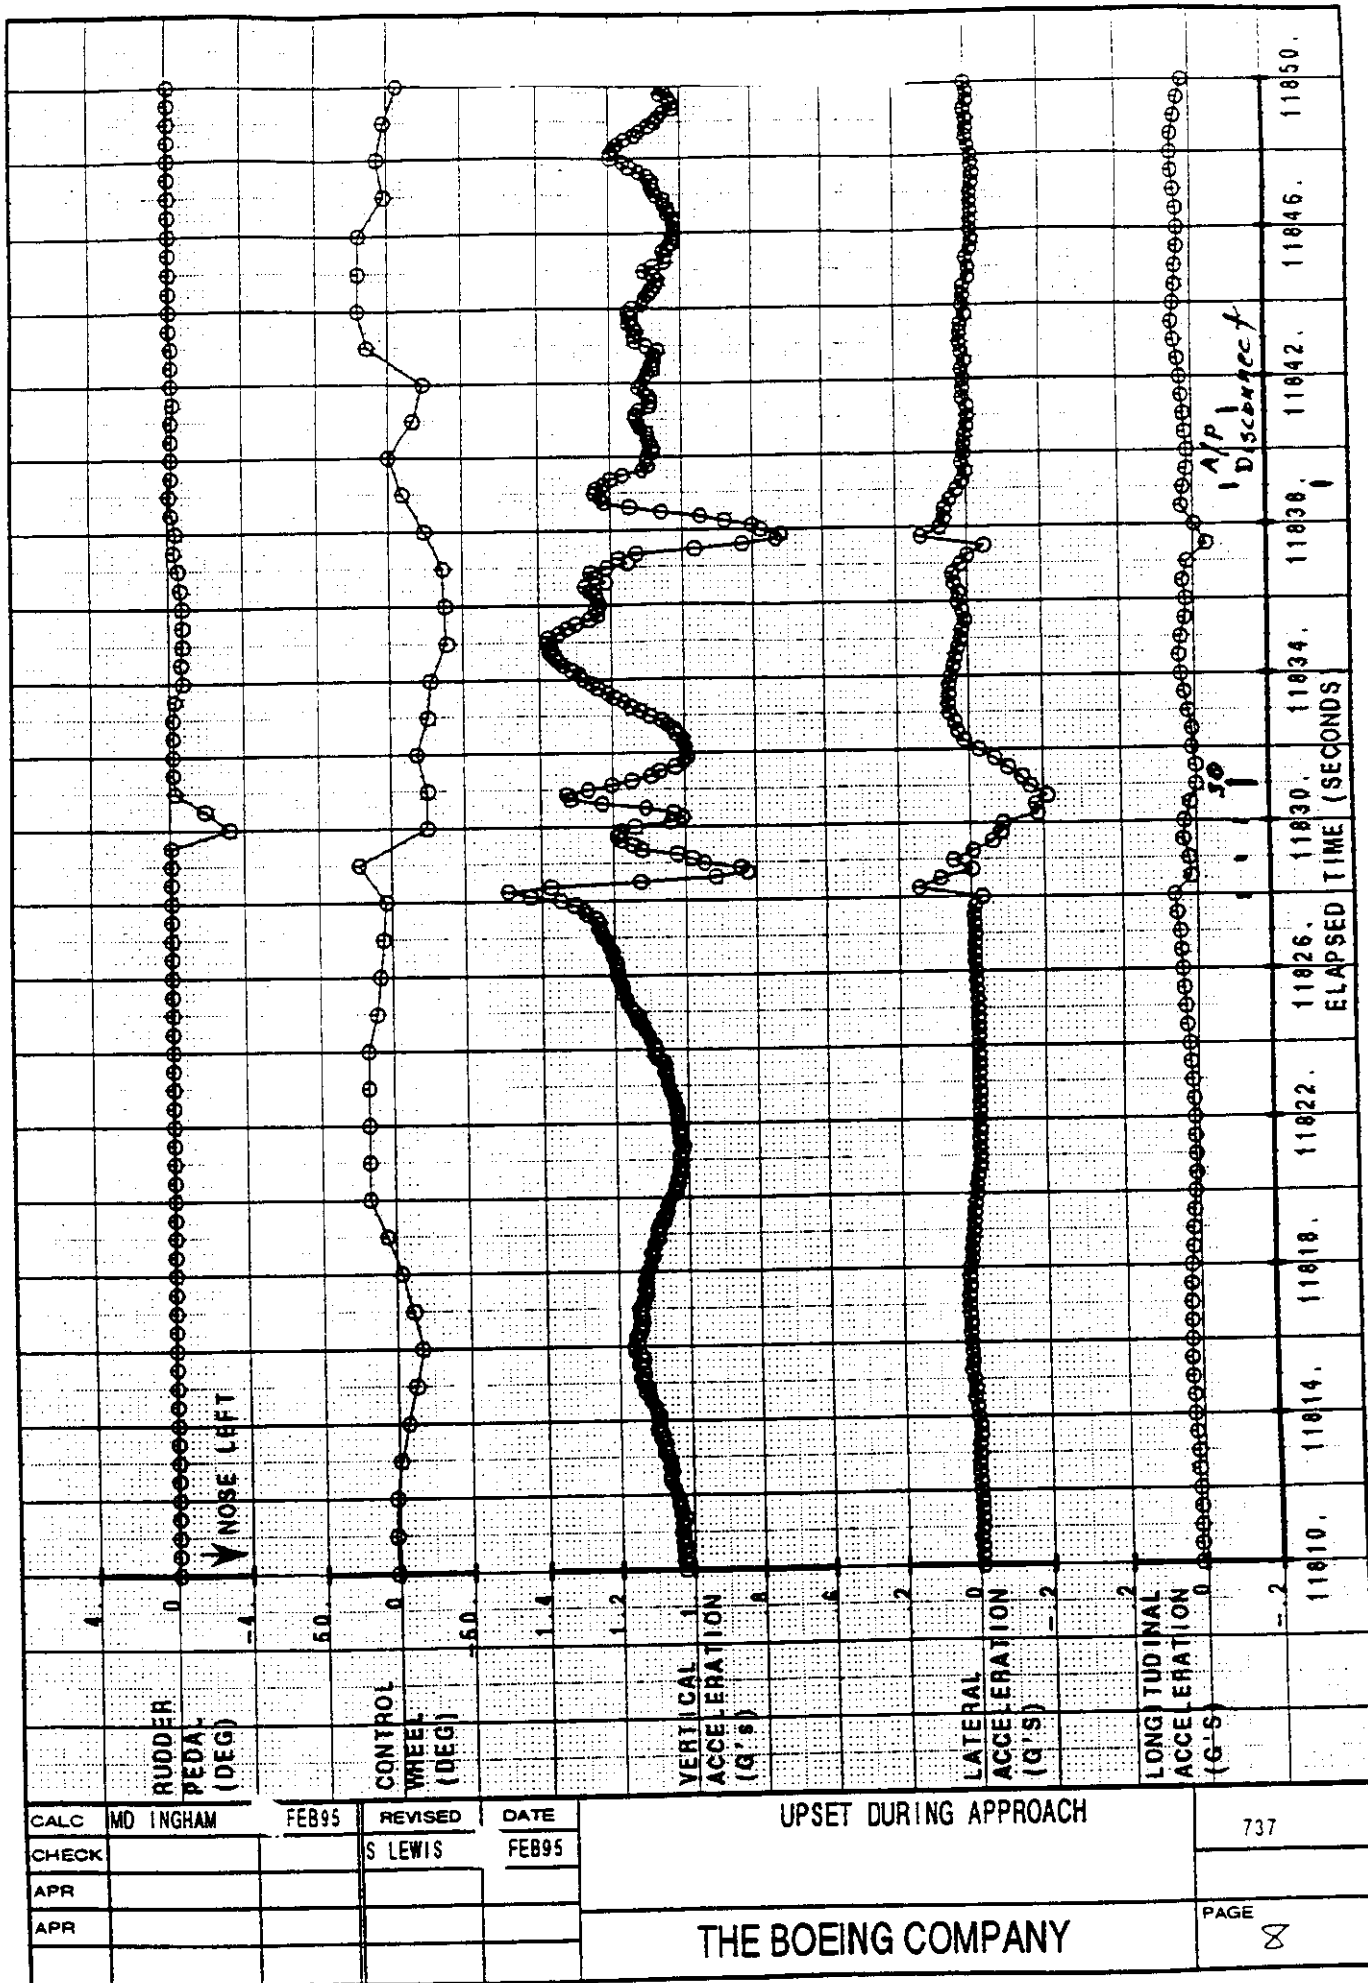
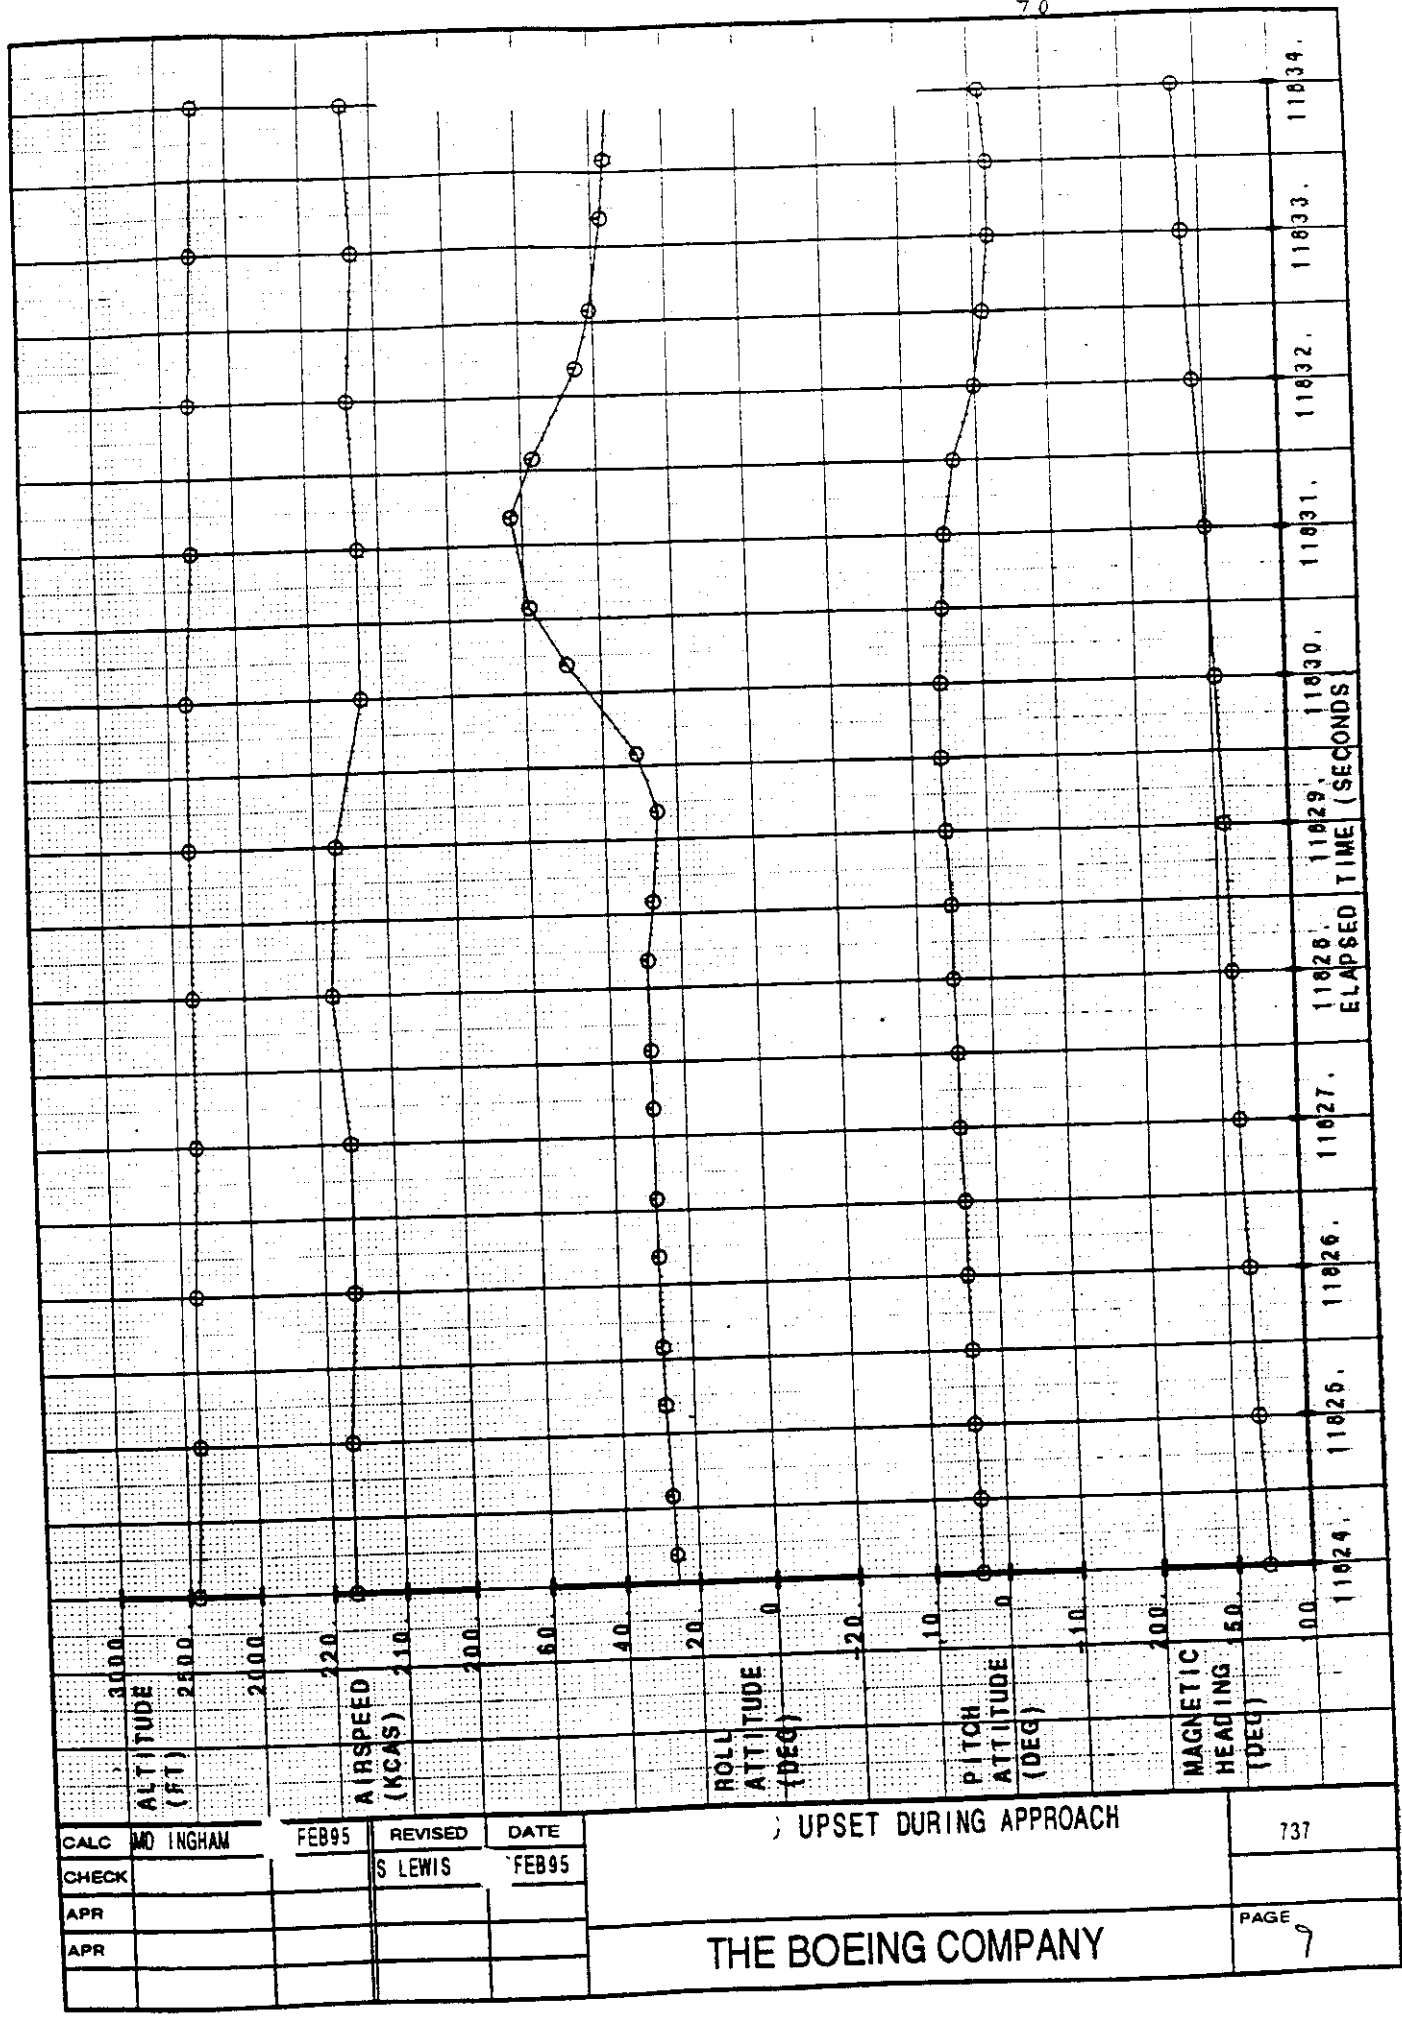
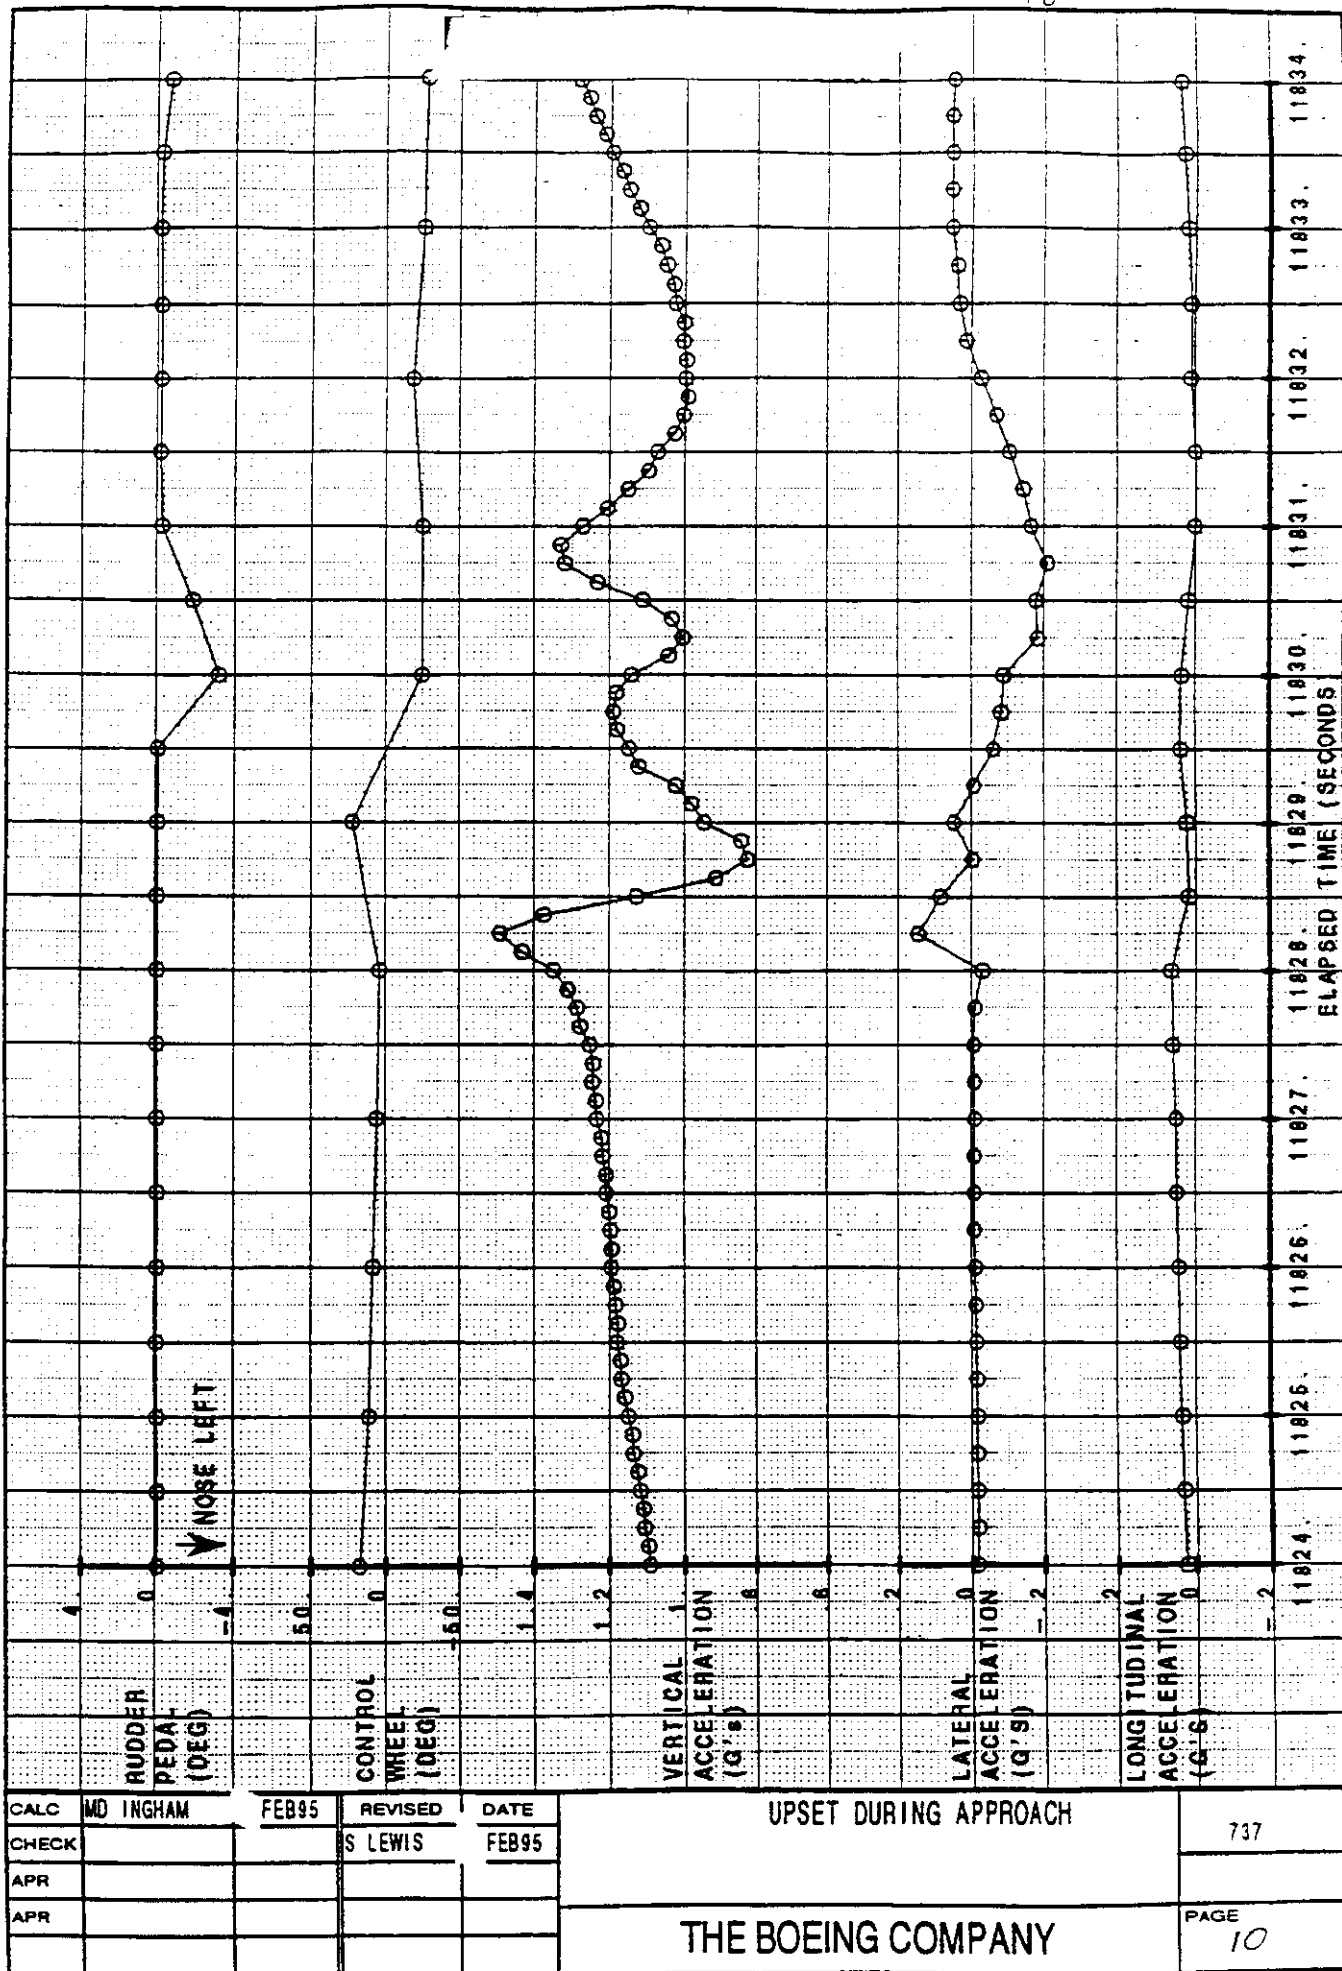
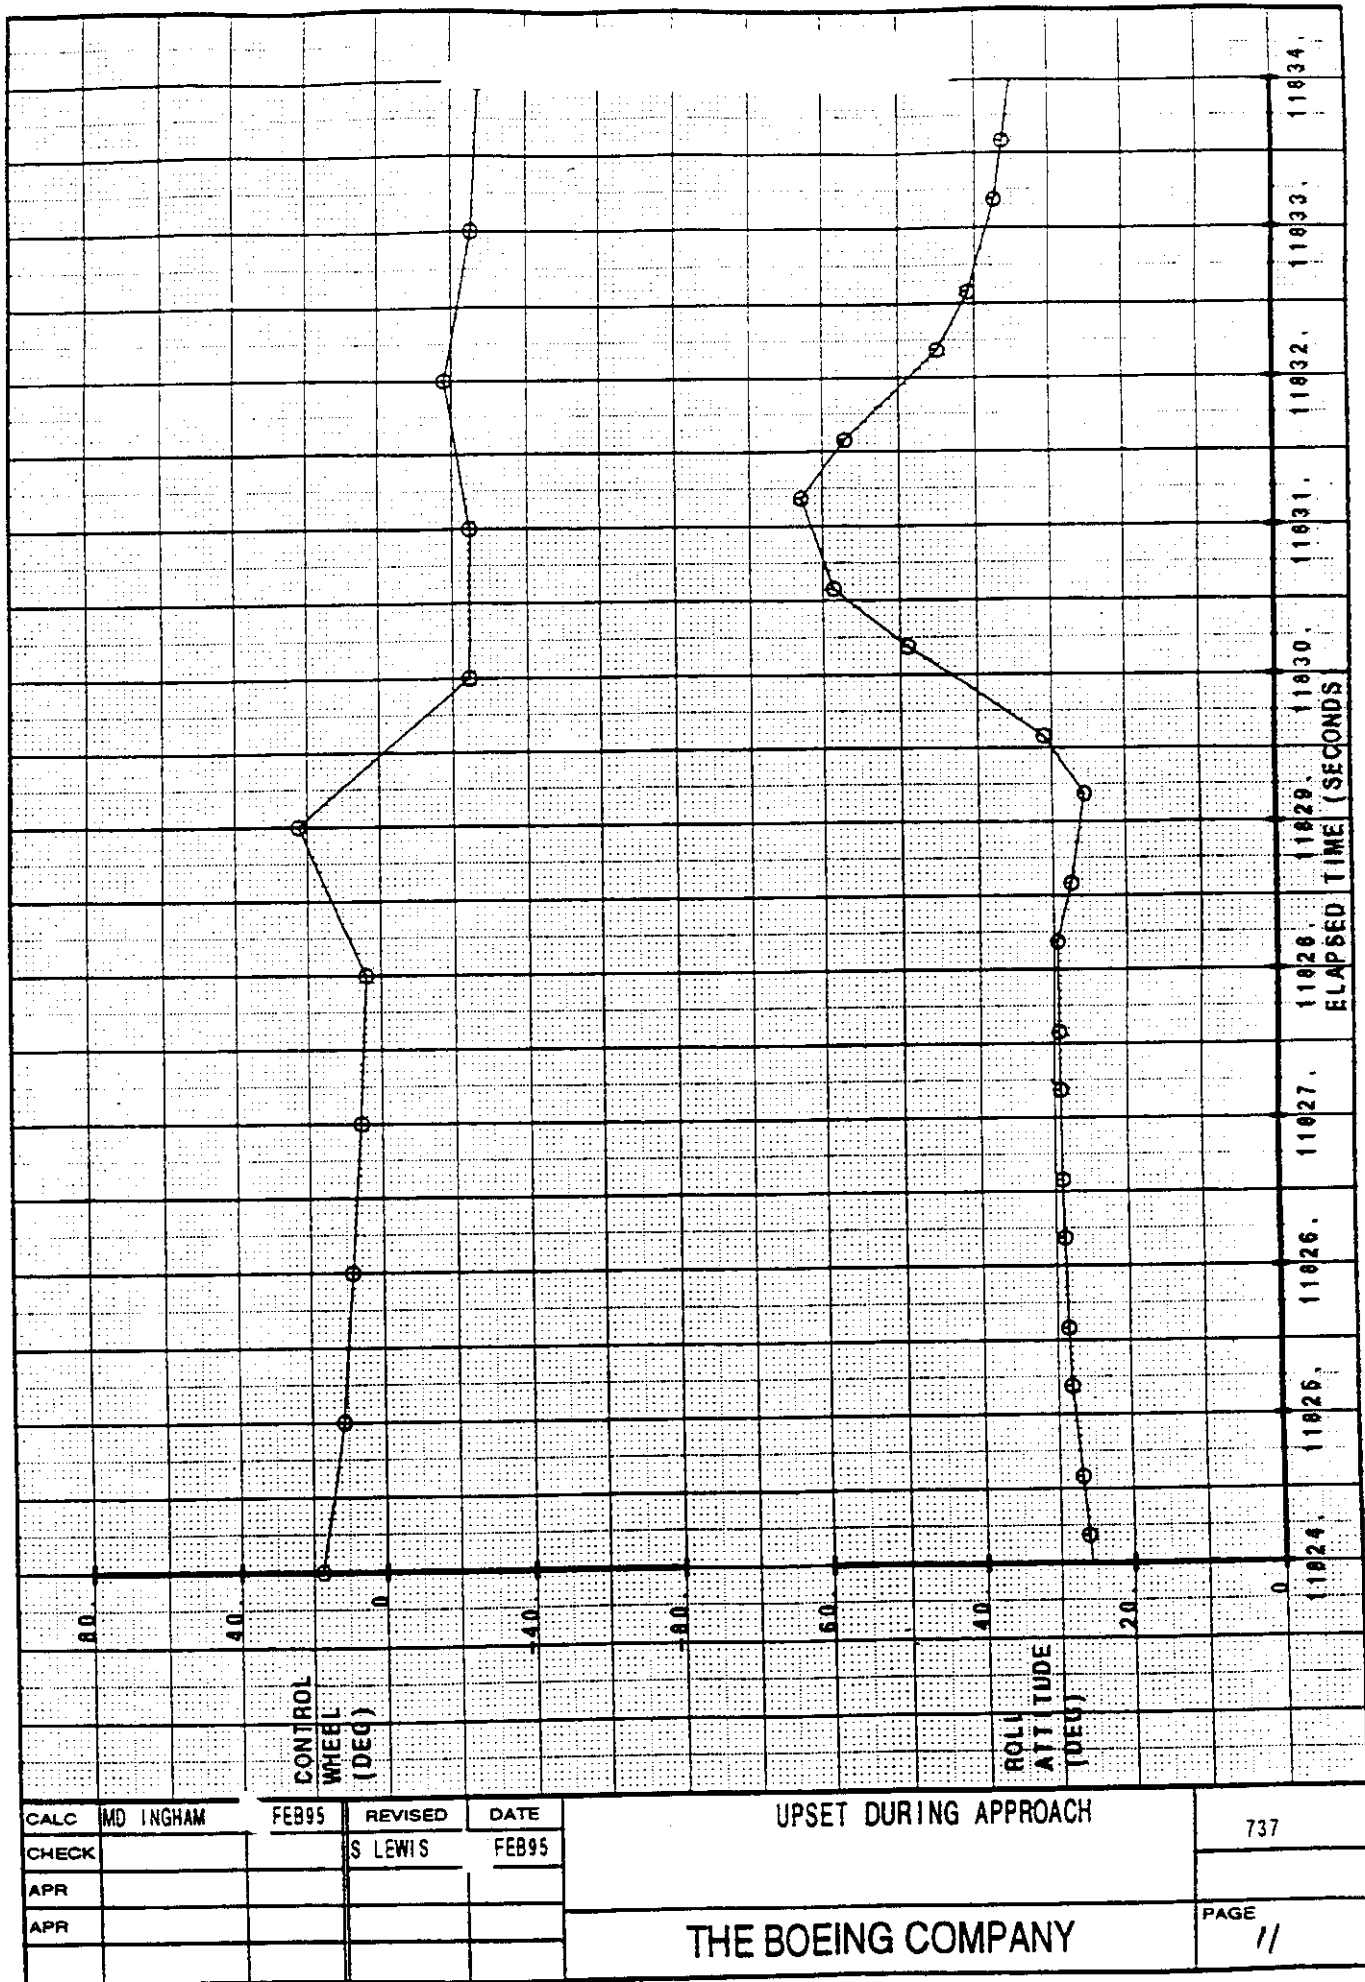
The roll upset was identified as having occurred between the elapsed times of 11829 and 11830. However, just prior to the roll upset a disturbance can be clearly seen in both vertical and lateral accelerations beginning at elapsed time of 11828. This disturbance precedes the roll upset, and is characteristic of an external disturbance (atmospheric or wake) acting on the aircraft. It is clear that these changes in acceleration and the resulting roll upset are not due to any control input from the aircraft.

While it was reported that the aircraft was on autopilot at the beginning of the upset, data show the pilot applied appropriate wheel and rudder to counter the roll beginning at an elapsed time of 11830.

The one control wheel data point at 11929 may be the autopilot attempting to maintain heading / lateral navigation, as this is within the flaps 1 autopilot wheel authority limit. This wheel input occurs after the initiation of this event, and could not have induced this roll and acceleration upset.

Between 27 and 28 seconds a sharp lateral accel was felt by the airplane and the bank angle was driven off the 30 degree limit to approx. 25 degrees. This change in bank command from the desired bank angle of 30 degrees resulted in an autopilot wheel command of approx 26 degrees which is the flaps 1 autopilot limit. Between 28 and 29 seconds the airplane banked to 50 degrees and the wheel responded by reversing direction to the approx autopilot flaps down limit in the other direction, which it held for one more data frame as the airplane continued to roll to 60 degrees. Somewhere between 28 and 30 seconds the autopilot dropped to Roll CWS and disconnect occurred between 38 and 40 seconds.

The autopilot can move the wheel at approx 60 deg/sec within the limits of the aileron force limiter. The wheel rates and wheel directions which occur between 27 and 29 seconds are those to be expected from the autopilot responding to the externally induced roll rates.
