**Submission to the  
National Transportation Safety Board  
for the**

**Alaska Airlines Flight 261  
Accident Investigation**

**The Boeing Company**

**23 August 2002**

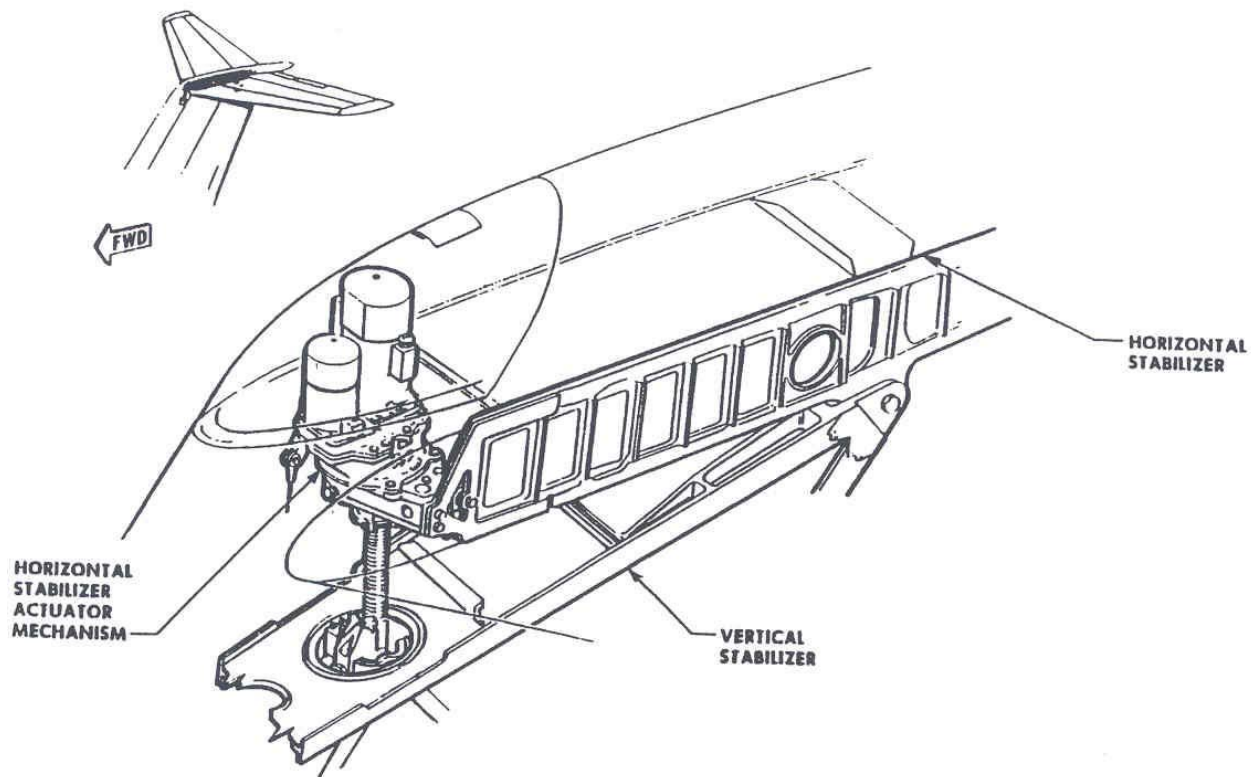
**Figure 1. Horizontal Stabilizer Trim System**

is actuated by a jackscrew mechanism (“jackscrew assembly”) that is housed within the jet’s vertical stabilizer (fig. 1).

Attached to the top of the vertical stabilizer, the jackscrew assembly (fig. 1) comprises an acme screw about 2 ft long that is mounted in a gimbal-mounted acme nut. When the flight crew adjusts the airplane’s pitch trim while hand-flying, or when the autopilot commands a new pitch trim during automated flight, the assembly’s electric motors, operating through a gearbox mounted to the front of the horizontal stabilizer, rotate a titanium torque tube that is mounted inside the hardened steel acme screw. In turn, this torque tube rotates the acme screw inside the acme nut, thus raising or lowering the leading edge of the horizontal stabilizer. The resultant vertical positioning establishes the angle of attack of the horizontal stabilizer, and thus the Twinjet’s pitch-trim condition.

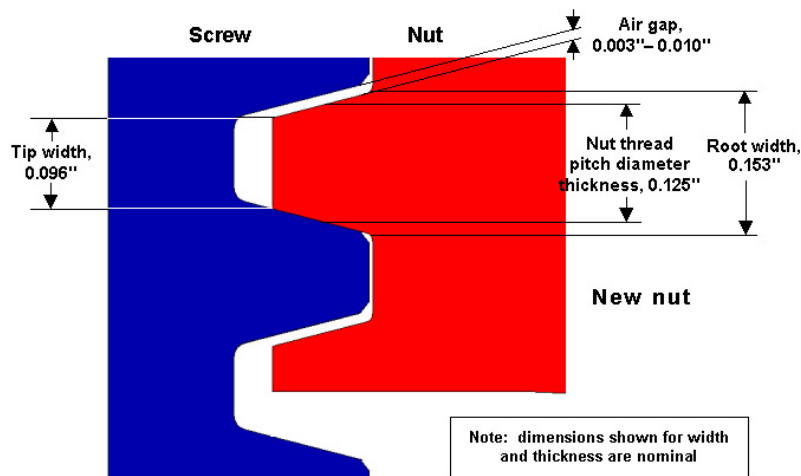
**Figure 3. Interface of Screw and Nut Threads, New Jackscrew Assembly**

Because wear occurs almost entirely in the acme nut threads, Douglas designed this nut to be robust (i.e., significantly oversized). When new, the cross-sectional thickness of a single nut thread at the pitch diameter is 0.125 in.<sup>8</sup> (fig. 3). The 32 nut threads that are in contact with the threads of the acme screw define a structural shear area of approximately 20 inches square. This design and the acme nut material properties together provide at least 1.3 million lb. of structural load capability.<sup>9</sup> This robust capability decreases over time as a function of material loss due to the wearing of the nut threads. When the

<sup>8</sup> At its root, the acme nut thread is 0.153 in. thick and at its tip 0.096 in. thick. See figure 3 for these dimensions.

The endplay check measures the air gap present between the thread flanks of the screw and those of the nut in which it is mounted. Because the aluminum-bronze threads of the acme nut have a different coefficient of thermal expansion than the threads of the steel screw, new jackscrew assemblies are manufactured with an air gap of 0.003 to 0.010 in. between the screw and nut threads<sup>22</sup> (fig. 3). This initial gap (which also is the initial endplay value) slowly widens over many thousands of airplane flight-hours as trimming causes wear in the jackscrew assembly.

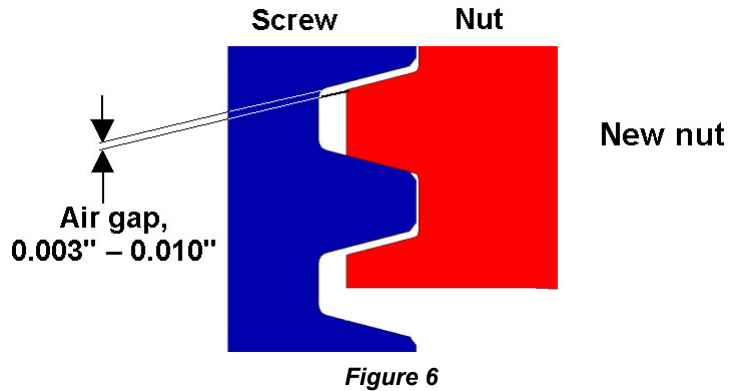
The series of illustrations beginning at right depicts the evolution of this nut thread remnant. Figure 6 shows the cross section of the individual threads of a newly manufactured jackscrew unit. Note that the air gap between the thread flanks of the nut and screw is very small, and that the air gap (and thus the initial endplay measurement) of a new jackscrew unit is 0.003 to 0.010 in.

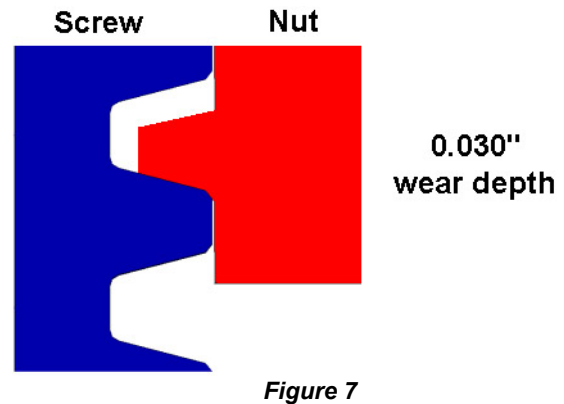
Figure 7 illustrates a nut that has worn to a depth of 0.030 in. At nominal wear rate, this value is consistent with approximately 30,000 flight-hours of in-service use.

The measured endplay value for a jackscrew unit worn to this degree will be between 0.033–0.040 in. (i.e., the initial air gap plus the subsequent wear). Jackscrew assemblies must be replaced at endplay values greater than 0.040 in.

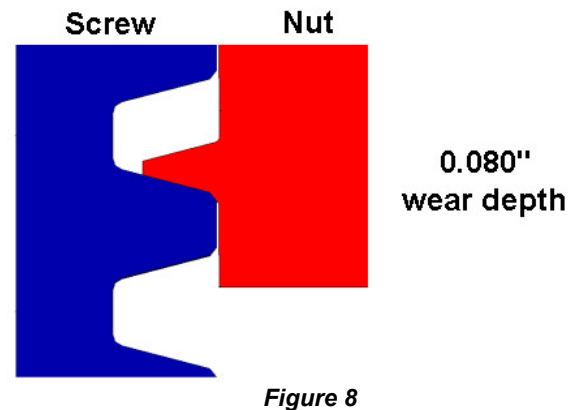
Figure 8 shows the acme nut threads worn to a depth of 0.080 in., which is equivalent to a measured endplay reading of 0.083 to 0.090 in.—more than two times the removal threshold.

Up until this point, the load is distributed relatively uniformly across the flank of the nut thread and the wear rate is predicted to be constant (assuming that the basic environmental conditions are unchanged).<sup>39</sup> Even when worn to this degree, the threads of the acme nut retain more than five times the strength needed to support the ultimate design load.

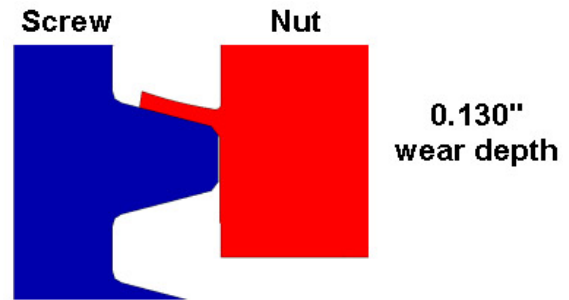
Figure 9 represents the acme nut thread worn to a wear depth of 0.130 in.<sup>40</sup> Note that although the acme nut threads are still able to support normal operating loads, the remaining nut thread's shape is now being noticeably deformed. As noted above, this increasing deformation leads to an ever-increasing rate of wear.
