**FedEx Flight 14
MD-11-F, N611FE
Newark, New Jersey
31 July 1997
DCA97MA055**

**Proposed Findings
Boeing—Long Beach Division**

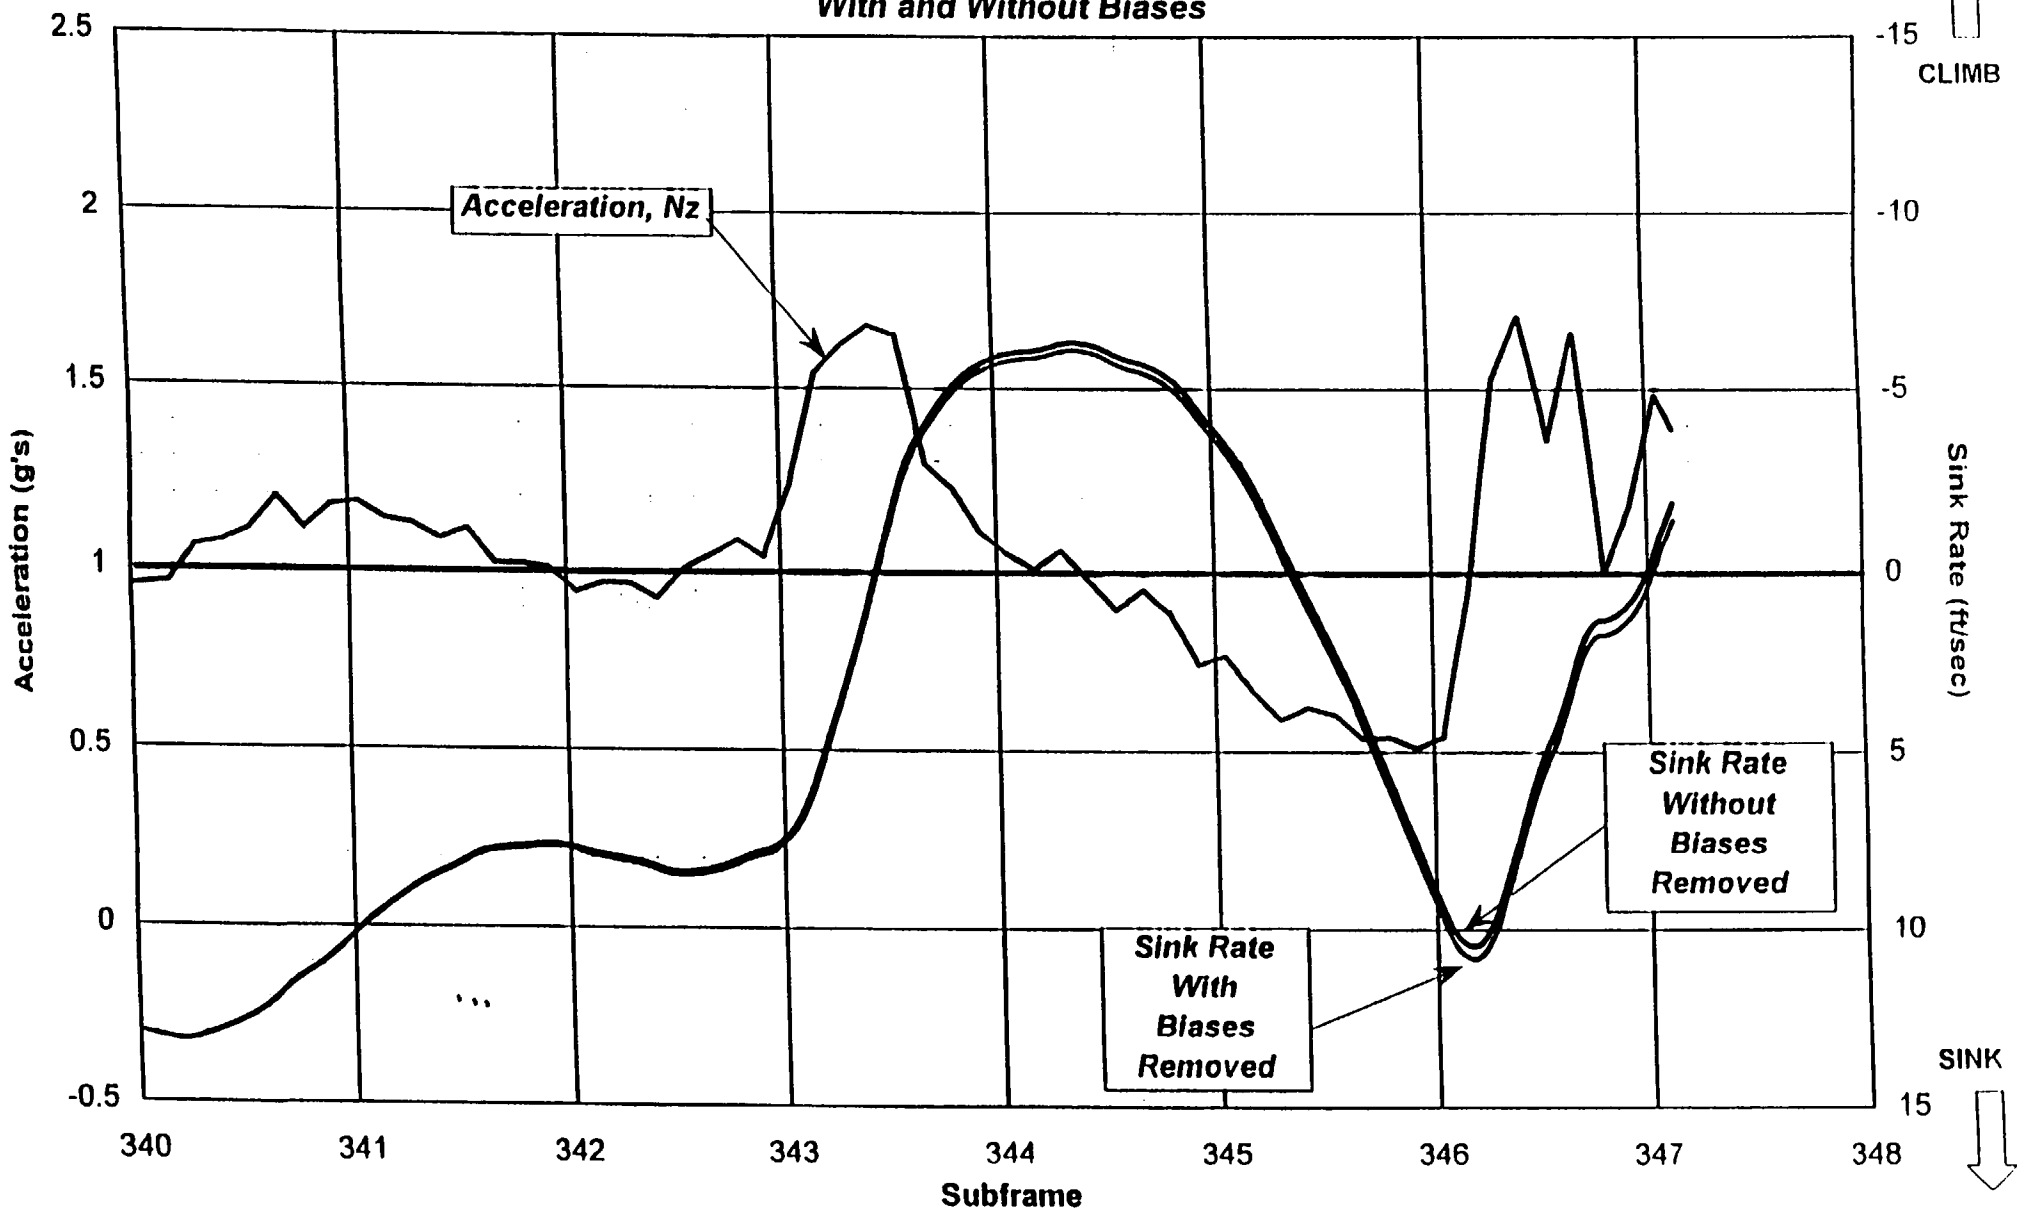
FedEx MD-11 Newark Accident
Recorded Vertical Acceleration and Aircraft's CG Sink Rate
With and Without Biases

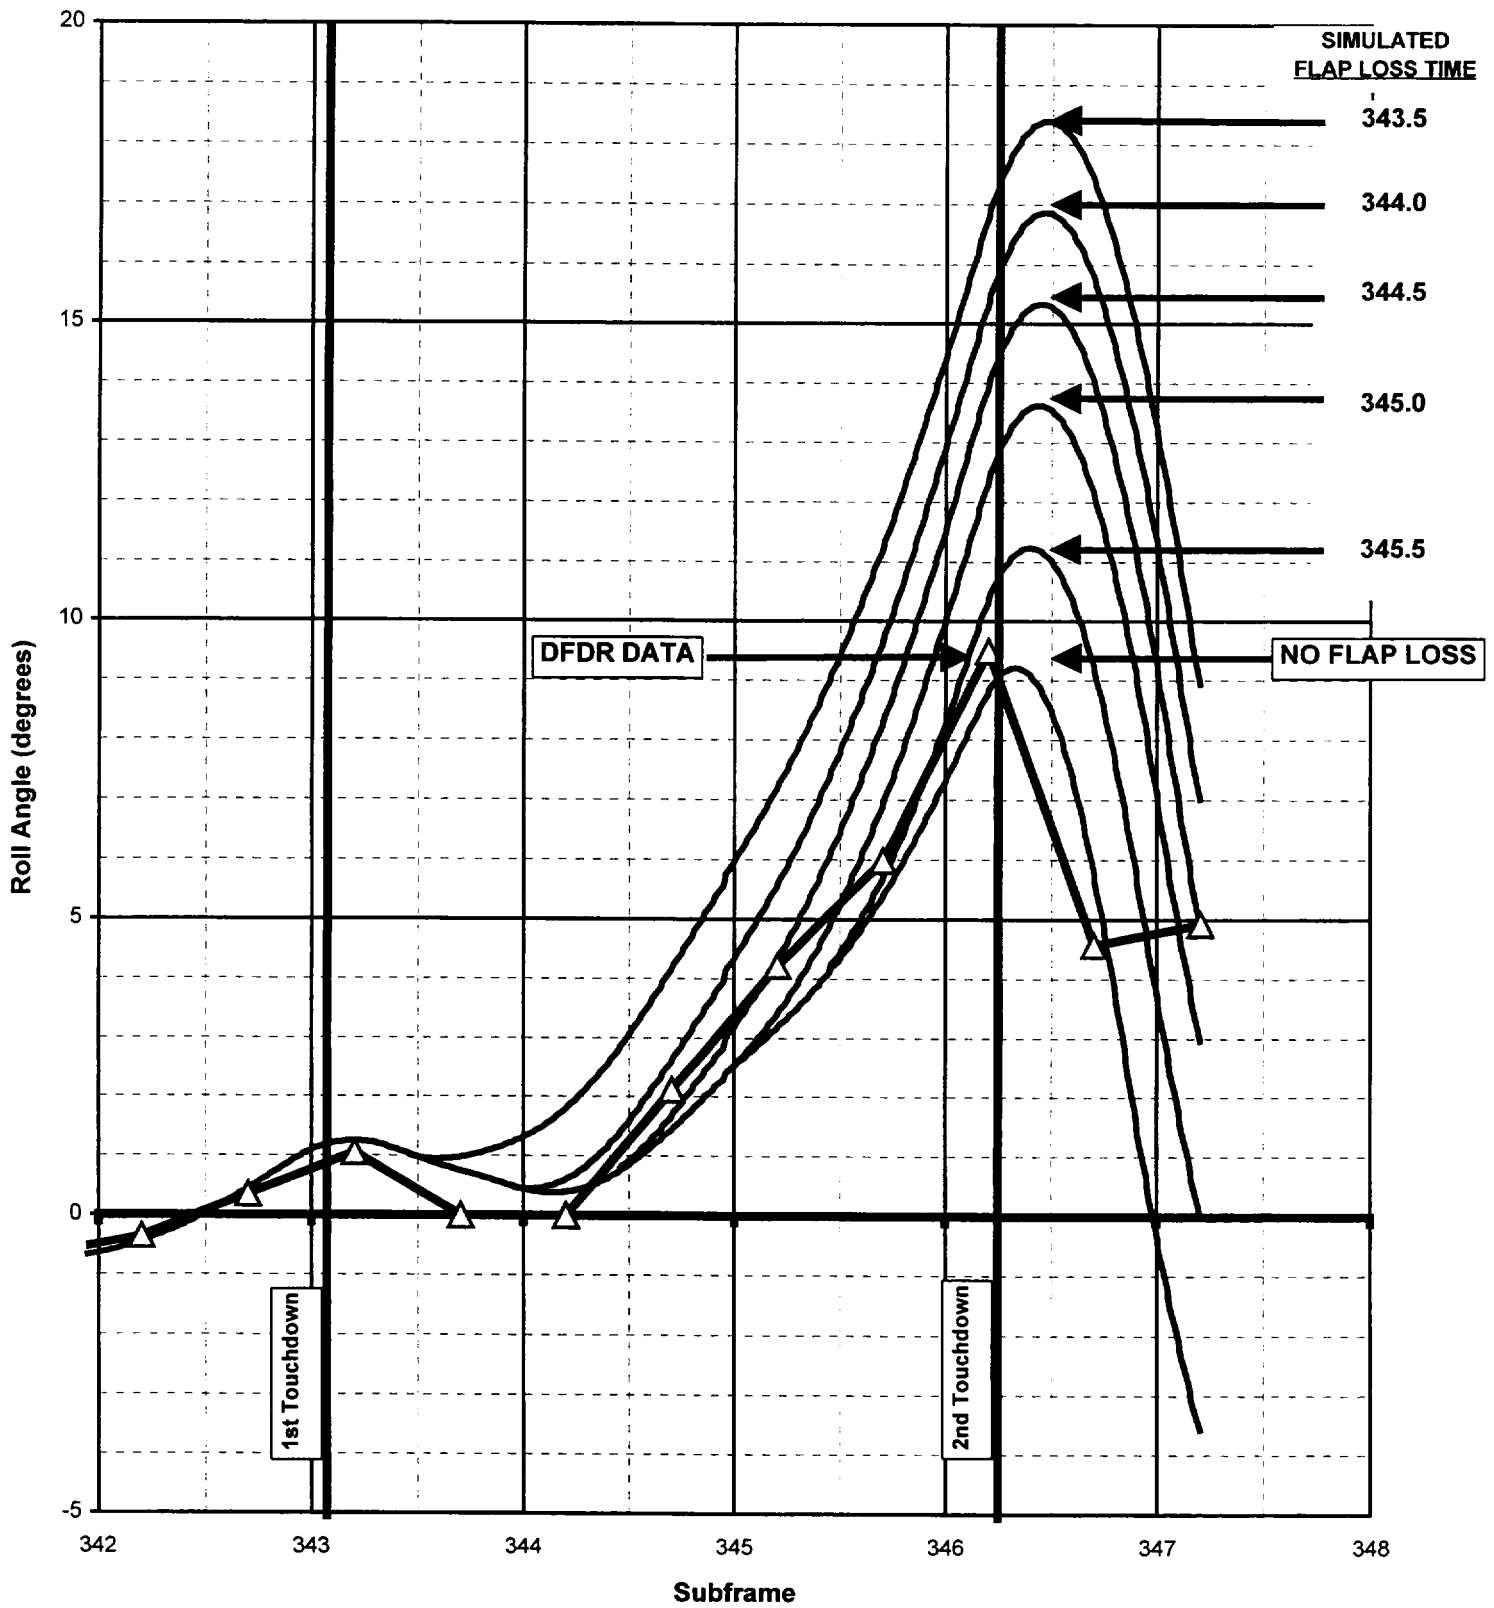
FEDEX MD-11 Newark Accident - Inboard Flap Departure Investigation
Aircraft Roll Response Following Simulated RIB Flap Failures in Comparison to DFDR Data

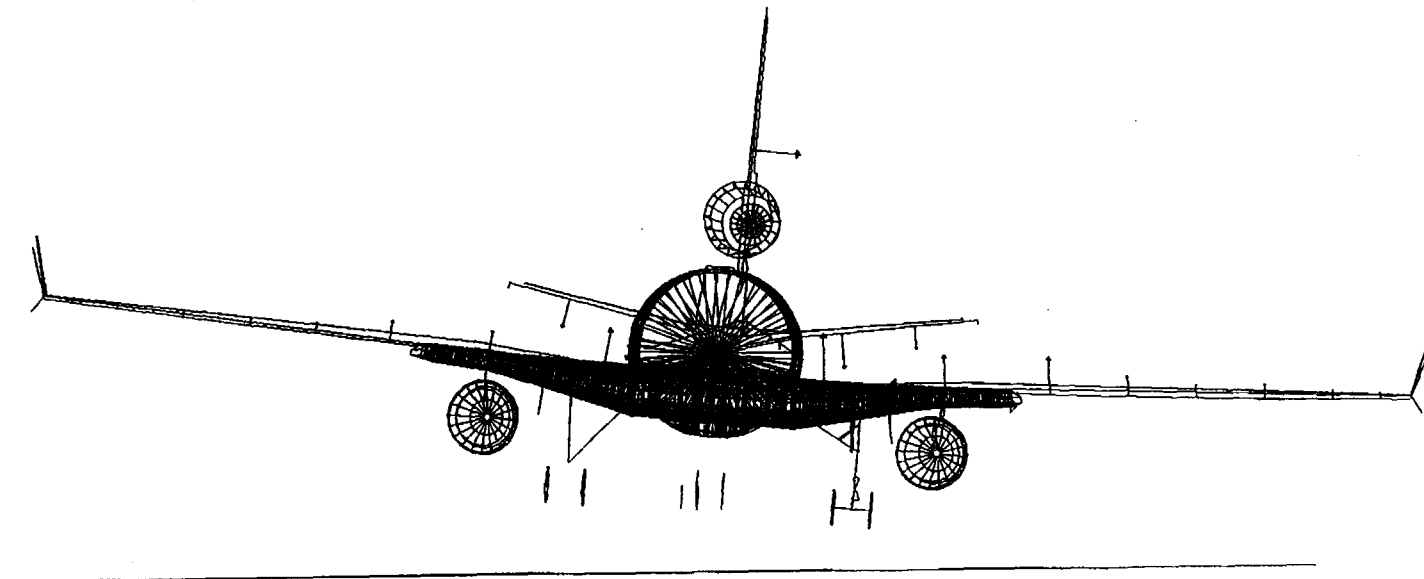
Figure 1

This theory was simulated using a modified ADAMS idealization by analytically failing the inboard rear spar shear web at the appropriate load level. See Appendix 5.11, Figures 1 and 2.

Just Prior to 2nd Touchdown Impact

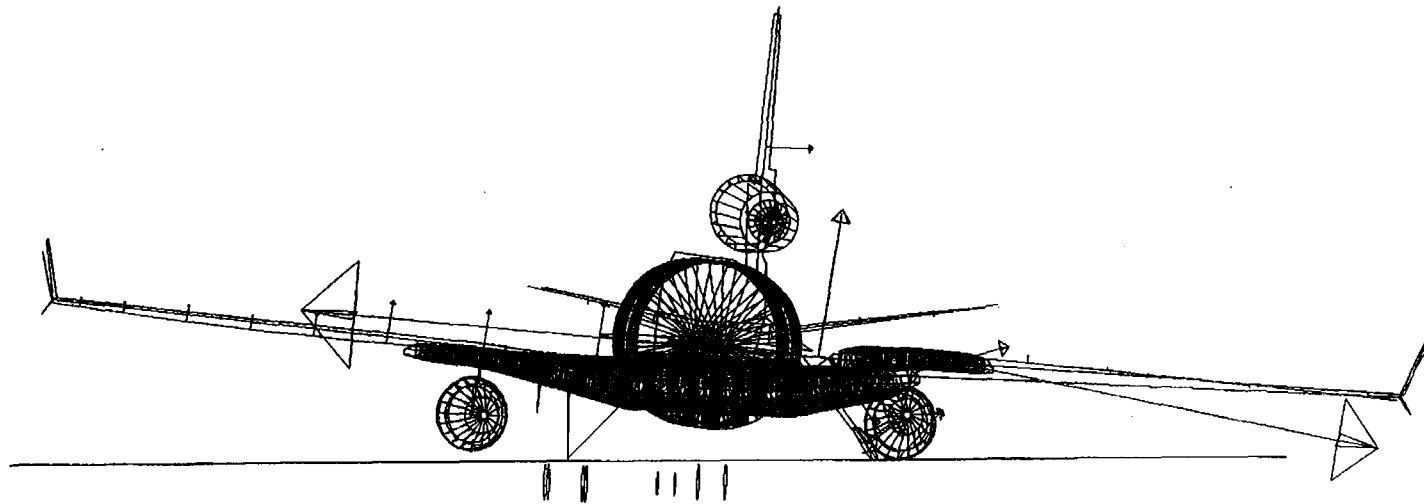
which would allow for sequenced failures so an “extreme case” single-failure idealization was used. In this idealization the entire wing cross-section was analytically failed just inboard of the landing gear support (264) bulkhead. See Figure 3 in Appendix 5.11. Please note that the models of the left and center main landing gears and the nose landing gear are simplified such that they appear to penetrate the ground plane in Figures 2 and 3 of Appendix 5.11

After second touchdown impact. Entire-wing-cross-section-failed idealization.
