Our reference no.: CL600-2B16.5194.23-5-12

Subject: Challenger 601-3R N207JB (A/C 5194), In-Flight Main Passenger Door

Separation Accident, 23 May 2012, Hallandale, Florida

Challenger 601-3R N207JB (A/C 5194) In-Flight Main Passenger Door Separation Accident May 23, 2012 Hallandale, Florida

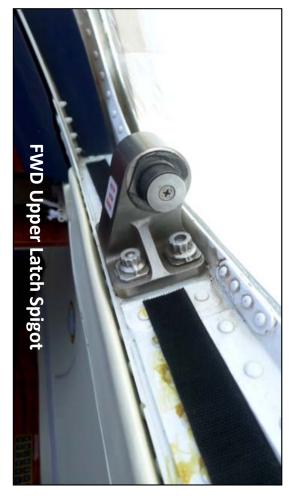
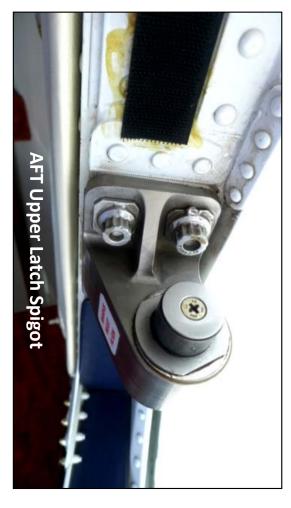
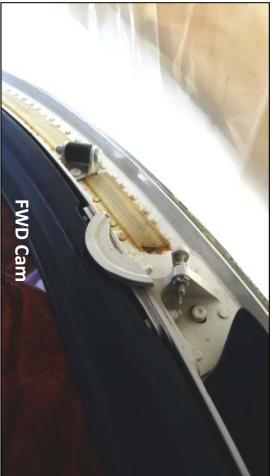
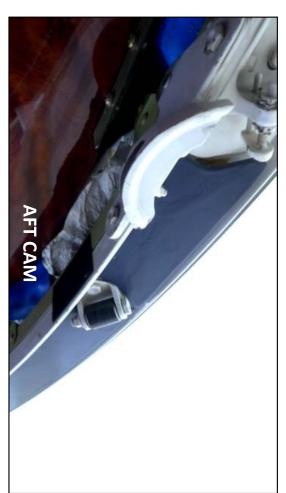
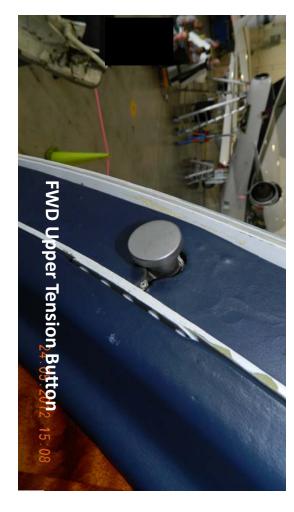
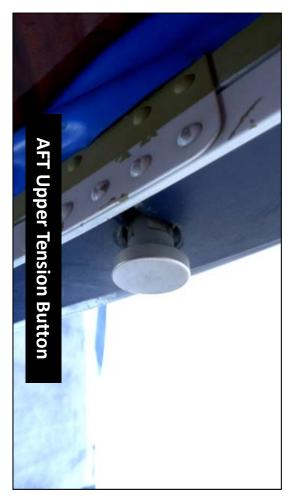
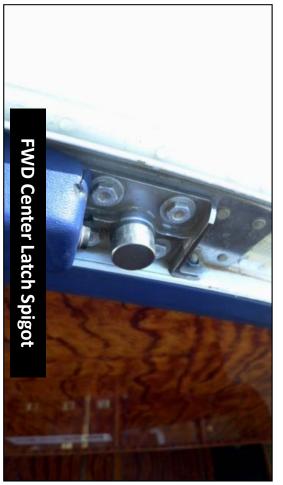
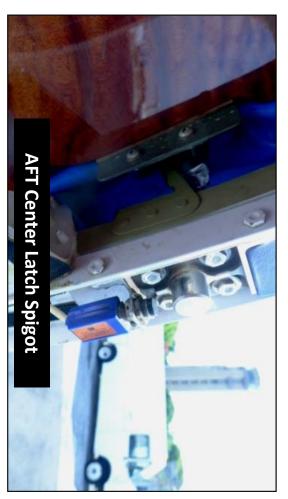
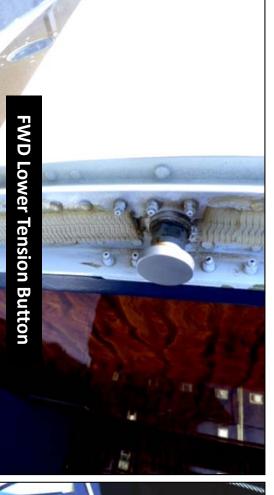
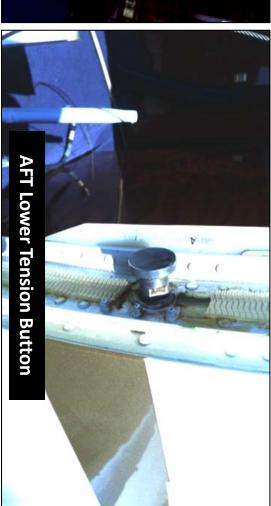
Note: ITEM 10 9 ∞ 7 6 G 4 ω \vdash 2 Aircraft had approximately 4,913 hrs and 2,492 landings at the time of the accident Aft upper tension button Forward upper tension button Aft roller Forward roller Forward stop Aft cam (Pull-in lever) Forward cam (Pull-in lever) Aft upper latch spigot Forward upper latch spigot Aft stop PART / AREA / CHECK 4. AIRFRAME (MAIN PASSENGER DOOR AREA) INFORMATION Found no evidence of visible anomalies or structural failure Found no evidence of visible anomalies or structural failure Found no evidence of visible anomalies or structural failure Found no evidence of visible anomalies or structural failure Found no evidence of visible anomalies or structural failure Found no evidence of visible anomalies or structural failure Found no evidence of visible anomalies or structural failure Found no evidence of visible anomalies or structural failure Found no evidence of visible anomalies or structural failure Found no evidence of visible anomalies or structural failure CONDITION

16	15	14	13	12	11	ITEM	
Door electrical harness interface	Door mechanical interface	Aft lower tension button	Forward lower tension button	Aft center latch spigot and proximity switch	Forward center latch spigot and proximity switch	PART / AREA / CHECK	4. AIRFRA
 Found severed and approximately two (2) feet of electrical wiring was dangling from connector P2MB The severed wires contained four (4) power wires and were free to make contact with the airframe in flight Any one of the four (4) power wires in the bundle could create a short circuit if it were to come into contact with the airframe and can potentially trip circuit breakers CB-D17 and CB-B160 	Found severed	Found no evidence of visible anomalies or structural failure	Found no evidence of visible anomalies or structural failure	Found no evidence of visible anomalies or structural failure	Found no evidence of visible anomalies or structural failure	CONDITION	4. AIRFRAME (MAIN PASSENGER DOOR AREA) INFORMATION

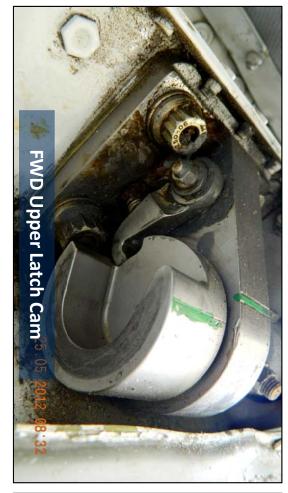
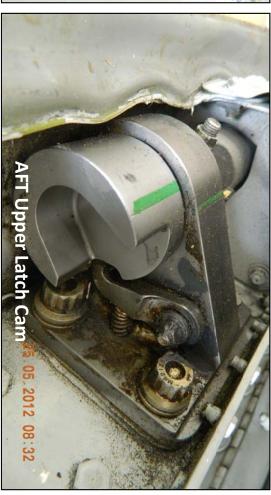
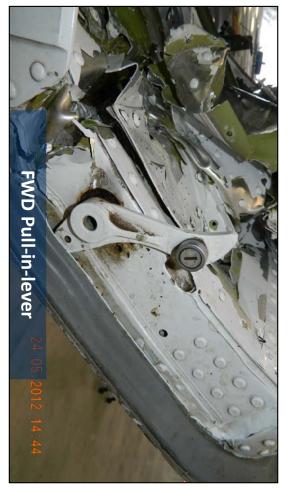
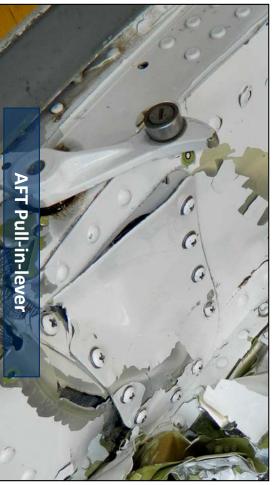
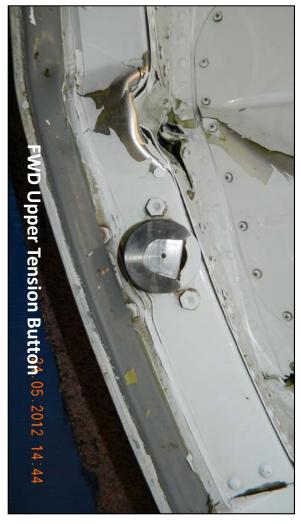
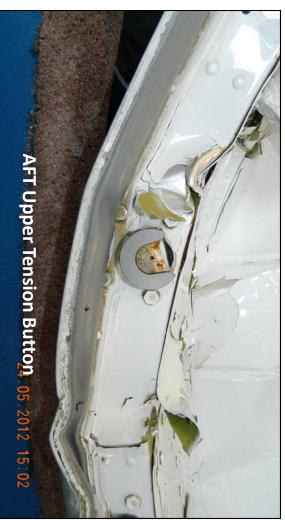
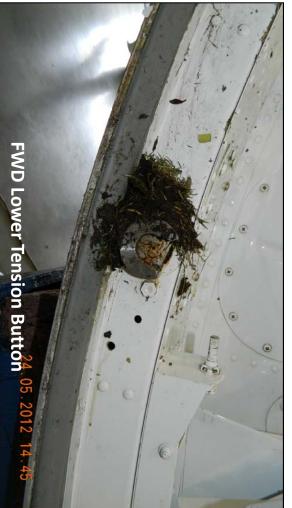
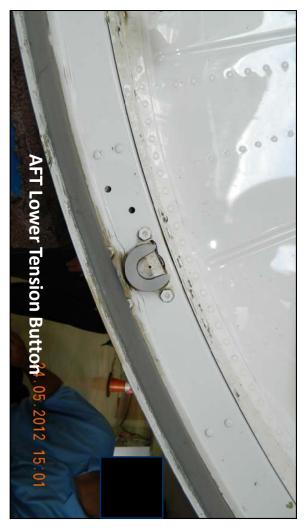
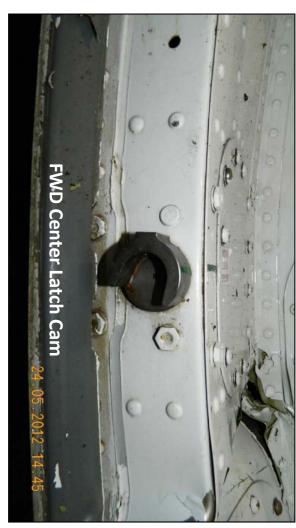
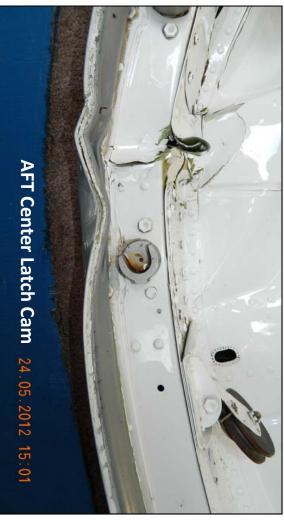
5. MAIN PASSENGER DOOR INFORMATION
ITEM	PART / AREA / CHECK	CONDITION
Ъ	Forward upper latch cam and proximity switch	 Found no evidence of visible anomalies or structural failure The green alignment marks were present and visible When manipulating its associated linkage, the latch cam rotated
2	Aft upper latch cam and proximity switch	 Found no evidence of visible anomalies or structural failure The green alignment marks were present and visible When manipulating its associated linkage, the latch cam rotated
ω	Support leg	Found severed
4	Forward pull-in lever	Found no evidence of visible anomalies or structural failure
О	Aft pull-in lever	Found no evidence of visible anomalies or structural failure
6	Forward tension fitting	Found no evidence of visible anomalies or structural failure
7	Aft tension fitting	Found no evidence of visible anomalies or structural failure
∞	Forward center latch cam	 Found no evidence of visible anomalies or structural failure The green alignment marks were present and visible

9	Aft center latch cam	 Found no evidence of visible anomalies or structural failure The green alignment marks were present and visible

16	15	14	13	12	11	10	ITEM	
Pushrod between upper latch cams and center latch cams	Aft handrail	Forward handrail	Door upper half	External handle	Pull out handle	Internal handle	PART / AREA / CHECK	
Found severed at lower rod end with evidence of compression load failure	Found severed	Found severed	Found crushed with evidence of compression load failure	 Found no evidence of visible anomalies or structural failure When operated by hand, the forward and aft center latch cams, the internal handle and their associated linkages operated normal When centered horizontal, the handle would retract in its stowed position 	 Found handle bend approximately 20 degrees opposite from its contour Found handle in its stowed position with the bend portion standing proud and was difficult to extend Found its linkage to the internal and external handles severed from tension loads 	 Found no evidence of visible anomalies or structural failure When operated by hand, the forward and aft center latch cams, external handle and their associated linkages operated normal 	CONDITION	5. MAIN PASSENGER DOOR INFORMATION

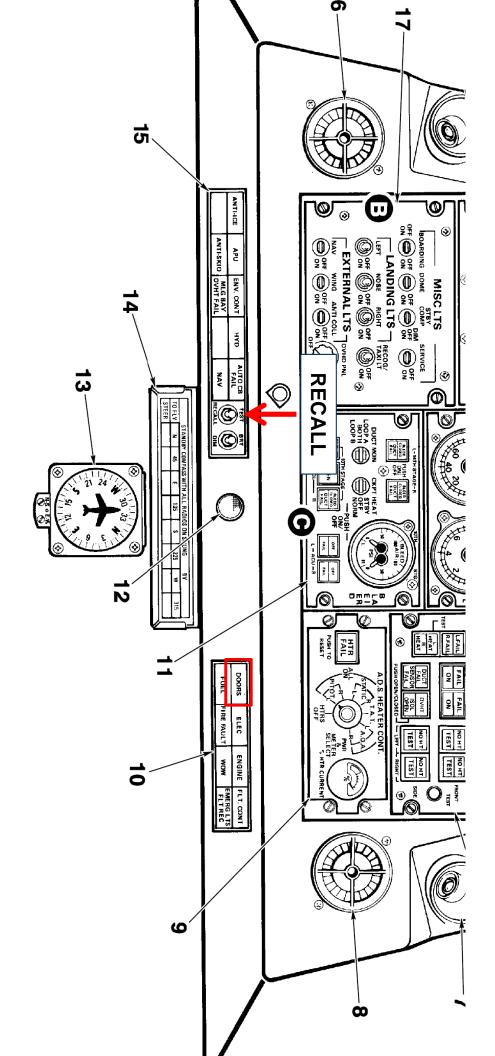
Overhead Panel

a) The DOORS caution light on the 8-CHANNEL ANNUNCIATOR PANEL illuminated when the cockpit was electrically powered up and extinguished normally when pressing the master caution button b) The DOORS caution light on the 8-CHANNEL ANNUNCIATOR PANEL was successfully recalled when the RECALL switch, located on the 10-CHANNEL ANNUNCIATOR PANEL, was selected 	The following was found during the illumination check of the door warning lights: a) The PASS DR UNLKD light, on the cockpit CABIN & DOOR SIGNS PANEL ASSEMBLY, was not illuminated when the cockpit was electrically powered up due to the severed door interface circuitry Note: The PASS DR NOT RDY, PASS DR READY lights do not illuminate if the door is opened normally on the ground b) The PASS DR NOT RDY, PASS DR UNLKD and PASS DR READY lights on the CABIN & DOOR SIGNS PANEL ASSEMBLY illuminated when tested with the cockpit pushto-test switch located on the pilot's side console	Found the CABIN & DOOR SIGNS PANEL ASSEMBLY, on the cockpit center pedestal , not in the factory certified location Note: The factory certified location is in the center lower portion of the cockpit center pedestal	Found no anomalies with the master caution warning system	CONDITION	9. MAIN PASSENGER DOOR WARNING SYSTEM INFORMATION
