National Transportation Safety Board

Marine Accident Brief

Allision of *Amy Frances* Tow with Natchez–Vidalia Highway 84 Bridge

Accident no.	DCA16FM020
Vessel names	<i>Amy Frances</i> , MM-46
Accident type	Allision
Location	Lower Mississippi River at mile marker 363.3 at Natchez, Mississippi 31°33.6' N, 091°25.2' W
Date	January 21, 2016
Time	1247 central standard time (coordinated universal time – 6 hours)
Injuries	None
Property damage	>\$542,000 est.
Environmental damage	24,654 gallons of catalytic cracked clarified oil
Weather	Visibility 10 miles, winds south at 10 mph, air temperature 71°F
Waterway information	The Lower Mississippi River near mile marker 363.3 was under an extreme high-water safety advisory from the US Coast Guard Captain of the Port due to “hazardous conditions associated with strong currents, severe outdrafts, [and] missing/off-station aids to navigation and diving buoys.”

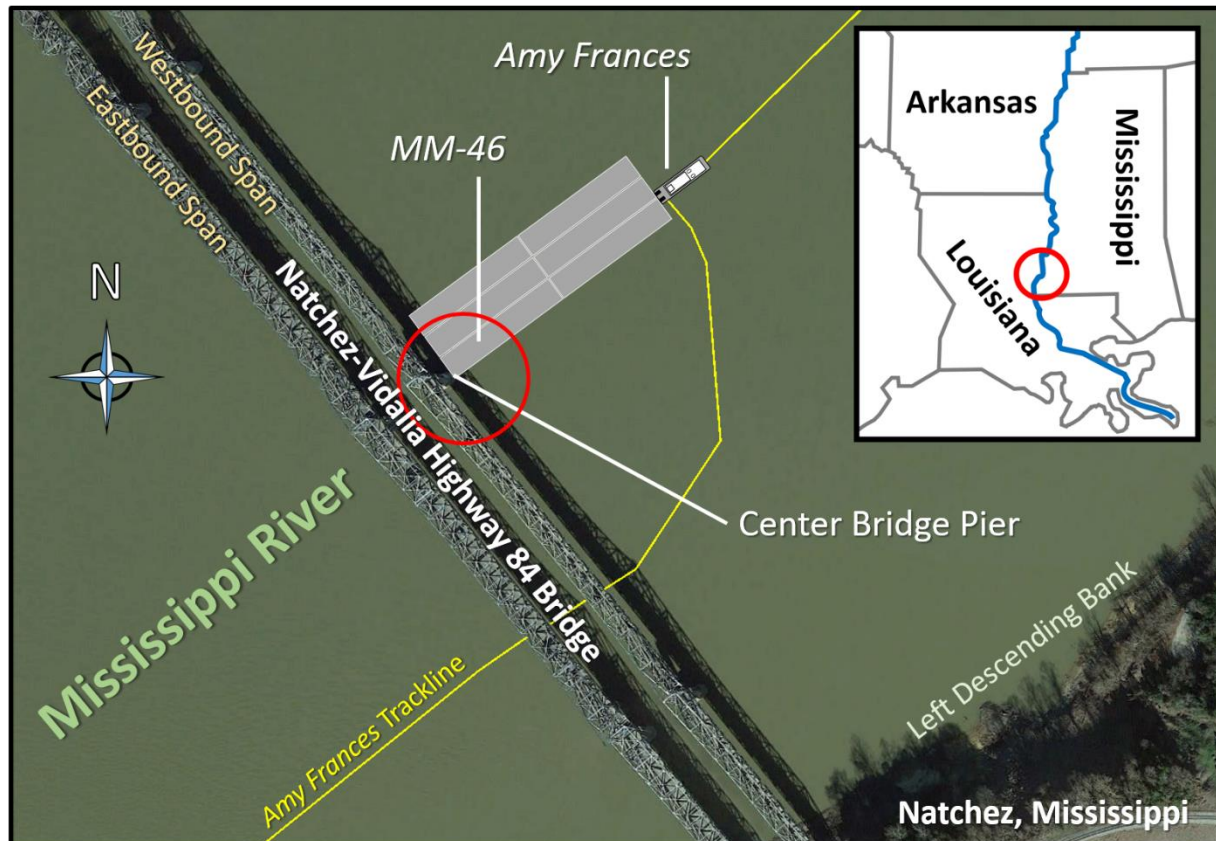
Satellite image of the accident site overlaid with a graphical depiction of *Amy Frances* tow and automatic identification system (AIS) track data. (Background by Google Earth Pro).

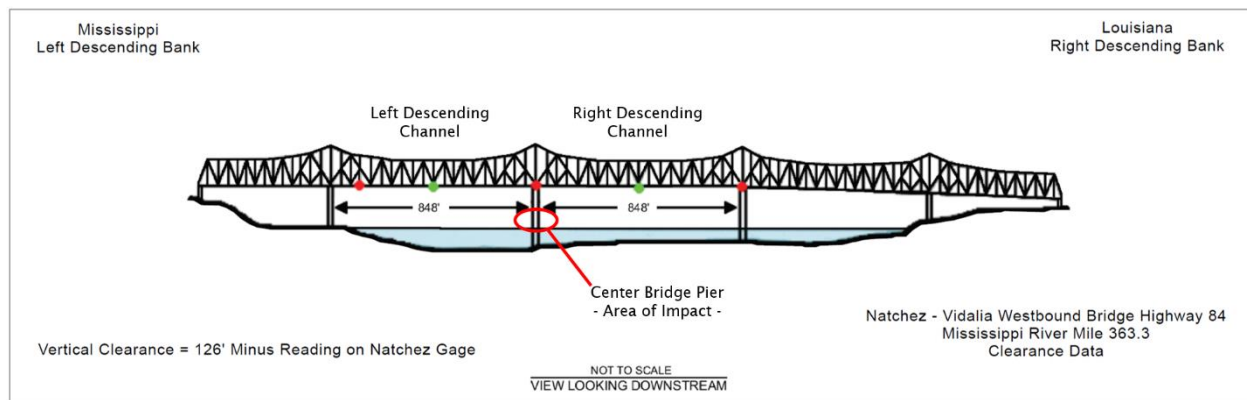
Natchez–Vidalia Highway 84 Bridge. (Diagram by US Army Corps of Engineers)

The Natchez–Vidalia Highway 84 Bridge has twin cantilever-style bridges that connect the cities of Natchez, Mississippi, and Vidalia, Louisiana. The upriver span is for westbound vehicular traffic and the downriver span for eastbound traffic. Both spans have six concrete piers—structures designed to support the spans—as pictured above. Three of the piers on each span form two main channels for vessels to navigate, the left descending channel and the right descending channel. The Army Corps of Engineers chart for the Lower Mississippi River lists the horizontal distance between the main channel piers as 848 feet, while the Coast Guard Light List states the distance

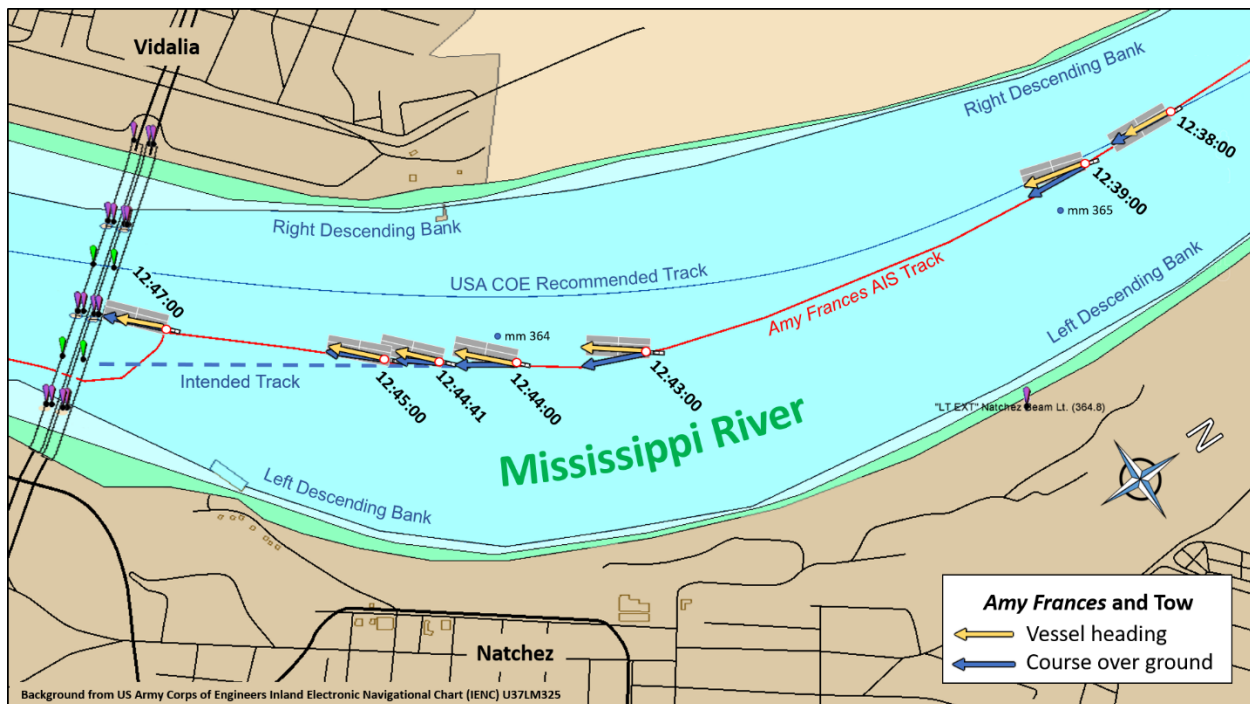
Per ECS, shortly after 1238 the vessel's heading began to shift to the right. By 1239, it was steering 196 degrees but still making good a course of 182 degrees. At 1243, as it passed mm 364.2, the *Amy Frances* was heading 228 degrees while making a course good of about 200 degrees—toward the left descending bank. At 1243:12, the vessel's heading remained the same but the course made good began coming to the right. At 1244:00, the speed was 12.9 mph, the heading was 236 degrees, and the course made good was 215 degrees. A steady course made good of 215 degrees would have, by ECS, carried the tow through the left descending channel. However, ECS showed the course made good continued to change to the right. Twenty-seven seconds later, at 1244:27, the vessel was still heading about 236 degrees. Since the course made
